ASSESSMENT OF JAHN PERMEABLE MORTAR SYSTEM IN A HISTORIC BRIDGE ABUTMENT APPLICATION

Ian Anderson, Research Engineer
Vermont Agency of Transportation
Research Section

January 2019

Final Report 2019-01

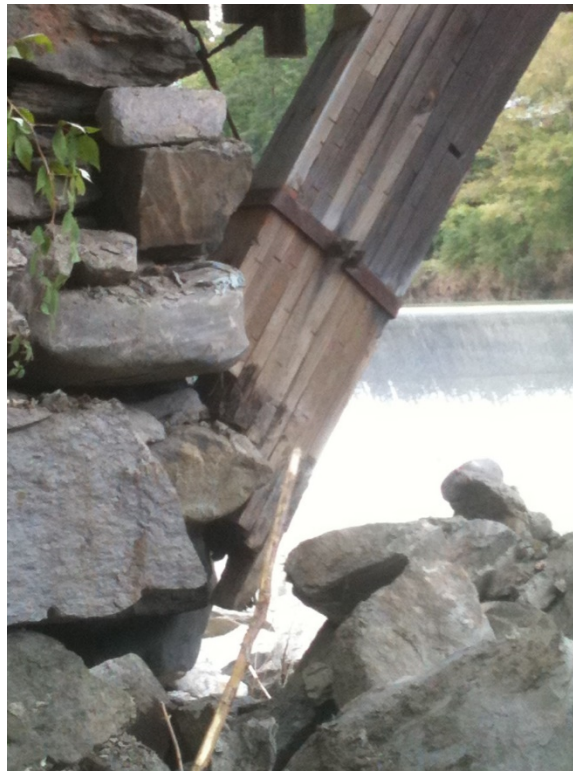
The flooding eventually undermined the western abutment at the downstream end. The abutment fractured, resulting in the downstream western arch to pull out of the stone socket securing it in place (Figure 11). In turn, the western span twisted, causing damage at connections throughout both spans. The covered bridge was scheduled for a nearly \$3 million National Covered Bridge rehabilitation project that was scheduled to begin in September 2012. Much of the work that was planned for that project was incorporated in the project resulting from the storm activities.

Figure 11: Downstream western arch dislodged from abutment

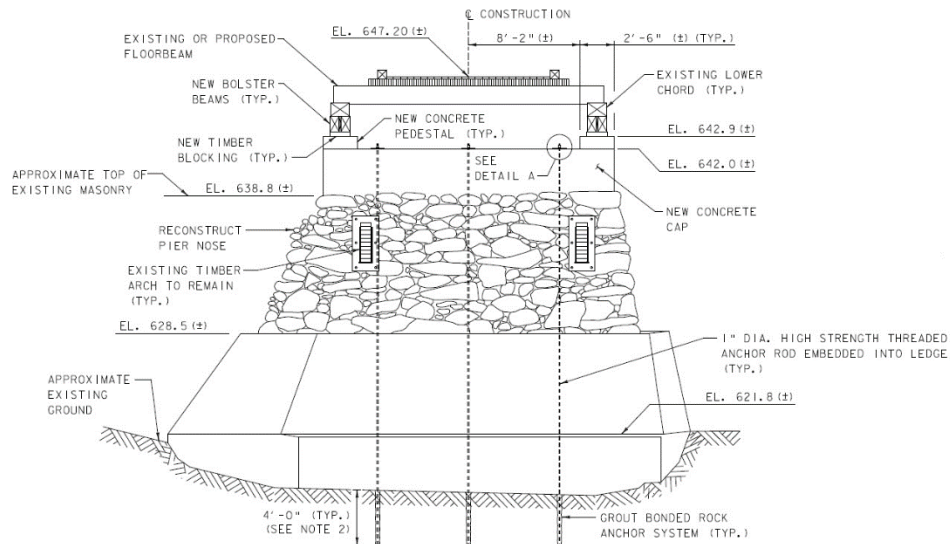
Figure 13: Details of the Bridge Pier

Alpine constructed an enclosure around the pier (Figure 13) and on February 5, 2013, the stonemasons began initial application of the Jahn Pointing Mortar on the western face of the pier. The purpose of this initial activity was for testing and training on how to prepare the dry-laid stone for the mortar, mix the mortar to the right consistency and apply to it. Cathedral Stone Products was onsite to oversee the testing and to train the stonemasons. The contractor provided heat in the enclosure to bring the atmospheric and stone temperatures up to the specified level for stone pointing and grouting. Initial observations indicated that the mortar mix had to be adjusted initially to obtain the consistency required for pointing stones.

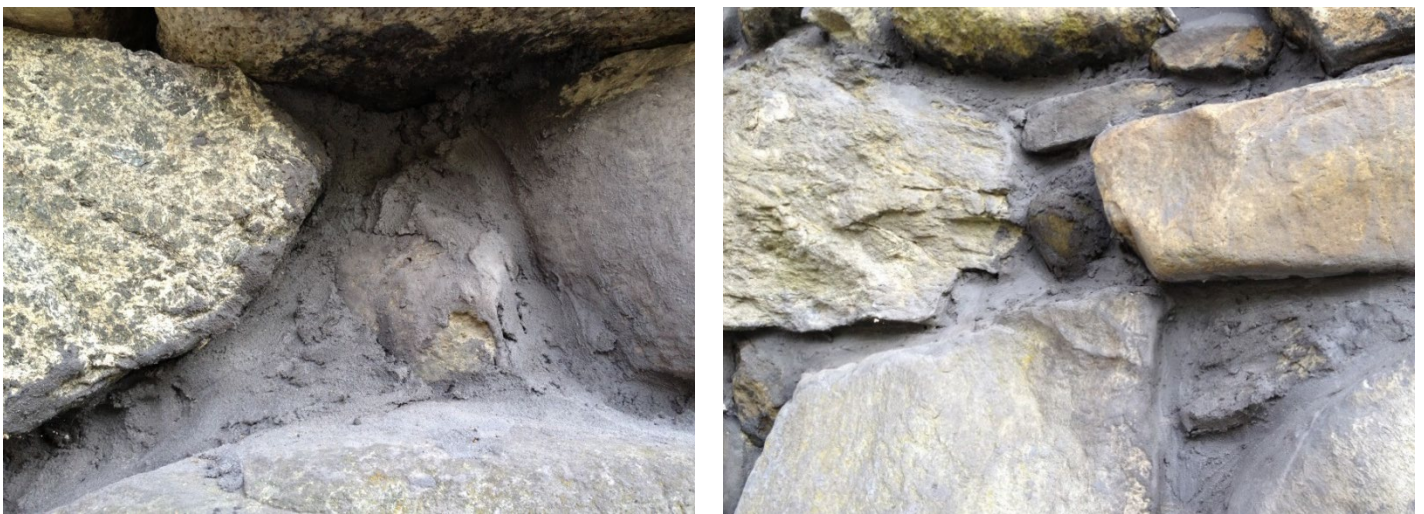
Figure 14: Up-close view of stone pointing and mortar work

The stonemason used a narrow pointed mason's trowel to pry out small loose stones and debris from the dry-laid stone joints. Using a brush or their hands, the stonemason would remove dust and dirt from within the joints. The crew had access to an air compressor, which they used to clean fines out of the joints. It was determined that a power washer would be the best option to conduct the final cleaning of the stones. Where there were gaps, the stonemason would size up a stone provided on the rigging, and fit it into the opening, carefully matching the shape of the stone to the shape of the gap. In places, several stones were required. Smaller stones were worked deep into the larger gaps (Figure 14). The stones for this work came from the collapsed western abutment that was being excavated. The larger stones were broken apart to make smaller stones for chinking.

Once the stone pointing and cleaning was complete, the stonemasons would mix a portion of the Jahn Pointing Mortar. The grout was given a blackish color to give the appearance of a void, to simulate the open joints of dry-laid stone. When cured, the color would become more of a dark gray. The stonemasons would work the mortar deep into the stone joints.

Repeated application would continue until the mortar either could no longer be worked into the joint or the stonemason felt the joints were sealed. The mortar was then worked into a smooth concave surface using a joint filler tool allowing the original stones to protrude out to maintain their original appearance.

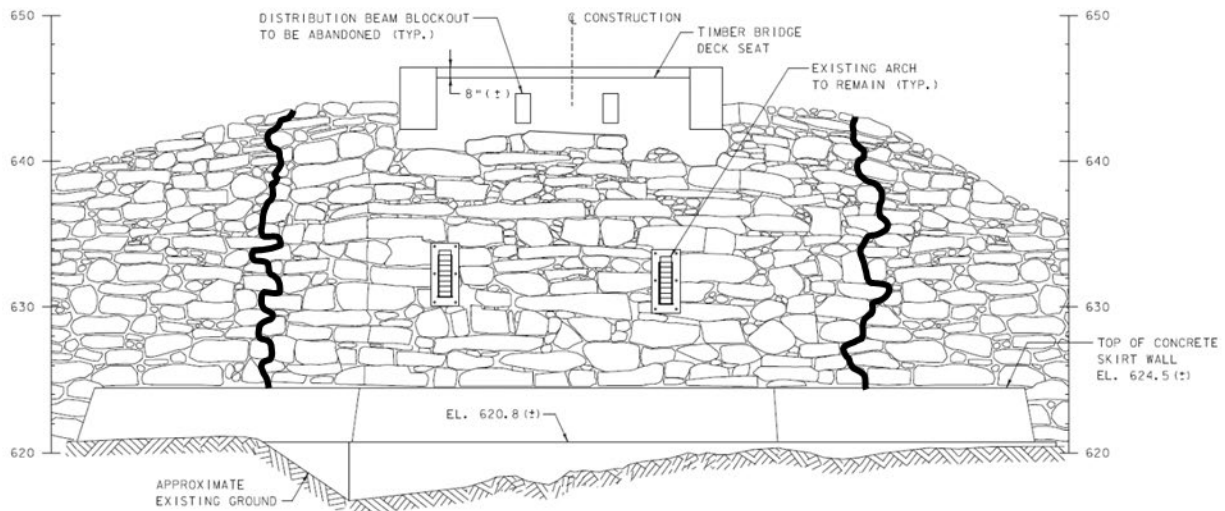
Figure 15: Details of the Eastern Abutment (dark lines shows extent of pointing)

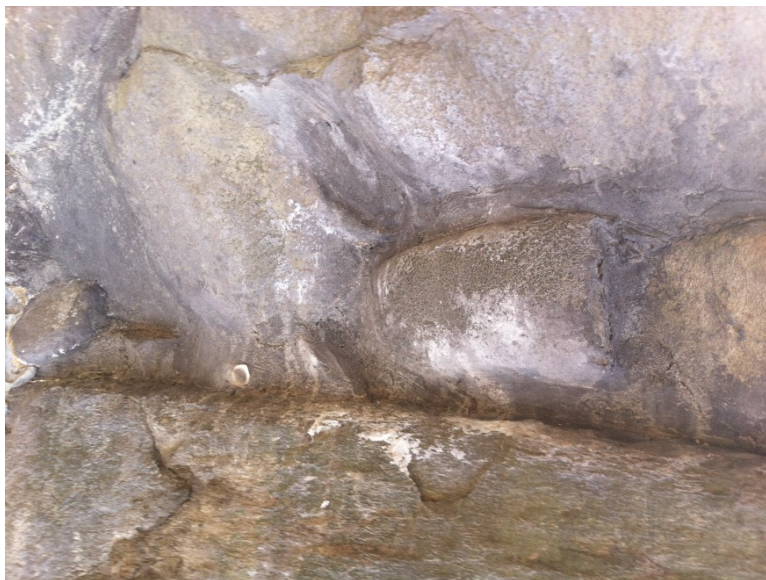
Research and Development has visited the project site once a year since the project was completed until 2017. In a discussion with the CEO of Cathedral Stone Products, Denis Rude, he said that as the salts leach out of the interior of the pier and abutment, a white powder like substance would appear on the surface of the grout. This powder would eventually blow off the surface with wind or be washed off by rain. There were concerns that the repairs to the pier and abutment would cause an efflorescence to form in places. The use of the Jahn products was intended to prevent such efflorescence from forming. Under observations from 2013-2017, the white powdery substance has been observed forming; however, it is not accumulating (Figure 17). There seems to be a consistent light dusting in places. Overall, the grout appears to be functioning as expected.

Figure 17: Up-close view of white powdery residue on mortar (2017)

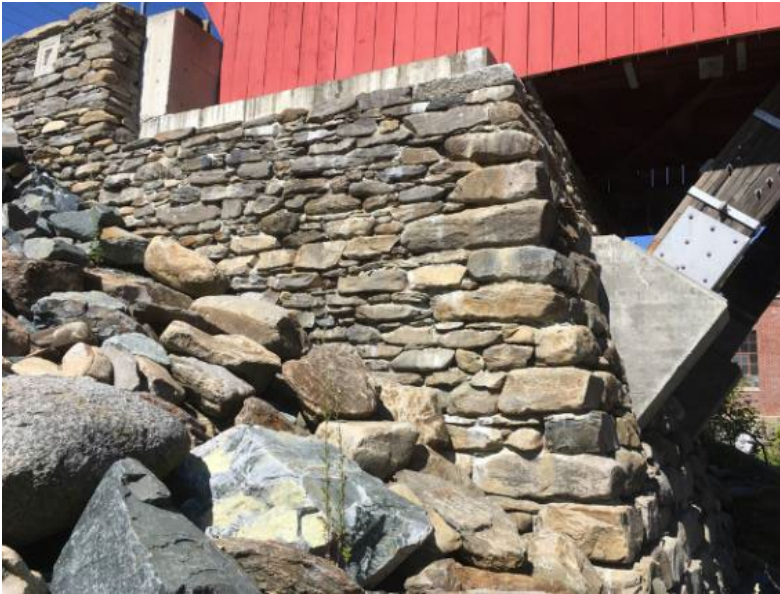
Figure 18 shows the overall view of the Southern wall of the west abutment and a close-up view of a powdery residue (most likely chlorides) leaching out of the mortar of the Southern wall of the west abutment. The observed residue stains consisted of two different colors, yellow/orange and white/gray. The yellow/orange stains might be indicating that the mortar is drawing out other minerals besides chlorides or that iron elements are deteriorating within the abutment.

Figure 18: Southern Abutment and closeup of mortar leachate (2017)

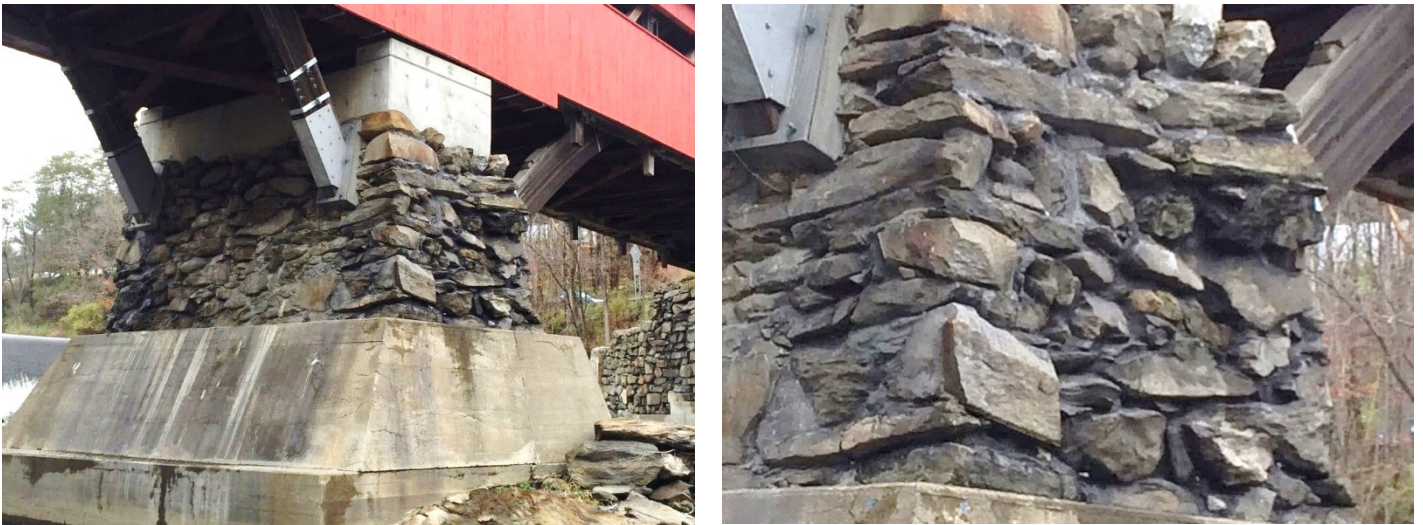
Another purpose of using the Jahn products was to strengthen the dry-laid stone pier and abutment to preserve the overall historic appearance of the bridge. Concerns were that the mortar would be obvious from a distance. Observations at various distances from the substructure units gave an appearance of dark joints between stone (Figure 19). The mortar and pointed stones were virtually invisible to the eye from afar. Even up close, the dark grey color of the mortar has aged in a way that it is not obvious in most places on each substructure unit. Places where the mortar is visible are where there were large gaps in the dry-laid stone (Figure 19).

Figure 19: Pier after Construction in 2014
