ALTERNATE PAINT SYSTEMS FOR OVERCOATING

**SPR-PL-PR-1(31)
PROJECT 12323 D
(Formerly Project 94-10, X2727)**

Research Project Conducted by
Gary L. Tinklenberg
CORROSION CONTROL CONSULTANTS & LABS, INC.
KENTWOOD, MICHIGAN

October, 2000

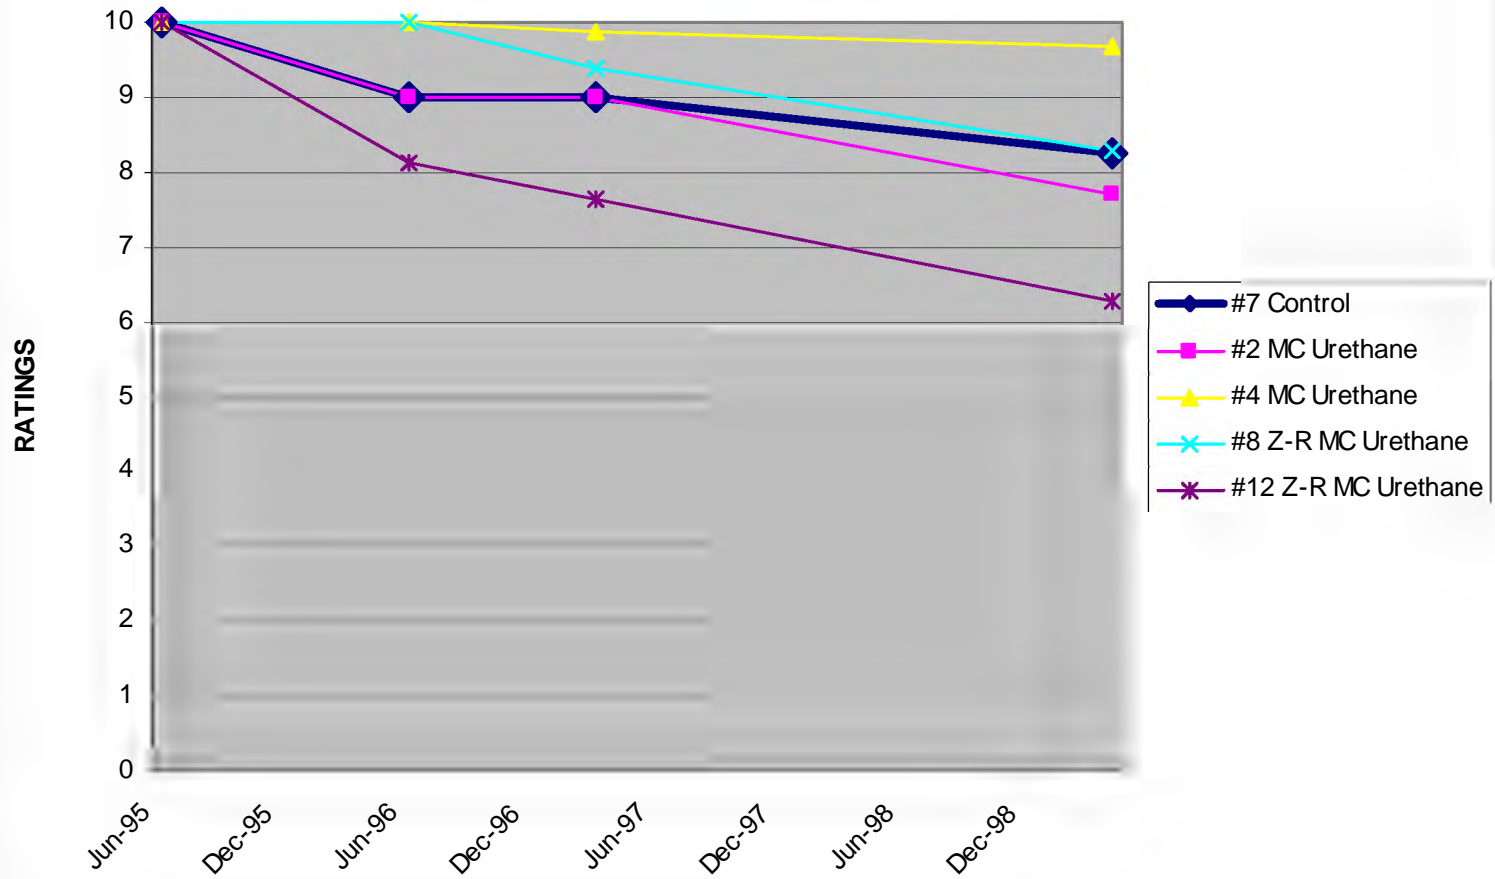
Figure 2. COMPARE PERIODIC PANEL AVERAGES (FR/BK)
of MOISTURE-CURE URETHANE SYSTEMS to PANELS AVERAGES of CONTROL

In general the three-coat urethane systems did very well. The two-coat systems rated somewhat lower, mostly as a result of their poorer performance in the previously rusted areas. A thicker film build over rust did enhance performance. Figure 2 is a comparison of the various urethane systems to the control. It should be noted that in this comparison graph and all others, the worst test panel from each set of eight (four locations, front and back) was deleted and the remaining seven panels averaged. In almost every case, the worst panel rating was the result of a delamination of the original primer. We believe that a system should not be down-graded based on one unusual data point caused by a loosely adherent existing coating. If however, there were numerous panels that had a delamination problem, it is more likely that the paint system had an effect on the adhesion of the original system. If there was no panel that delaminated, all eight values were used in the average rating.

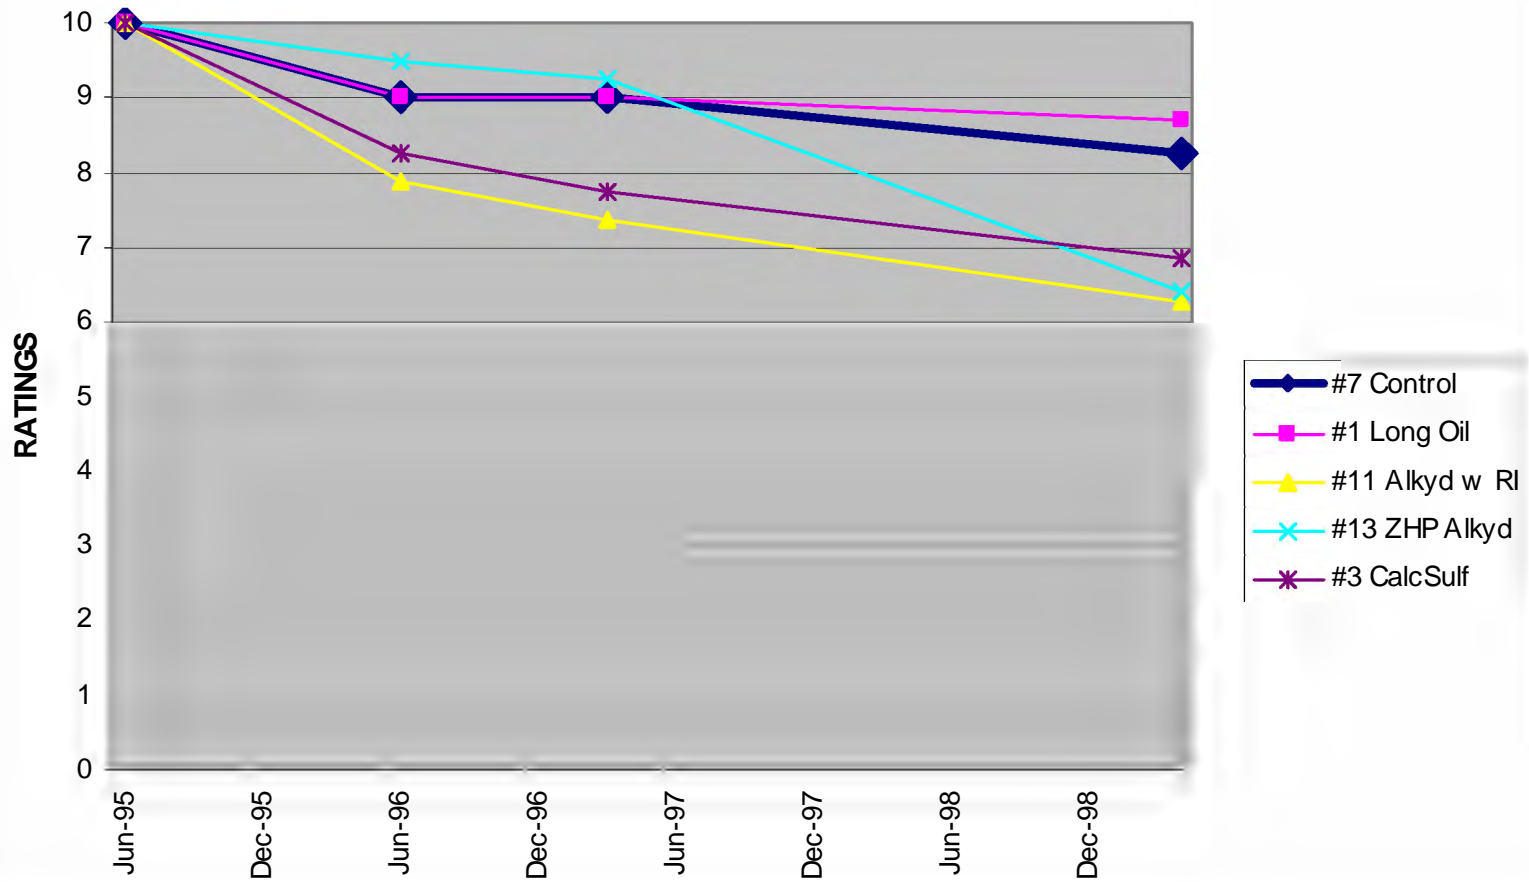
**Figure 3. COMPARE PERIODIC PANEL AVERAGES (FR/BK)
of ALKYDS & CALCIUM SULFONATE to PANEL AVERAGES of CONTROL**

In the four years of the evaluation period, one of the three alkyds - a very slow-drying long oil variety - performed equal to the Control; the other two were not as good as the Control. This is clearly demonstrated in Figure 3. The only concern was System 13 - The New Hampshire Zinc-Hydroxy Phosphite System. This system appears to be deteriorating at a significant rate between the third and fourth rating. The slope of this line is not encouraging.

yard with no traffic below the beams, it can only be assumed that on a "real world" bridge, the dirt accumulation problem would be further exacerbated. For these reasons it is clear that the calcium sulfonate system as tested cannot be recommended for use. If the system had utilized a topcoat that does not have such an affinity for dirt collection, it is probable that the results would be much different. (See Figure 3-included in chart with alkyds.)

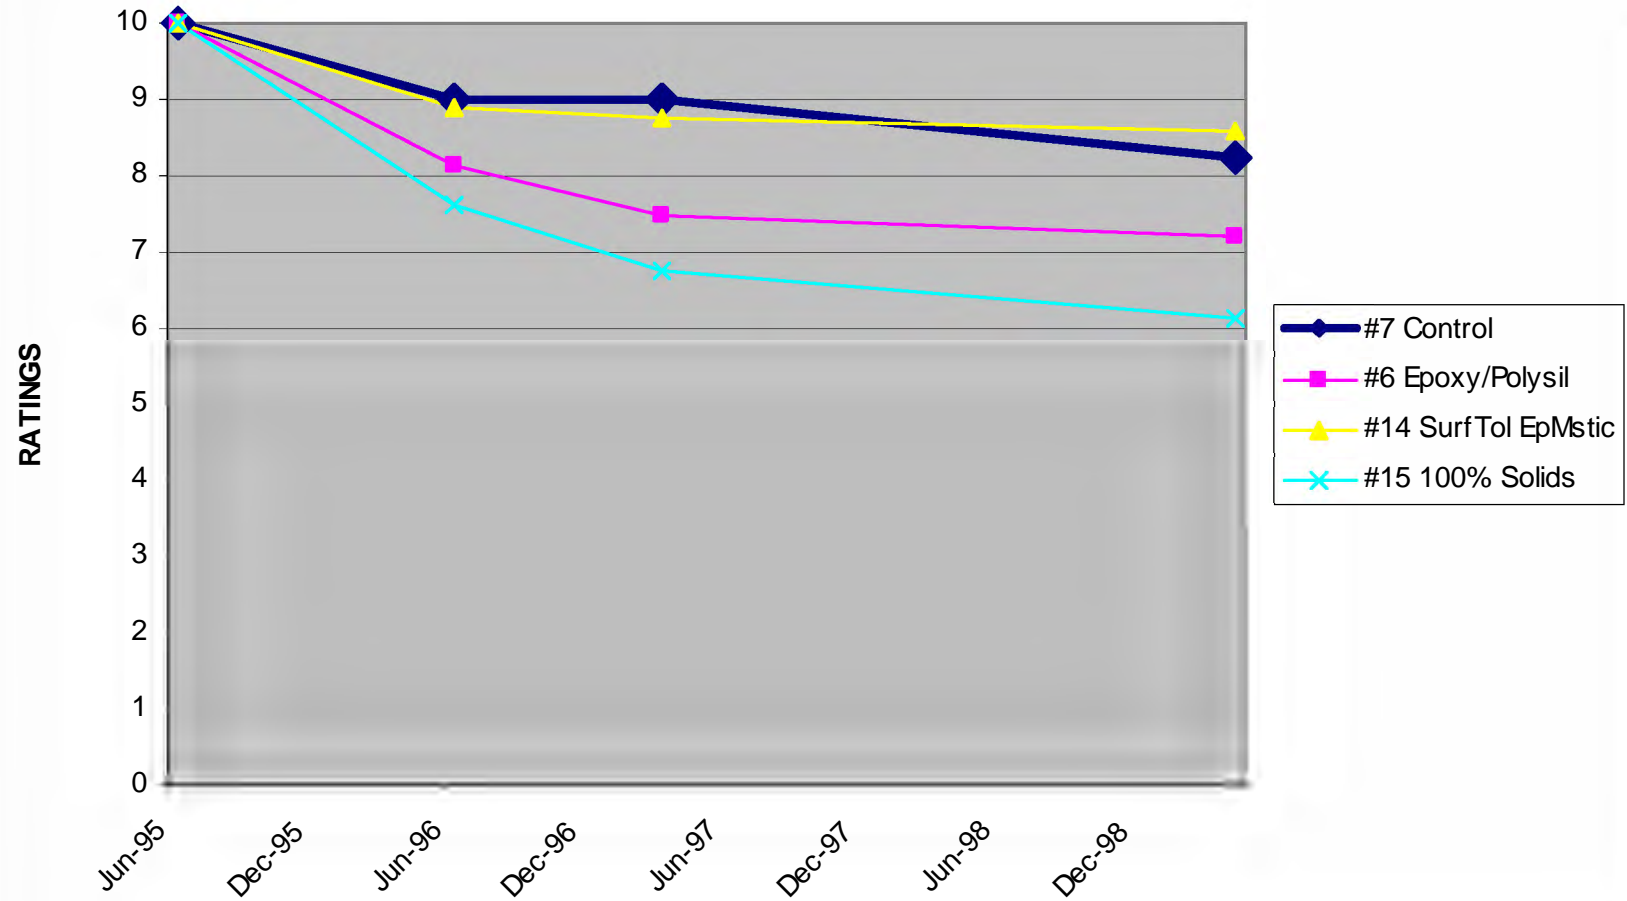
**Figure 4. COMPARE PERIODIC PANEL AVERAGES (FR/BK)
of EPOXIES to PANEL AVERAGES OF CONTROL**

5. Epoxies tend to place sufficient stress on the existing system to cause the original primer to delaminate. One epoxy system that was based on a flexible epoxy primer performed essentially the same as the Control.

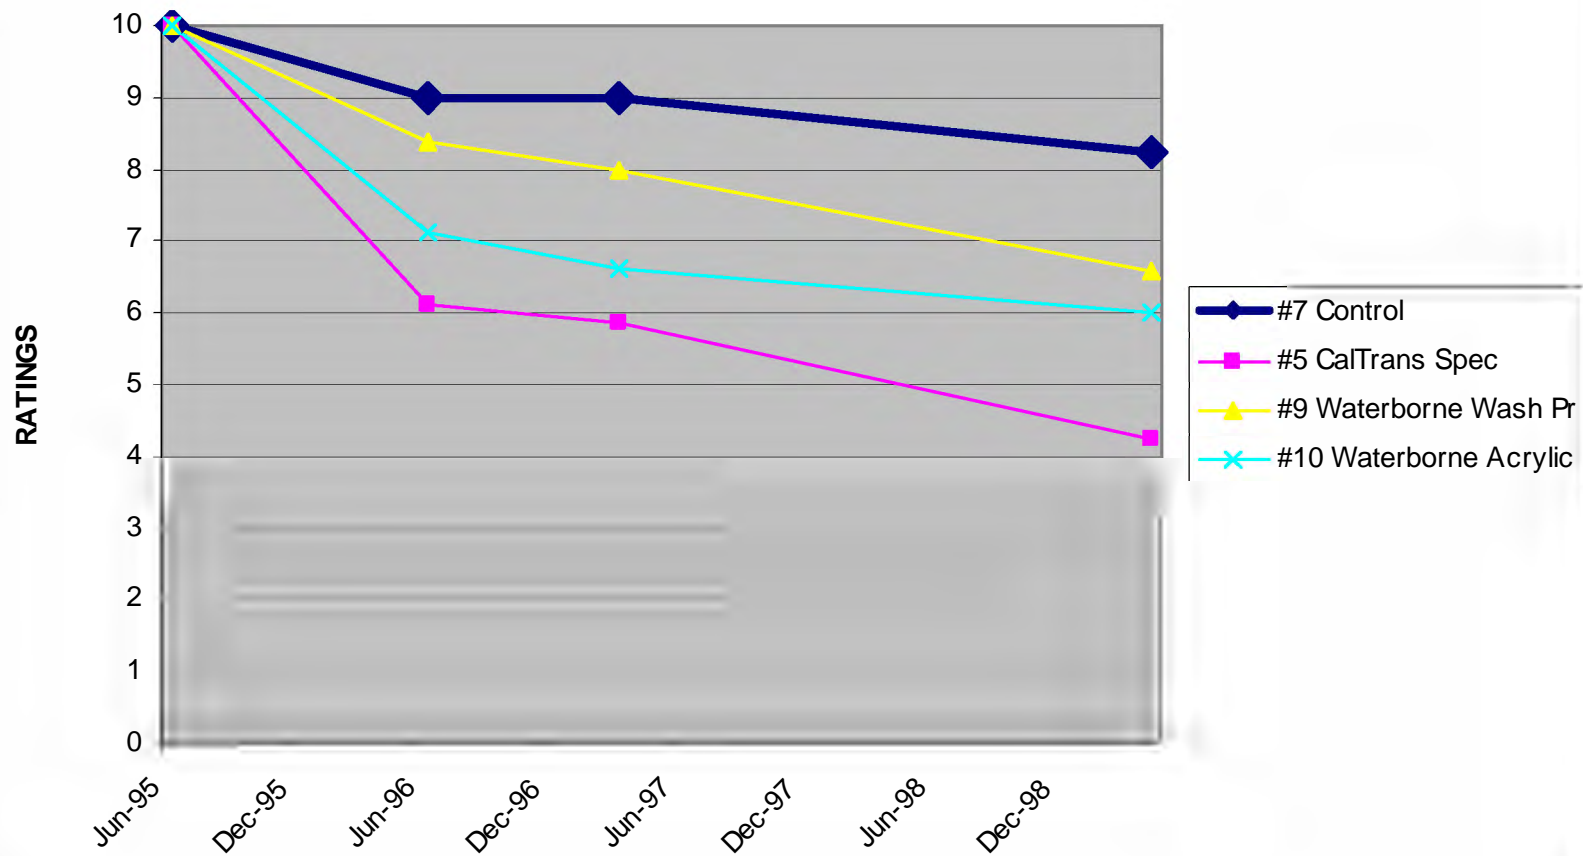
Figure 5. COMPARE PERIODIC PANEL AVERAGES (FR/BK)
of ACRYLICS to PANEL AVERAGES of CONTROL

The acrylics were the biggest disappointment in the study. See Figure 5. If they could have been utilized only over sound, existing coating, they would have performed quite well. However, once the previously rusted areas were considered, the group as a whole performed the worst of all coatings. Simply put, there was not enough resistance to flash rusting and/or contamination below the coating for acrylics to perform well in the test. Since it is our belief that on any re-coating project, there are bound to be some areas of rust, and these areas must be protected, we cannot recommend acrylics at this time. If a system were found which utilizes a solvent-borne spot primer for rusted areas, it is probable that the performance of acrylic systems would be greatly enhanced. This would allow the obvious advantages of acrylics - water clean-up, one component materials, easy application - to be fully utilized.
