A HYDRAULIC EVALUATION OF FISH PASSAGE THROUGH
ROADWAY CULVERTS IN ALASKA: DATA REPORT

Paula M. Wellen and Douglas L. Kane

Institute of Water Resources/Engineering Experiment Station
University of Alaska-Fairbanks
Fairbanks, AK 99701

May 1985

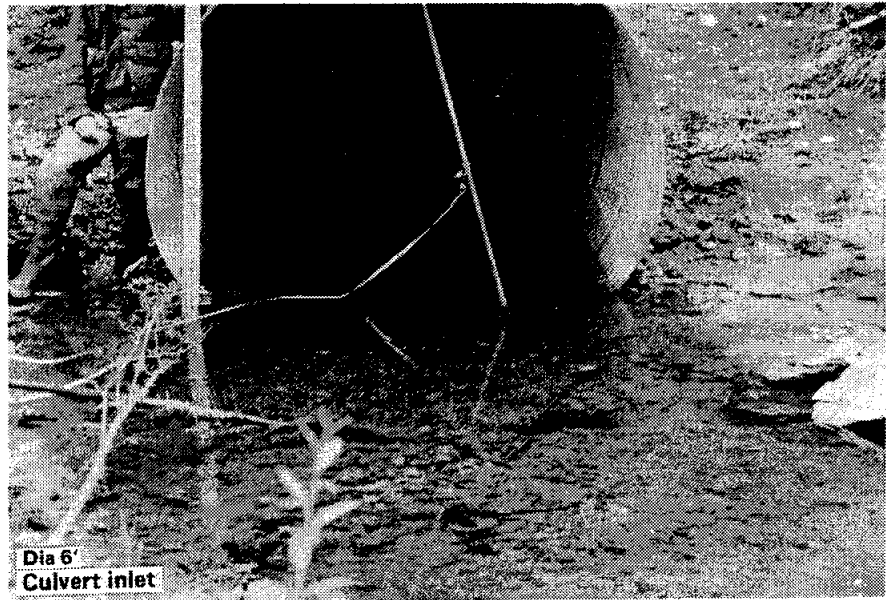
C-001
16 AUG 1982
CULVERT EXIT

Three culverts were observed at the Steele Creek site along Chena Hot Springs Road on August 16, 1982. The main culvert (pictured) contained all of the flow (1.6 cfs). The water surface profile for this culvert and the stream appear in the diagram. A smaller overflow culvert (about 4 ft in diameter, crown slope 0.0054) was dry but erosion marks were visible at the outlet. A third culvert was completely buried at the outlet, and the inlet was only partially visible. The bedload was estimated as silt, sand, and very fine gravel. The first part of the main culvert barrel contained some drift, but the last part was clean. There was a quiet pool at the main culvert entrance, but none at the exit. The water depth at the culvert inlet was 0.70 ft and at the outlet was 0.30 ft. The watershed area was 10.60 sq mi.

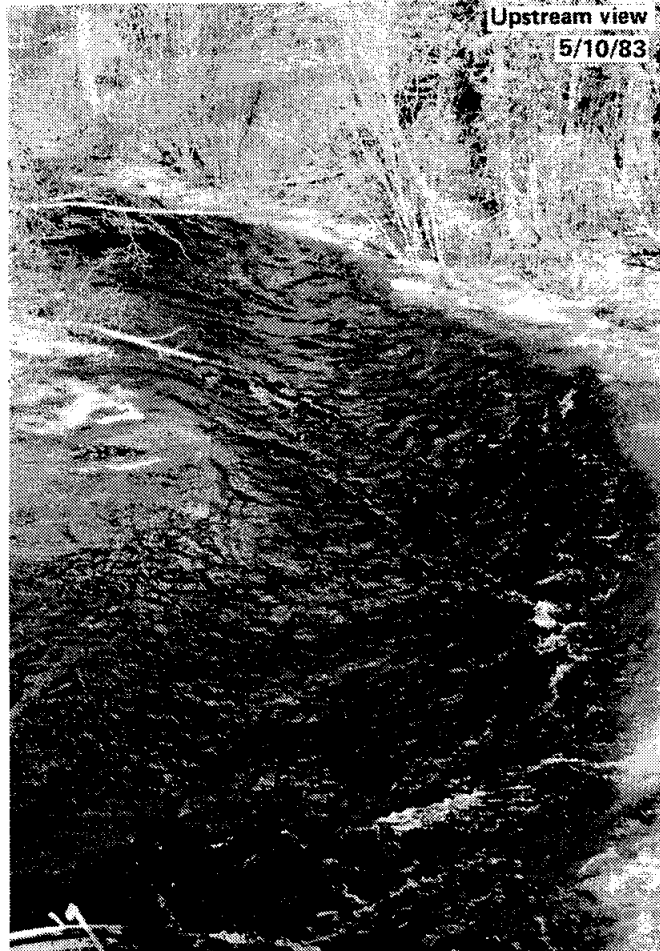
B-002
 10 MAY 1983
 CULVERT EXIT

Two identical culverts contained the 50.2 cfs discharge in this creek on May 10, 1983. Ice was noted in both culverts, filling about 2/3 of each barrel. Anchor ice was present in the stream channel and the discharge measurement was taken on top of the ice. A velocity profile measurement was taken at the outlet of the north culvert. Here the ice was 5.62 ft thick and the water depth on top of the ice was 1.10 ft. The watershed area was 36.2 sq mi. The water surface profile for this stream is shown in the diagram.

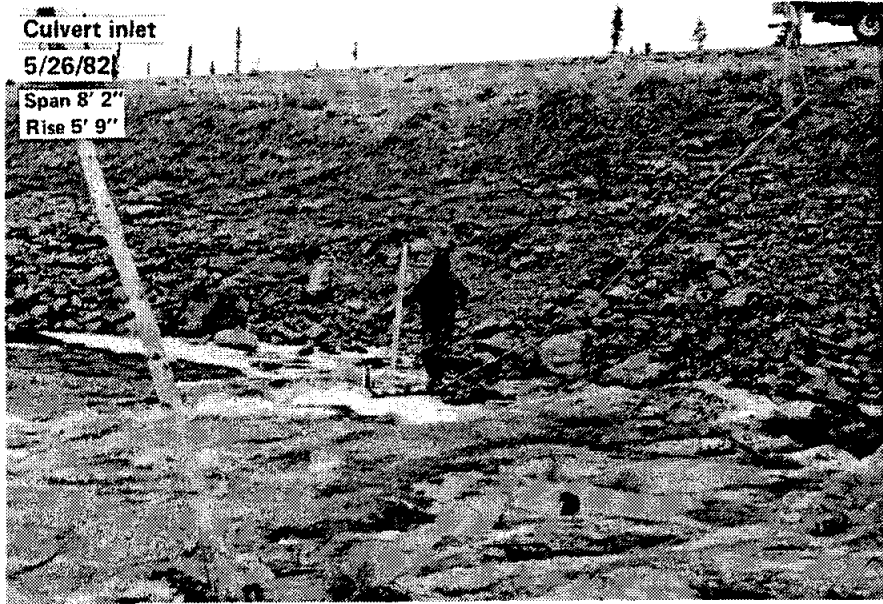
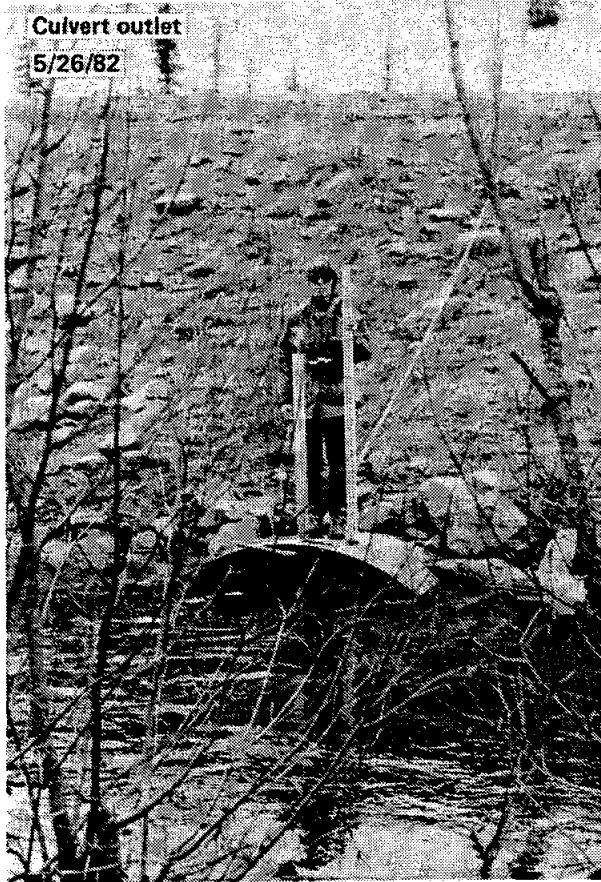
B-003
26 MAY 1982
CULVERT EXIT

This site was first visited on May 26, 1982. No discharge measurement was made due to the aufeis up and downstream of the culvert. Upstream, the channel was full of ice causing the water to flow through the trees; downstream the channel was filled with debris and ice. Some ice was also noted inside the culvert. No slope measurements were made above and below the culvert due to the lack of a defined channel. The watershed area was 4.3 sq mi.

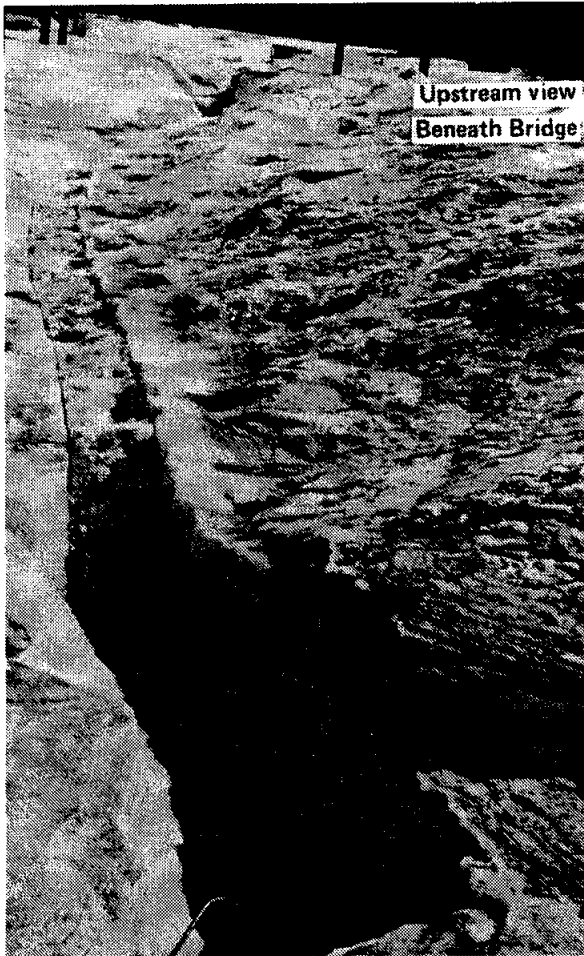
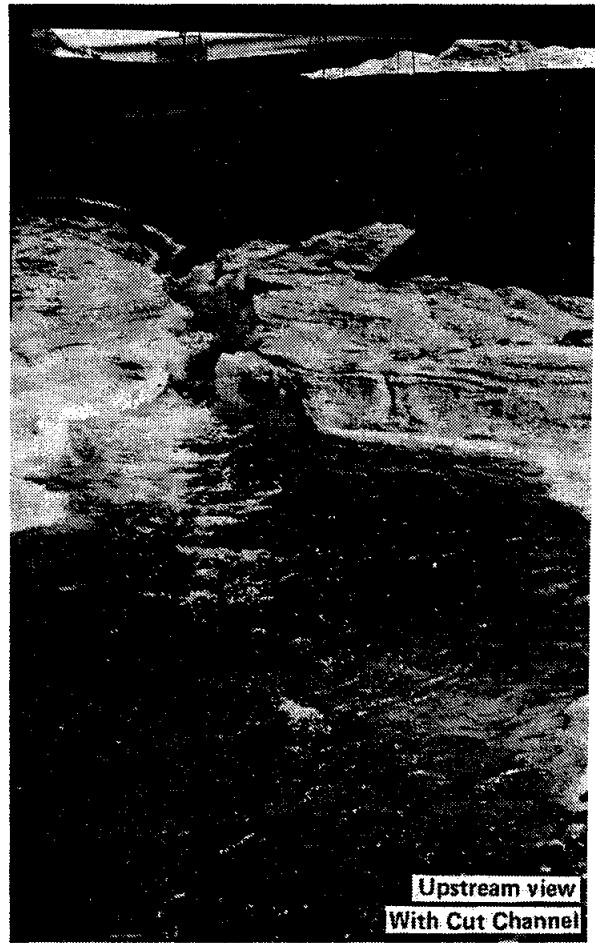
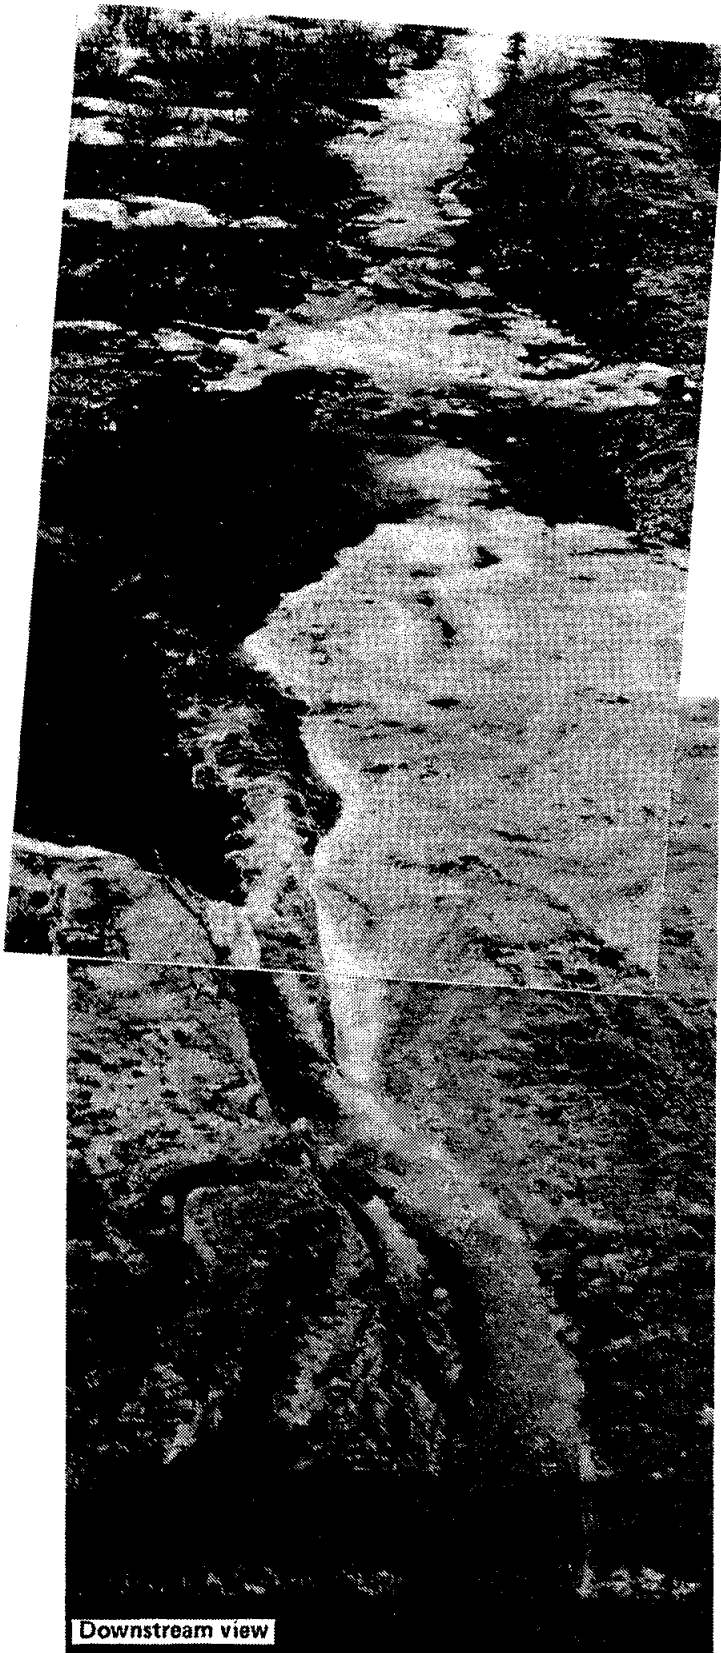
The culverts at Douglas Creek were replaced with a bridge in the summer of 1982. By the first spring (1983) severe icing and maintenance problems developed. The ice buildup came to within several inches of the bridge deck on May 11, 1983. Upstream of the bridge, highway maintenance personnel were cutting a channel through ice upwards of 10 ft thick.

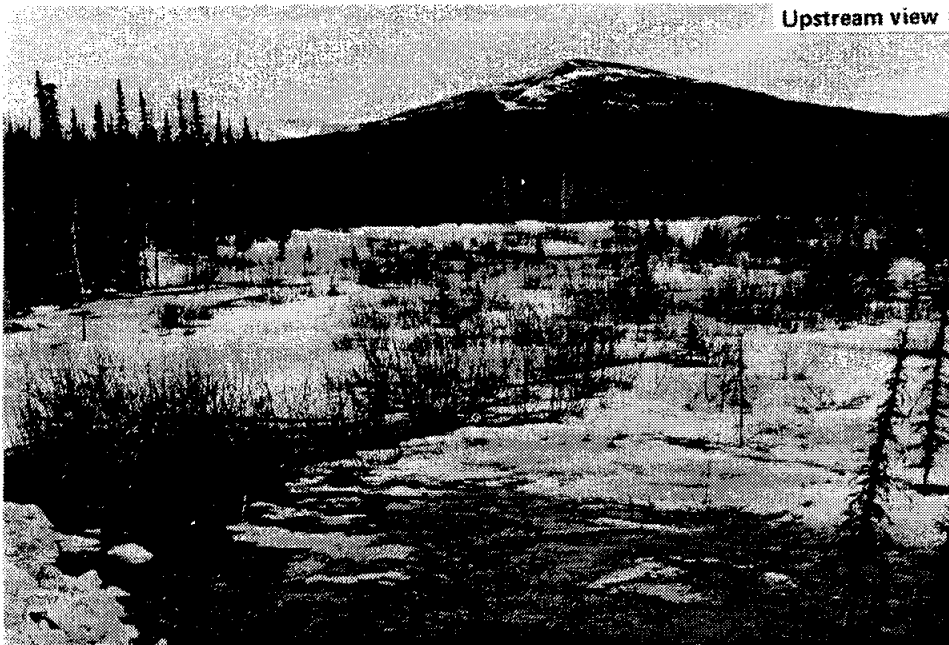
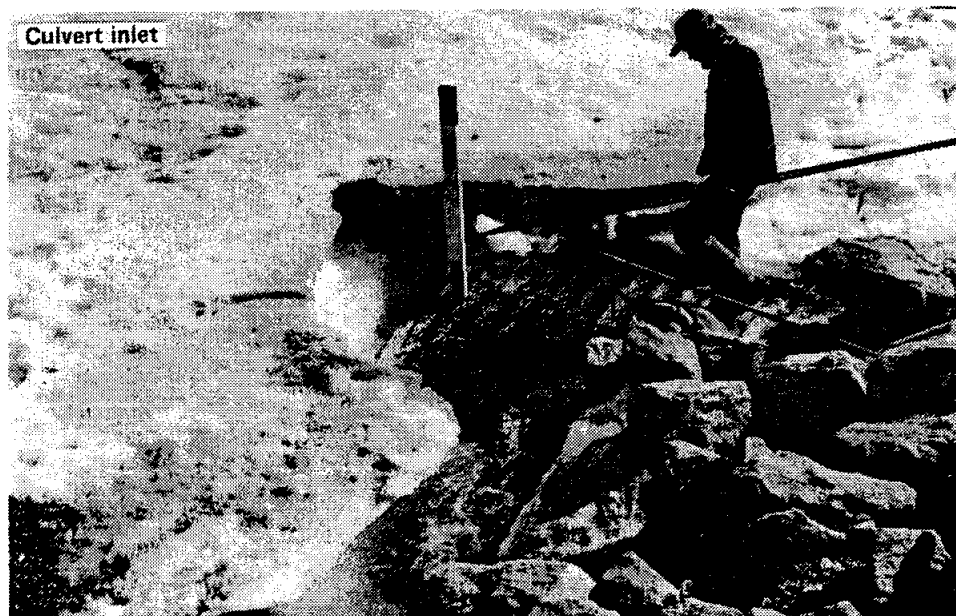
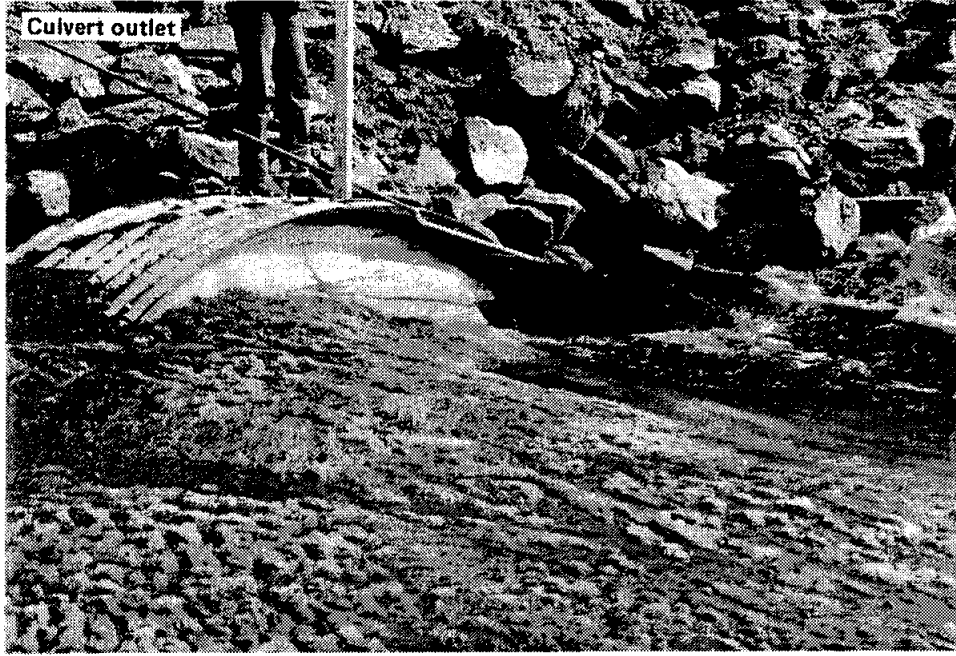
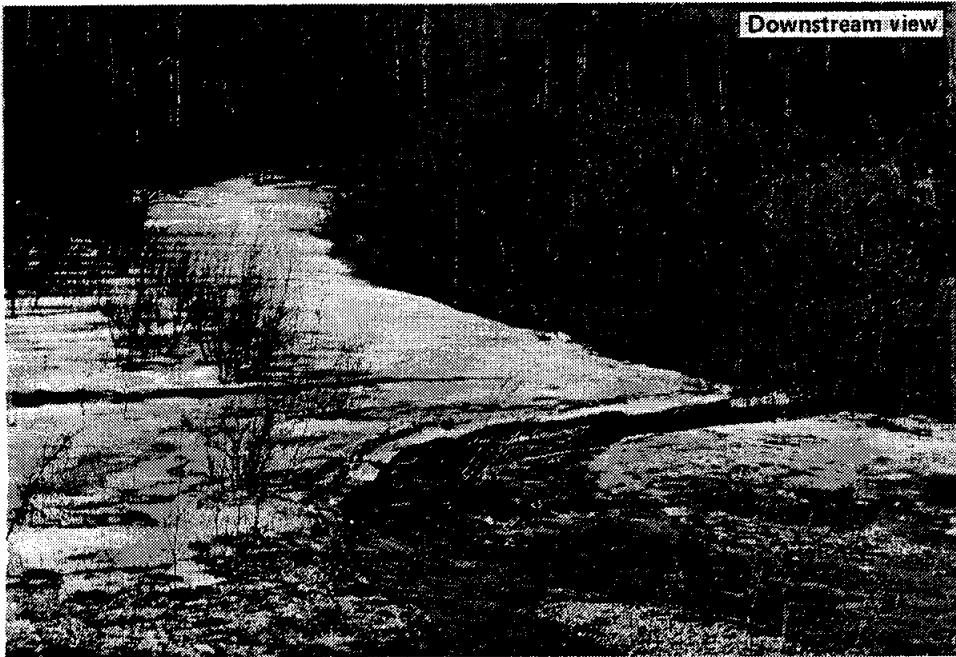
Rosie Creek was visited again on May 11, 1983. No measurements were recorded, but the pictures on these two pages show the icing conditions at this site. Flow upstream of the culvert was over the ice and through willows and brush; the main stream channel was not visible. Downstream, the creek was not flowing in the main channel from the previous summer but was mostly contained by a second channel. The culvert had ice up to the barrel crown; the flow dropped down from the ice into the culvert at the entrance and welled up at the exit to continue downstream on top of the ice.

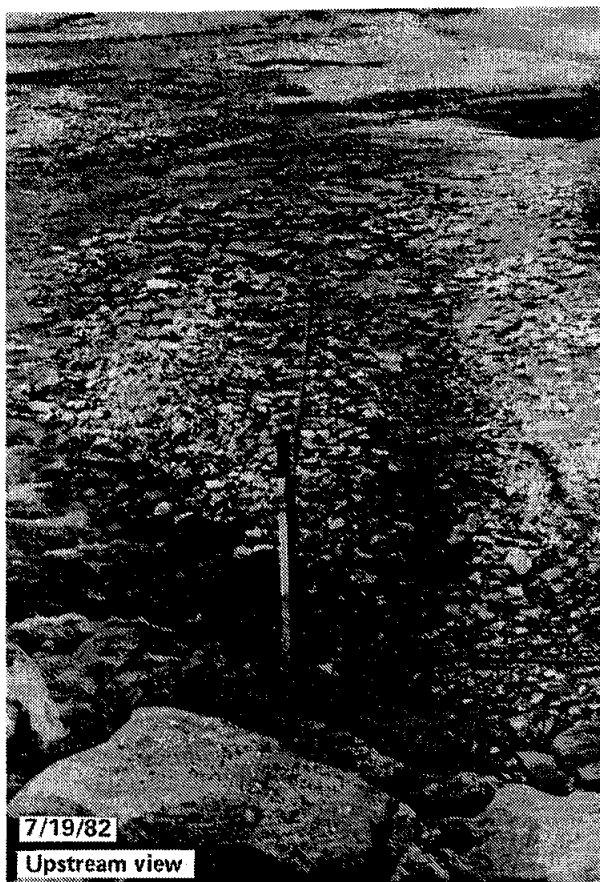
B-036
 19 JULY 1982
 CULVERT EXIT

Measurements at Brockman Creek were made on July 19, 1982. The streamflow was 10.4 cfs. The discharge measurement was poor due to the rocky shallow stream channel. The culvert inlet water depth was 0.70 ft, while the outlet water depth was 0.55 ft. The culvert barrel was clean except for some 5 to 6 in diameter rocks. At the culvert outlet a 20 ft diameter pool was noted. The stream channel at this location was rerouted when the culvert was installed. Upstream the channel was quite braided; downstream a man-made channel was cut. About 100 ft north of the main culvert was a small dry channel with no culvert installed. About 300 ft north of the main stream channel was a large dry overflow culvert and stream channel. The watershed area was 19.5 sq mi.

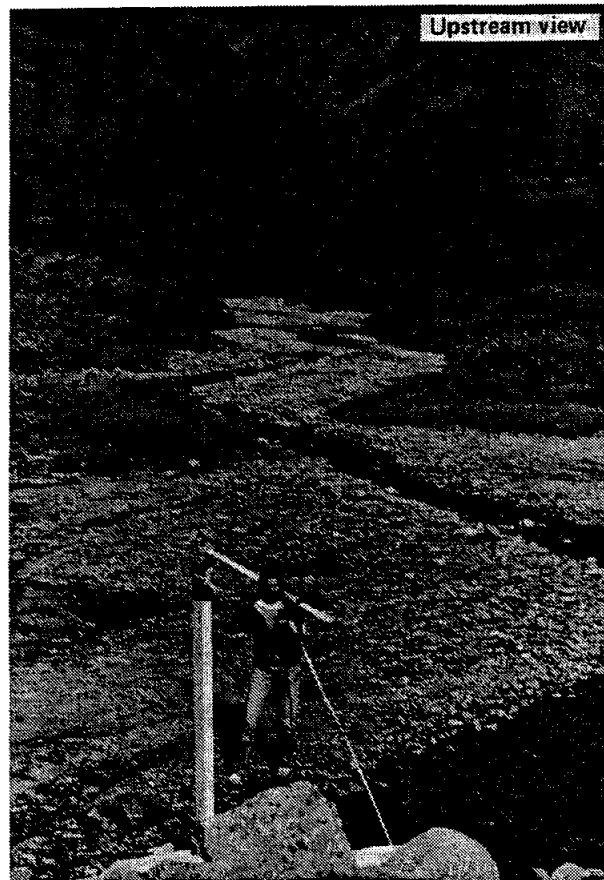
B-042A
 20 JULY 1982
 10' UPSTREAM FROM
 CULVERT EXIT

This small unnamed creek was observed on July 20, 1982. The discharge through the culvert was 3.4 cfs; the two overflow culverts were dry. The water surface profile for the creek and culvert are shown in the diagram. Culvert inlet and outlet water depths were 0.60 and 0.25 ft, respectively. The bedload was mostly cobbles 4 to 5 in in diameter. No pools were observed at either end of the culvert. The stream emptied directly into the Chandalar River at the culvert exit. Upstream of the culvert the streambed was highly braided. The lower 1/3 of the barrel was clean; the upper 2/3 had rocks up to 5 in in diameter deposited in it. The watershed area was 2.1 sq mi.

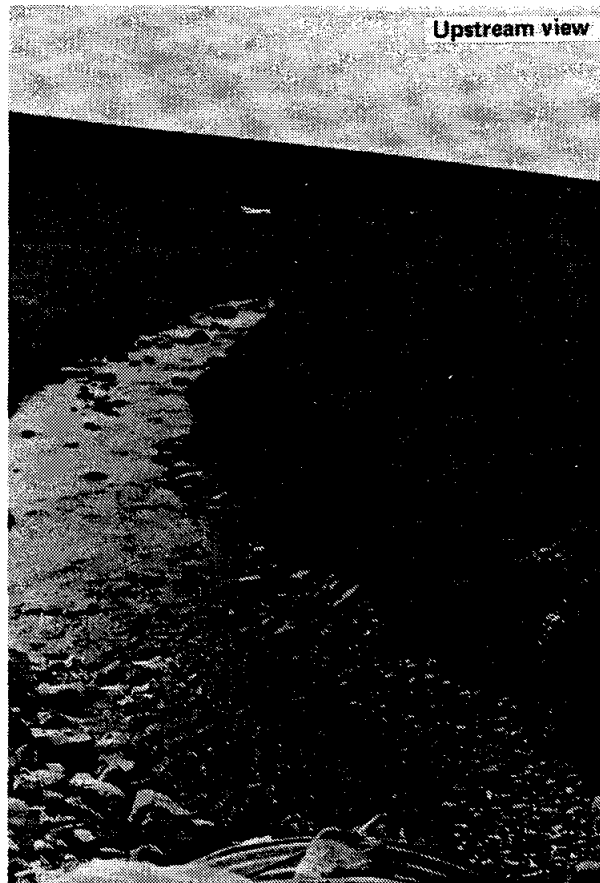
B-055
 21 JULY 1982
 10' DOWNSTREAM
 FROM CULVERT EXIT

Observations were made at Dan Creek on July 21, 1982. A discharge of 8.2 cfs was contained by one large arch culvert. The water surface profiles for the creek and culvert appear in the diagram. The water depth at the culvert inlet was 2.00 ft. The water depth was 1.20 ft at the culvert outlet. The bedload size was difficult to measure. Some 2 ft diameter rocks were in the stream channel; smaller rocks (predominantly 3 to 4 in in diameter) were also noted. The culvert barrel was clean except for some rocks (1 to 2 ft in diameter) at the inlet. Pools (30 by 30 ft) were observed at each end of the culvert. The slope of the culvert increased through the barrel. Small fry and large grayling were noted inside the culvert. The watershed area was 34.4 sq mi.

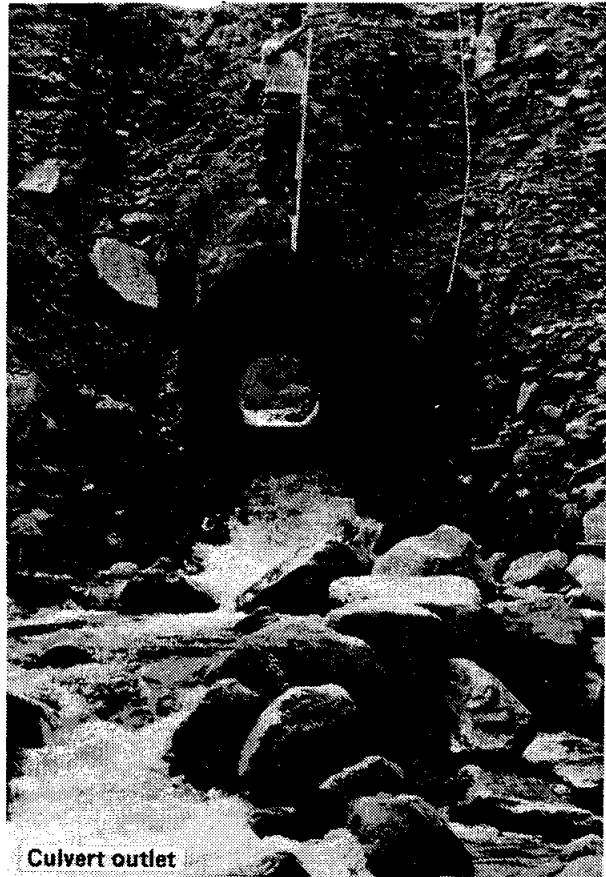
D-014
23 JUNE 1982
CULVERT EXIT

A double barrel culvert installation contained the flow at this stream site. Observations were made on June 23, 1982. Both barrels were clean, although 3 to 4 in diameter gravel was noted passing through the culverts. The stream channel was fairly shallow with large rocks in it, so no streamflow measurement was obtained. Downstream of the culvert was one main stream channel, while the stream was braided above the culvert. The surveyed slopes appear in the diagram. The upstream slope was measured along the west channel. Much of the downstream water surface drop occurred within 20 ft of the culvert exit. The outlet water depth was 0.40 ft. The watershed area was 6.2 sq mi. A high water mark was observed 1.40 ft above the existing water surface 50 ft downstream of the culverts on the east bank.

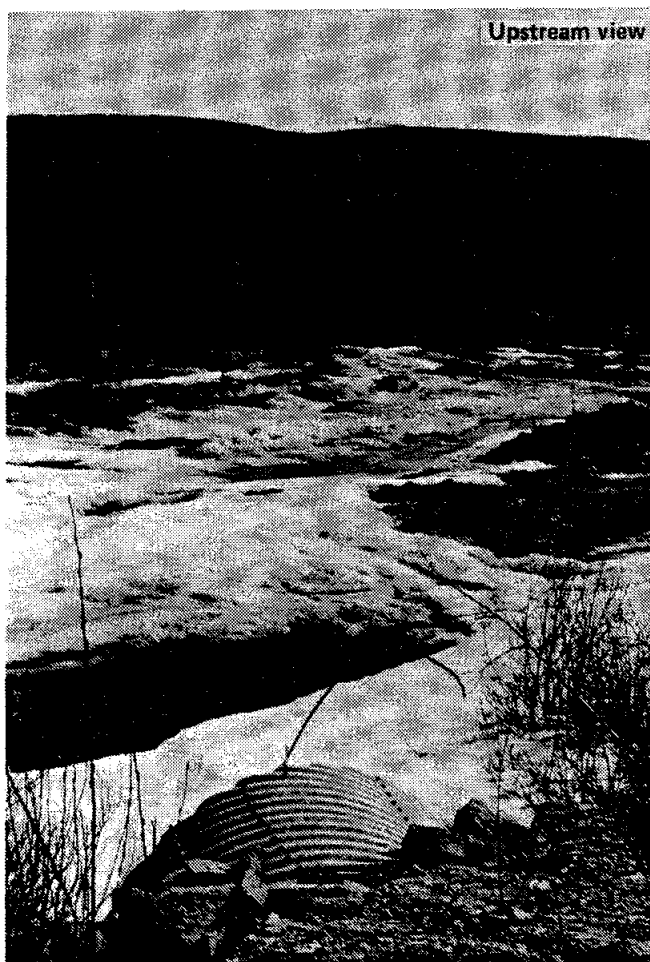
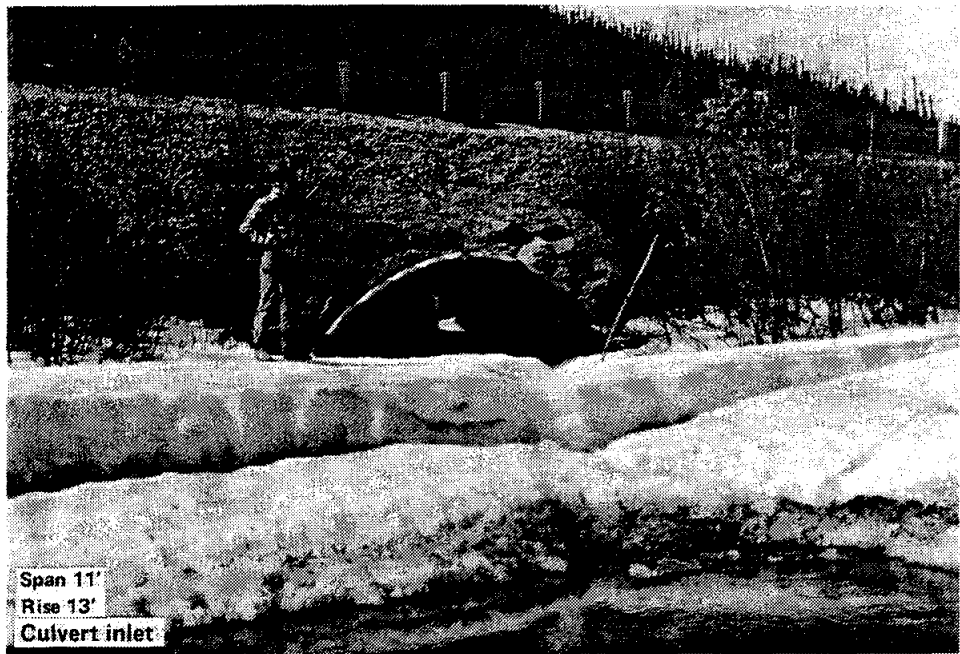
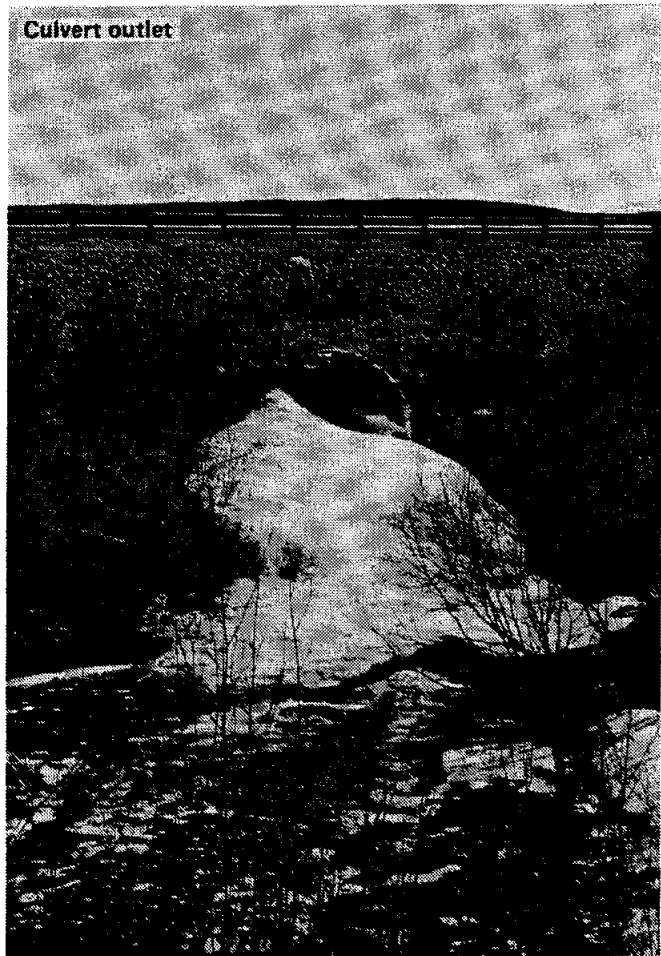
This site was visited a second time on May 9, 1983. Although no measurements were made, the pictures on these two pages show the severe icing conditions that occurred at this culvert. Water was flowing through the culvert at this time in a channel cut in the ice. Upstream of the culvert, water flowed over the ice and snow; the natural streambed was not visible. Downstream of the culvert the water was contained in the stream channel, although some ice was noted along the banks.

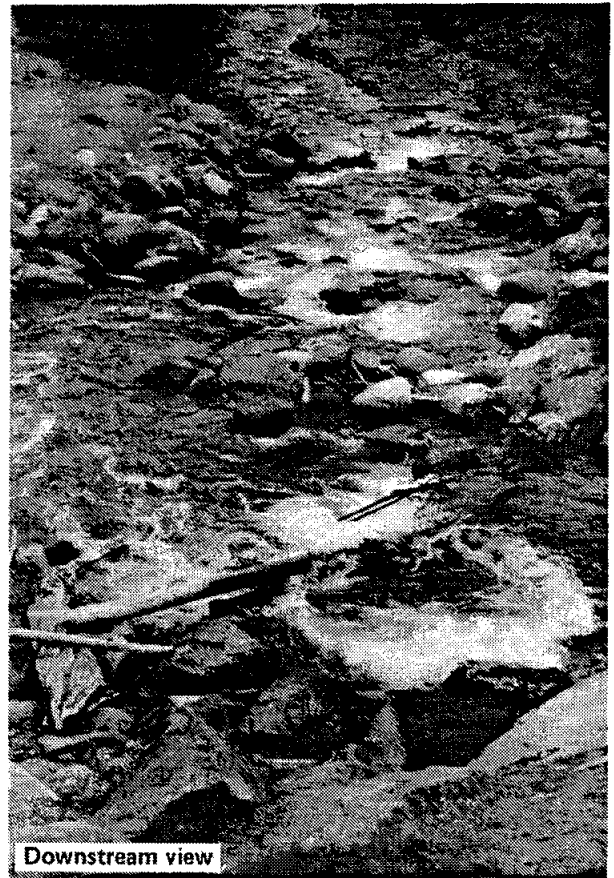
SW-001
15 JULY 1982
CULVERT EXIT

Two similar culverts contained the discharge from Rabbit Creek on July 15, 1982. The north (or right culvert, facing downstream) contained most of the 22.7 cfs flow. Inlet and outlet water depths for the two culverts were: 1.20 ft (inlet, right culvert); 1.35 ft (outlet, right culvert); 0.30 ft (inlet, left culvert); 0.35 ft (outlet, left culvert). The bedload ranged from small gravel to material 8 in in diameter. The left culvert contained rocks up to 6 in in diameter; deposits up to 1.5 ft thick were observed in some places. Larger rocks in the lower reach of the right culvert were also noted. Concrete baffles were installed in both culvert barrels. They had mostly been destroyed or were missing from the right culvert and were not visible in the left culvert. The downstream slope noted in the schematic was measured over a 200 ft distance, however, most of the drop occurred within 100 ft of the culvert exit (7.84 ft/100 ft). The watershed area was 13.3 sq mi.

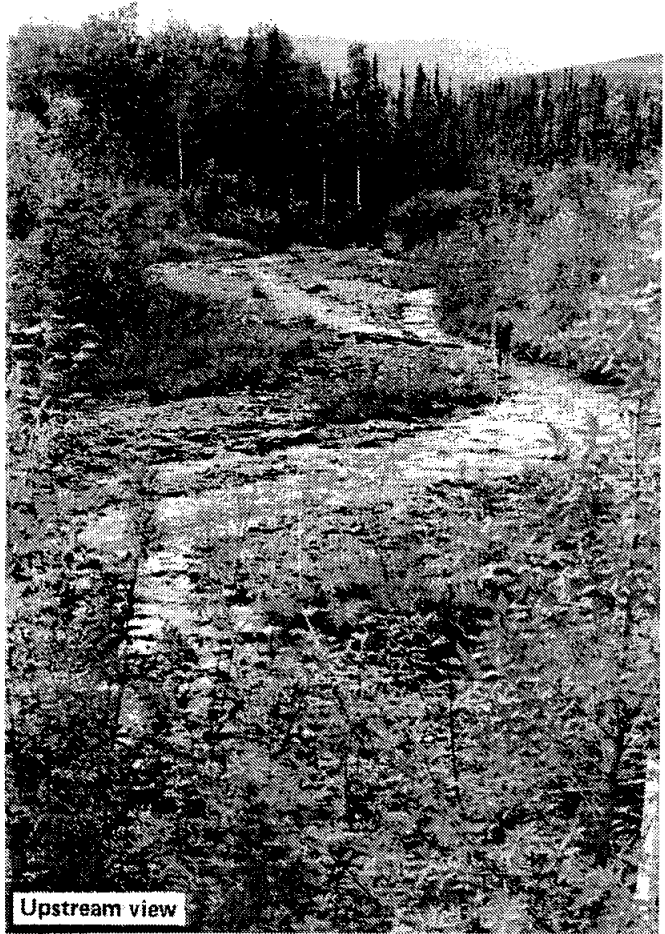
S-036
23 AUG 1983
CULVERT EXIT

This location was visited on August 23, 1983, and the measured discharge was 4.8 cfs. The surveyed slopes appear in the diagram. Large cobbles in the streambed resulted in a poor discharge measurement. Sawpit Creek was a high gradient clear head-water stream. No pools or other rest areas for fishes were observed. The culvert barrel was clean except for a very small amount of drift at the entrance. The inlet and outlet water depths were 0.50 and 0.40 ft, respectively. The watershed area was 5.2 sq mi.
