CRASH TESTING OF MISSOURI'S W-BEAM TO THRIE-BEAM TRANSITION ELEMENT

MIDWEST ROADSIDE SAFETY FACILITY

MwRSF Research Report No. TRP-03-94-00

September 12, 2000

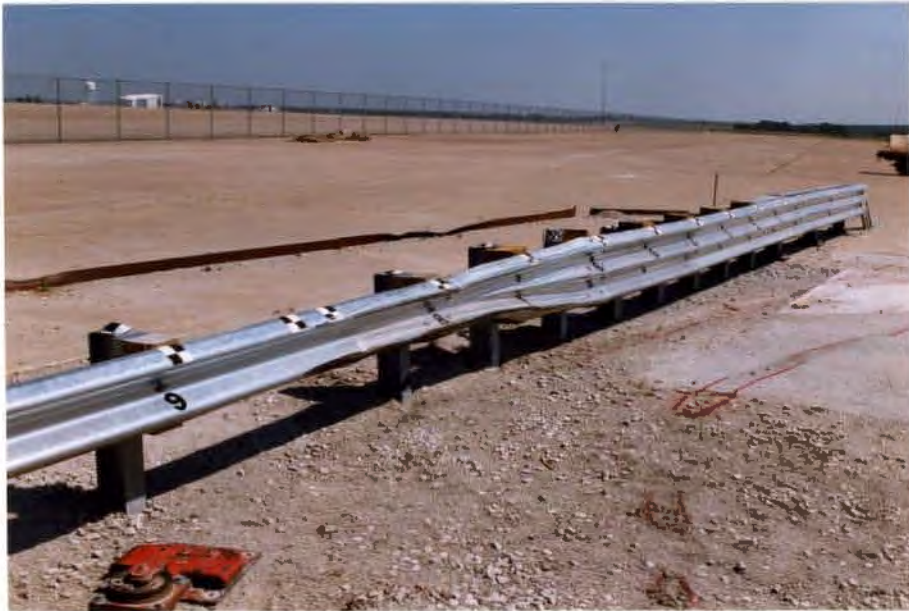
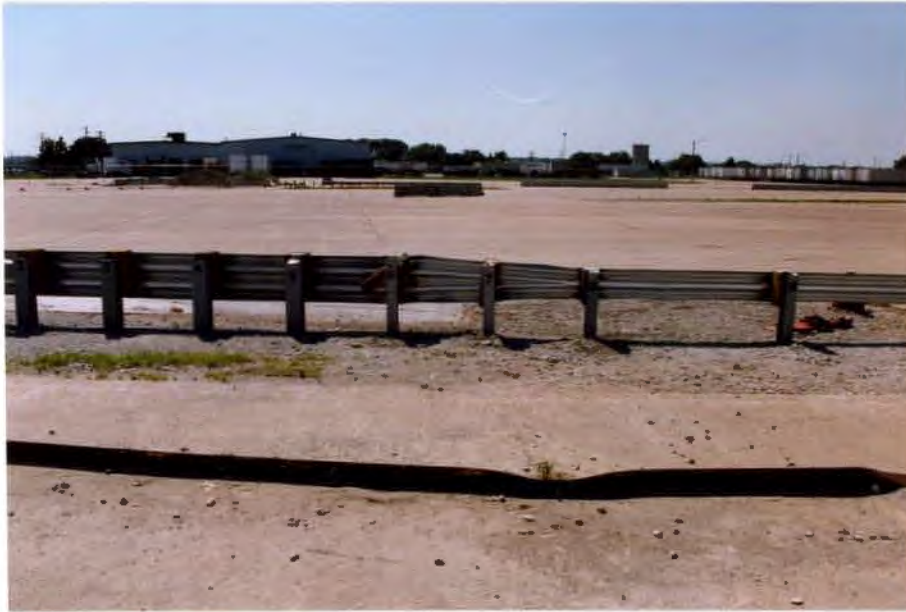
Figure 28. W-beam to Thrie Beam Transition Damage, Test MWT-1

Damage to the barrier was minimal, as shown in Figures 28 through 32. Barrier damage consisted mostly of deformed W-beam, contact marks on a guardrail sections, deformed guardrail posts, and damaged spacer blocks. The W-beam to thrie beam transition element damage consisted of moderate deformation and flattening of the lower corrugation. Contact marks were found on the W-beam and W-beam to thrie beam section between post nos. 6 and 9. Black marks were found along the bottom corrugation and green and red marks were found on the top and middle

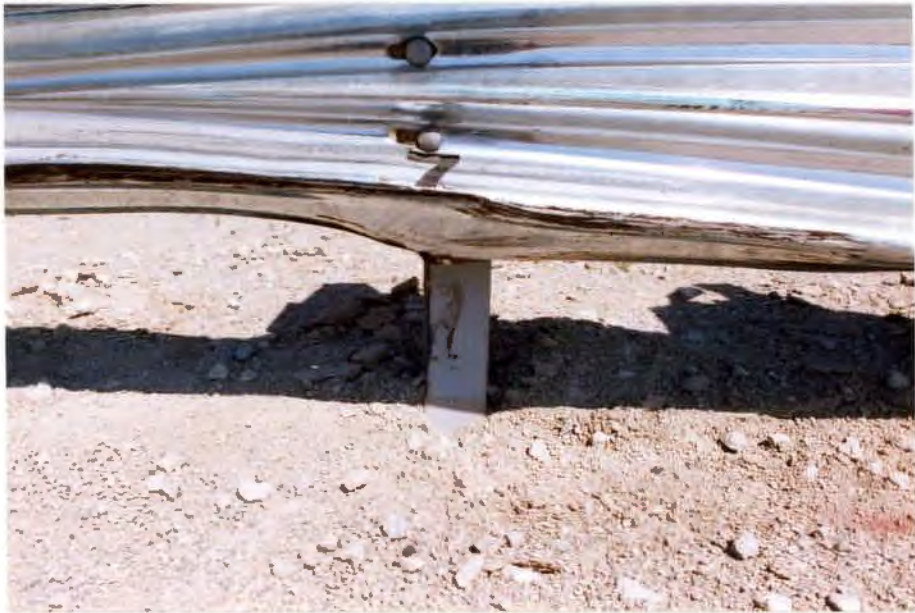
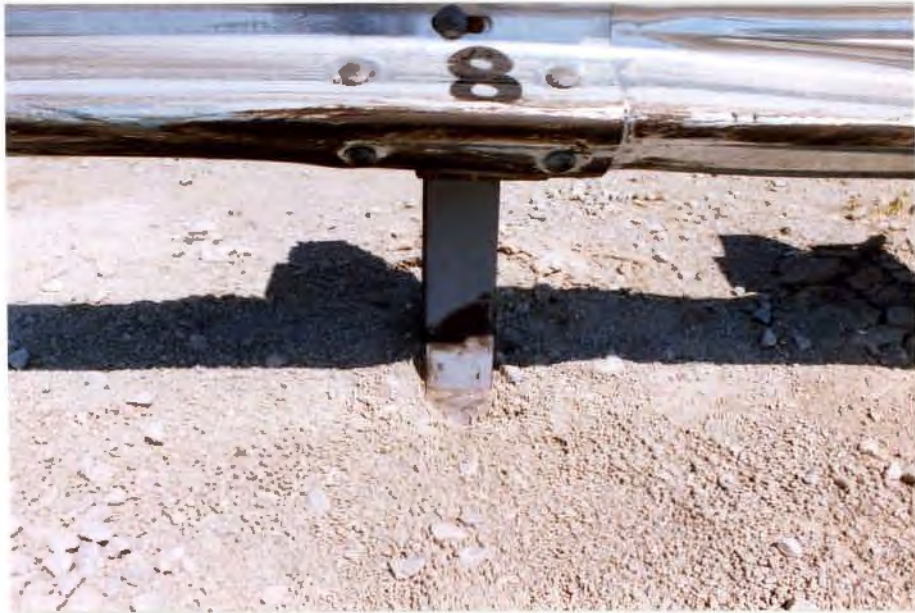
Figure 30. Post Nos. 7 and 8 Damage, Test MWT-1

During the impact event, damage and deformations were observed at several post locations and consisted of permanent post deformations, contact marks, and damaged wooden blockouts. Post nos. 5 through 8 deflected backwards. Post no. 7 also was twisted. Black contact marks were found on the front faces of post nos. 6 through 8 and the wood blockouts of post nos. 7 and 8. The wood blockouts at post nos. 6, 9, and 10 were cracked. The wood blockout at post no. 6 also was split. No significant post or guardrail damage occurred upstream of post no. 10 nor downstream of post no. 4.

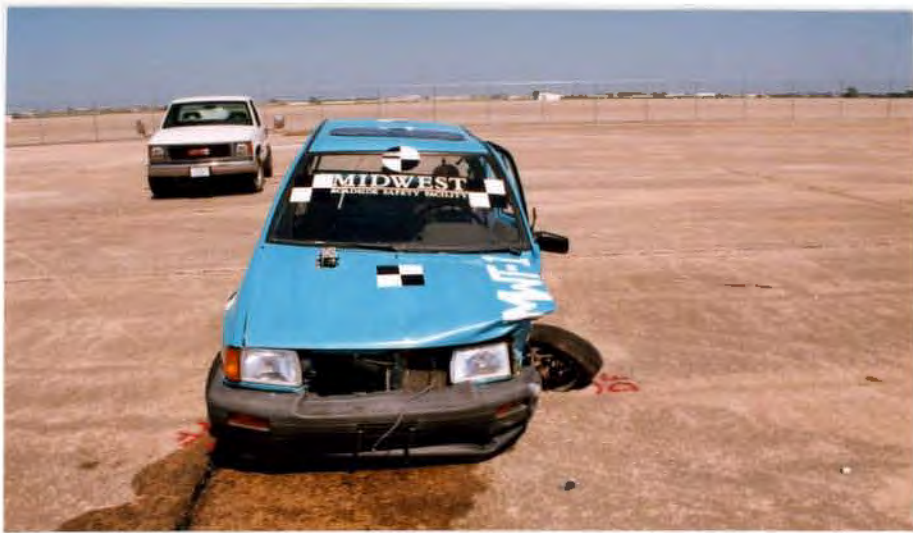
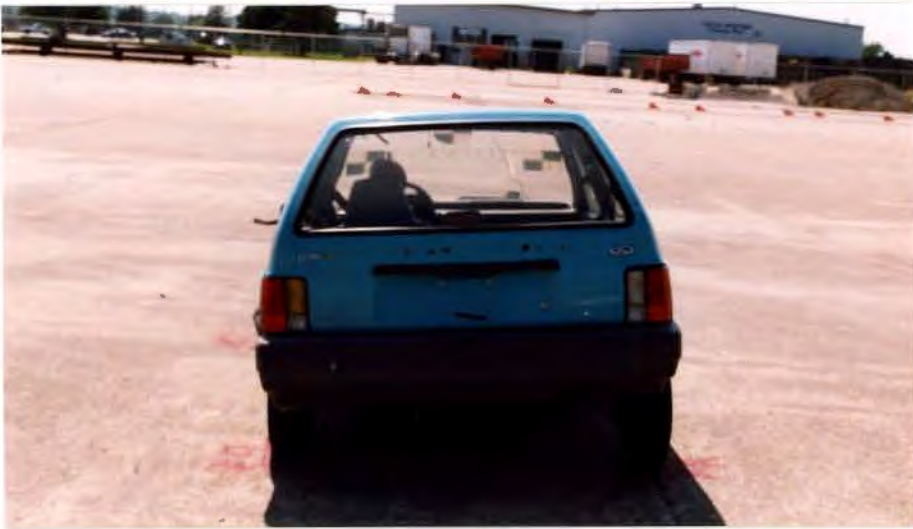
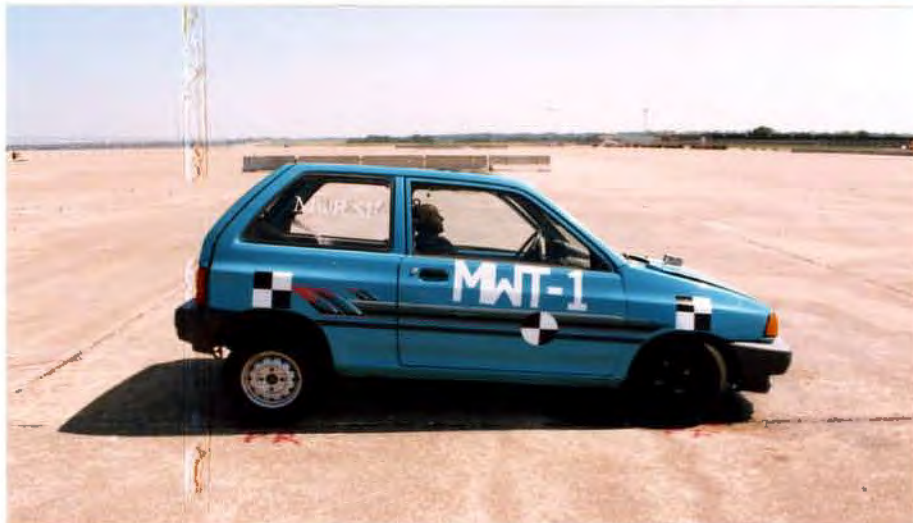
Figure 33. Vehicle Damage, Test MWT-1

Exterior and interior vehicle damage was moderate, as shown in Figures 33 through 35. Most of the vehicle damage occurred near the left-front corner of the vehicle, as shown in Figure 34. The left-front corner was crushed inward toward the engine. The major left-front wheel components, such as the lower A-frame, the tie rod end, the brake line, and the shock attachment, disengaged. Major damage occurred to the left-front tire rim, and the tire was slashed. The vehicle's left side encountered contact marks and deformations due to the vehicle/rail interlock. The engine hood was shifted to the right, and the grill disengaged from the front mounts. The plastic, front-bumper cover

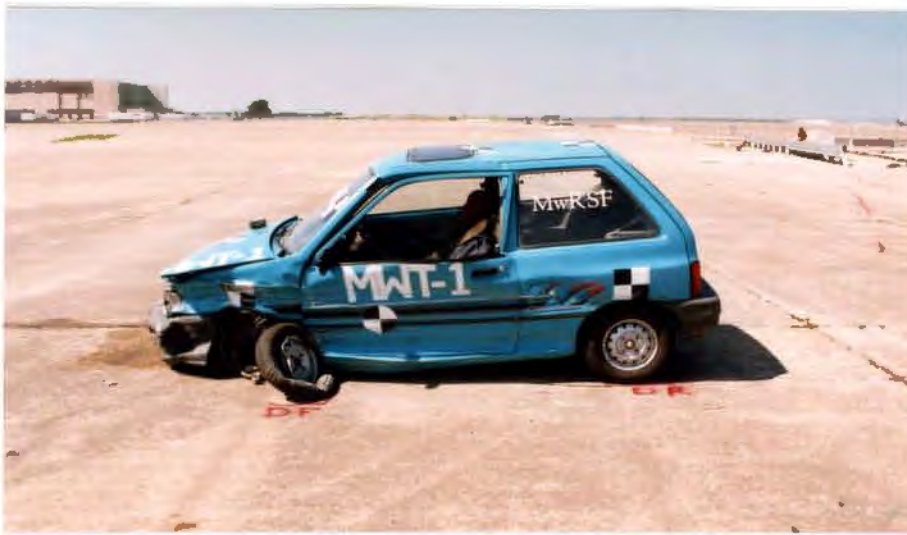
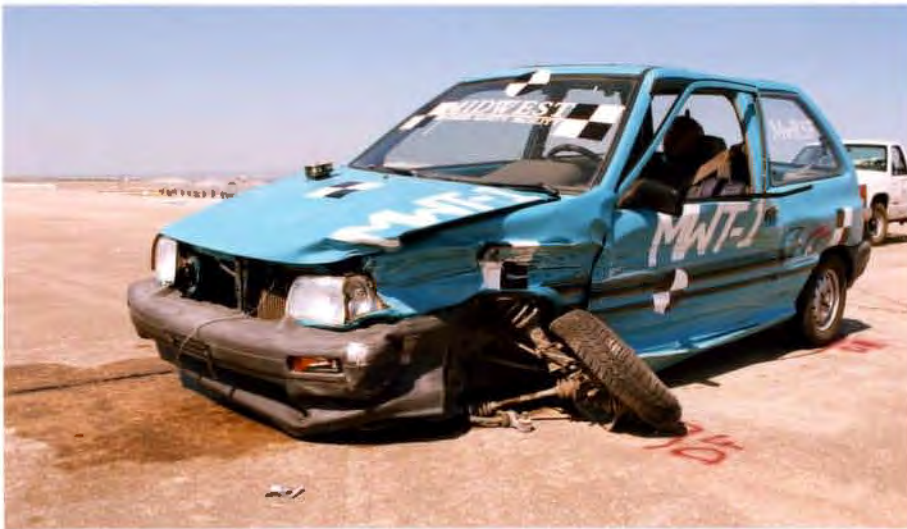
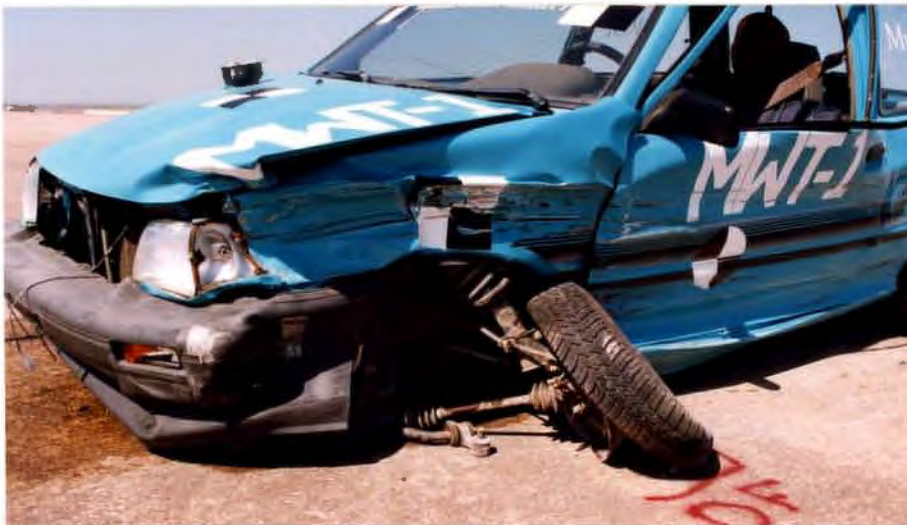
Figure 34. Vehicle Damage, Test MWT-1

was also deformed. The left-door's window was shattered. The top of the left door was ajar, and the lower portion of the door was deformed inward. A longitudinal buckling point was found on the left side of the roof, 660 mm from the A-pillar. The maximum occupant compartment deformation occurred near the lower-left corner of floorboard as the sheet metal was pushed inward 104 mm. The right side and rear remained undamaged.

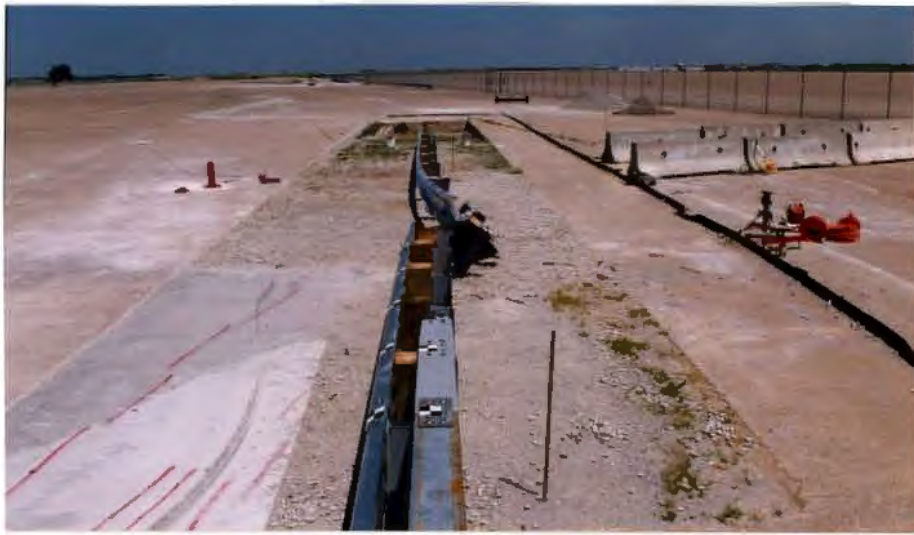
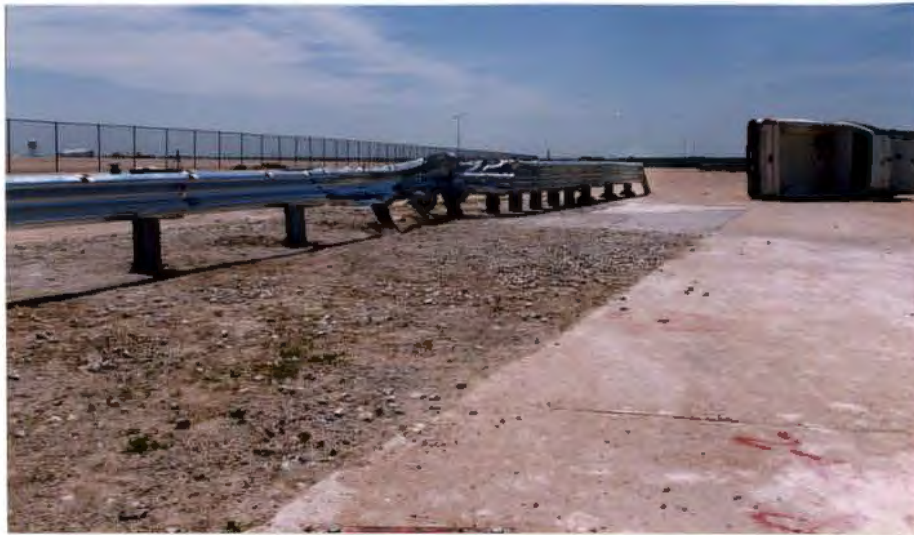
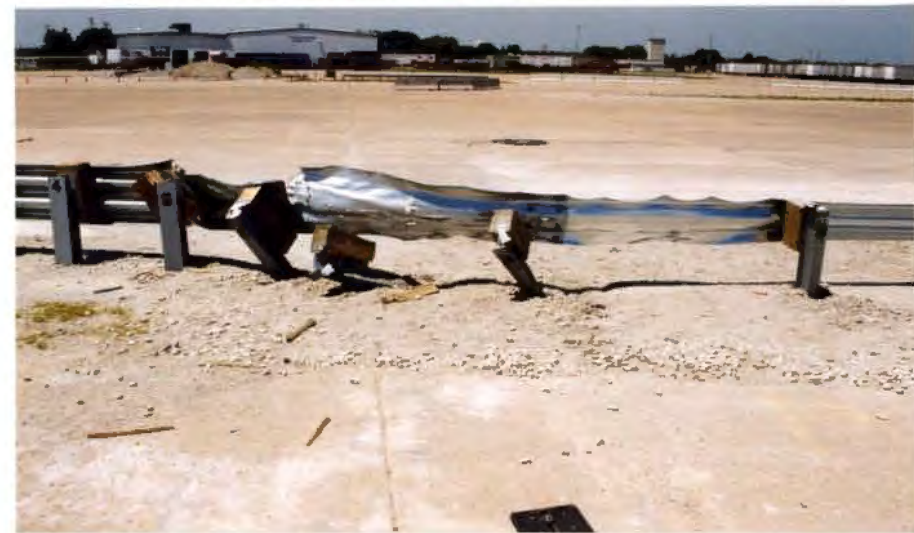
Figure 44. W-beam to Thrie Beam Transition Damage, Test MWT-2

Damage to the barrier was moderate, as shown in Figures 44 through 50. Barrier damage consisted mostly of deformed guardrail including W-beam, W-beam to thrie beam transition, and thrie beam, contact marks on a guardrail, deformed guardrail posts, and damaged spacer blocks. The W-beam damage consisted of moderate deformation and flattening of the lower portion of the impacted section between post nos. 8 and 9. The W-beam to thrie beam transition damage consisted of moderate deformation and flattening of the impacted section of transition between post nos. 6 and 8. The thrie beam damage consisted of moderate deformation and flattening of the impacted section of rail between post nos. 4 and 6. The W-beam to thrie beam transition element ripped at the guardrail splice located on the upstream side of post no. 6, as shown in Figure 45. Contact marks were found on the guardrail between post nos. 4 and 10.

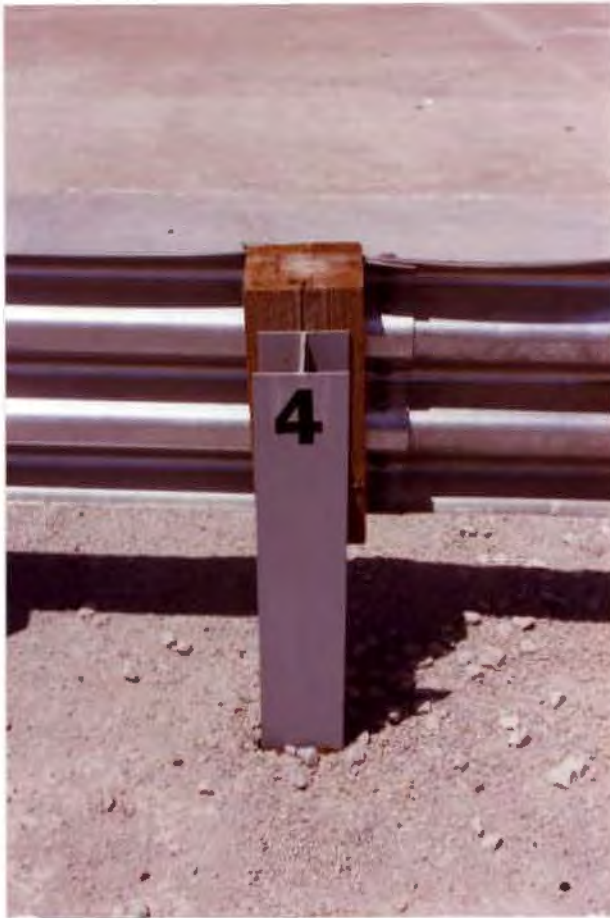
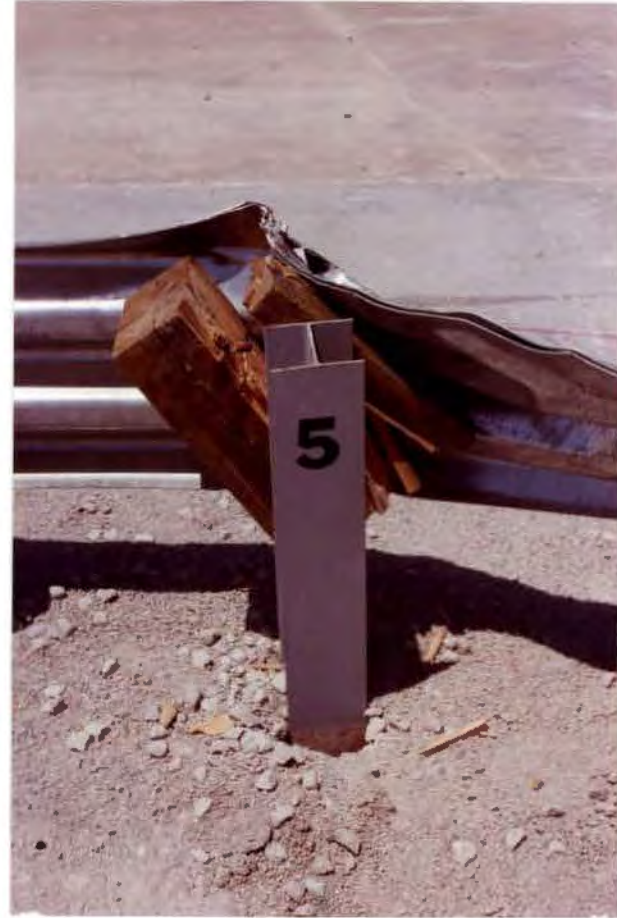
Figure 47. Post Nos. 4 and 5 Damage, Test MWT-2

contacted on the front edge and nearly flattened. Post no. 7 was not contacted, but was rotated and deformed to the ground. Post no. 6 was not contacted, but was twisted and flattened. Post nos. 2 through 5 were not contacted, but moved slightly with soil failure. The wood blockout at post no. 5 split down the blockout's length at the traffic-side quarter-point. No significant post or guardrail damage occurred downstream of post no. 1.

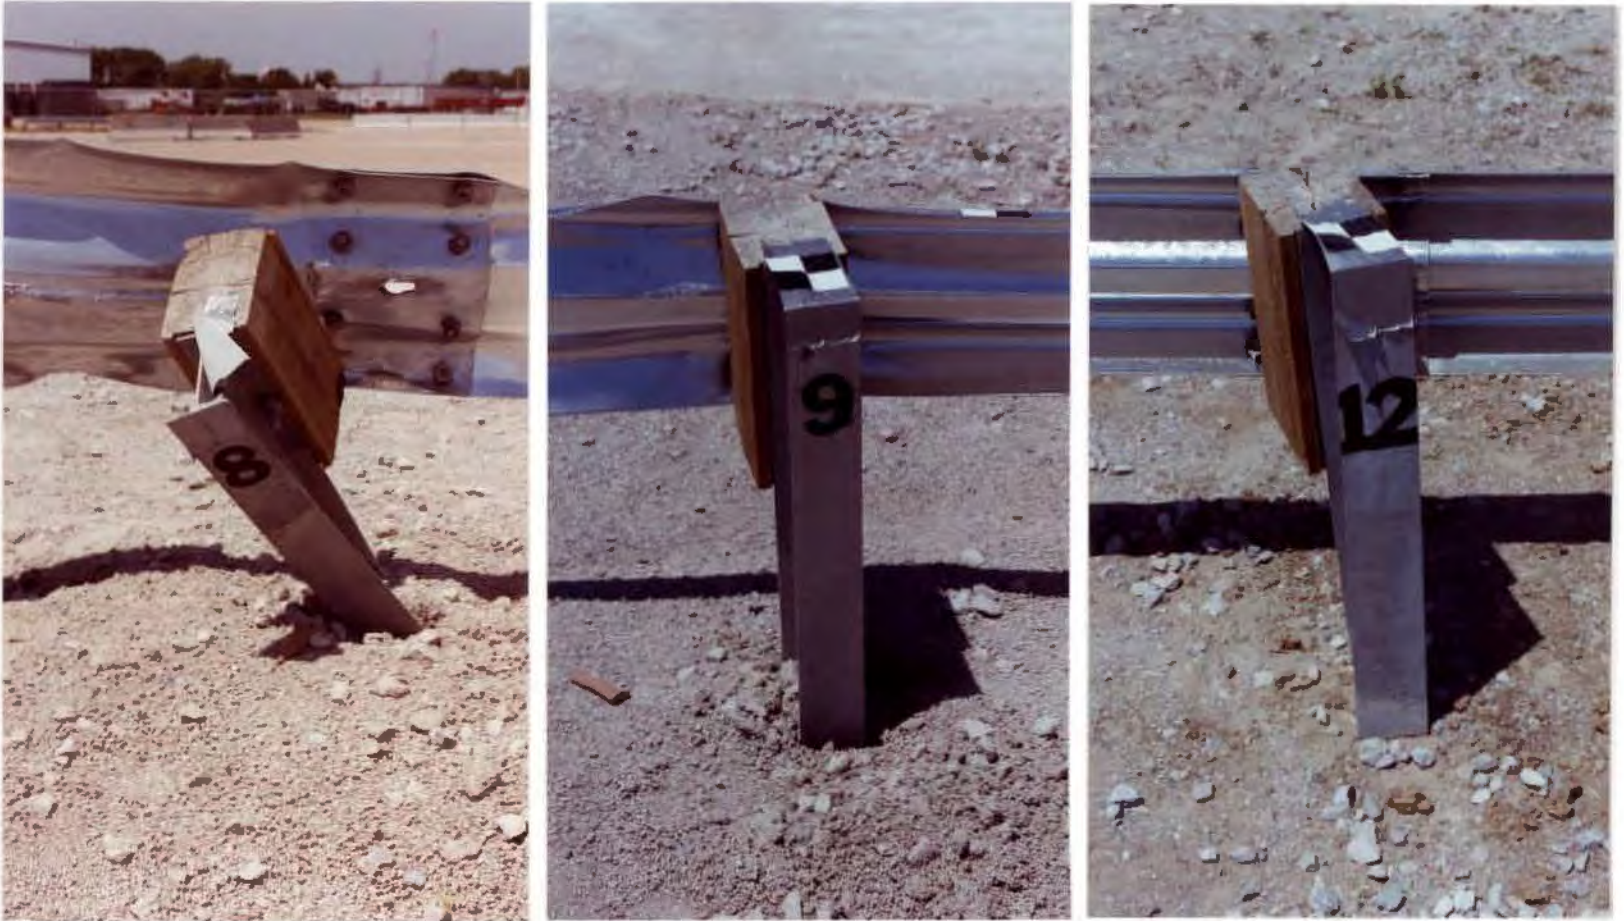
Figure 49. Post Nos. 8, 9, and 12 Damage, Test MWT-2

During the impact event, damage and deformations were observed at several post locations and consisted of permanent post deformations, contact marks, and damaged wooden blockouts. Post nos. 10 through 14 were twisted and the bolts pulled through the bolt holes in the guardrail causing slot damage. Post no. 9 was not contacted but twisted and rotated backward. Post no. 8 was

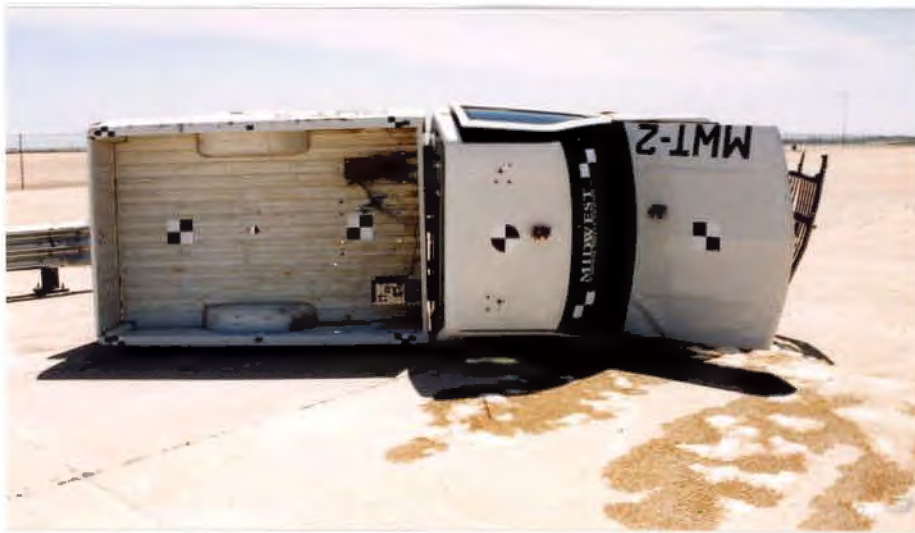
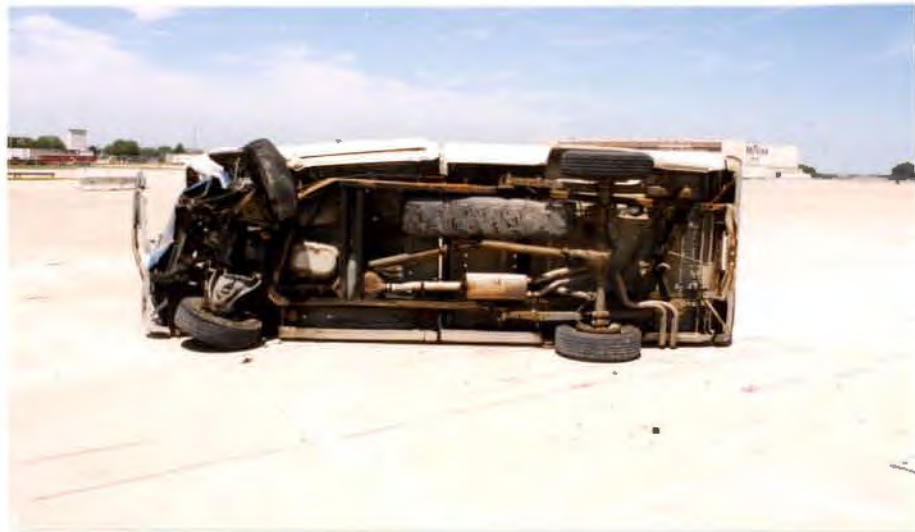
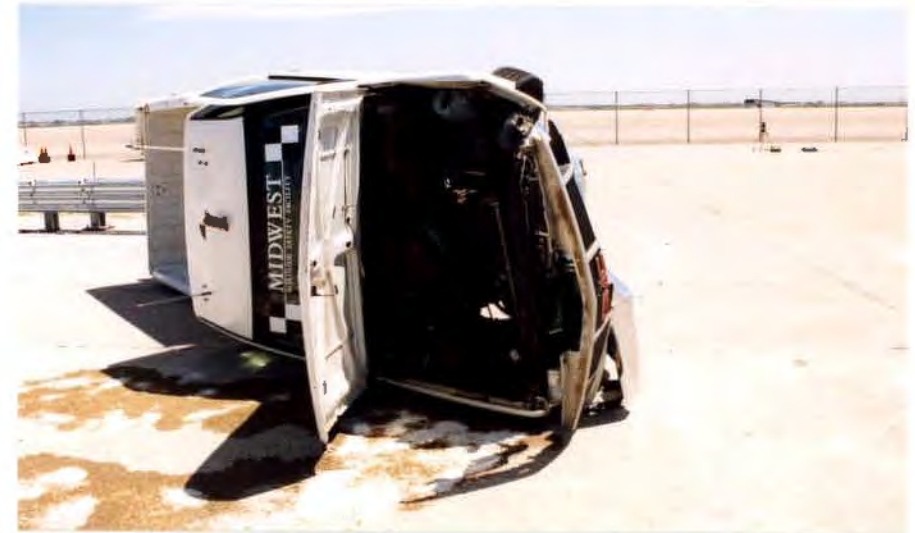
Figure 51. Vehicle Damage, Test MWT-2

Exterior and interior vehicle damage was extensive and occurred at several body locations, as shown in Figures 51 through 53. Most of the vehicle damage occurred to the left-front corner of the vehicle. Severe deformation and damaged occurred to the left-front frame and bracket, the left-front wheel and suspension, and the front bumper. All of the major left-front wheel linkages, including the tie rod, the ball joint, and the sway bar, disengaged. The engine and transmission mounts also disengaged. Deformation occurred to the drive shaft. The left-front steel rim encountered major damage. The floorboard's center hump buckled toward the occupant compartment's rear wall. The firewall of the occupant compartment crushed inward under the brake pedal. All the window glass remained undamaged.
