**CORROSION PERFORMANCE OF EPOXY-COATED
REINFORCEMENT–MACROCELL TESTS**

Research Report No. 1265-3

STRUCTURAL INTEGRITY OF EPOXY-COATED BARS

Texas Department of Transportation

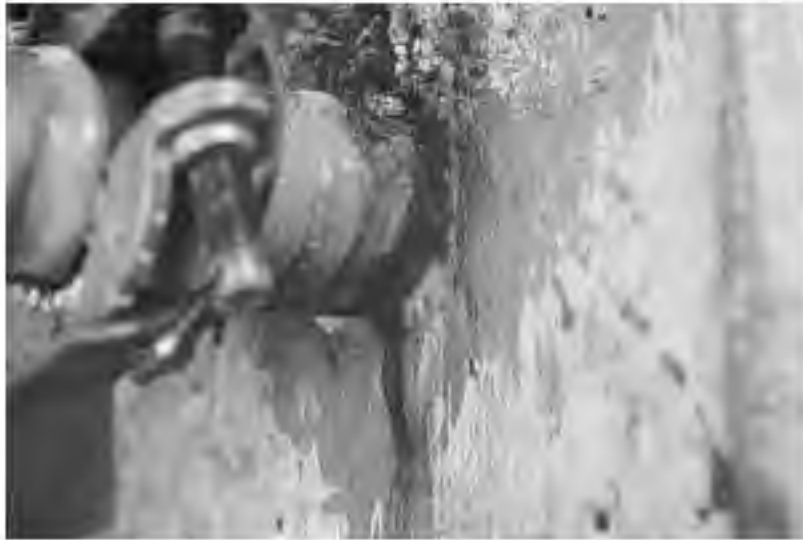
Figure 2.10 Brown solution exuding from protruding bar at front face of specimen.

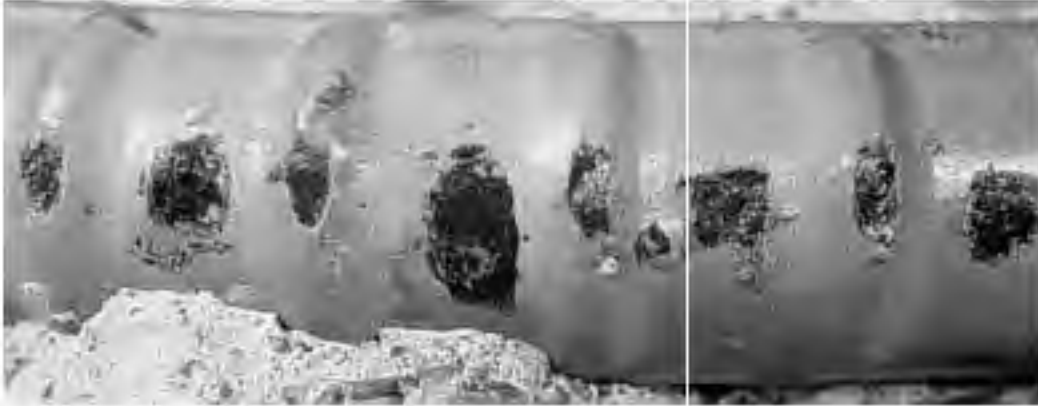
The large bars showed relatively more corrosion activity; however, metal loss was minor as shown in Figure 2.18. Rust spotting at some patched areas was visible. On the majority of the large bars, many variable size blisters distributed on the coated surface were noted. The blisters formed at spots facing air voids in concrete as shown in Figure 2.19. Based on appearance, the worst bars, from both series, were those with exposed damaged areas slightly exceeding 2% of the bar surface area.

Figure 2.18 Example of 25-mm (#8) coated bar specimens after one year of exposure.

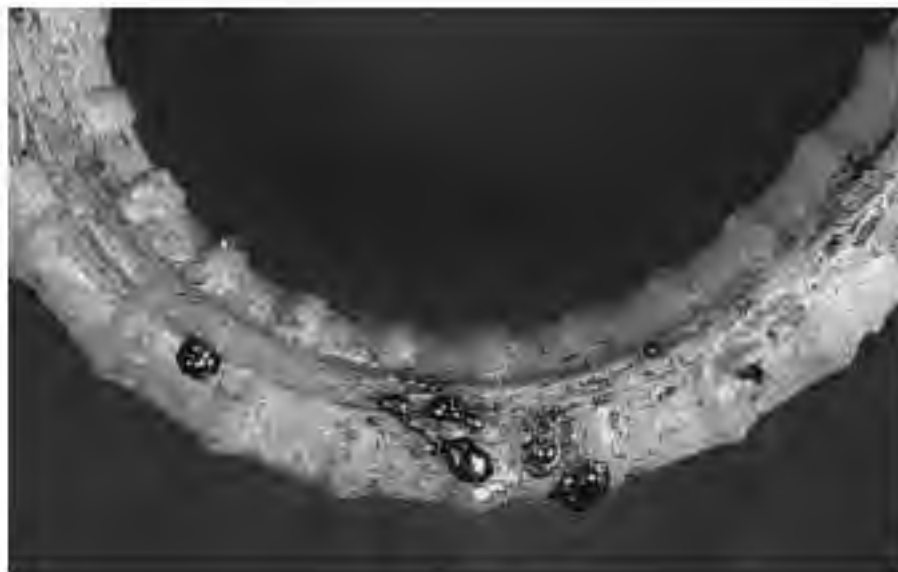
Figure 2.30 Brownish, liquid solution exuded on surface of epoxy-coated bars.

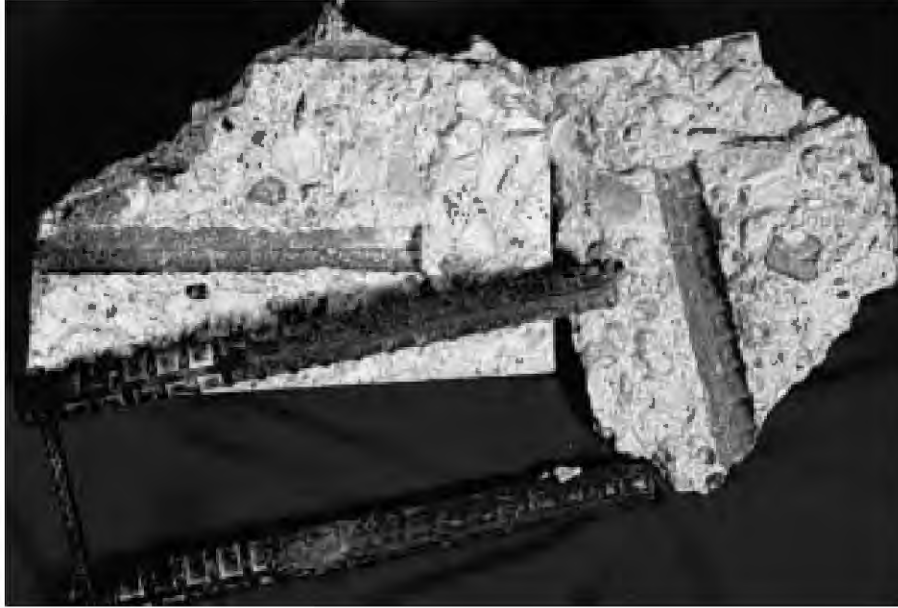
Figure 2.31 Cathodic uncoated bars at bottom of macrocell specimens.

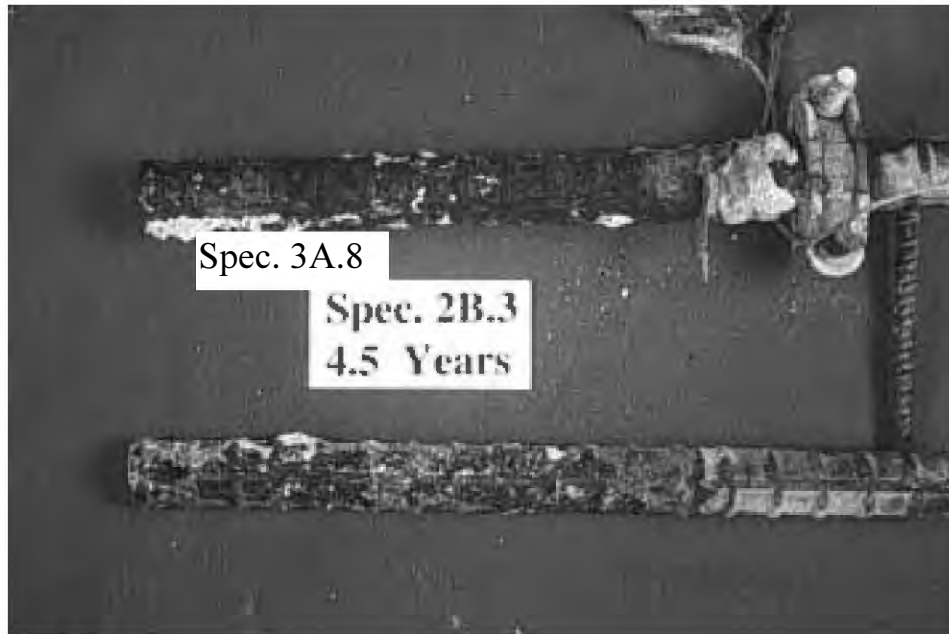
concrete showed extensive dark and reddish-brown rust staining, similar to the corrosion observed on the bars. Sites adjacent to pitted locations in the bars showed accumulation of solid rust products, usually inside concrete voids.

Figure 2.32 Corrosion at bottom side of cathodic, bottom bars of specimen 3A.8.

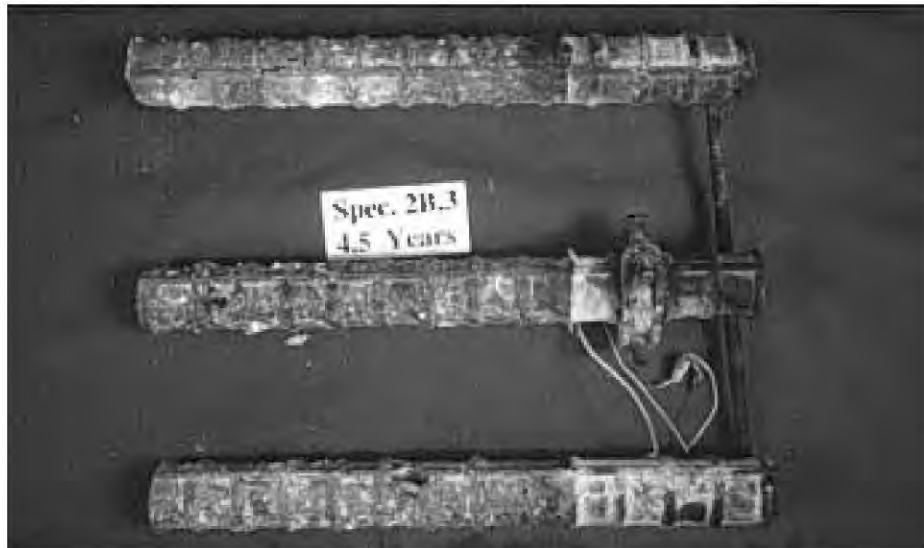
dark stains appeared at the uncorroded portion on the bottom side (a 11.5-cm long zone closer to the front face of the specimen). Laitance was present at the adjacent bar trace in concrete, suggesting that something occurred at the metallic surface (ions that were generated by the cathode may have reacted with concrete). Macrocell currents in specimen 3B.5 experienced incidental large drops between cyclic high and low peaks after 2 years. This suggests that corrosion of the cathodic bar started to affect the currents measured.

Figure 2.33 Appearance of bottom side of cathodic, bottom bars of specimen 2B.3.

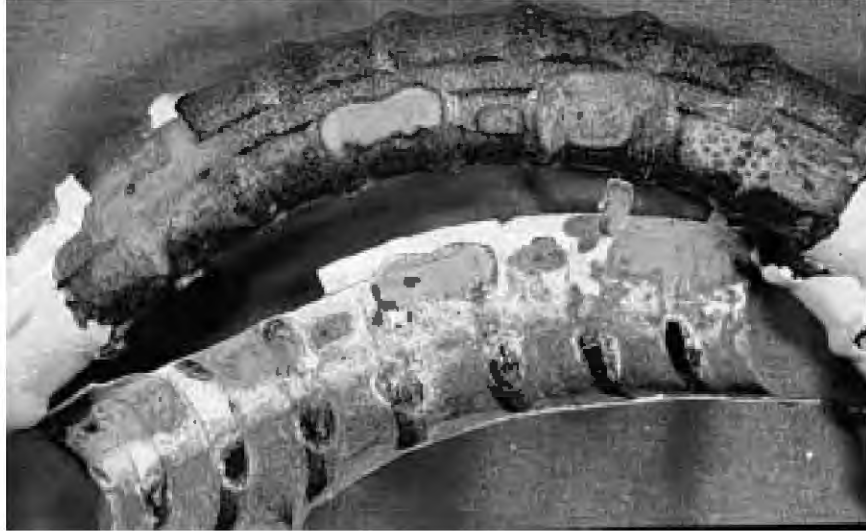
Figure 2.40 Corrosion deposits on bottom side of steel surface.

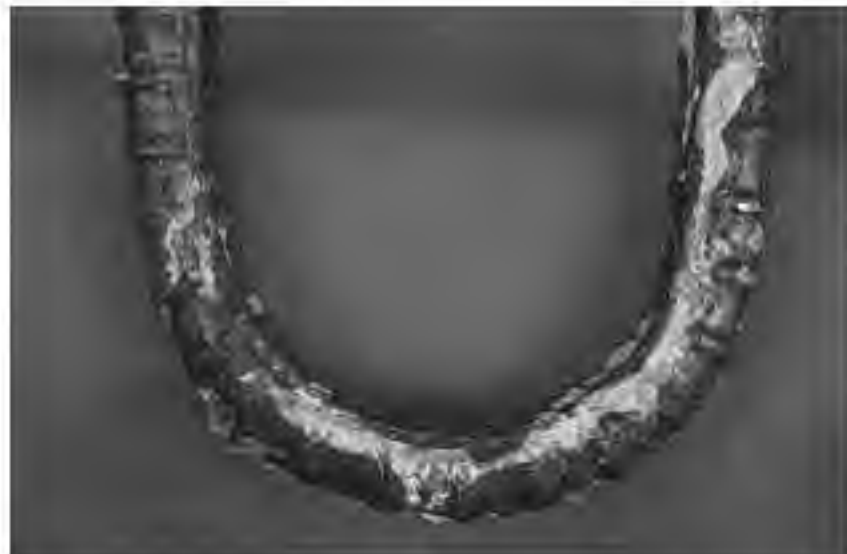
Figure 2.44 Whitish products alongside longitudinal lug at bottom side of bar 1A.5.

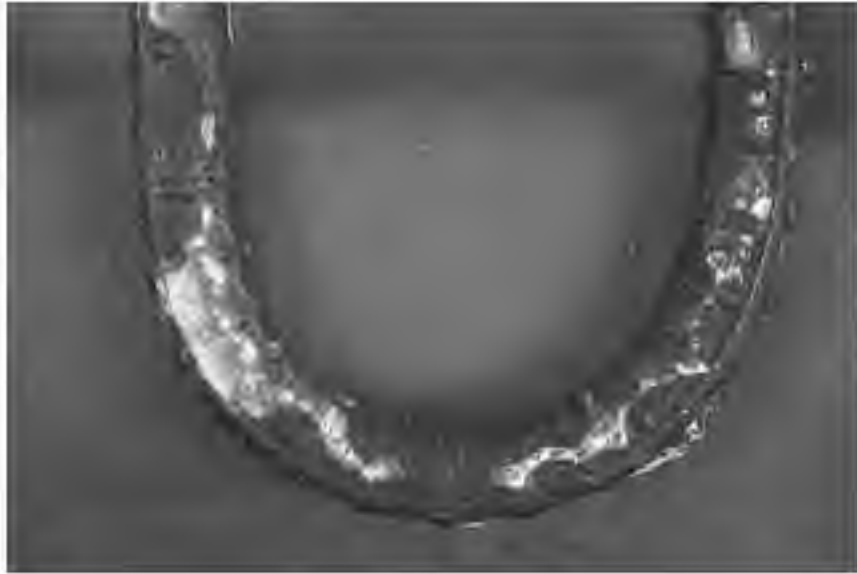
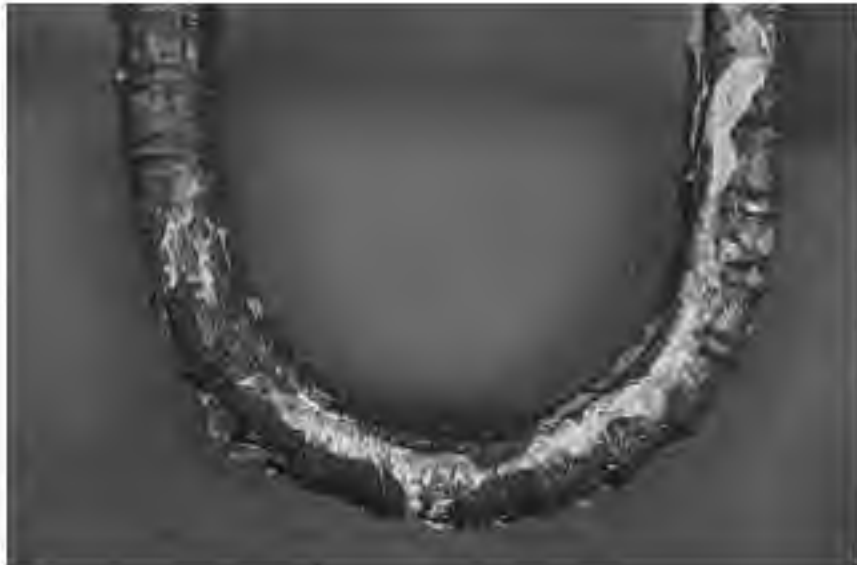
Among smaller bars, specimen 1A.5 (damage > 2%) suffered the worst corrosion (Figure 2.45), followed by bars 2A.6 (cracks with damage < 1%) and 1A.10 (damage > 6x6 mm). The bar with best condition was, amazingly, 3A.3 (damage > 6x6 mm) (Figure 2.46), followed by bar 3A.7 (damage < 2%). Among larger bars, specimen 3B.5 (damage > 2%) suffered the worst corrosion (Figure 2.47), followed closely by bar 3B.4 (damage > 2%, patched). The extent and severity of corrosion was similar for the remaining bars. Interestingly, in bars with damage greater than 6x6 mm, corrosion spread much more on the repaired bar (3B.2) than on the unrepaired bar (2B.3).

Figure 2.45 Whitish and yellowish-brown corrosion products on bar 1A.5.

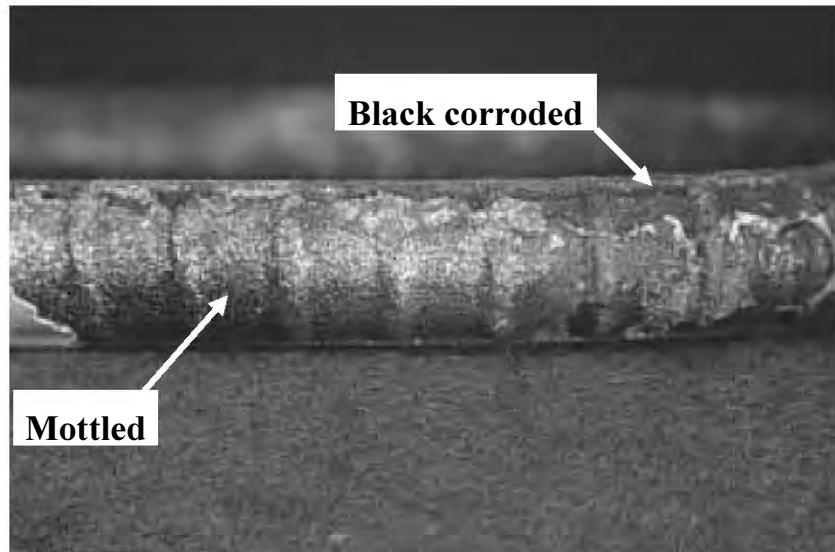
(a) Mottled, glittering golden-brown steel surface under the coating.

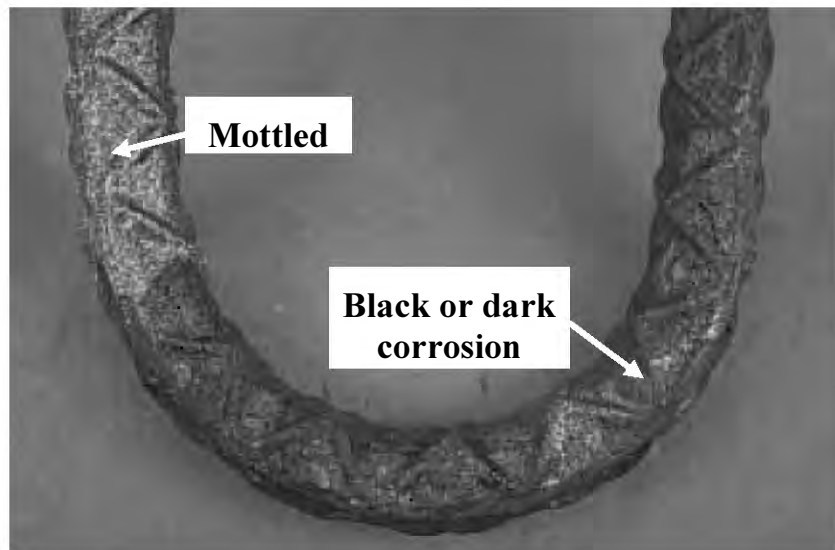
(b) Black or dark corroded surface.

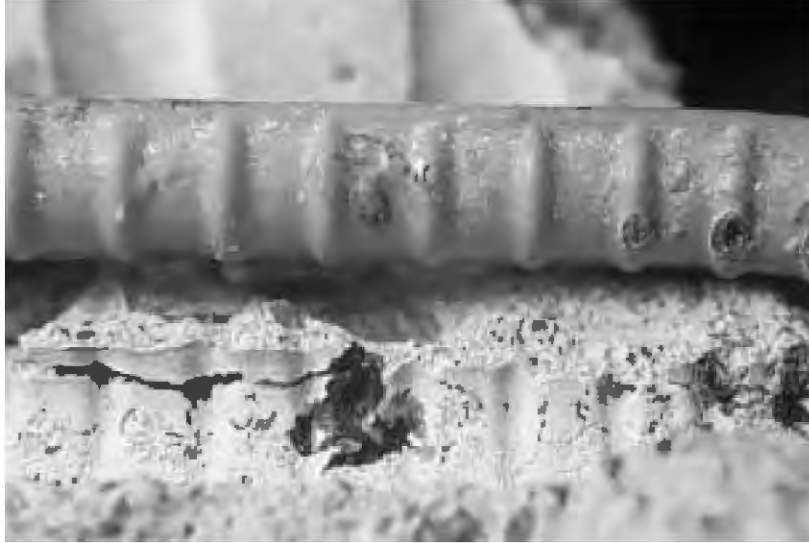
Figure 3.24 Blisters always formed adjacent to concrete voids.

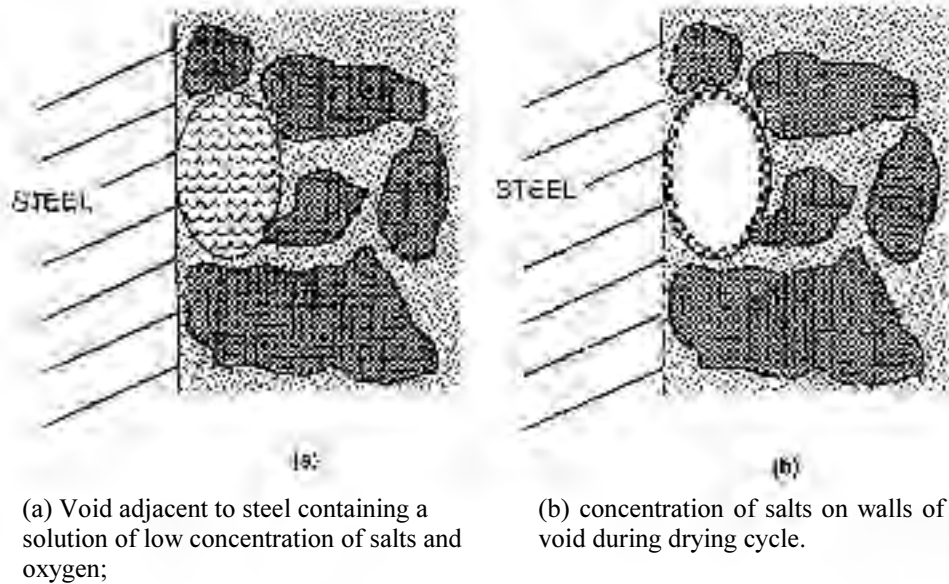
Figure 3.28 Voids promoting steel corrosion in concrete.

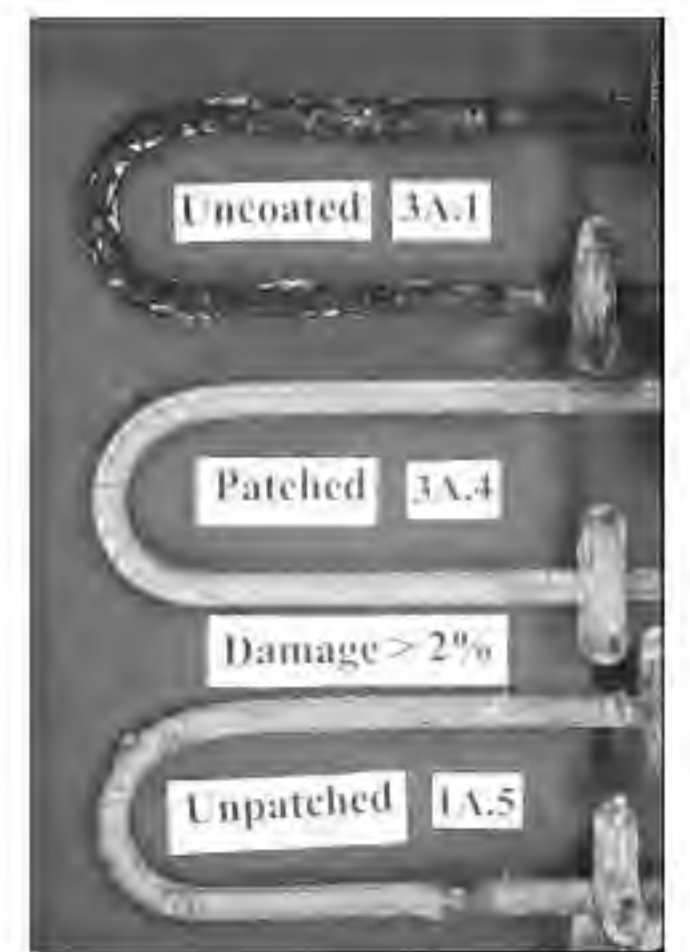
Figure 3.35 Comparative performance of uncoated and coated bars after 4.5 years of exposure.

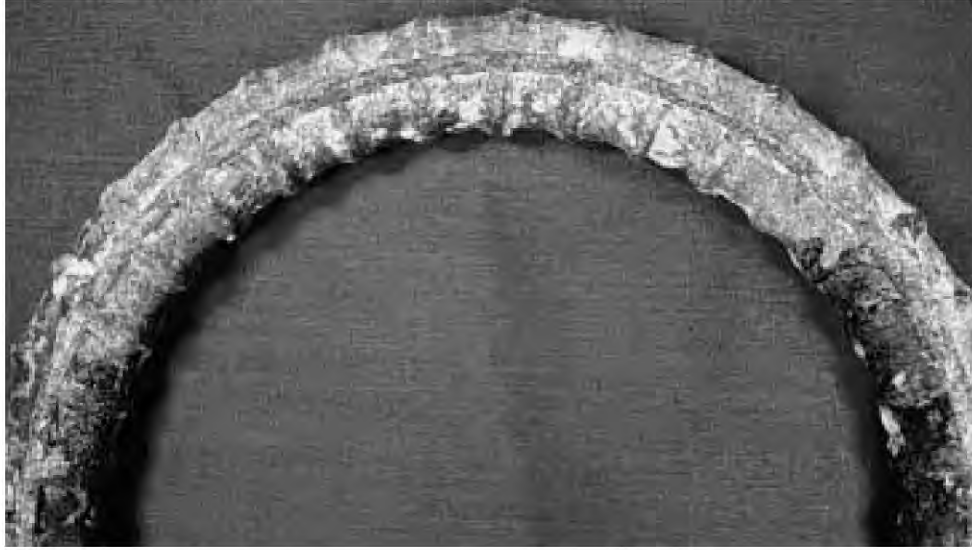
(a) Uncoated bar free of rust at bend

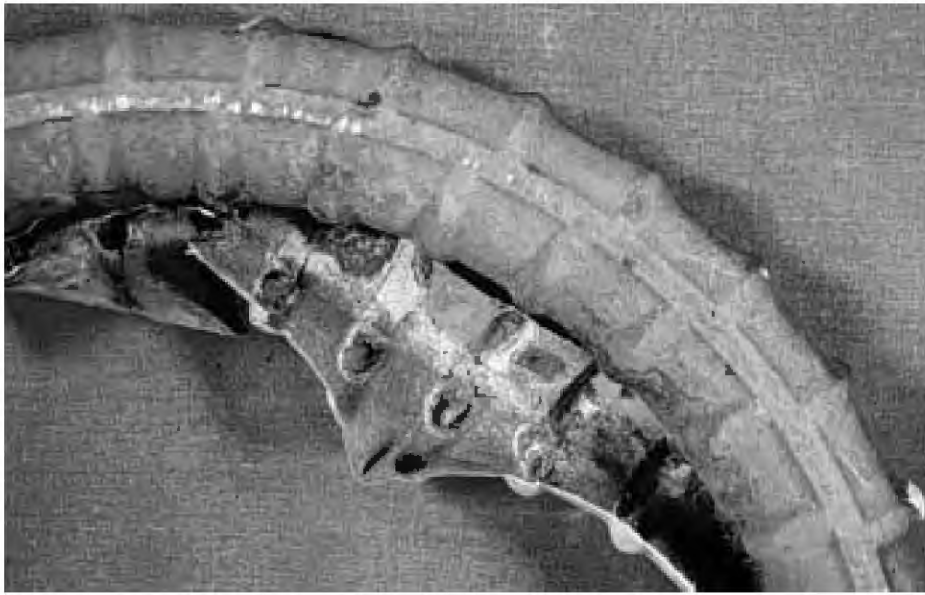
(b) Coated bar with corroded bend

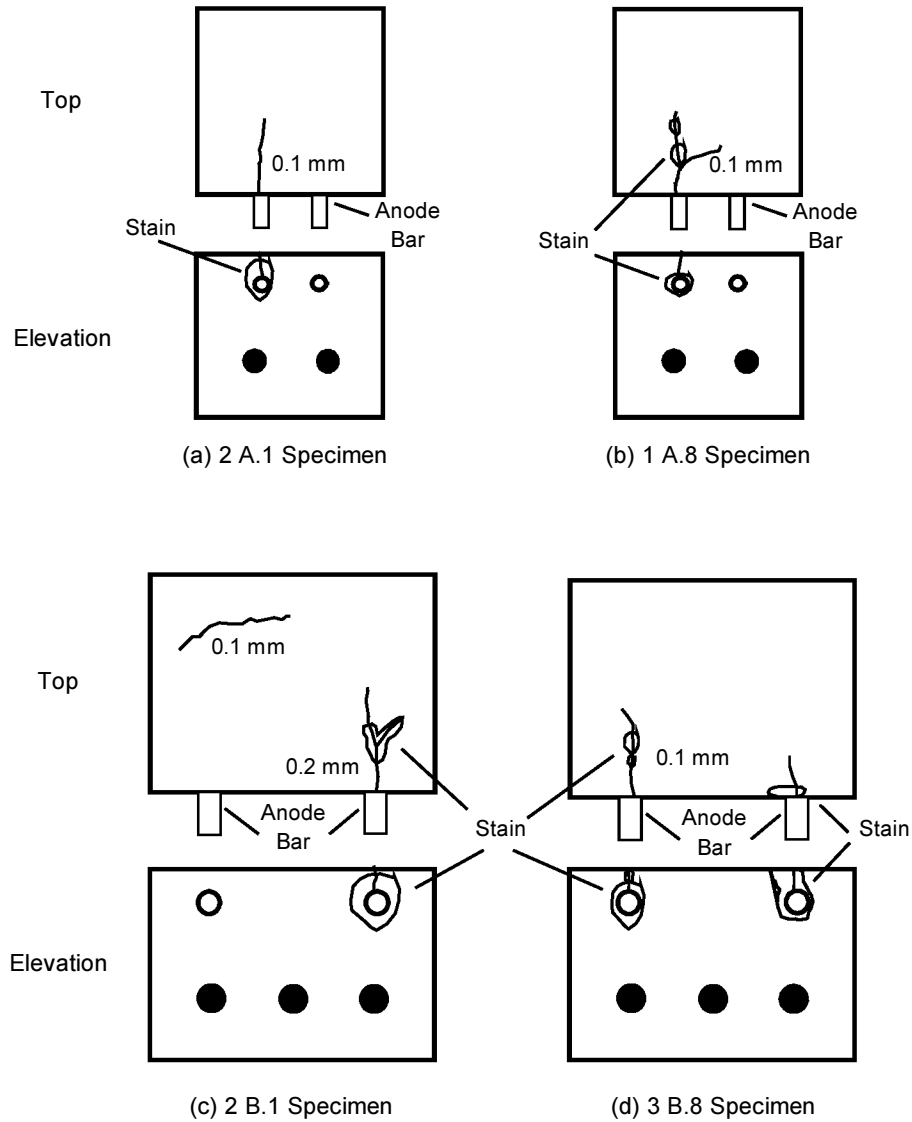
Figure A.21 Cracks and stains on macrocell specimens autopsied after one year of exposure.

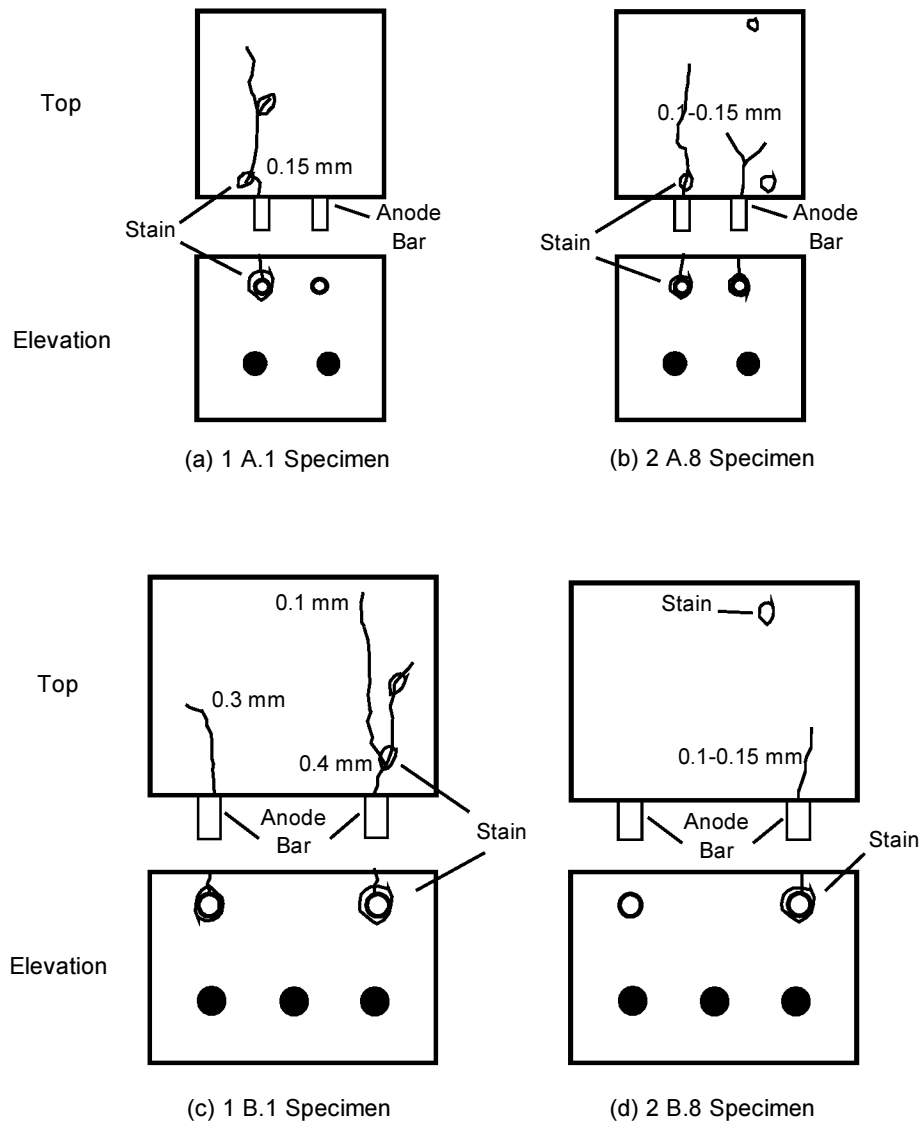
Figure A.22 Cracks and stains on macrocell specimens autopsied after two years of exposure.

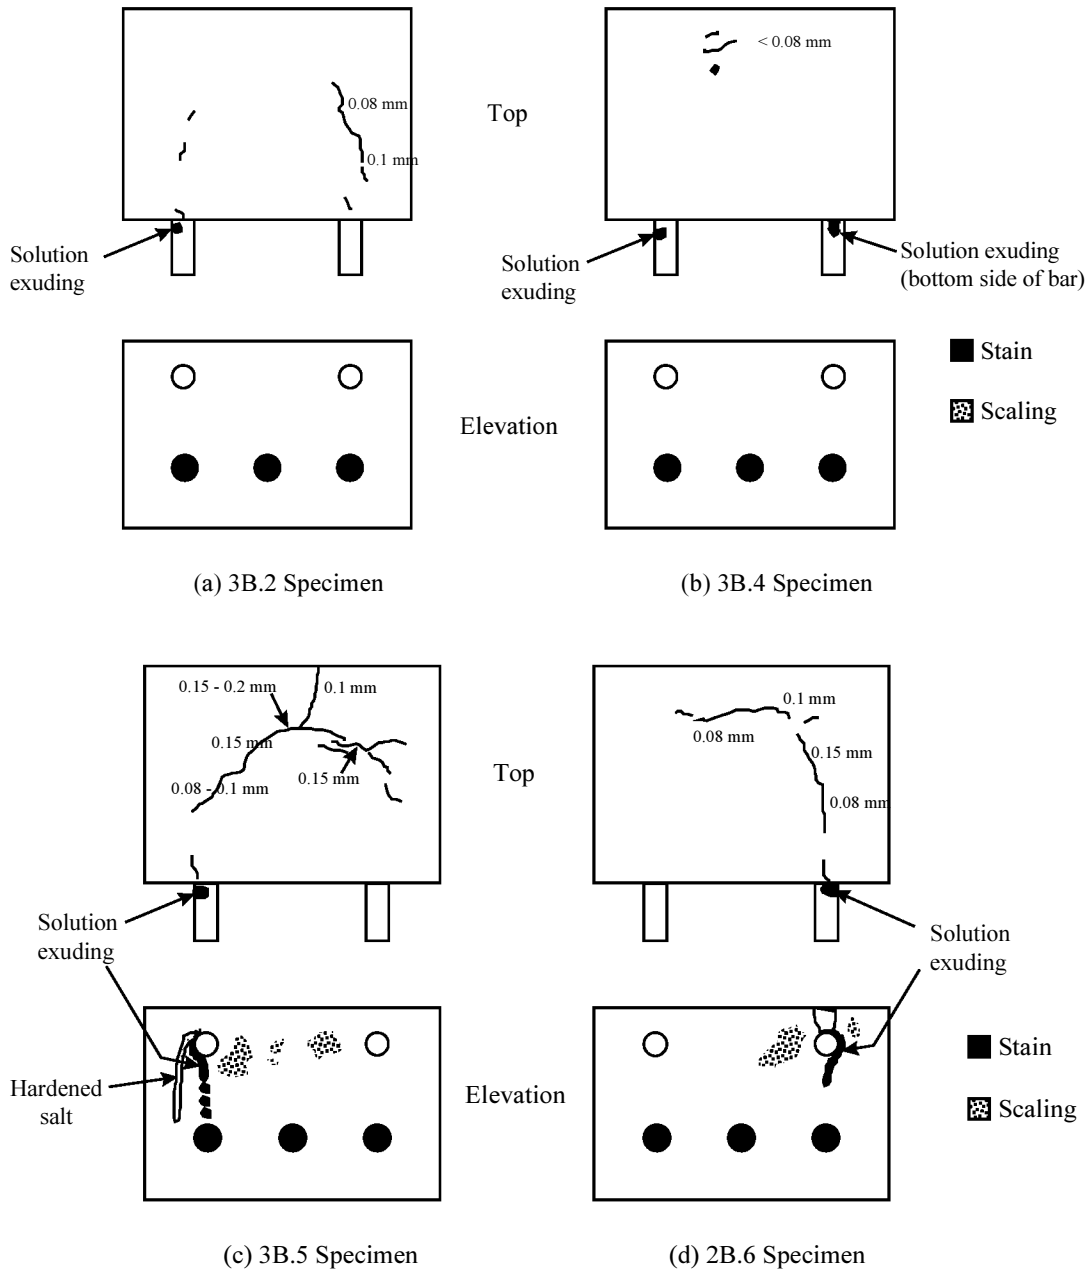
Figure A.25 Cracks and stains on macrocell specimens 3B.2, 3B.4, 3B.5, and 2B.6 inspected after 4.5 years of exposure.

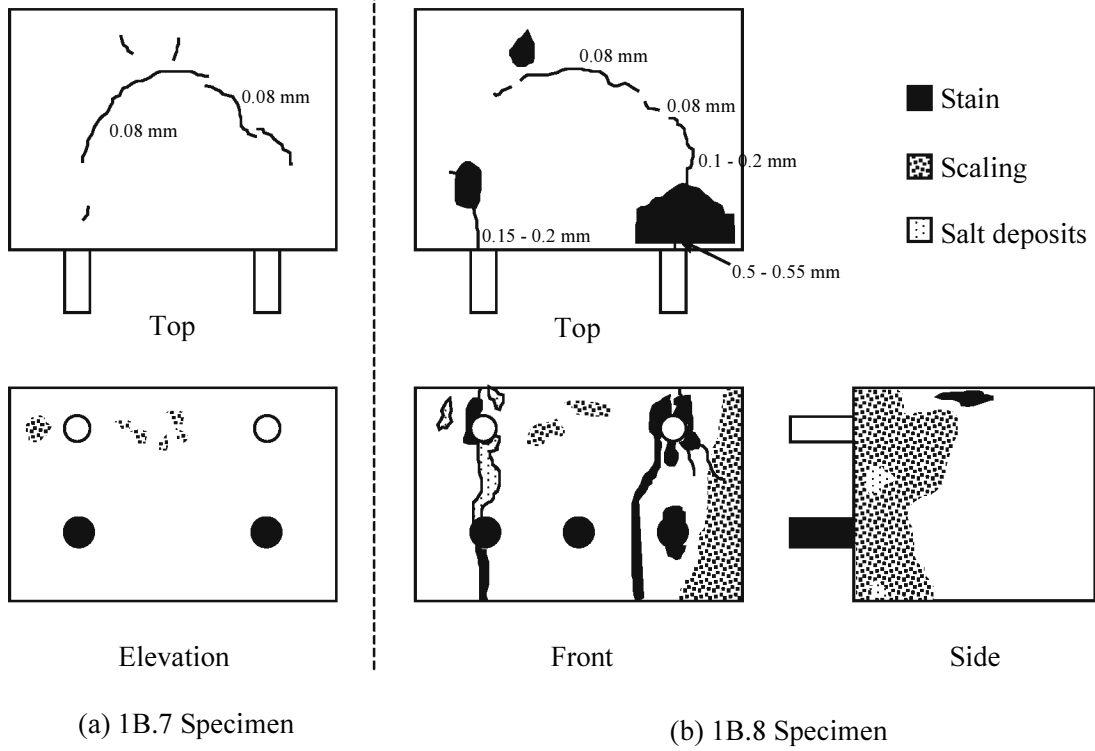
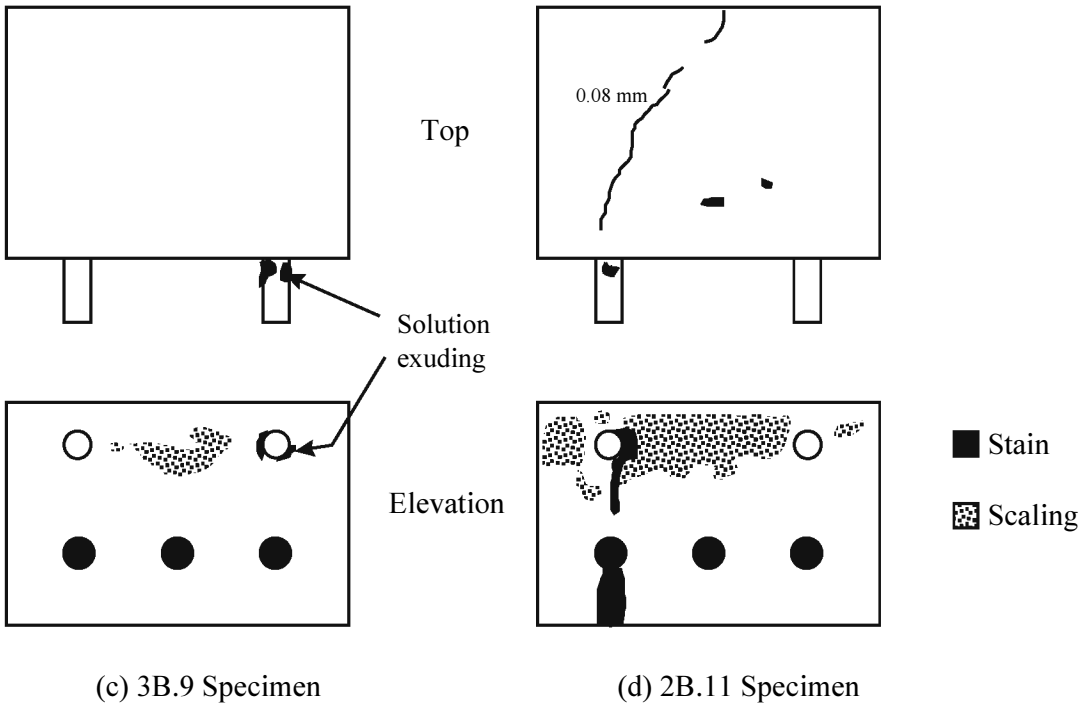
Figure A.26 Cracks and stains on macrocell specimens 1B.7, 1B.8, 3B.9, and 2B.11 inspected after 4.5 years of exposure.
