# CONSTRUCTION OF BRIDGE DECKS WITH PRECAST, PRESTRESSED CONCRETE DECK PLANKS

**PHYSICAL RESEARCH REPORT NO. 139  
APRIL 2002**

**Illinois Department of Transportation**

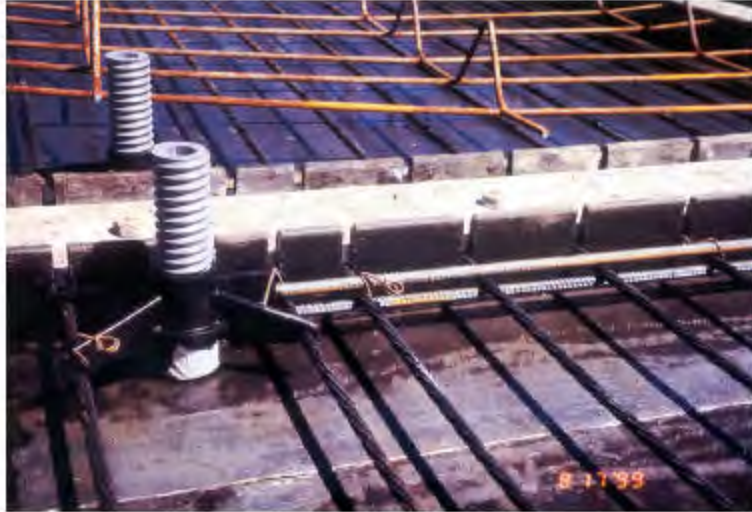
PEC developed a solution to the cracking by adding #3 reinforcing bars above and below the strands, 1.5 inches from each end of the plank, as seen in Photo 4. While the bars reduced a number of the cracks, a great number of planks were still rejected due to hairline cracks.

Photo 4. #3 rebar above and below strands

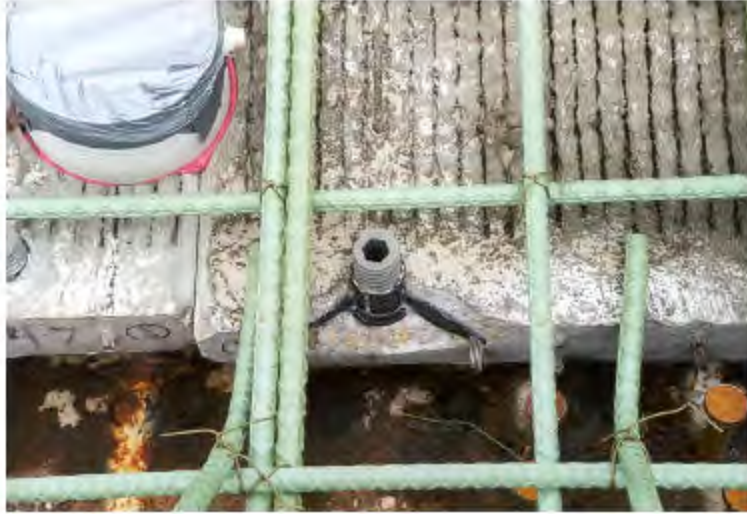
When seating PPC deck planks for Stage 1, the laborers were slowed down while installing the leveling screws. Many of the imbedded inserts were slightly compressed, making screw installation very difficult. Furthermore, several of the planks developed spalls in one or more of the corners after the leveling screws were installed (see Photo 8). This was probably a result of the force applied when the leveling screws were installed.

Photo 8. Spall at leveling insert (District 8 – Stage 1, June 24, 1999)

PEC began installing the screws during fabrication. The laborers only had to adjust the screws during the seating process. This solution greatly reduced the time and effort required for seating the deck planks.

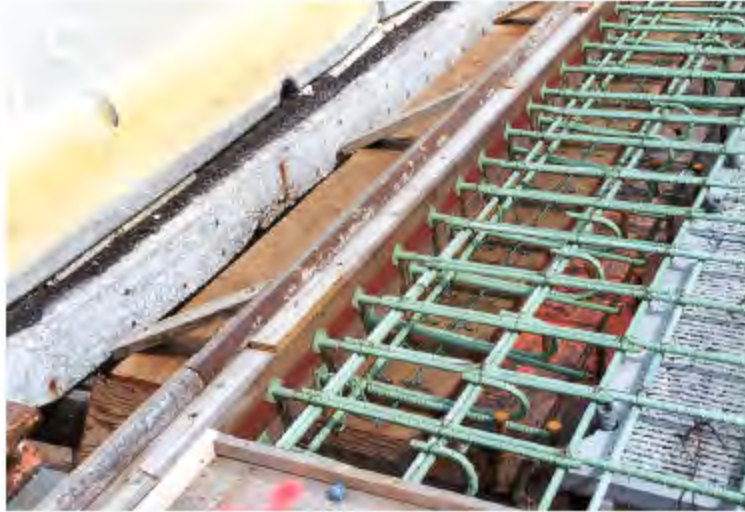
Because of the deck planks, reinforcement bars had to be modified in some places. Splice bars had to be cut three to four inches shorter, because they were too long to accommodate the deck planks (see Photo 10). Some of the vertical bars for the parapet wall had to be cut shorter, since they had to rest on the deck planks (see Photo 11).

Photo 10. Bottom splice bars cut short  
(District 8 – Stage 1, June 24, 1999)

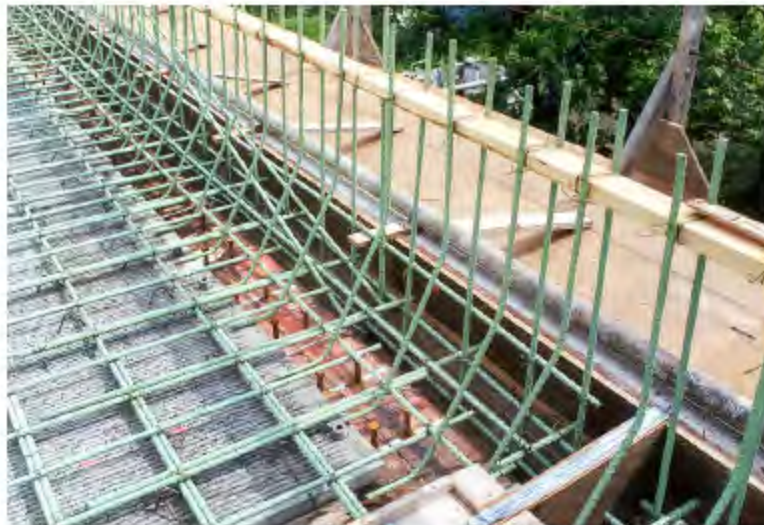
Photo 11. Inside parapet wall bars resting on plank  
(District 8 – Stage 1, June 24, 1999)

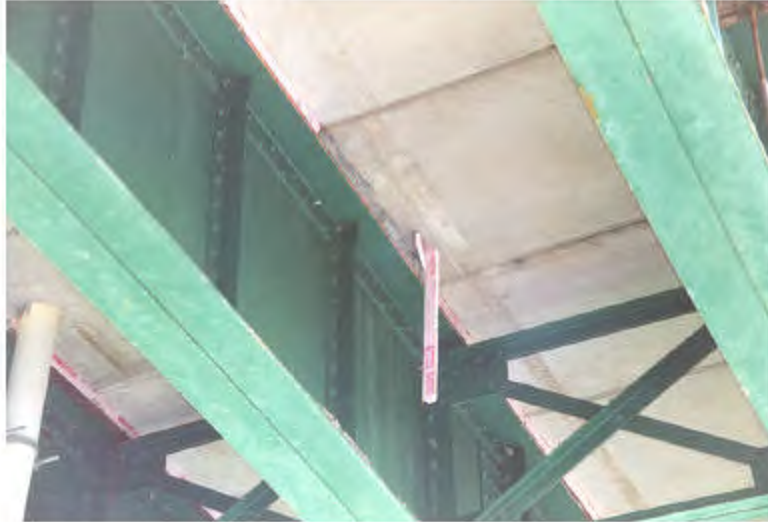
During Stage I paving, several “blow-outs” were reported. A blow-out occurs when the concrete either pushes out or breaks some sections of polystyrene, as shown in Photo 12. Without the polystyrene there to act as a dam, some concrete was lost in those areas. ASTM C 578 Type IV extruded polystyrene was used for both Stage I and 2. The movement and vibration of the bridge from the traffic may have caused the caulking bond to weaken between the polystyrene and the beams.

Photo 12. Blowout (District 8 - Stage I, June 28, 1999)

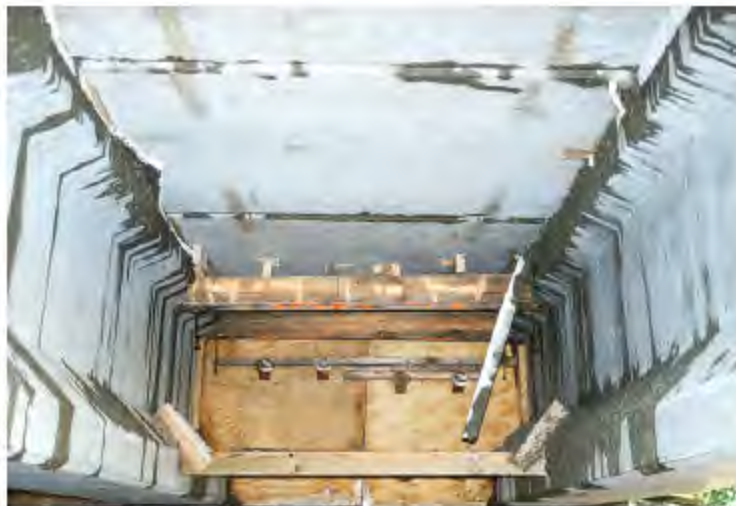
District 6 had even more blowouts during both Stage I and Stage II construction than District 8 (see Photo 13). The grade of polystyrene for the Stage II construction was changed to reduce the blowouts. For Stage 1, expanded polystyrene was used. ASTM C 578 Type IV extruded polystyrene was used for Stage 2. The extruded polystyrene did not appear to help in reducing the blowouts during the Stage II pour (see Photo 14).

Photo 13. Blowouts (District 6 – Stage 1, August 16, 1999)

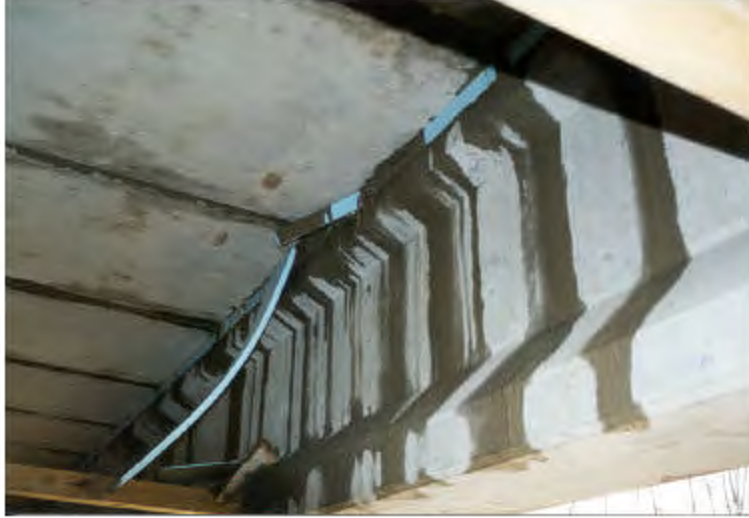
Photo 14. Blowouts (District 6 – Stage 2, March 13, 2000)

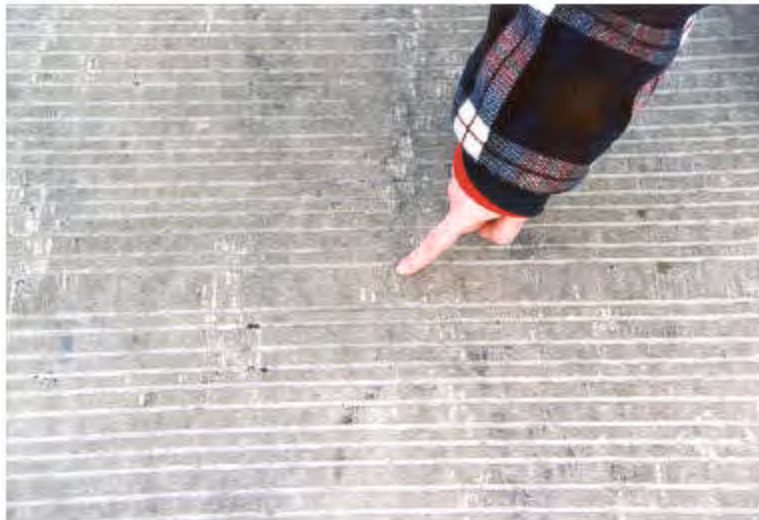
On December 1, 1999, a distress survey was performed on the Jersey-Greene county bridge. Numerous transverse cracks were found in Stage 1 (the northbound lane). The transverse cracks extended across at least 50 percent of the lane and were typically spaced 3.5 to 5.0 feet apart. The majority of the cracks were hairline, as shown in Photo 15. Stage 2 (the southbound lane) looked better than Stage 1. Only two transverse cracks and no longitudinal cracks were found.

Photo 15. Longitudinal Crack (District 8 – Stage 1, Dec. 1, 1999)

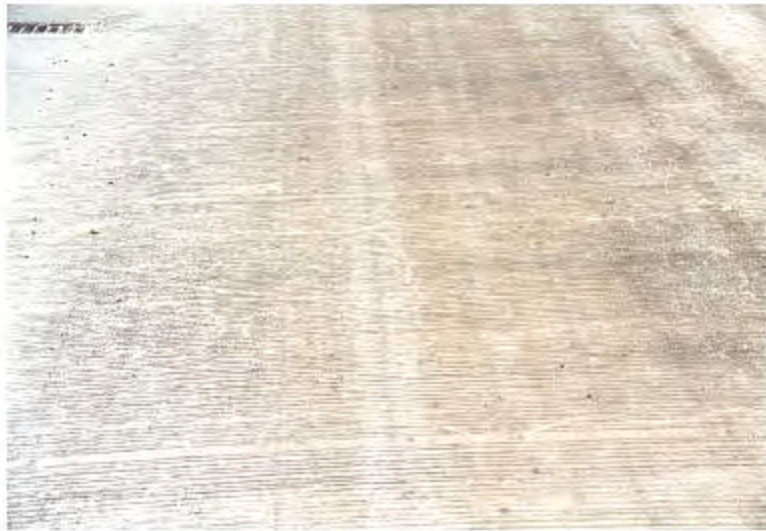
Approximately two months later, on January 28, 2000, a quick survey was performed on the Jersey-Greene County bridge. In Stage 1, several longitudinal cracks were observed. In fact, a single longitudinal crack, mostly above the first interior girder, ran along at least 50 percent of the northbound lane. In this survey, cracks were possibly more visible due to salt residue covering the bridge deck surface. Several transverse cracks were also seen in

Stage 1 (see Photo 16). Like the December survey, no longitudinal cracks and only two transverse cracks were found in Stage 2.

Photo 16. Longitudinal Crack (District 8 – Stage 1, January 28, 2000)

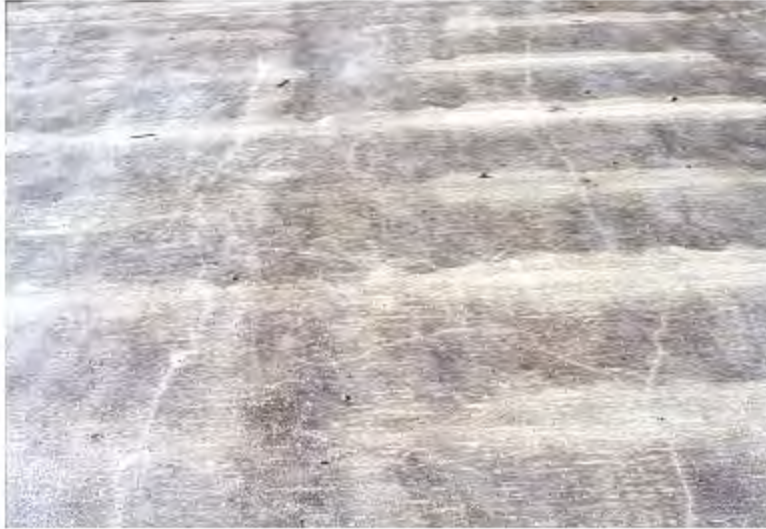
Photo 17. Longitudinal, transverse, & diagonal cracks before traffic loading  
(District 6 – Stage 1 “overflow” bridge, August 30, 1999)

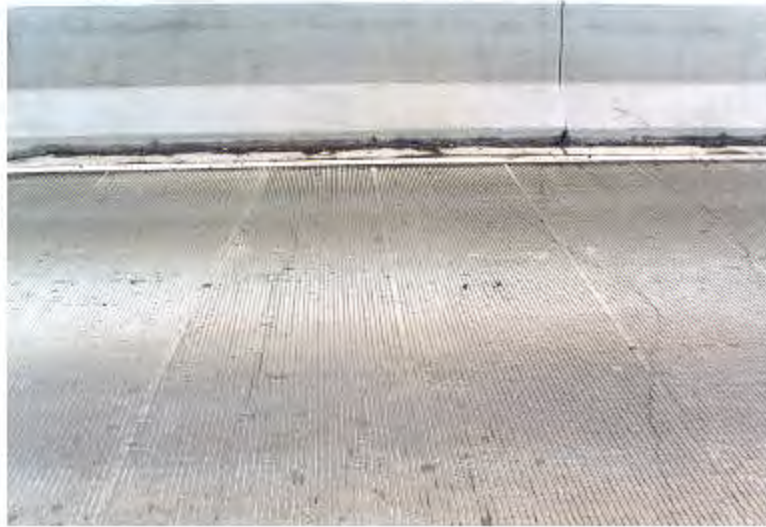
The more severe and visible transverse cracks were located directly above the piers. Two cracks in an hourglass shape were located above Pier #1 in Stage 1 of the “creek” bridge (see Photo 18) Two fairly straight transverse cracks were located above Pier #2. The survey notes for the 1999 PPC deck plank bridges previously surveyed indicate that similar cracks were located over most of the piers.

Photo 18. Transverse cracks above Pier #2  
(District 6 – Stage 1 “creek” bridge, March 13, 2000)

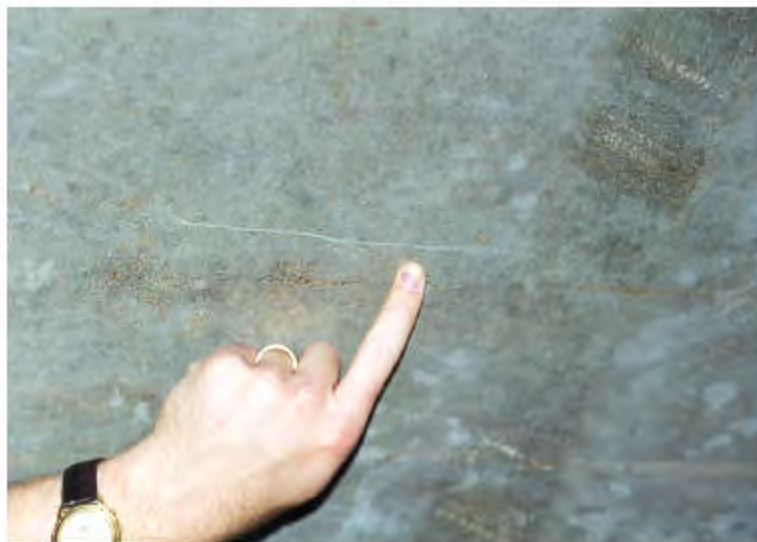
The surveyors examined the underside of both bridges. While they were able to look at all three spans of the “overflow” bridge, they were only able to look at one span of the “creek” bridge due to the water level. They found only one plank in the “overflow” bridge that appeared to have some cracking (see Photo 19). Even the cracking they saw was minor. The rest of the planks appeared to be in good condition.

Photo 19. Crack on underside of PPC deck plank  
 (District 6 – “overflow” bridge, May 30, 2000)
