## **DEVELOPMENT OF A 7.62-m LONG SPAN GUARDRAIL SYSTEM – PHASE II**

### **MIDWEST ROADSIDE SAFETY FACILITY**

MwRSF Research Report No. TRP-03-88-99

August 13, 1999

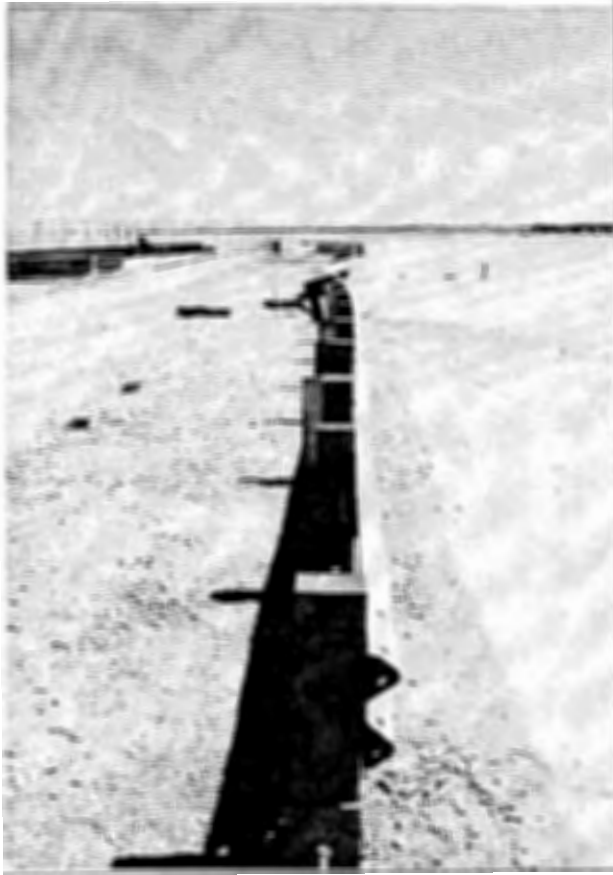
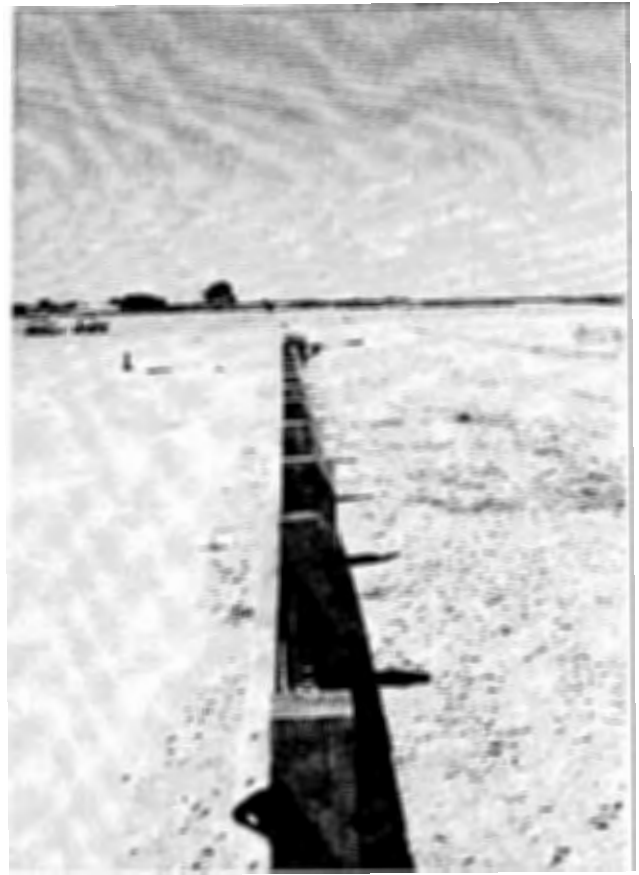
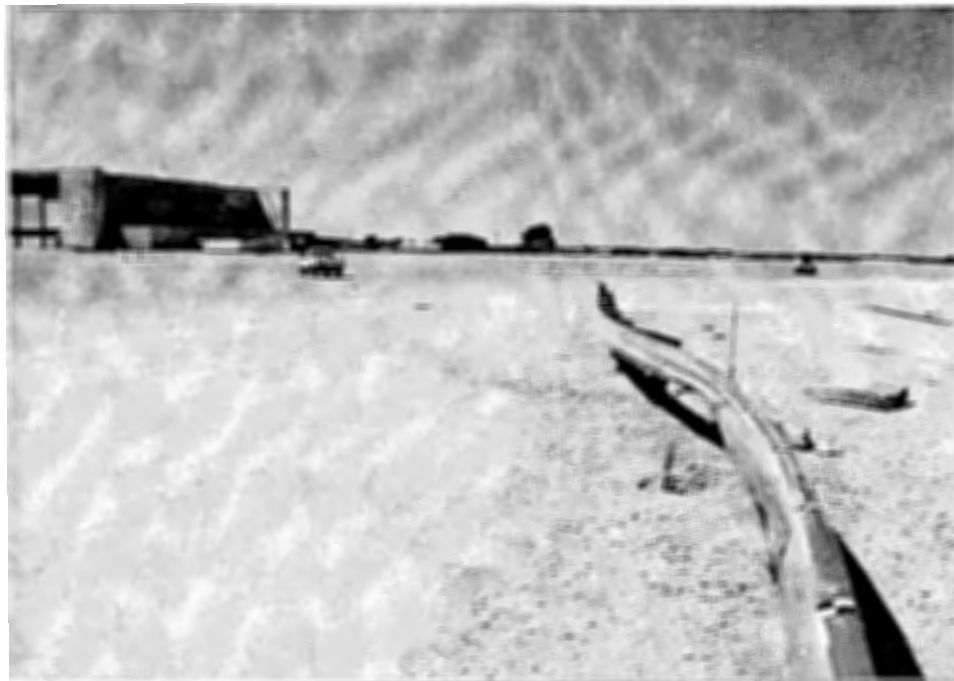
Figure 14. Long-Span Guardrail System Damage, Test OLS-3 (Design No. 3)

Damage to the barrier was moderate, as shown in Figures 14 through 18. Barrier damage consisted mostly of deformed W-beam, contact marks on a guardrail section, and deformed and fractured guardrail posts. The W-beam damage consisted of moderate deformation and flattening of the lower portion of the impacted section between post nos. 9 and 12. Contact marks were found on the guardrail between post nos. 9 and 12. The rail 533-mm downstream of post no. 11 had a major crease on the lower portion. The W-beam rail was pulled off of post nos. 3 and 4.

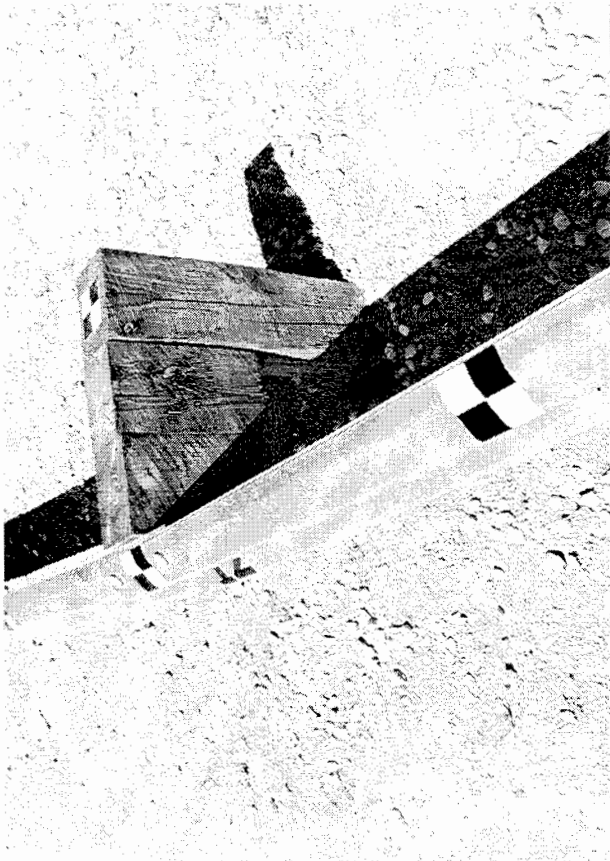
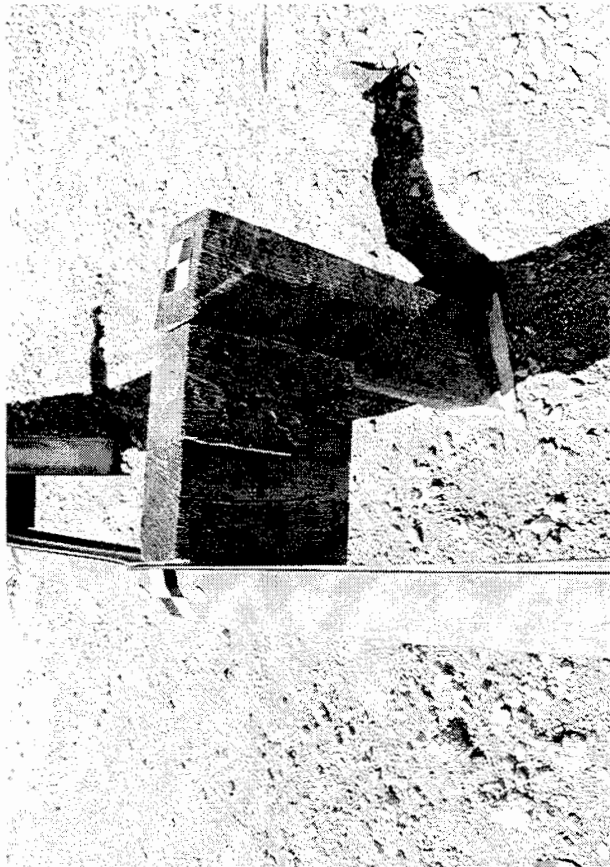
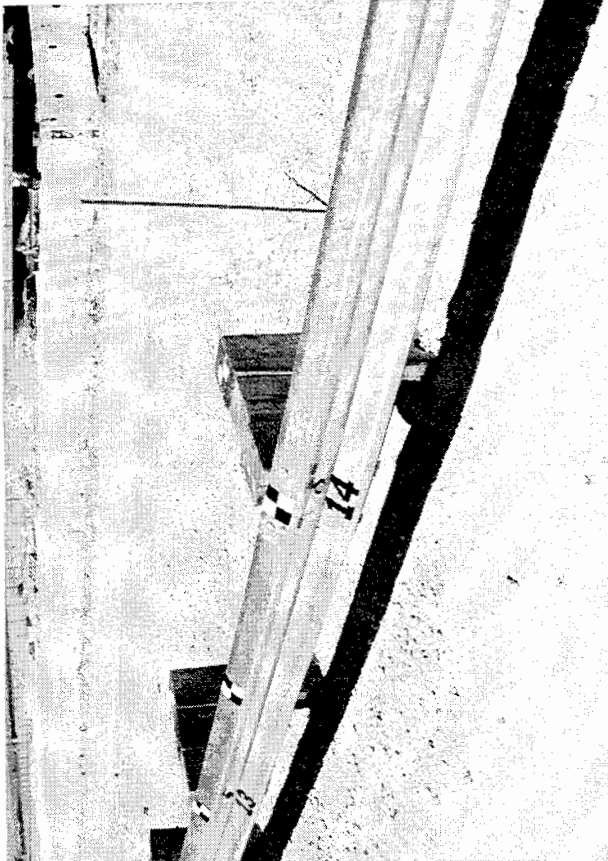
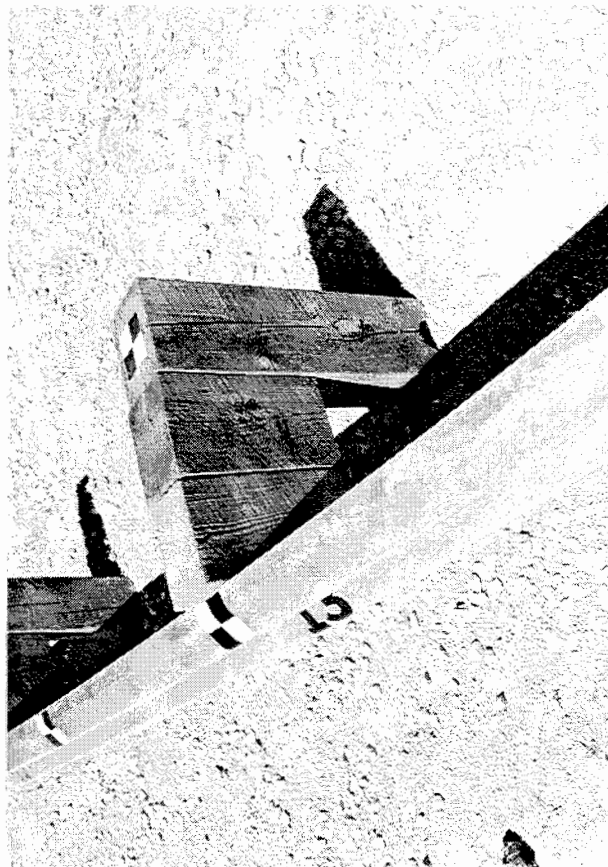
Figure 16. Final CRT Post Nos. 9, 12, 13, and 14 Positions, Test OLS-3 (Design No. 3)

Two CRT posts, post nos. 10 and 11, completely fractured while CRT post nos. 9 and 12 through 14 rotated backward, as shown in Figures 16 and 17. Steel post nos. 7 through 8 and 15 through 24 were twisted slightly and pushed backward. No significant post damage occurred to post nos. 3 through 6. No significant guardrail damage occurred upstream of post no. 14 nor downstream of post no. 9.

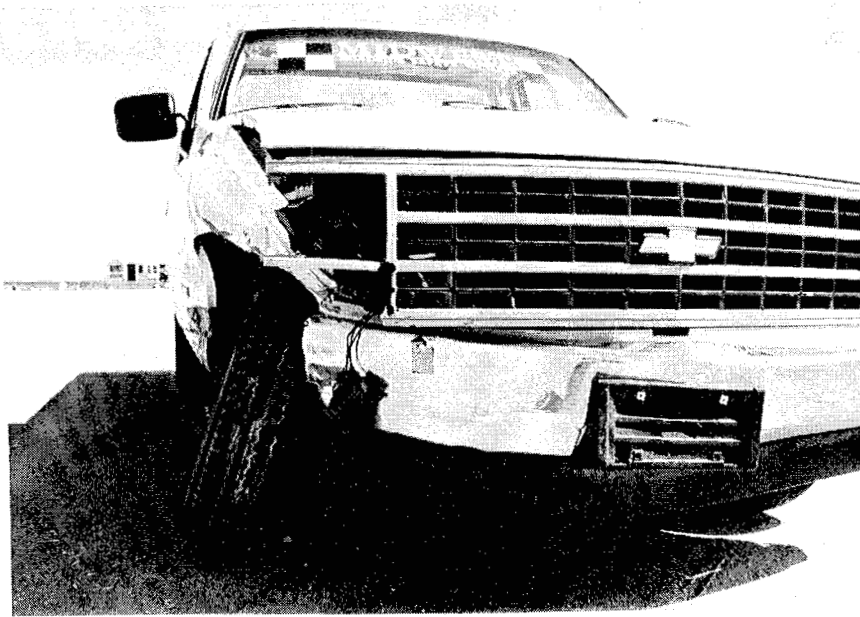
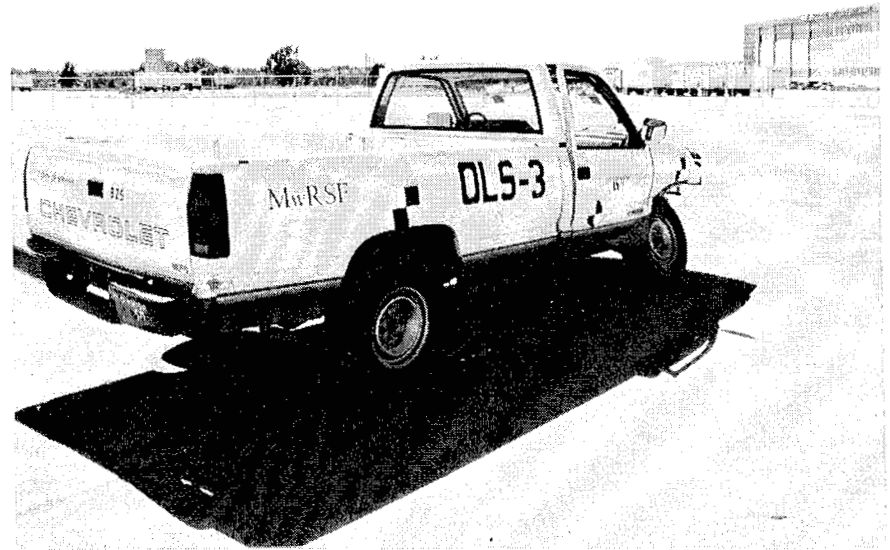
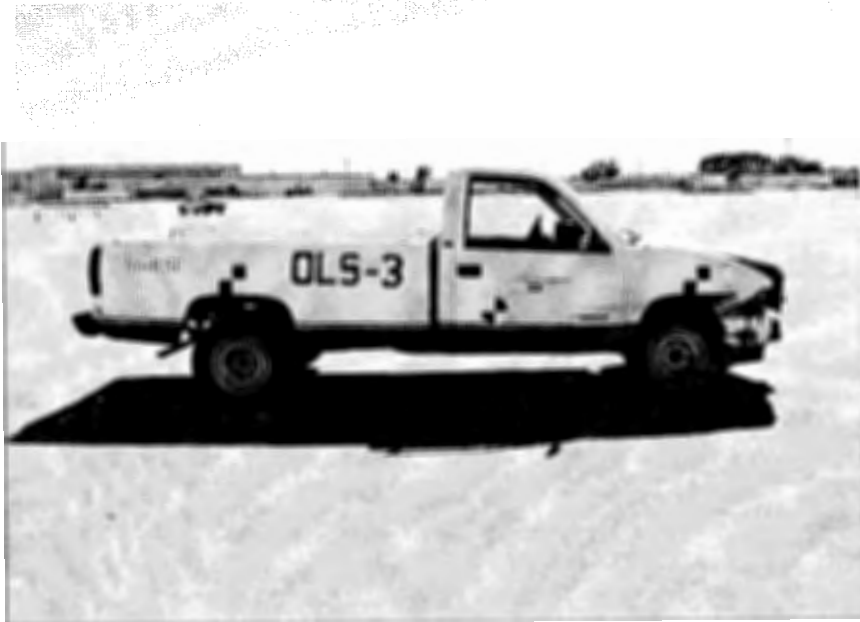
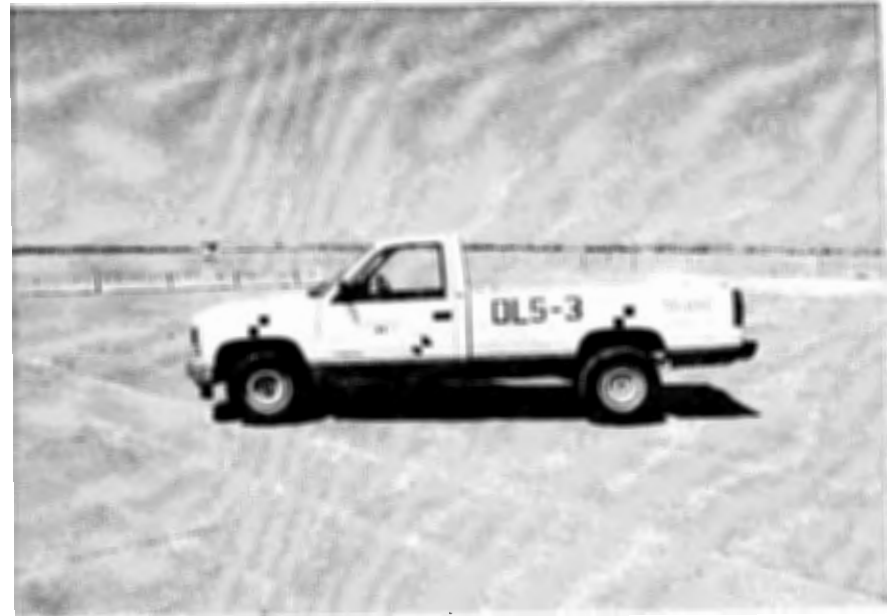
Figure 19. Vehicle Damage, Test OLS-3 (Design No. 3)

Exterior vehicle damage was minimal, as shown in Figure 19. Interior occupant compartment deformations were determined to be negligible. The right-front quarter panel was crushed inward, and the right side of the front bumper was also bent back toward the engine compartment. The right-front wheel assembly was deformed slightly, including contact marks on the rim. Small contact marks were found on the lower right side of the rear fender, the right-rear bumper, the lower right side of the truck box, and the right-side door. The right side of the box shifted downward and was twisted. No other damage to the vehicle was observed.
