Research  
Paper  
FPL-RP-597

# Field Performance of Timber Bridges

## 21. Humphrey Stress-Laminated T-Beam Bridge

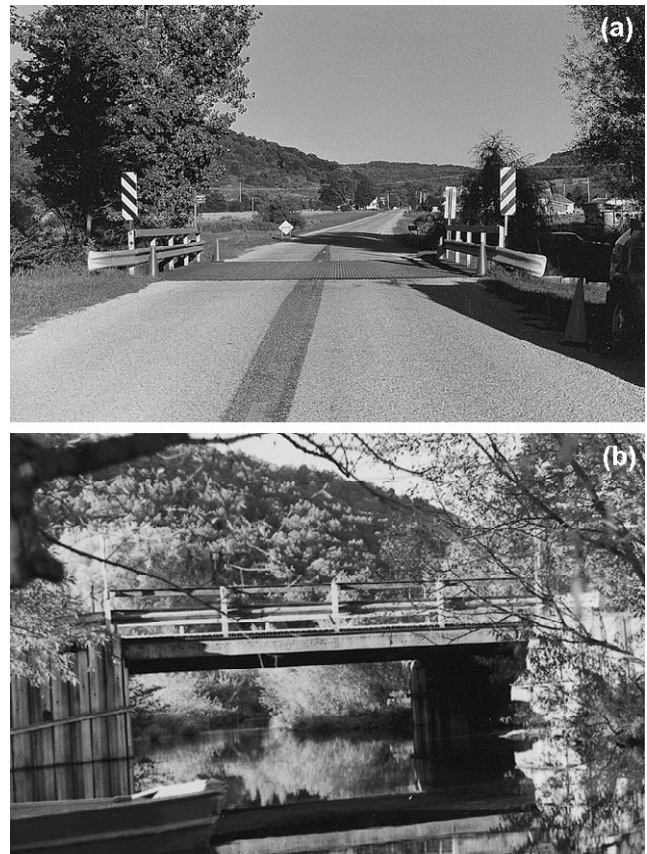
The original Humphrey bridge was 7.3 m (24 ft) wide and 9.8 m (32 ft) long and consisted of a steel grate deck on steel stringers with concrete abutments (Fig. 2). When periodic (annual) monitoring revealed that the steel components were deteriorating and hydraulic flow under the bridge was insufficient during high water, replacement of the bridge was deemed necessary.

Figure 2—Original bridge: (a) end view, (b) side view.

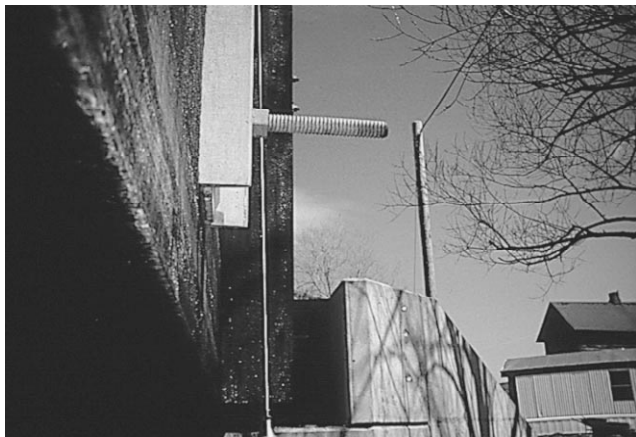
Another change is that the exterior beams are not vertical at mid-span (Fig. 24). The beams seem to be “toeing-in” as a result of the tensioned diaphragm bars pulling the beams together at the one-third points and the deck resisting the movement. The sawn lumber area was less resistant to the bar tension at the diaphragms than at the deck. Therefore, when all bars were tensioned to the same level, the diaphragms shrunk at a greater rate than did the deck, which created the “toe in.” The structural performance of the bridge is not directly affected by the toe-in, but the railing system is no longer parallel because the posts are attached to the exterior beams. This detracts from the appearance of the bridge.

**Figure 24**—“Toe in” of exterior beams resulting from tensioned diaphragms.

- The exterior beams are “toeing in” and cracking in response to the tensioning of the diaphragm bars. Over time, additional cracking may occur that could ultimately lead to a loss of section on these beams. We recommend that the bar force on the diaphragm bars be reduced or removed. To perform their function, diaphragms do not need to be restrained under compressive stress.

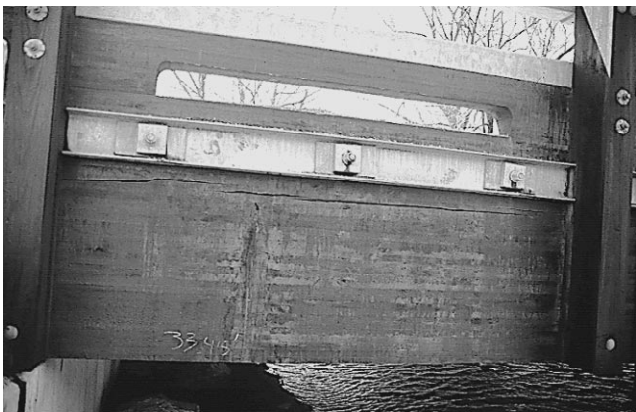
Wood components of the bridge showed no signs of deterioration. However, inspection of the exterior beams revealed cracks just beneath the steel bearing channel (Fig. 25). The cracking is a result of the toe-in of the exterior beams. The bottom of each beam is restrained at the abutment and the top is continuously restrained by the deck; therefore, any change in transverse dimension causes the beam to bend and twist in the Y–Y axis. The strength of a glulam beam is in the X–X axis. Therefore, to alleviate the stresses developed in the beams, cracking formed. If the cracks are allowed to propagate through the member, a substantial reduction in load capacity could result. The cracks also open the exposed exterior beams to potential decay, because the preservative may not have penetrated to the depth of the cracks.

**Figure 25**—Cracking in exterior beams resulting from beam twisting.

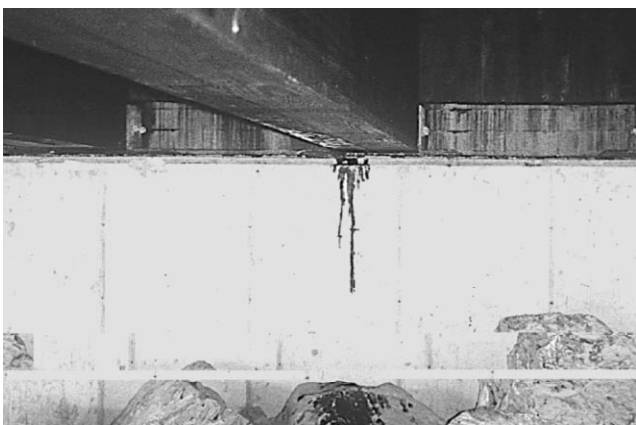
Inspection indicated that creosote treatment may have been too heavy in some areas. Several areas on the concrete abutments were stained with creosote (Fig. 26), and excess creosote was present on the surfaces of the rail and posts. Leaching of creosote could have been eliminated by proper pressure preservation, including appropriate retention levels, post-treatment drying, and the use of reverse vacuum techniques (AWPA 1990).

**Figure 26**—Creosote staining of concrete abutments resulting from preservative leaching.
