| 4. Title and Subtitle NCHRP REPORT 350 COMPLIANCE TEST OF THE NEW JERSEY SAFETY SHAPED BARRIER | | | | 5. Report Date | |
| 7. Author(s) King K. Mak and Wanda L. Menges | | | | 8. Performing Organization Report No. Project 405491-1 | |
| 9. Performing Organization Name and Address Texas Transportation Institute The Texas A&M University System College Station, Texas 77843-3135 | | | | 10. Work Unit No. 3A5B | |

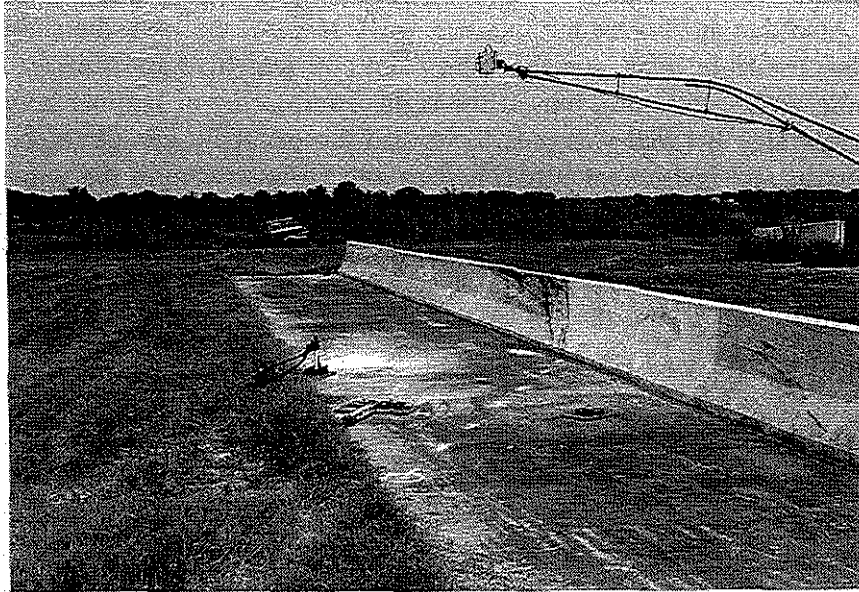
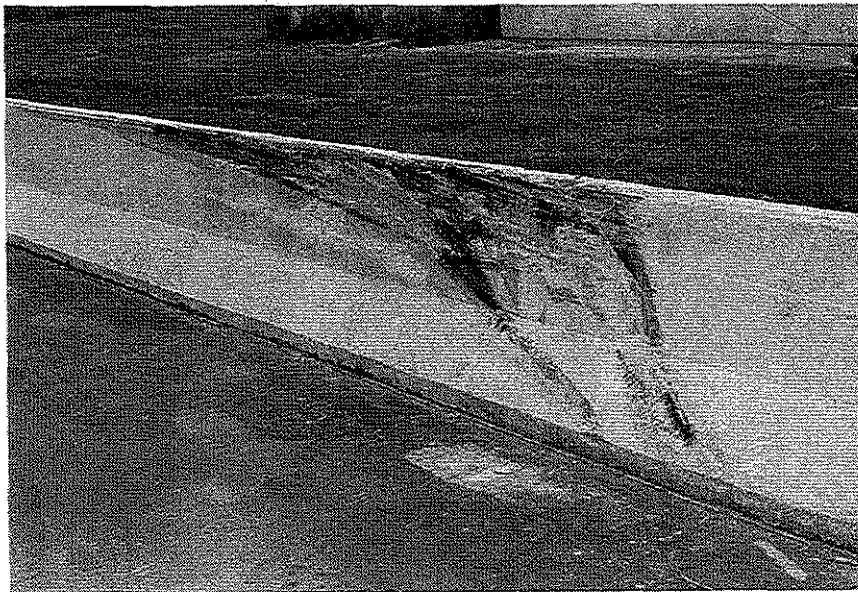
Figure 9. New Jersey safety shaped barrier test installation after test 405491-1.

There was only cosmetic damage to the New Jersey safety shaped barrier, as shown in figure 9. Tire marks reached the top of the barrier starting at 0.5 m after impact and continued along the top edge of the barrier on the traffic side until loss of contact. However, the tire marks did not extend across the top of the barrier. Total length of contact of the vehicle with the barrier was 6.8 m.

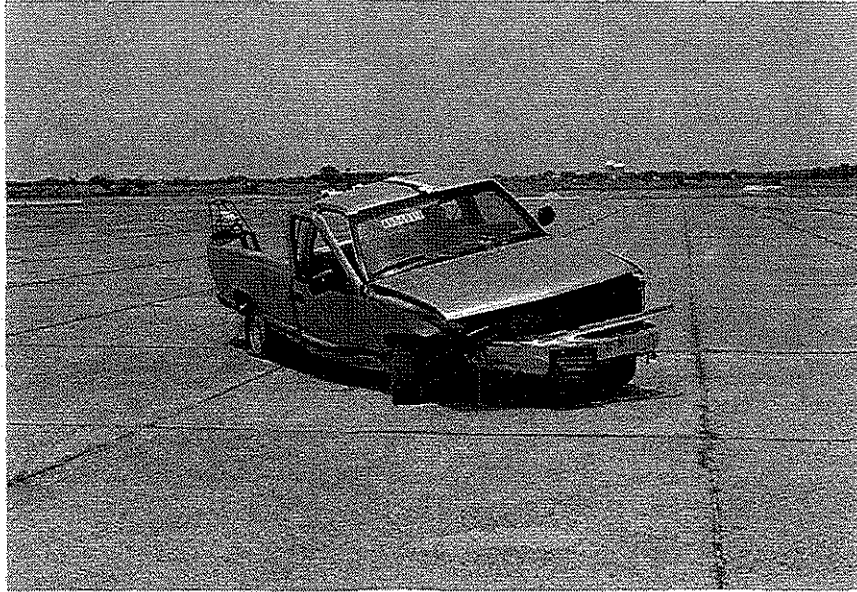
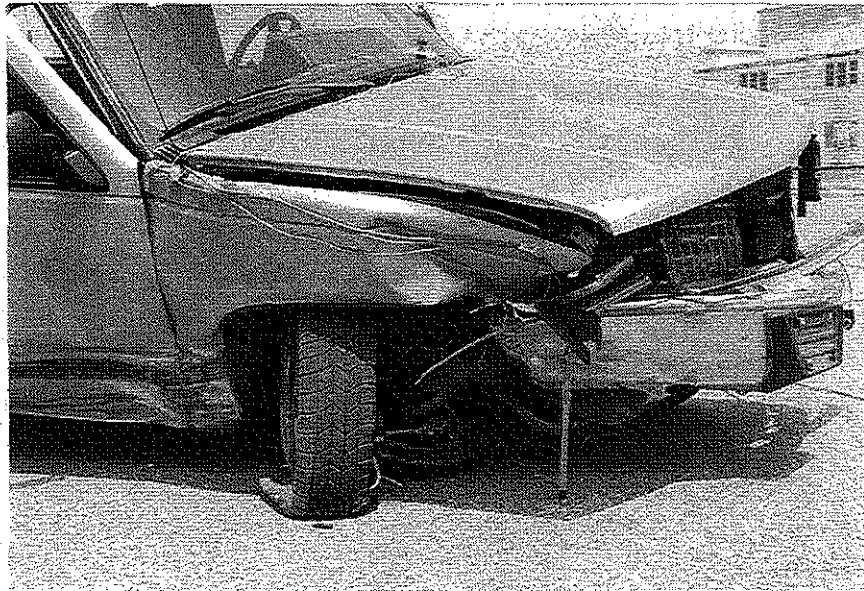
Figure 10. Vehicle after test 405491-1.

The front and right side of the vehicle were damaged during impact as shown in figure 10. The right side stabilizer bar, tie rods, and A-arms were damaged, and the right front frame was bent. Also damaged were the bumper, grill, radiator and fan, the right and left front quarter panels, the right door, and the right front and rear tires and rims. Maximum exterior crush to the vehicle was 560 mm at the right front corner at bumper height. During the collision the right side firewall was pushed toward the occupant compartment and deformed the floorpan and instrument panel, and caused stress cracks in the windshield. Maximum deformation into the occupant compartment was 84 mm at the center front firewall area. Buckling of the floorpan and damage to the instrument panel is shown in figure 11.
