The BR27C bridge railing on sidewalk was tested to performance level two requirements.⁽¹⁾ The following nominal test conditions were used:

The BR27C bridge railing on deck was also tested to performance level two requirements.⁽¹⁾ The following nominal test conditions were used:

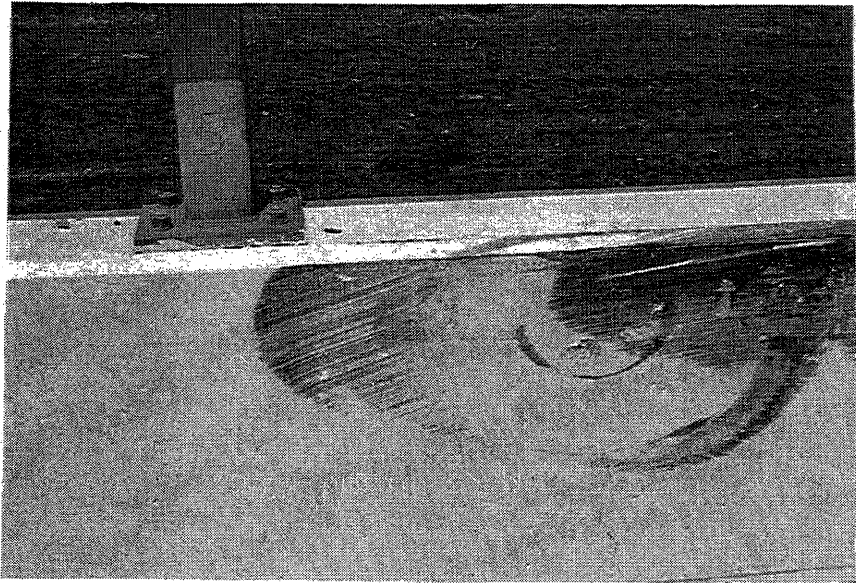
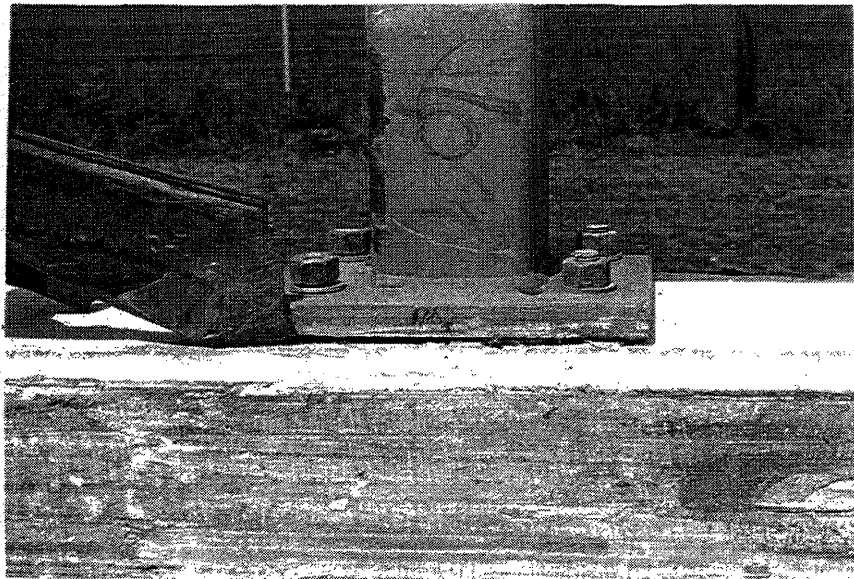
Figure 9. Damage at posts 5 and 6, test 7069-24.

As can be seen in figure 8, the bridge railing system received minimal damage. There was no measurable permanent deformation to the metal railing elements; however, the left corner of the bumper had snagged post 6 (leaving plastic trim). Also, posts 5 and 6 were pulled up such that the washers rotated freely under the nuts on the front side of the railing (see figure 9). There was only cosmetic damage to the concrete parapet, i.e., tire marks on the concrete parapet from post 5 on past post 6 and then again between posts 8 and 9 where the vehicle contacted the parapet the s time. The vehicle was in contact with the bridge railing system for 12.25 ft (3.7 m).

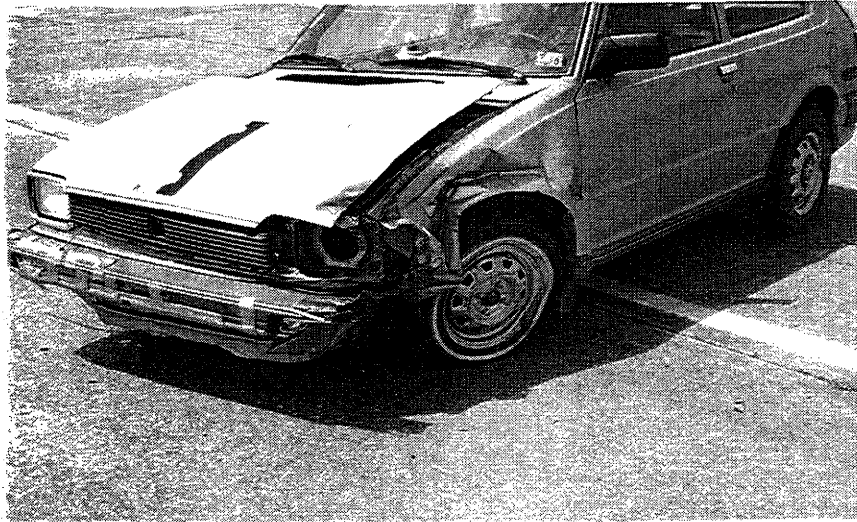
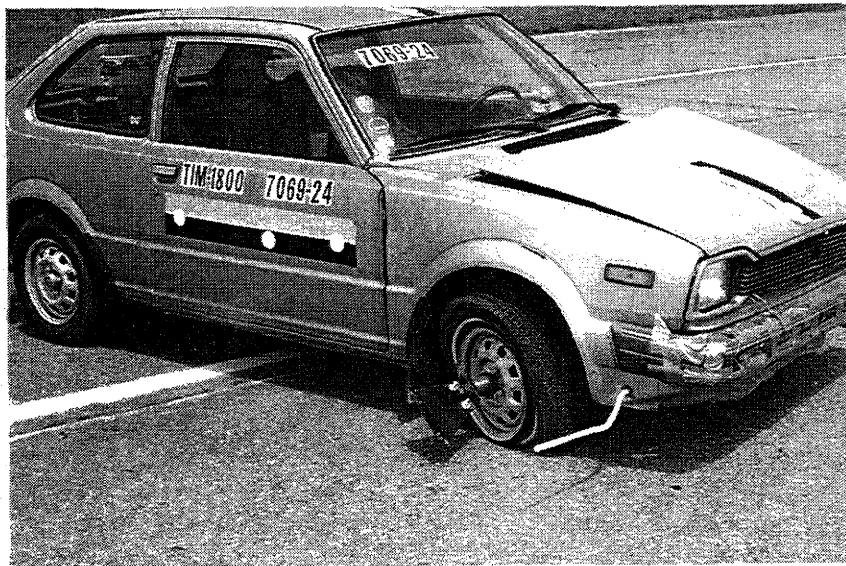
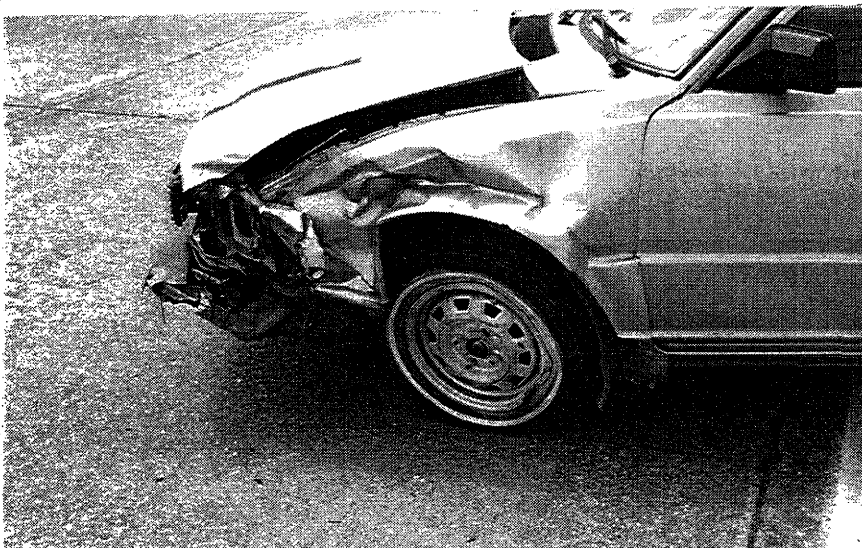
Figure 10. Vehicle after test 7069-24.

The vehicle sustained damage to the left side as shown in figure 10. Maximum crush at the left front corner at bumper height was 7.5 in (191 mm). The left front strut was bent and the left front wheel was pushed back reducing the wheelbase on the driver side by 3 in (76 mm). Also, damage was done to the front bumper, hood, left front quarter panel, left rear quarter panel, rear bumper, left front and rear tires and rims, and right front tire.

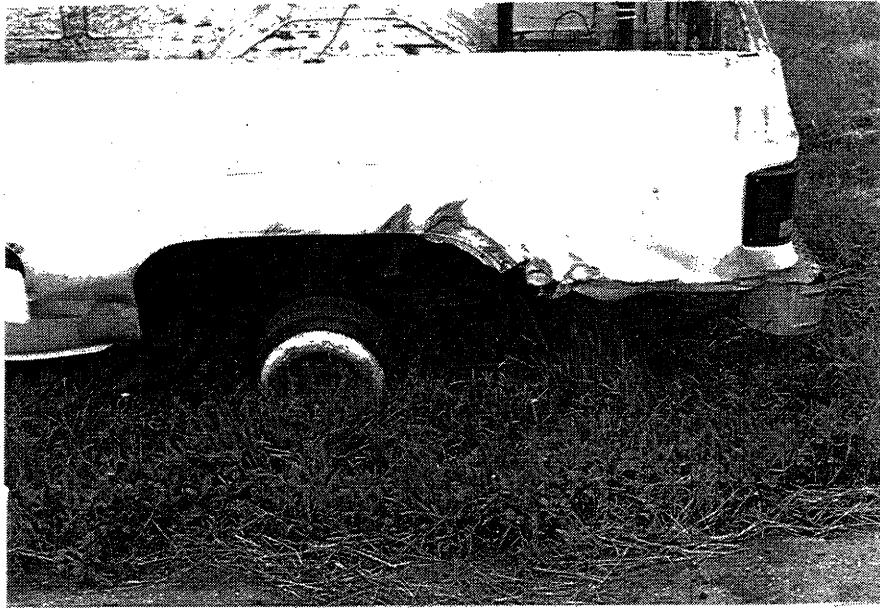
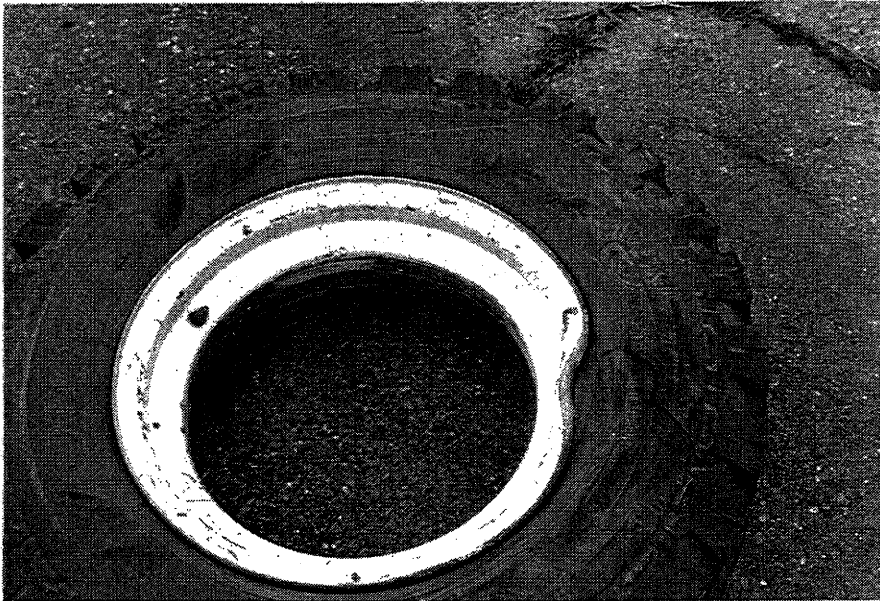
Figure 24. Damage to left rear wheel of vehicle after test 7069-25.

The vehicle sustained damage to the left side as shown in figures 23 and 24. Maximum crush at the left front corner at bumper height was 12.0 in (305 mm) and the right front corner was deformed outward 7.0 in (178 mm). The left front wheel was pushed back reducing the wheelbase on the driver side by 2.25 in (57 mm). Also, damage was done to the front bumper, hood, grill, left front quarter panel, left door and glass, left rear quarter panel, rear bumper and tailgate, left front tire and rim, and right front tire. The welds on the left rear rim broke and the tire separated from the rim as shown in figure 24.
