**EVALUATION OF THE CRASHWORTHINESS OF THIN-WALLED
ALUMINUM AND STEEL U-CHANNEL SIGN SUPPORTS**

New Hampshire Department of Transportation
Bureau of Traffic
220 Sheep Davis Road (NH 106)
Concord, New Hampshire 03302-0483

TTI Project No. 405231-1F
Final Report

June 1995

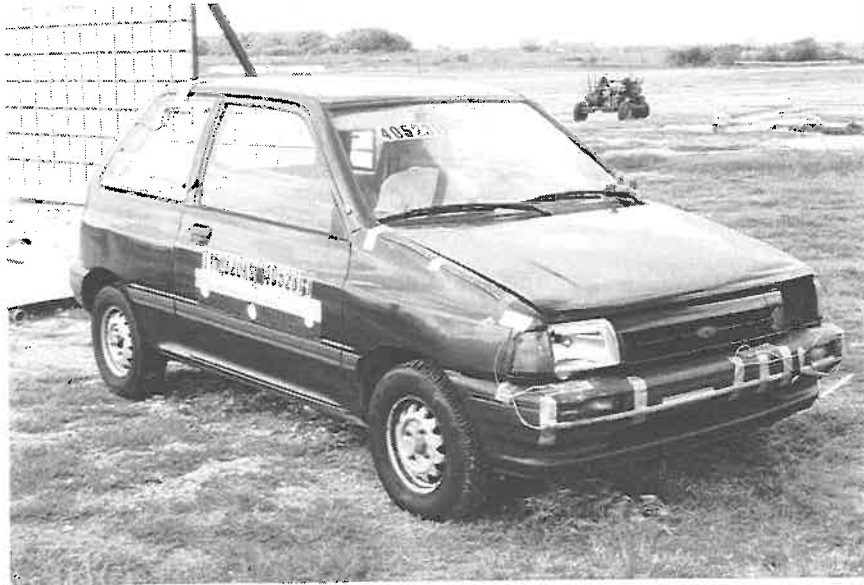
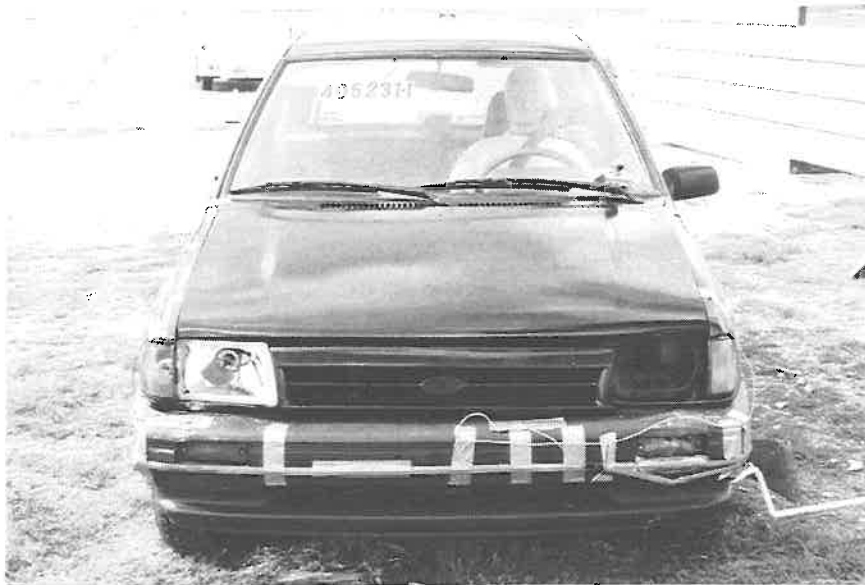
Figure 13 . Vehicle after test 405231-1.

reused in field renovation of this installation. Damage sustained by the vehicle during this test is shown in Figure 13. The vehicle sustained primarily cosmetic damage to the bumper and hood. The headlights were broken during the test, but the vehicle sustained no permanent deformation to the sheet metal. There was no deformation to the vehicle occupant compartment.

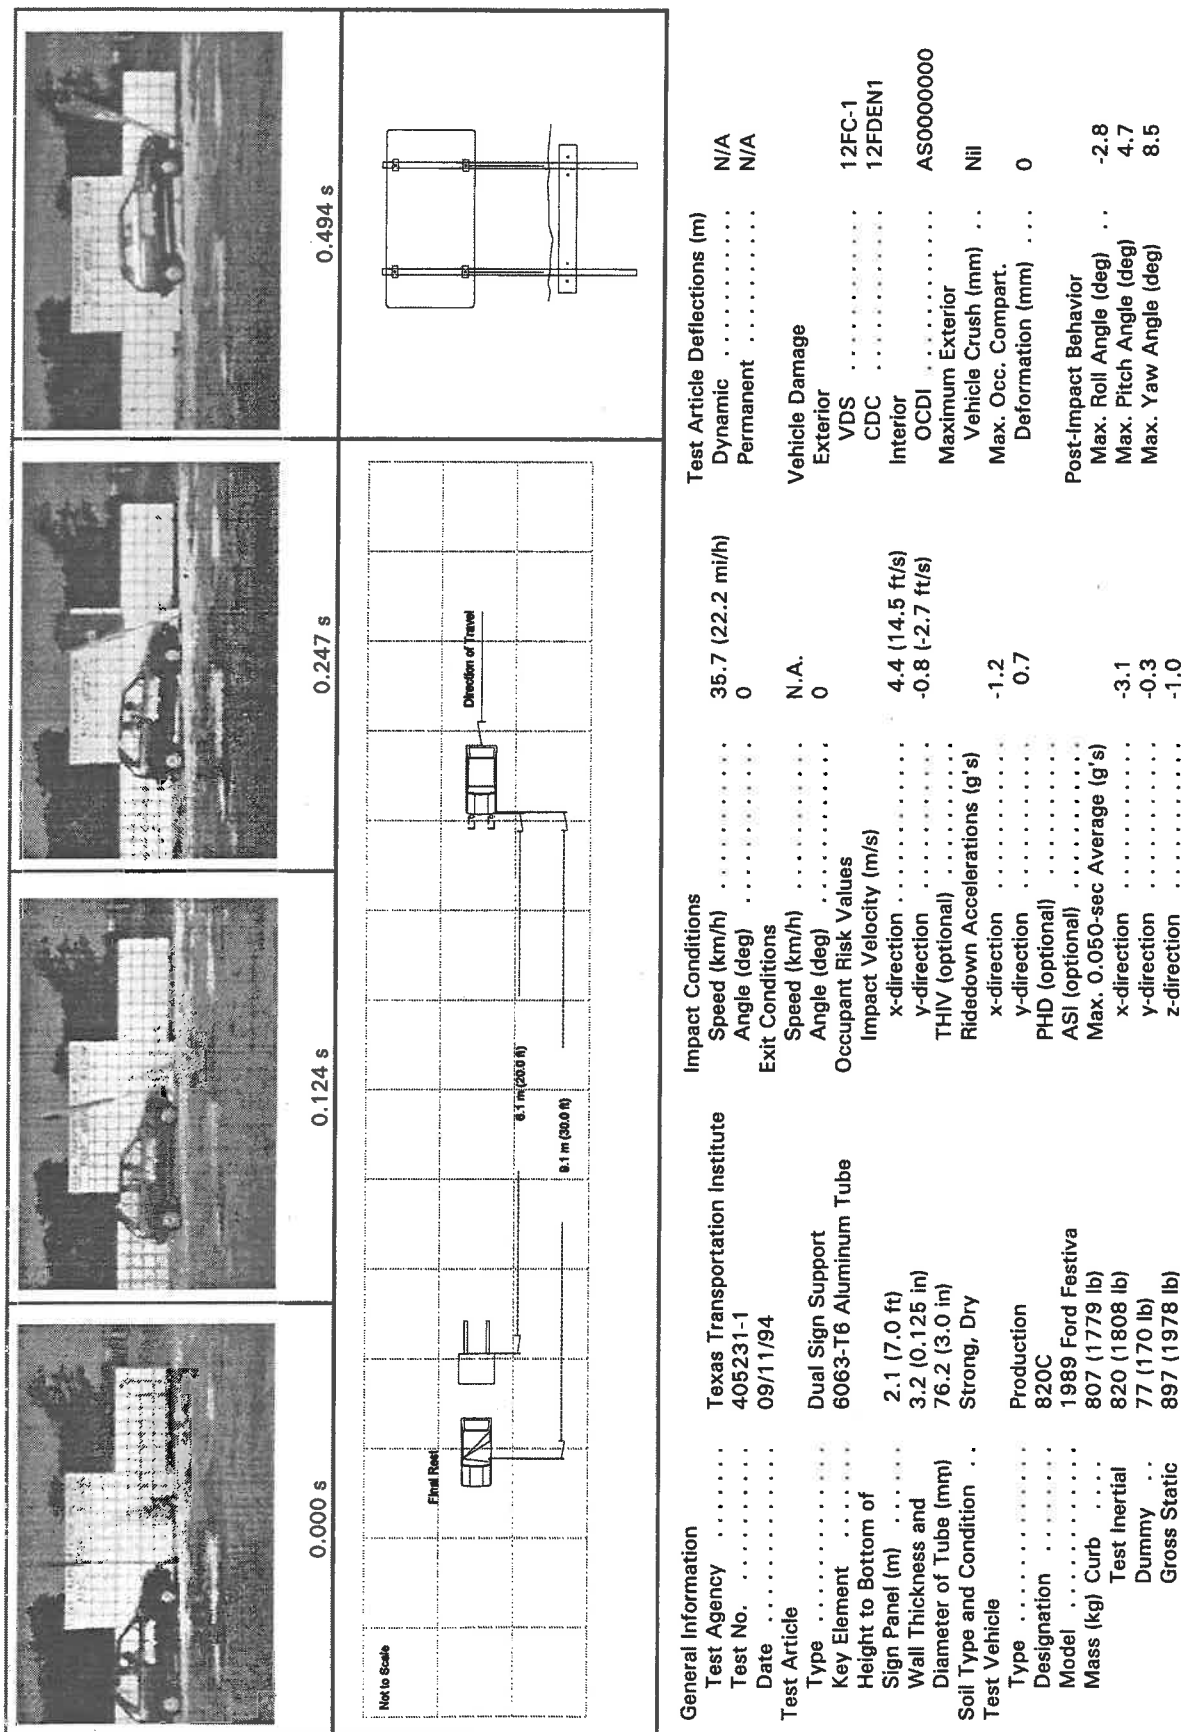
Figure 14. Summary of results for test 405231-1.

Test No.: 405231-1	Test Date: 09/11/94	Test Agency: Texas Transportation Institute								
Evaluation Criteria	Test Results	Assessment								
<p><u>Structural Adequacy</u></p> <p>B. The test article should readily activate in a predictable manner by breaking away, fracturing, or yielding.</p>	<p>The sign supports yielded by bending the aluminum tubes at ground level and fracturing in tension near bumper level.</p>	<p>Pass</p>								
<p><u>Occupant Risk</u></p> <p>D. Detached elements should not penetrate the occupant compartment, or present an undue hazard to other traffic, pedestrians, or personnel in a work zone. Deformations of the occupant compartment that could cause serious injuries should not be permitted.</p>	<p>The sign supports fractured but did not present a hazard to other travel lanes. There was no deformation of or intrusion into the occupant compartment.</p>	<p>Pass</p>

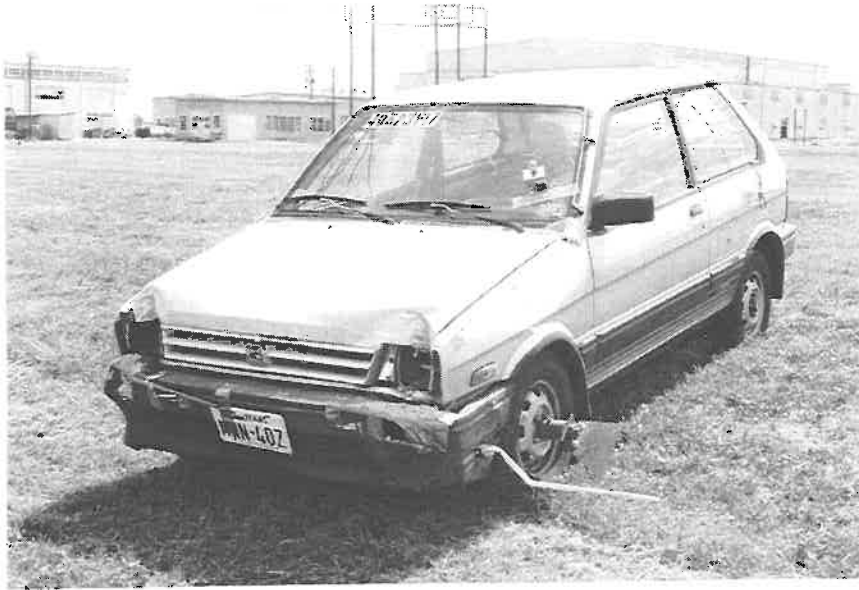
Figure 109. Vehicle after test 405231-17.
163

As shown in Figure 108, the supports were bent and fractured. Both supports failed at the holes located at ground level. The supports however bent 88.9 mm (3.5 in) below the upper holes. The sign panel and mounting and anchoring hardware received minimal damage and could be reused in field renovation of this installation. It should be noted, the left support was fabricated from two pieces of tubing by welding the sections together. In addition, the fabricated support failed at the weld when the support impacted the ground after the test and not due to the initial vehicle impact. The sign installation came to rest 7.6 m (25.0 ft) from the point of impact. Damage sustained by the vehicle during this test is shown in Figure 109. The vehicle sustained
