# Guardrail Testing Program II

## Final Report

Transportation Research Report TRP-03-52-95

FHWA Contract No. DTFH71-90-C-00035

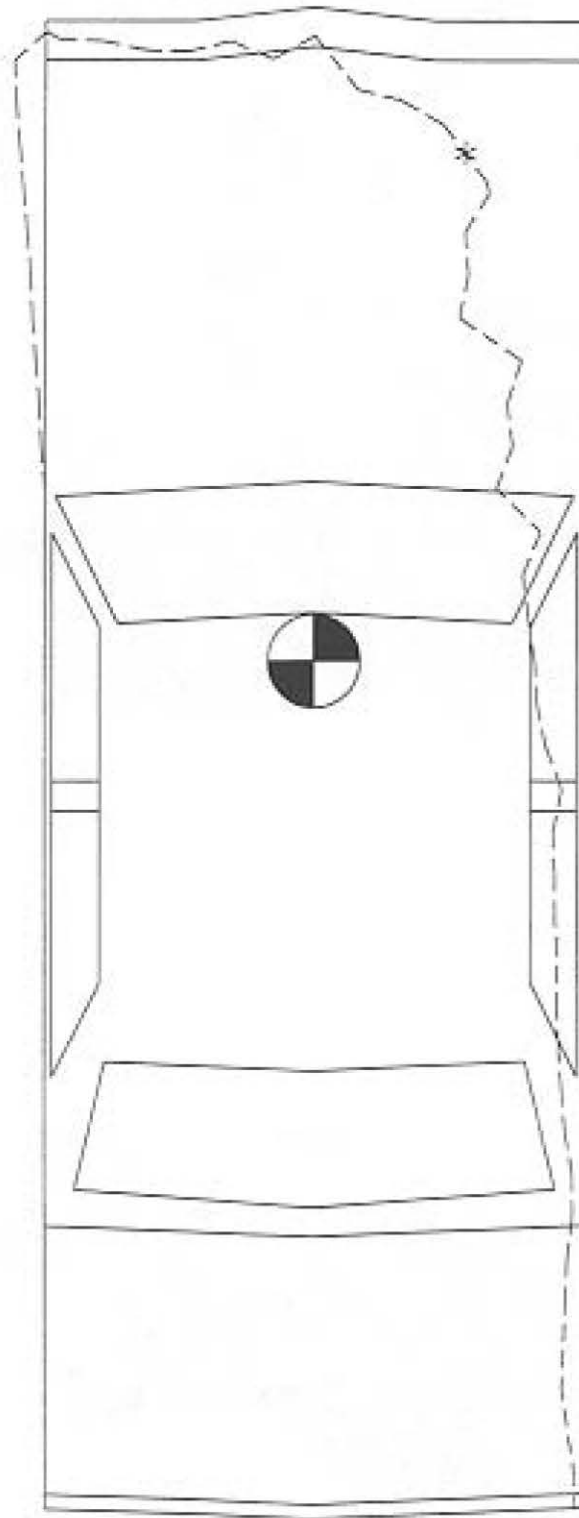
Figure 7. Crush Depth Diagram, Test SBT-1.

Damage to the vehicle, which can be seen in figure 6, included major crushing and deformation of the right front corner of the vehicle, as well as buckling of the vehicle roof. The entire front half of the vehicle was bent slightly toward the driver's side. Interior occupant compartment damage included buckling of the floorboard on the passenger's side, as well as buckling of the dash. The maximum crush deformation of 17 in (492 mm) is shown in figure 7.

\*Maximum Crush=17in. (492mm)

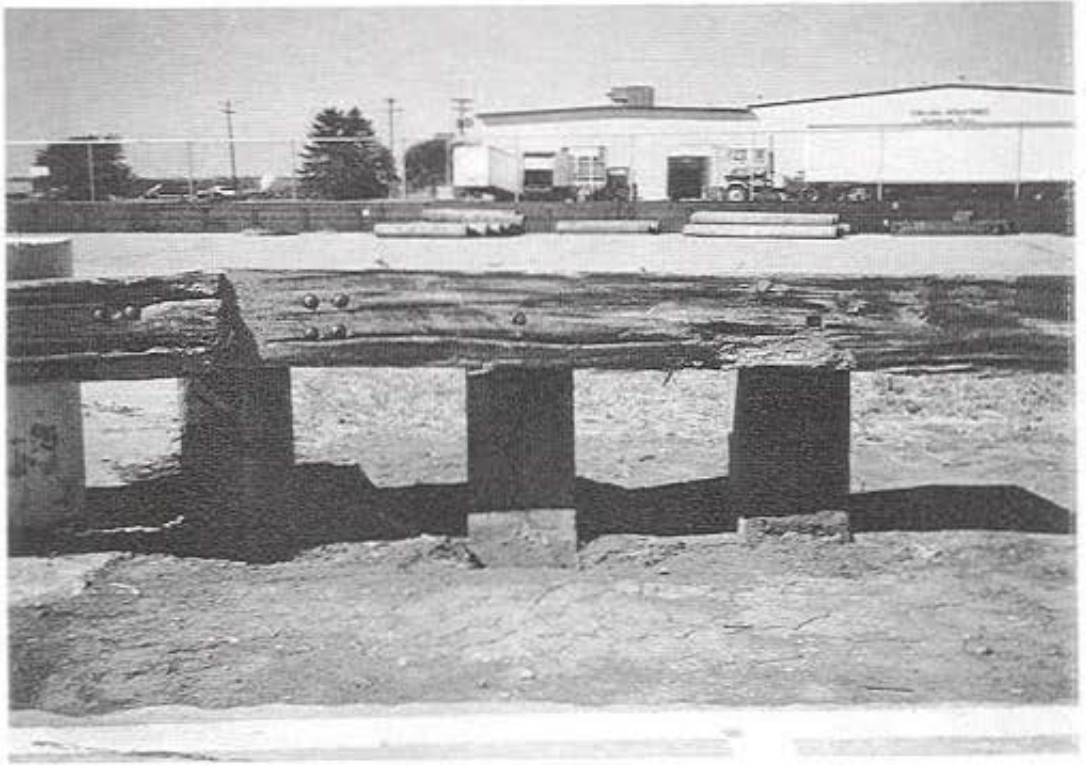
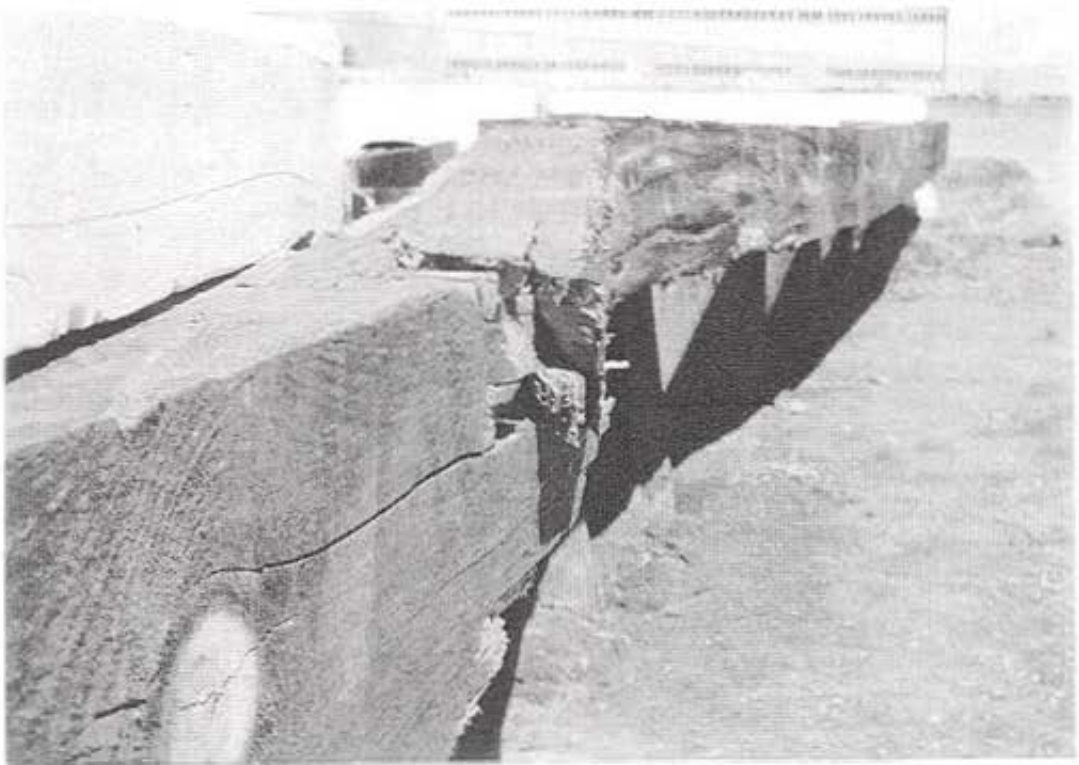
Figure 8. System Damage, Test SBT-1.

The damage to the system, shown in figures 8 and 9 consisted of a maximum permanent set deformation of 11.25 in (286 mm) at post no. 1. A flexural failure occurred in the first timber rail section, approximately 4.5 ft (1.37 m) from the downstream end of the rail. The 8-in (203-mm) inside diameter (I.D.) pipe located between the first rail and the concrete abutment was completely flattened. There was evidence of vehicle snagging at the splice between rail nos. 1 and 2, as sheet metal from the vehicle was embedded in the end of rail no. 1. There were continuous scrape marks along the face of the rail from the point of impact to exit, as well as impact markings on the concrete abutment.

The impact with the end of the concrete abutment caused excessive occupant compartment deformation, which resulted in the failure of this test. It was determined that the stiffness of the steel-backed wood rail was inadequate as it deflected considerably, allowing the

vehicle to impact the end of the concrete abutment. The system was redesigned by Eastern Federal Lands Highway Division engineers for the next test by increasing the length of posts nos. 1, 2, and 3 from 7 ft (2.13 m) to 8 ft (2.44 m). The 8-in (203-mm) I.D. pipe spacer between the rail and concrete abutment was replaced with an angled block of wood to restrict the deflection of the first rail. The splice between the first and second rails was stiffened by adding a second  $\frac{3}{8}$ -in (10-mm) backup plate. The bolts at this splice were moved closer to the post and increased in number from 8 to 12. The details of these design changes are presented in the plan drawings in appendix A.

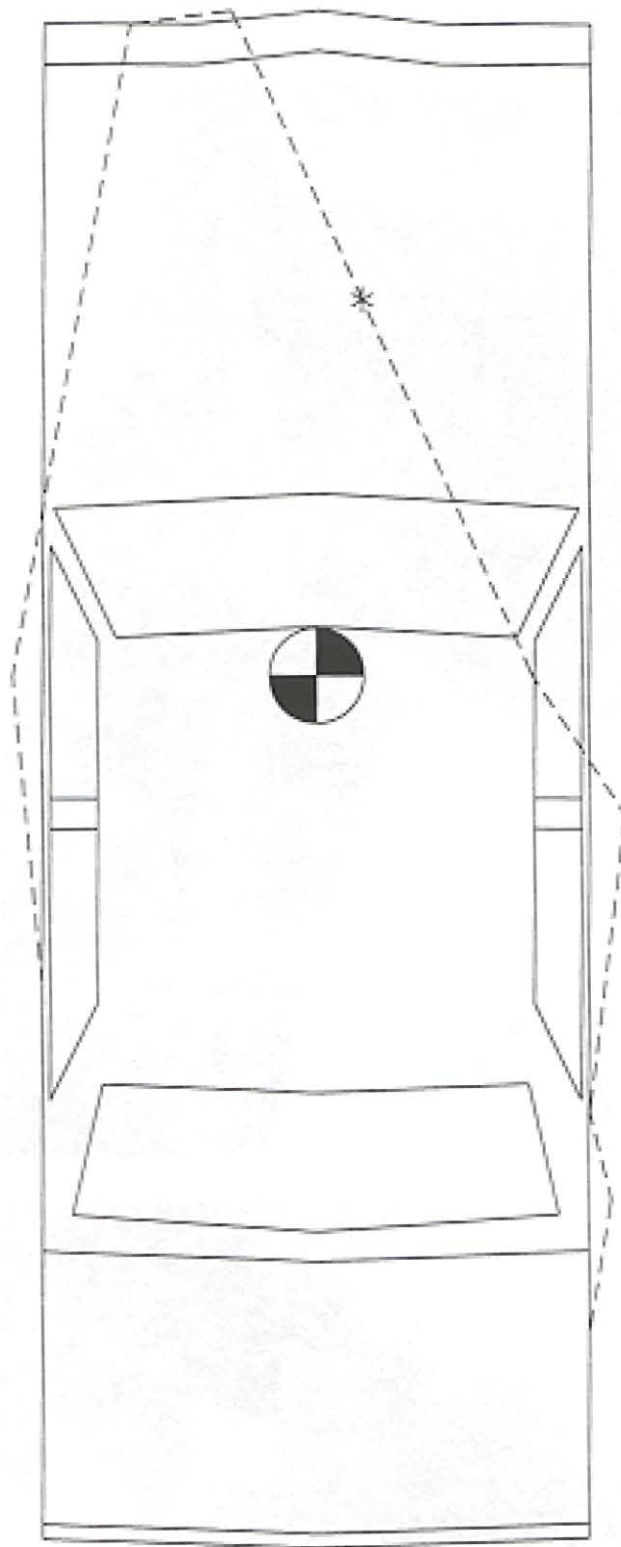
Figure 16. Crush Depth Diagram, Test SBT-2.

The damage to the vehicle was substantial as shown in figure 15. The entire front-right portion of the vehicle was crushed and pushed back toward the occupant compartment. The firewall and floorboard were pushed backwards and up on the passenger's side, and a section of the wood rail penetrated the firewall on the extreme right hand side. The windshield was broken and the roof of the vehicle was buckled considerably. The maximum vehicle crush of 31.5 in (800 mm) is shown schematically in figure 16.

\*Maximum Crush=31.5in. (800mm)

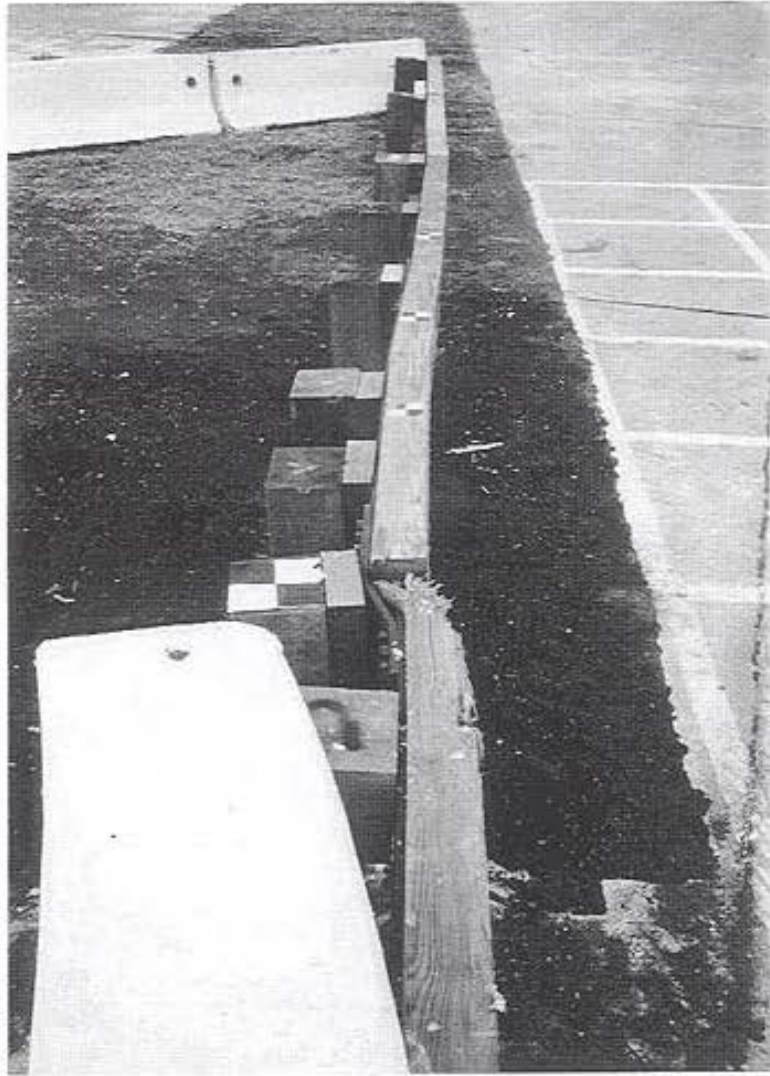
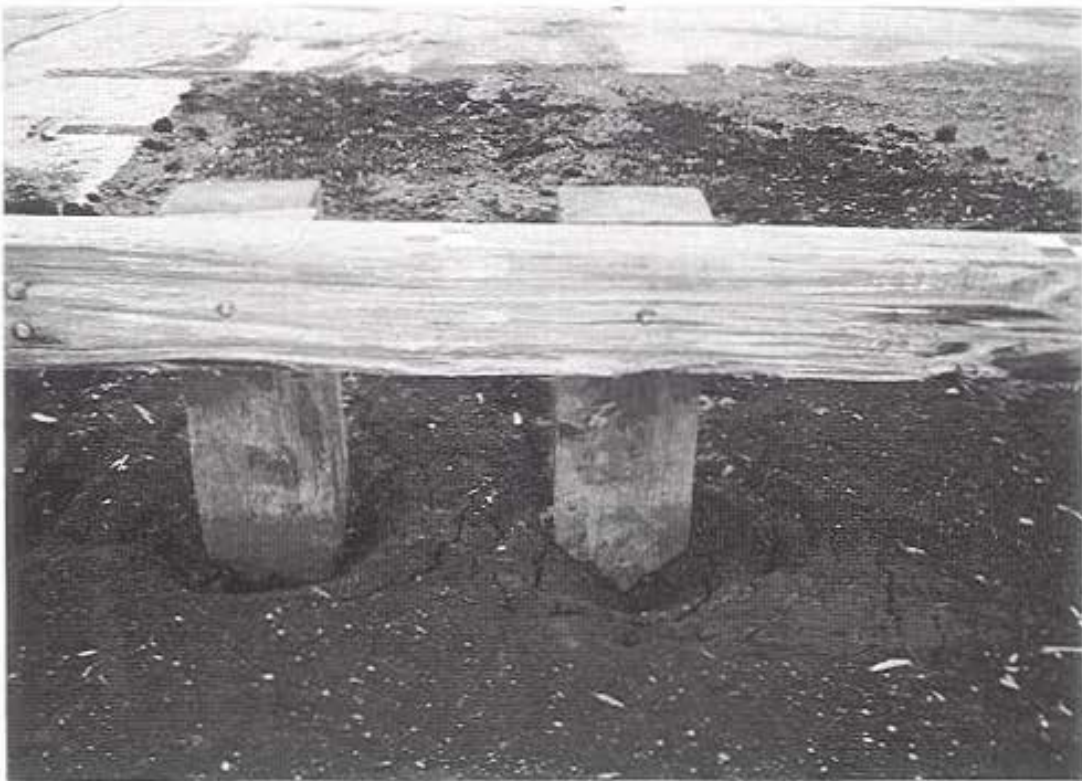
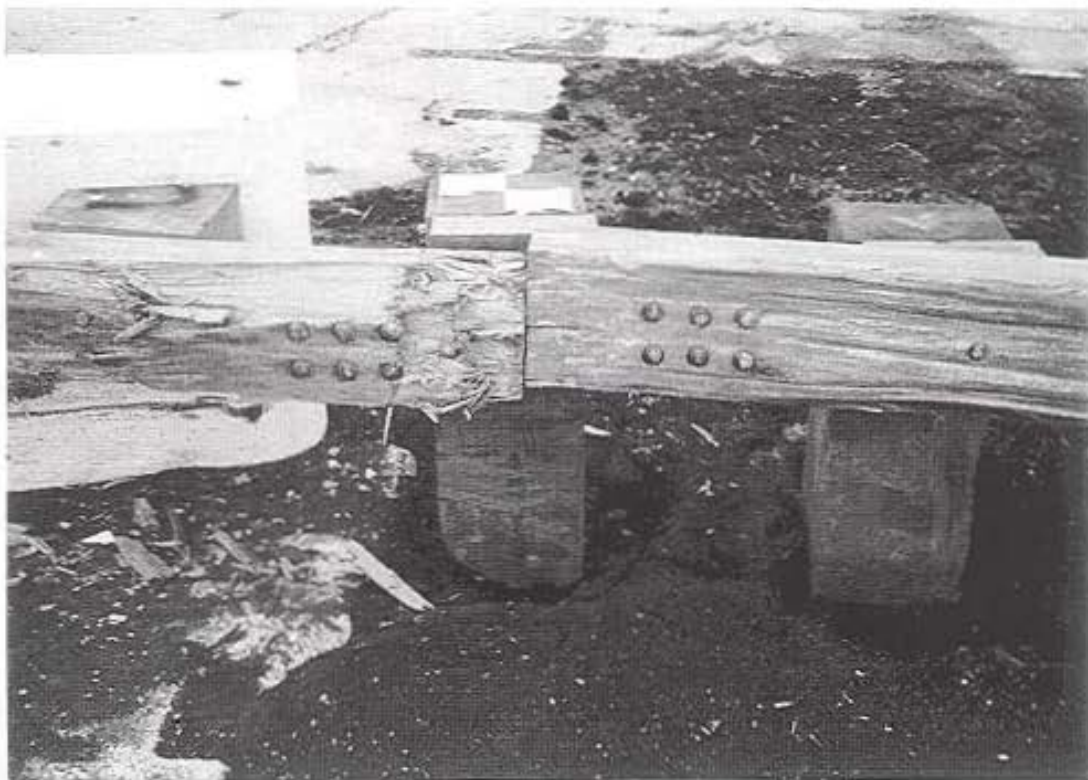
Figure 17. System Damage, Test SBT-2.

Damage to the steel-backed wood rail was considerable as can be seen in figure 17. The upstream end of rail no. 1 was damaged as the vehicle snagged on it, and the splice plates between rails no. 1 and no. 2 were bent significantly. There were marks along the face of the rail and concrete abutment throughout the length of contact.

Two of the systems design flaws became apparent as a result of this test. The first was that the wood blockout between the wood rail and concrete abutment made the first rail section much too stiff, resulting in the snagging problem at splice no. 1. The second observation was that the steel splice plates did not provide adequate strength for the splice between the first and second rail. Thus, two design changes were incorporated by FHWA engineers into the next design in an effort to alleviate these problems.

First, the angled wood blockout between the steel-backed rail and the concrete abutment was replaced with a 6 in (152-mm) diameter pipe. Secondly, the two  $\frac{3}{8}$ -in (10-mm) splice plates at post no. 1 were replaced with a 3-ft (0.91-m) length of 6-in by 4-in by  $\frac{1}{2}$ -in (152-mm by 102-mm by 13-mm) structural steel tube. The details of these design changes can be found in appendix A.

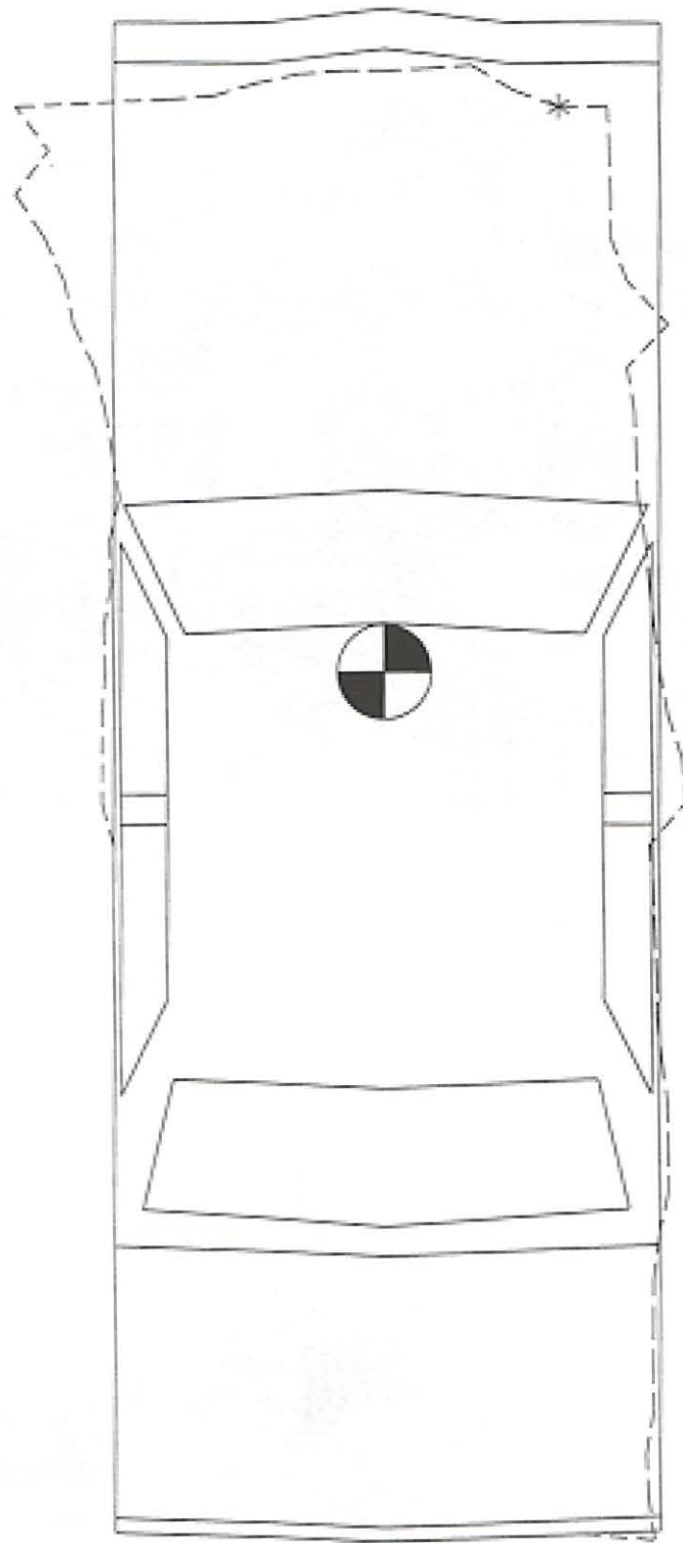
Figure 24. Crush Depth Diagram, Test SBT-3.

The vehicle damage, shown in figure 23, consisted of the crushing of the front-right corner of the vehicle, as well as scrapes and dents continuing down the side to the rear wheel assembly. The tire was torn off the front-right wheel, and the rim was bent. Occupant compartment damage included buckling of the floor on the passenger's side of the vehicle, as well as buckling of the dashboard. The maximum crush deformation of 13.75 in (349 mm) is shown schematically in figure 24.

\*Maximum Crush=13.75in. (349mm)

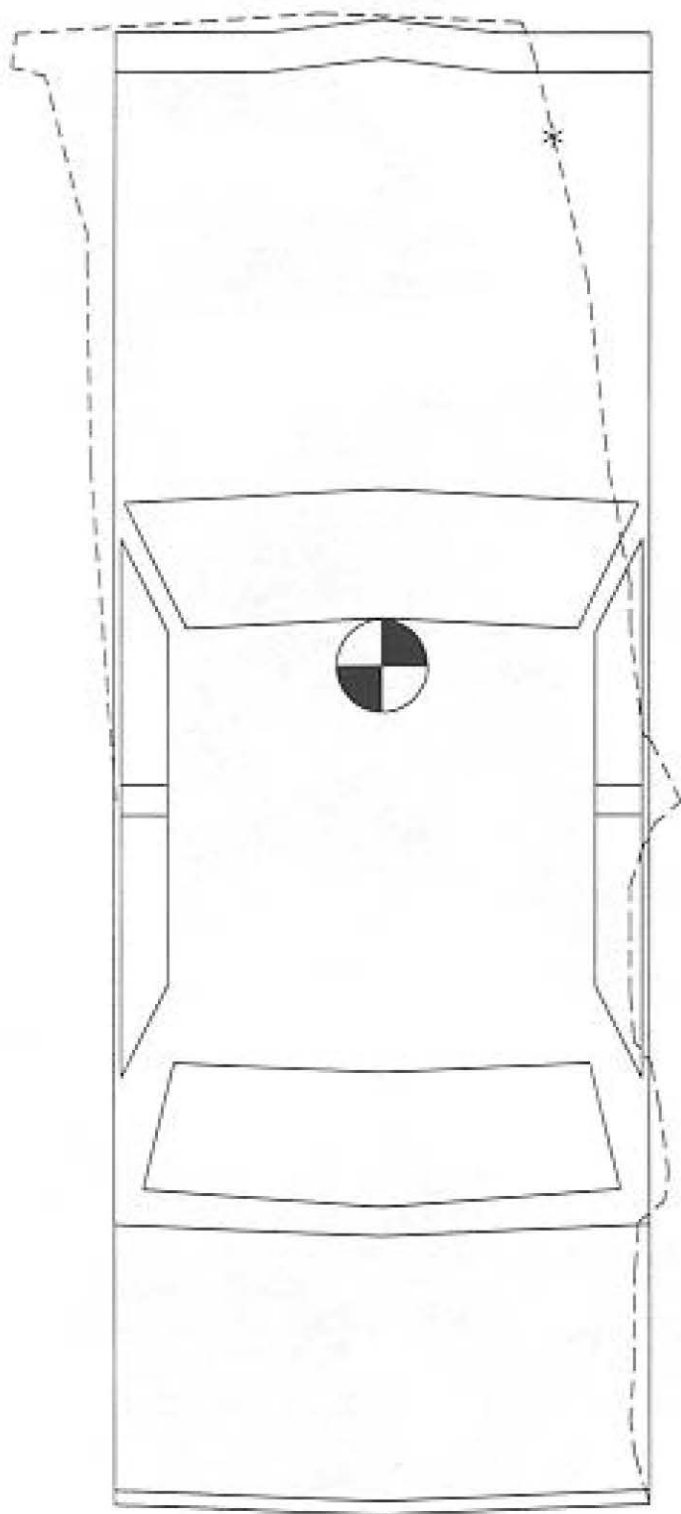
Figure 32. Crush Depth Diagram, Test SBT-4.

The damage to the vehicle, shown in figure 31, consisted of deformation of the front-right corner of the vehicle, which continued down the passenger side of the vehicle as scrapes and dents. The front-left tire was removed from the rim, and the front bumper was pushed toward the left away from the longitudinal centerline of the vehicle. The entire front end of the vehicle was pushed toward the left side, and the roof was buckled. Interior occupant compartment damage consisted of buckling of the floorboard on the passenger side and the front dashboard. The maximum crush deformation of 13.75 in (349 mm) is shown schematically in figure 32.

\*Maximum Crush=13.75in. (349mm)

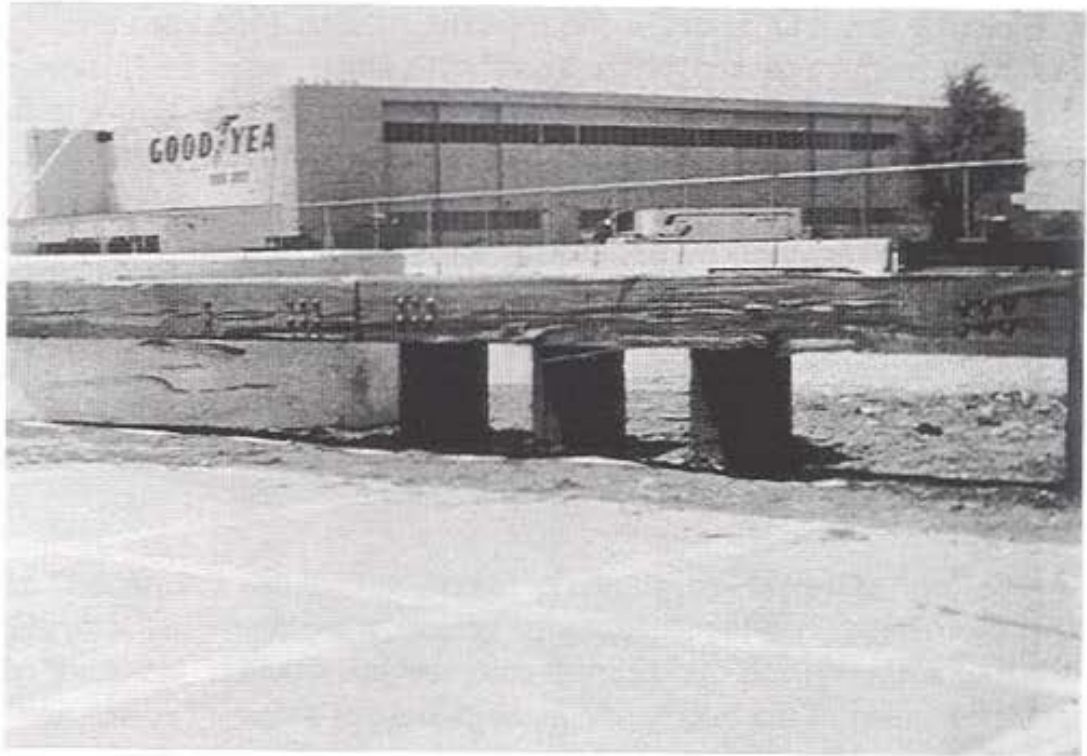
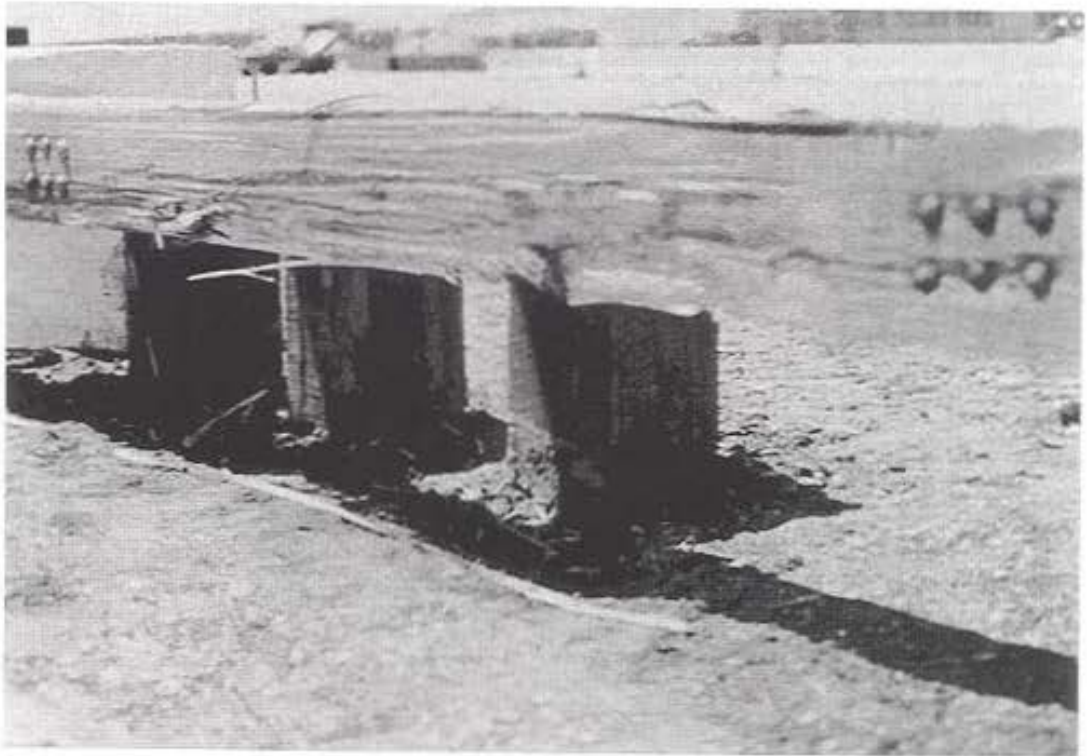
**Figure 33.** System Damage, Test SBT-4.

Damage to the system, shown in figure 33 consisted of scrapes and gouges along the face of the rail from the impact point to the midspan of the first rail. The spacer pipe between the rail and concrete abutment was deformed slightly, and the soil was gouged considerably in front of post nos. 1, 2, and 3. Markings on the posts indicated that the vehicle snagged approximately 1 in on posts no. 1 and 3 in on post no. 2.

3.55-m) wood rub rail was attached to post nos. 1, 2, and 3 for the next test. The details of this design change can be found in appendix A.

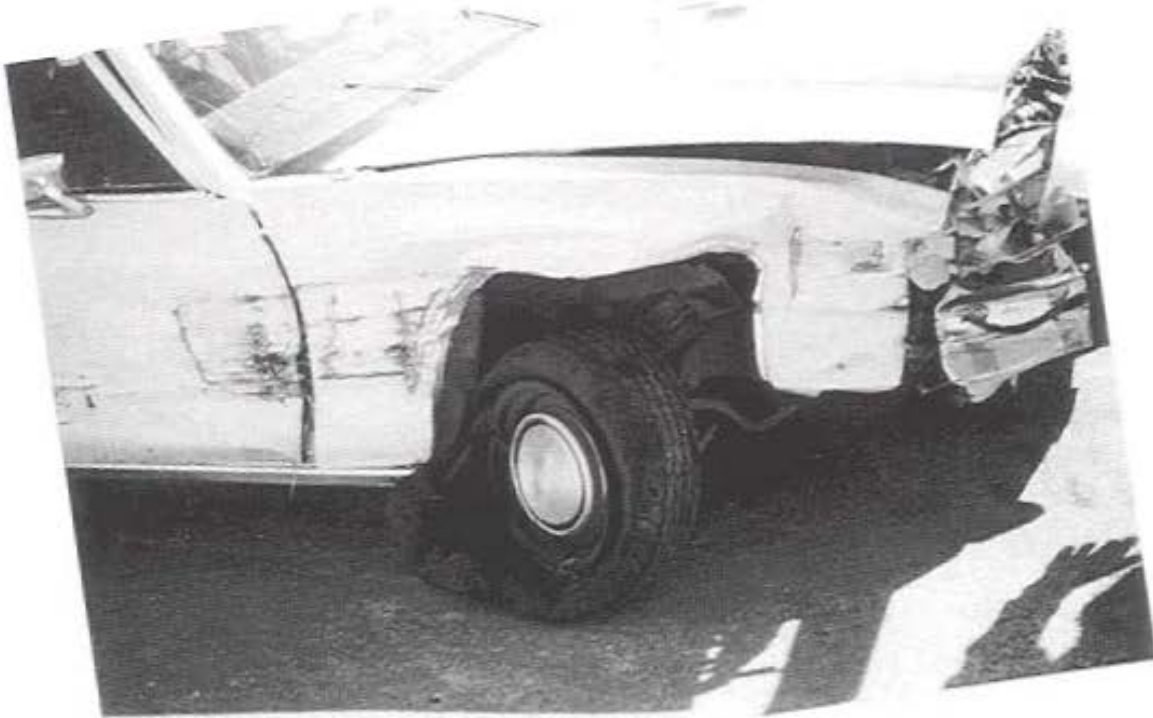
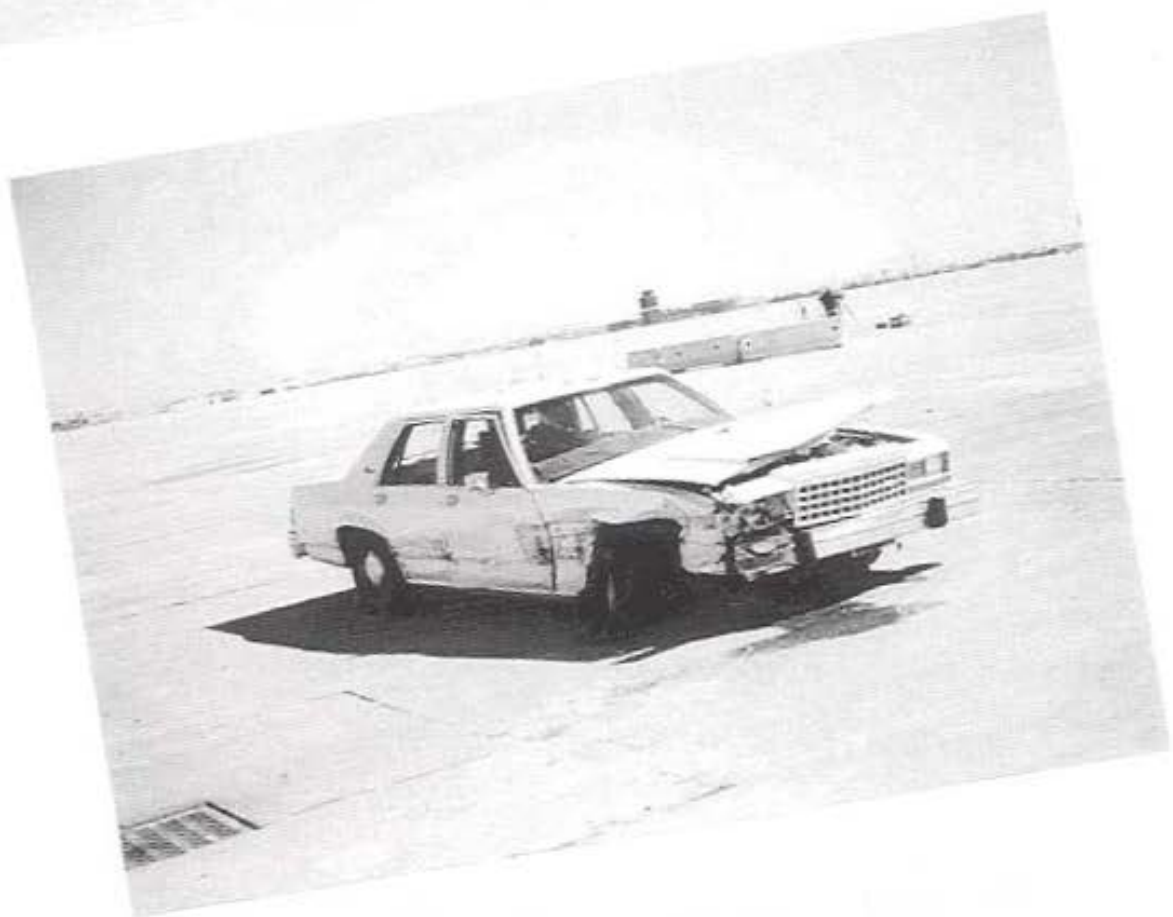
Figure 39. Vehicle Damage, Test SBT-5 (continued).

Damage to the vehicle, shown in figure 39, included deformation of the front-right corner, continuing along the length of the vehicle to the rear wheel assembly. There was no evidence of snagging, and the occupant compartment remained intact with the exception of minor deformation of the floorboard on the passenger's side. The maximum crush deformation of 19.4 in (492 mm) is shown schematically in figure 40.

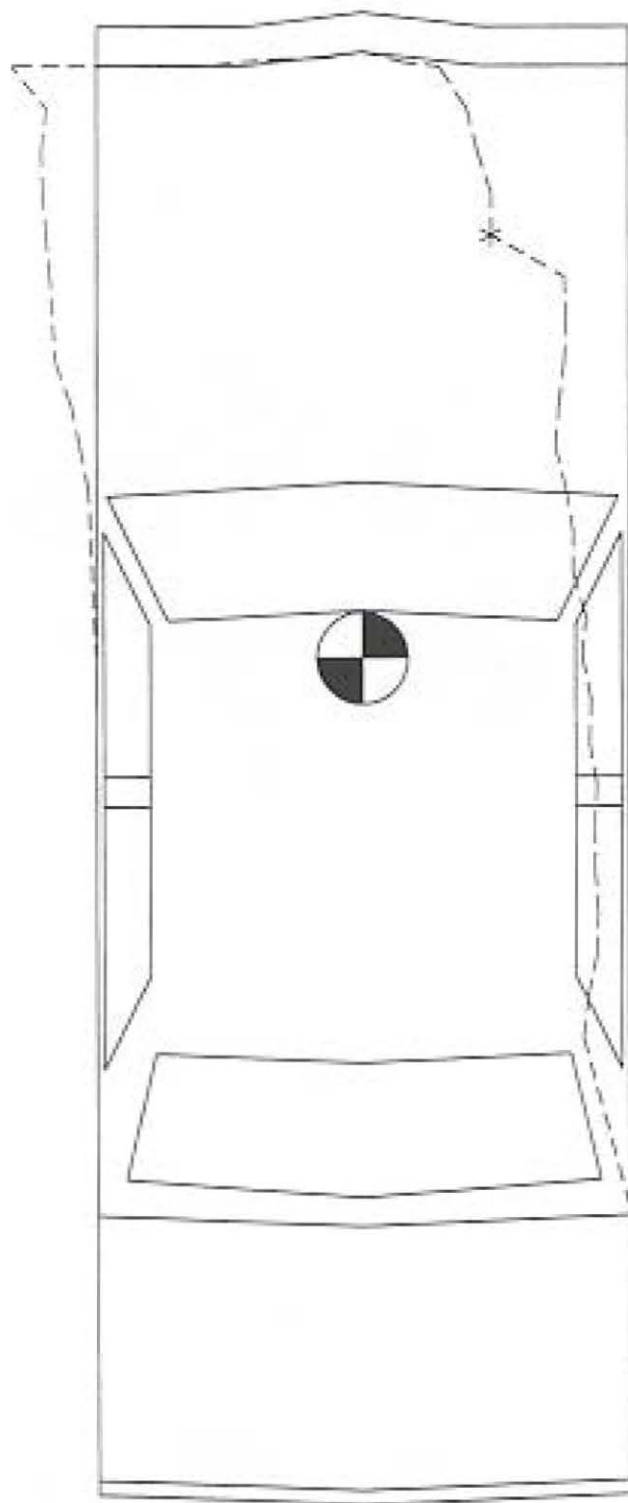
Figure 40. Crush Depth Diagram, Test SBT-5.

\*Maximum Crush=19.4in. (492mm)

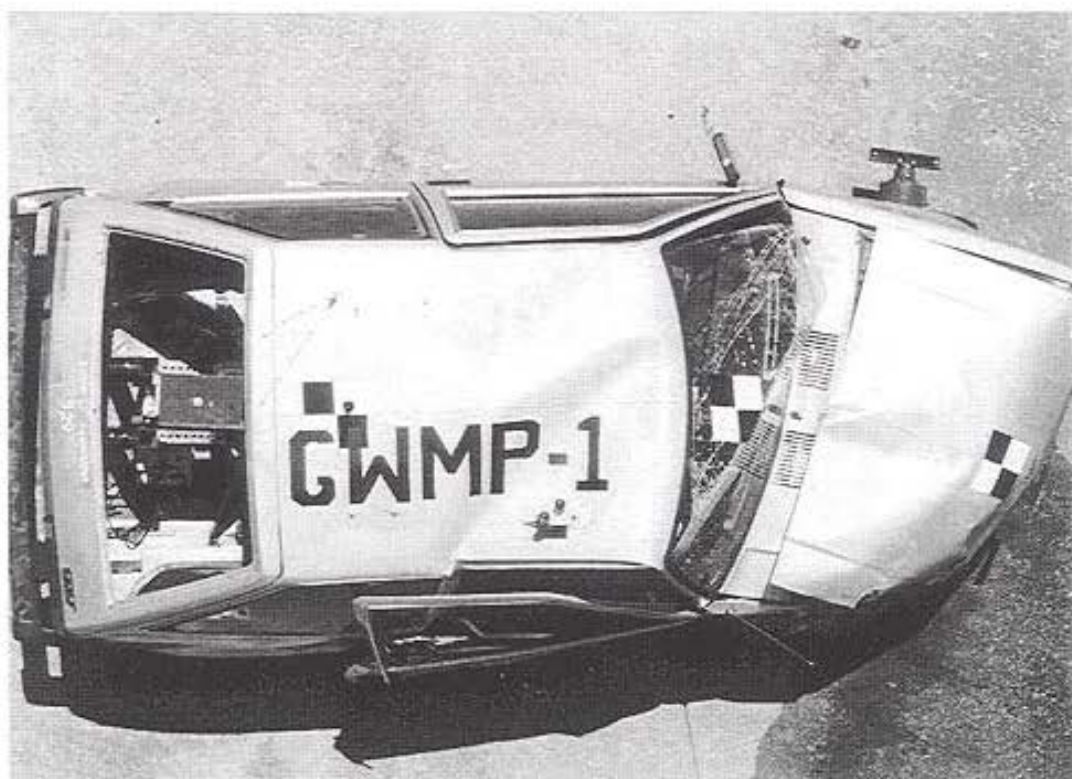
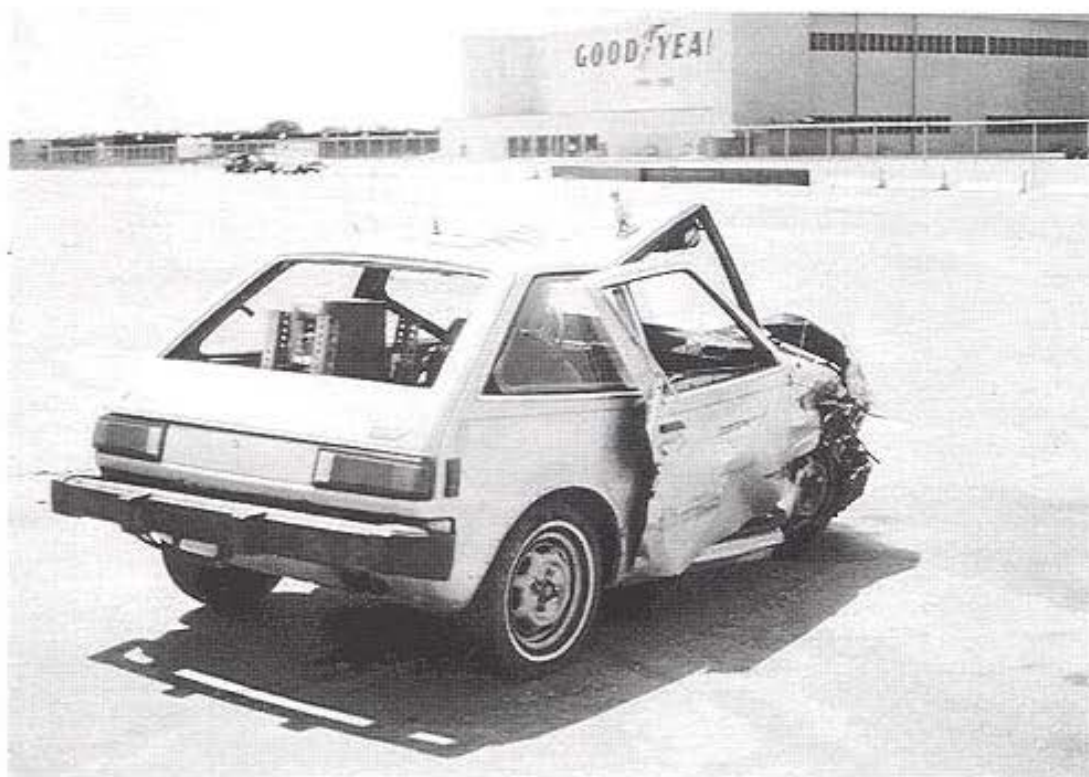
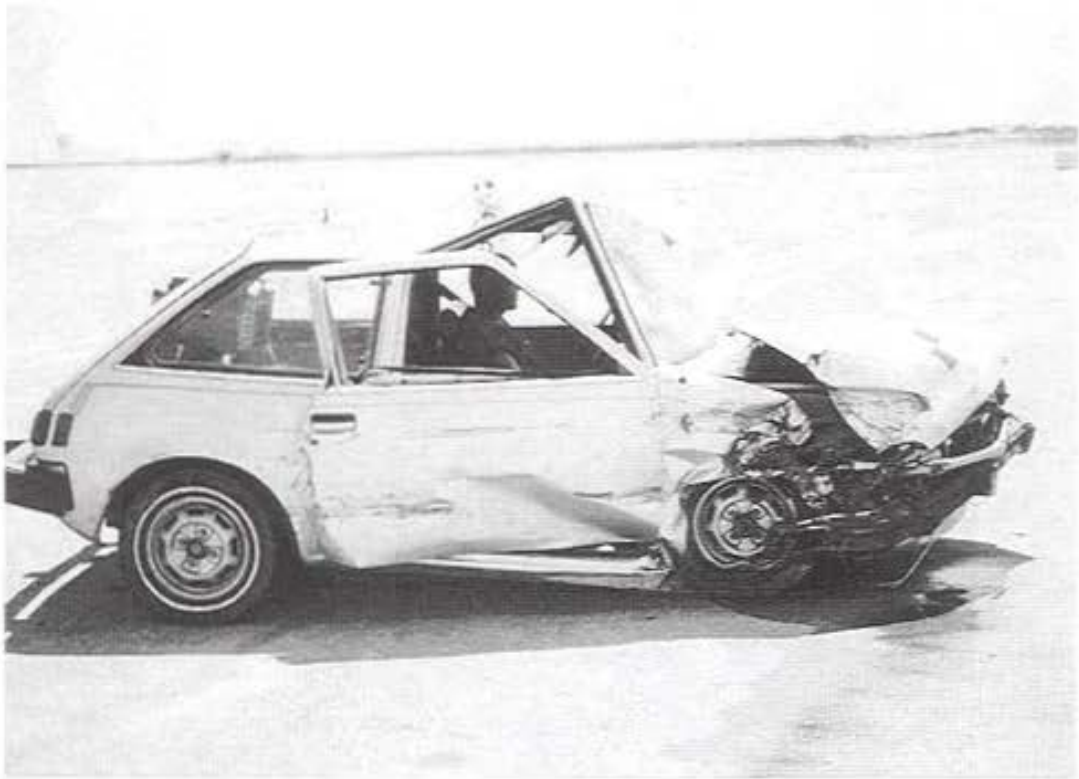
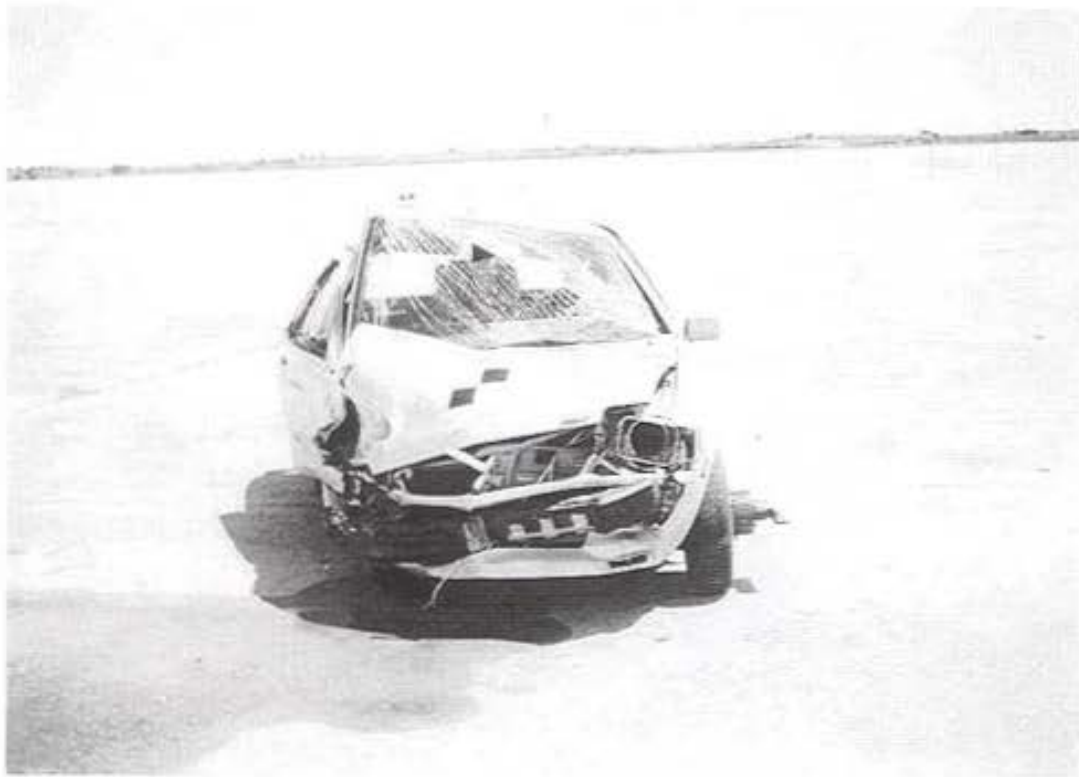
Figure 48. Vehicle Damage, Test GWMP-1.

The vehicle damage, shown in figure 48, included the crushing of the right-front corner of the vehicle, twisting of the car to the right of its longitudinal centerline, buckling of the hood, roof, windshield frame, firewall, passenger compartment floor, and the passenger side door. The right-front tire was deflated, and the rim was deformed. The maximum crush deformation of 21 in (53.3 cm) is shown in figure 49.

As evident in the vehicle damage shown in figure 48, there was significant occupant compartment damage to the test vehicle. This damage was caused by the snagging of the vehicle on posts nos. 4 and 5. This occupant compartment deformation, accompanied by excessive lateral ridedown decelerations, caused the system to fail this compliance test. To alleviate this snagging problem, the rail size was increased from 4.5 in O.D. to 5.0 in O.D. (114 mm to 127 mm), and it was moved further out from the post, effectively moving the face of the rail 1 in further from the post. The design details of this change can be seen in appendix A.

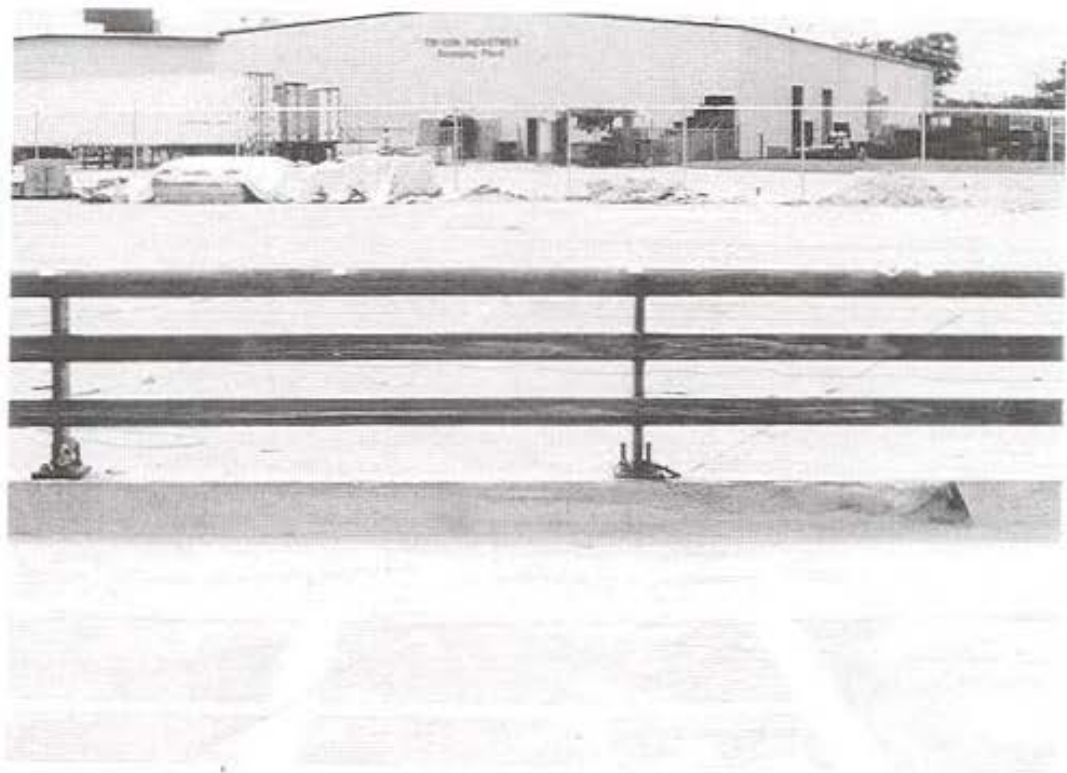
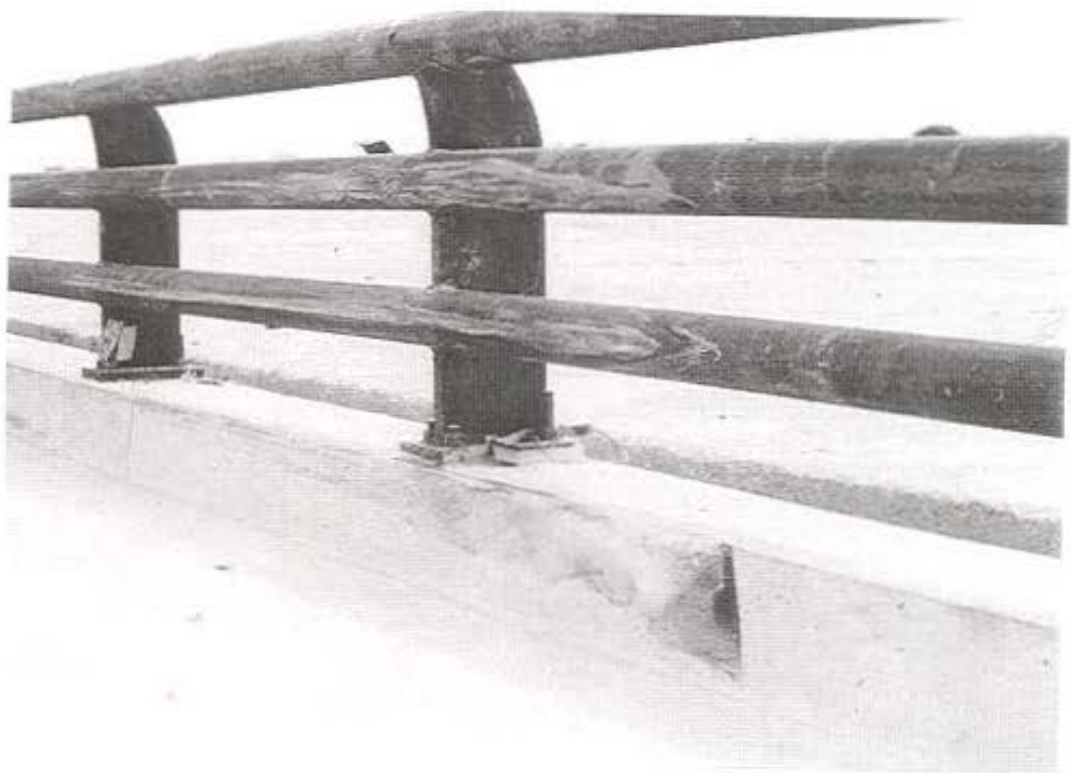
**Figure 50.** Bridge Rail Damage, Test GWMP-1.

The damage to the bridge rail was minor, with superficial scrapes on the curb, rail, and posts as shown in figure 50. There was no permanent set deflection in the bridge rail. The contact marks on the curb started at impact, 4 ft - 5 in (1.35 m) before post no. 4, and continued for 11 ft - 8 in (3.56 m). Contact with the lower rail began 4 ft - 0 in (1.2 m) before post no. 4 and continued for 19 ft - 6 in (5.94 m). Contact with the middle rail began 3 ft - 8 in (1.12 m) before post no. 4 and continued for 17 ft - 0 in (5.18 m).
