# Guardrail Testing Program II

## Final Report

Transportation Research Report TRP-03-52-95

FHWA Contract No. DTFH71-90-C-00035

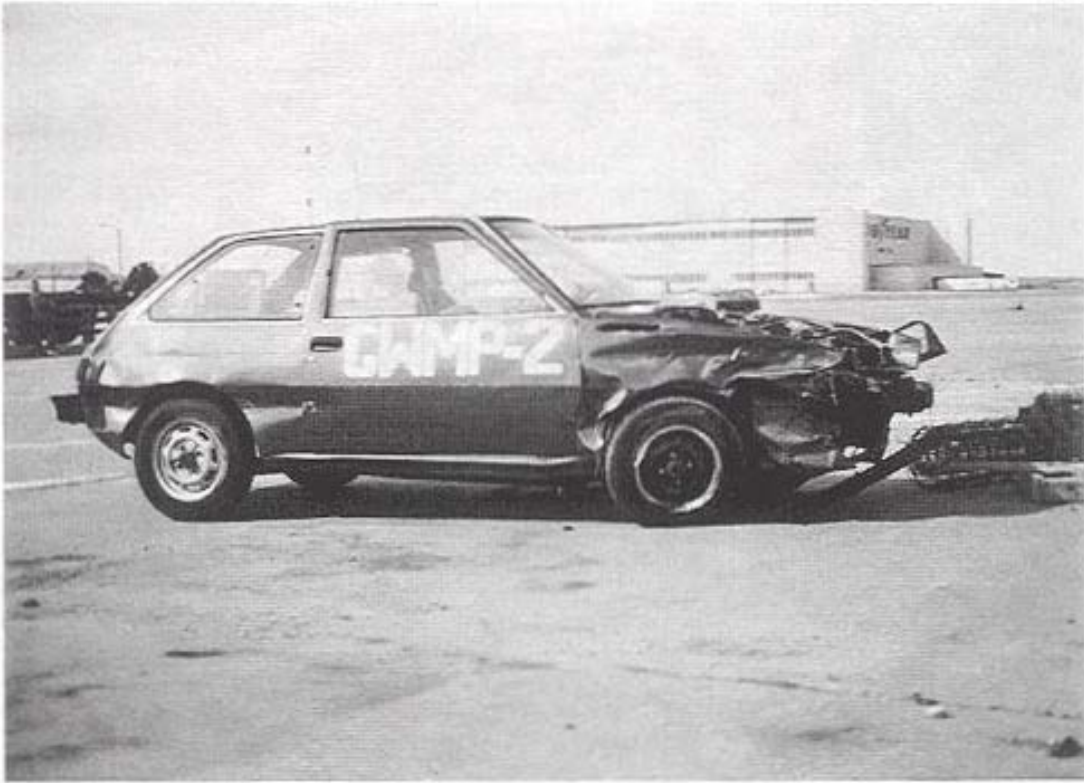
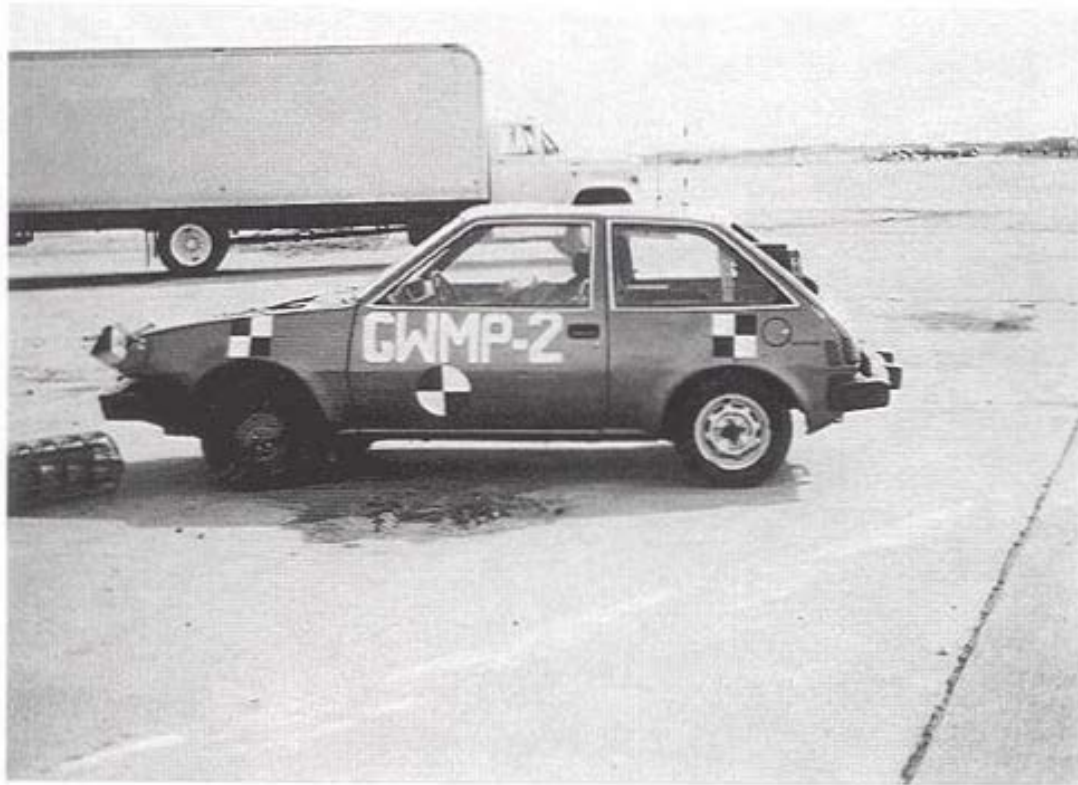
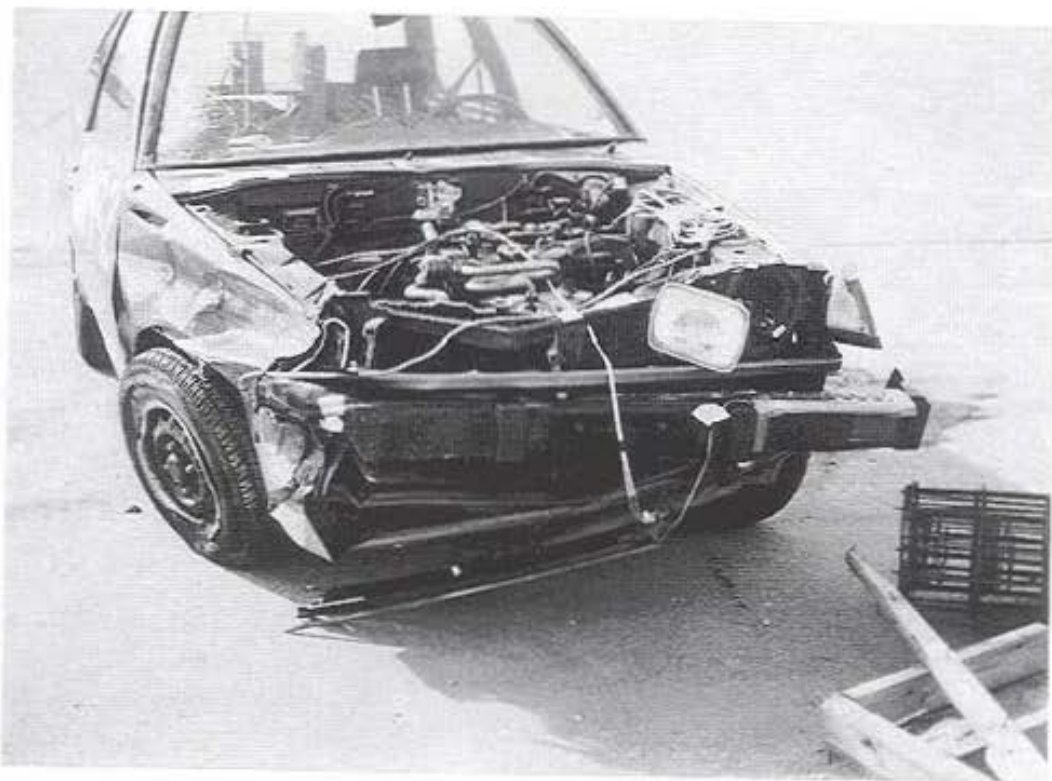
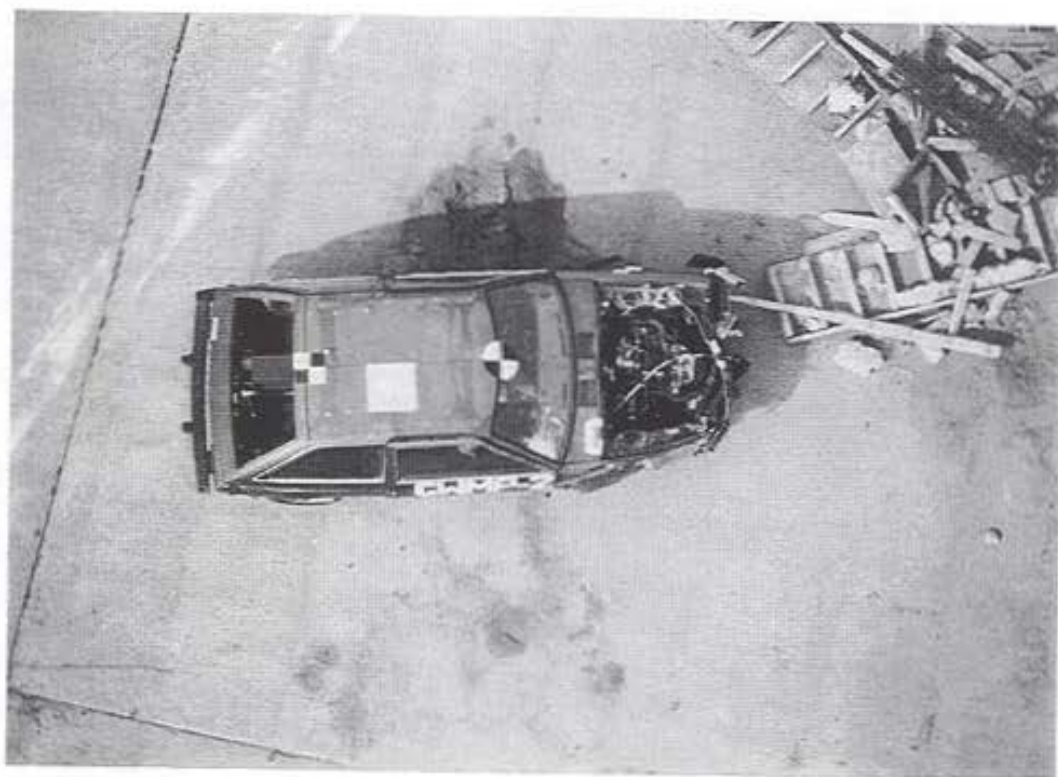
Figure 54. Vehicle Damage, Test GWMP-2.

The vehicle damage, shown in figure 54, included crushing of the right-front corner of the vehicle, minor scrapes and dents along the length of the passenger side, and separation of the hood. The windshield was not penetrated but did sustain localized cracking in the lower right corner. The right-front tire was blown out and the rim was bent outward at the top. The occupant compartment floor sustained minor buckling in the front passenger side floor area. The maximum crush deformation of 12 in (30.5 cm) is shown in figure 55.

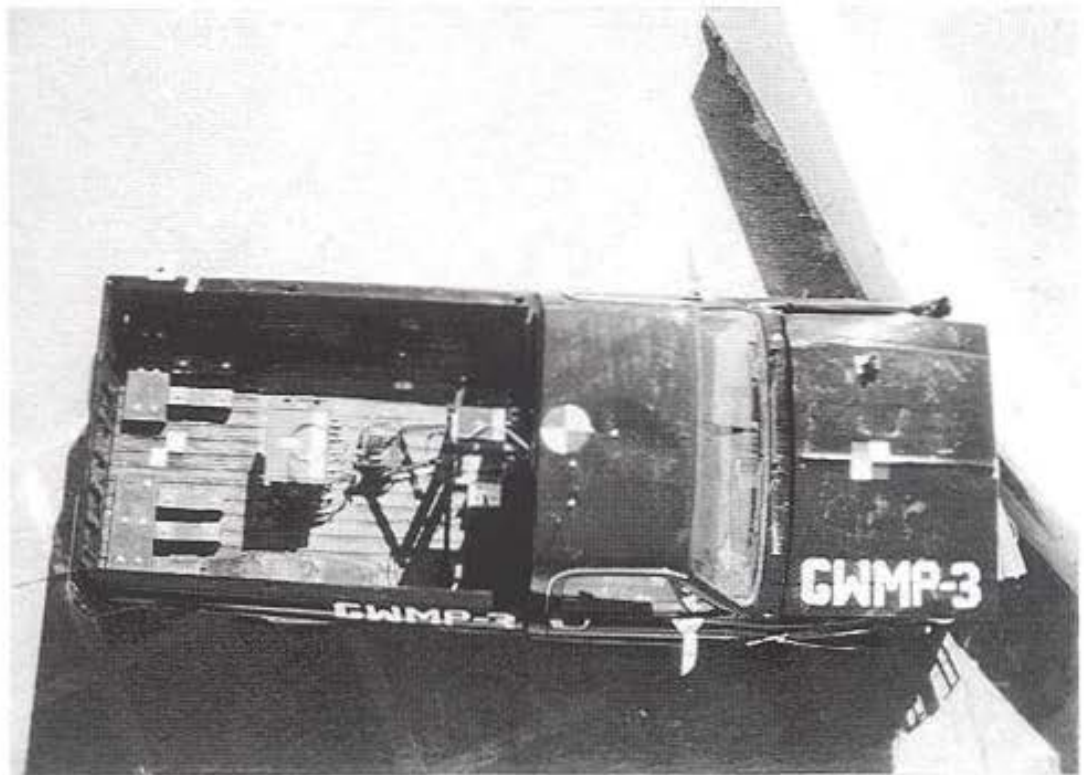
Figure 60. Vehicle Damage, Test GWMP-3.

The vehicle damage, shown in figure 60, included the crushing of the right-front corner of the vehicle, and scrapes and dents along the length of the passenger side. The right-front tire was blown out and the rim was deformed. The maximum crush deformation of 9.75 in (24.8 cm) is shown in figure 61. All damage to the vehicle on the driver's side of the longitudinal centerline occurred after impact with the bridge rail. Near the end of the vehicle's trajectory, the vehicle struck an obstacle on the testing grounds, resulting in damage to the left-front corner of the vehicle.

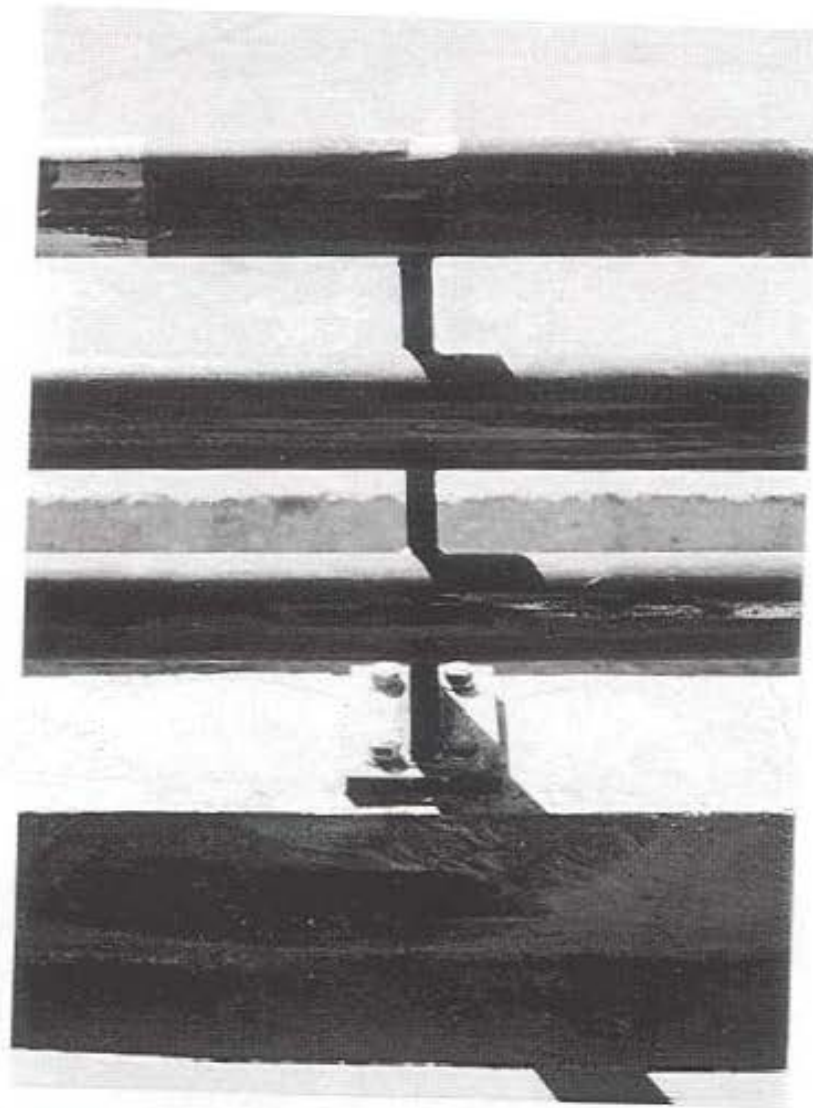
Figure 62. Bridge Rail Damage, Test GWMP-3.

The bridge rail sustained only minor cosmetic damage on each of the three rails as shown in figure 62. Contact with each of the rails began 3 ft 5 in (1.04 m) upstream of the expansion joint. The vehicle remained in contact with the rail for 8 ft (2.44 m) on the bottom rail, 8 ft 6 in (2.59 m) on the middle rail, and 8 ft 2 in (2.49 m) on the top rail.

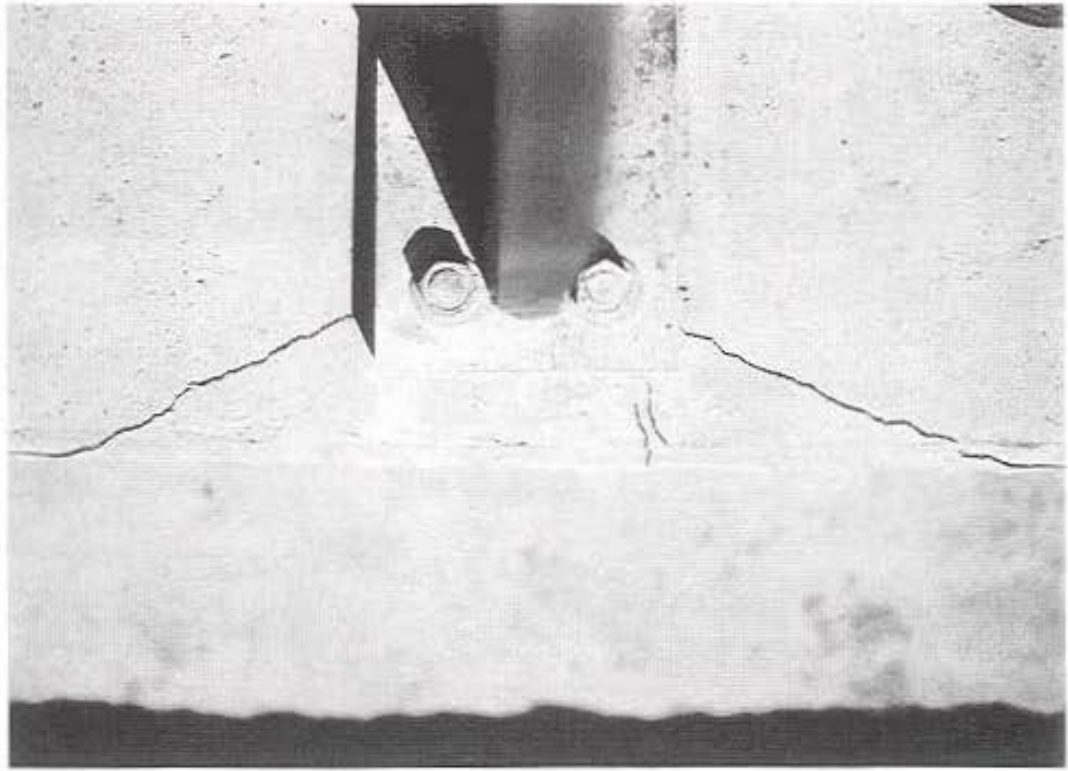
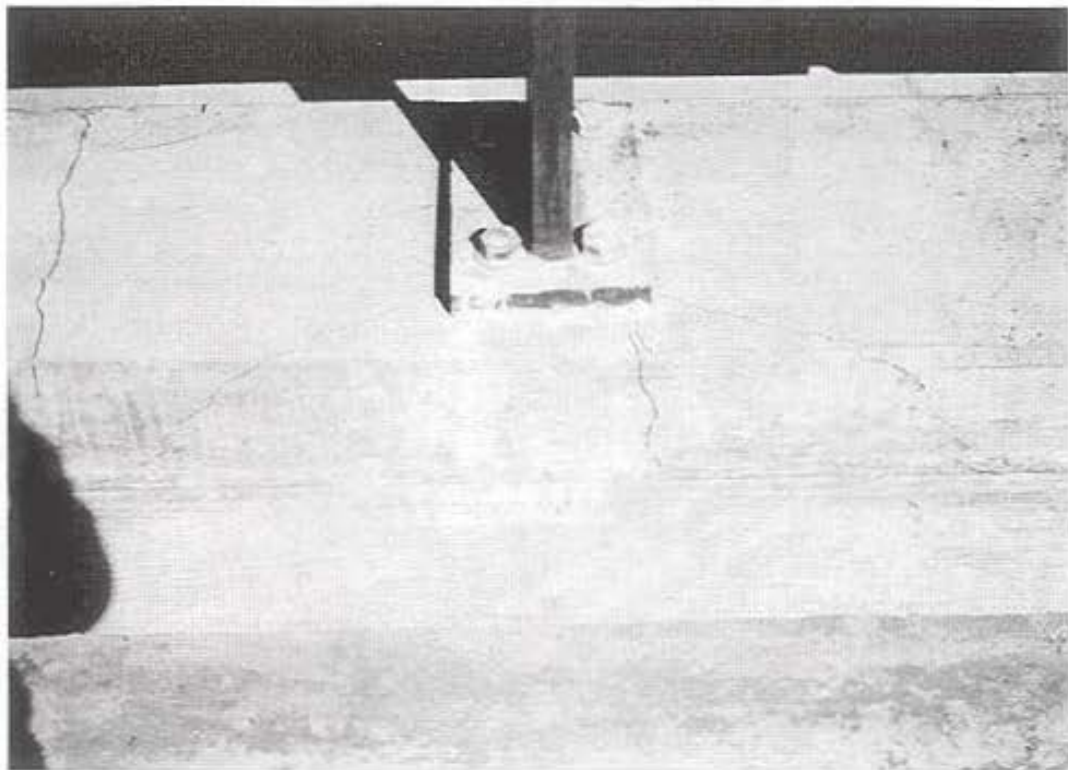
Figure 63. Curb Damage, Test GWMP-3.

Cracking occurred in the curb and bridge deck at post no. 6. On top of the curb, two cracks propagated outward from each of the rear post bolts, as shown in figure 63. The length of cracks upstream and downstream of post no. 6 were 10-in (25.4 cm) and 11 in (27.9 cm), respectively.

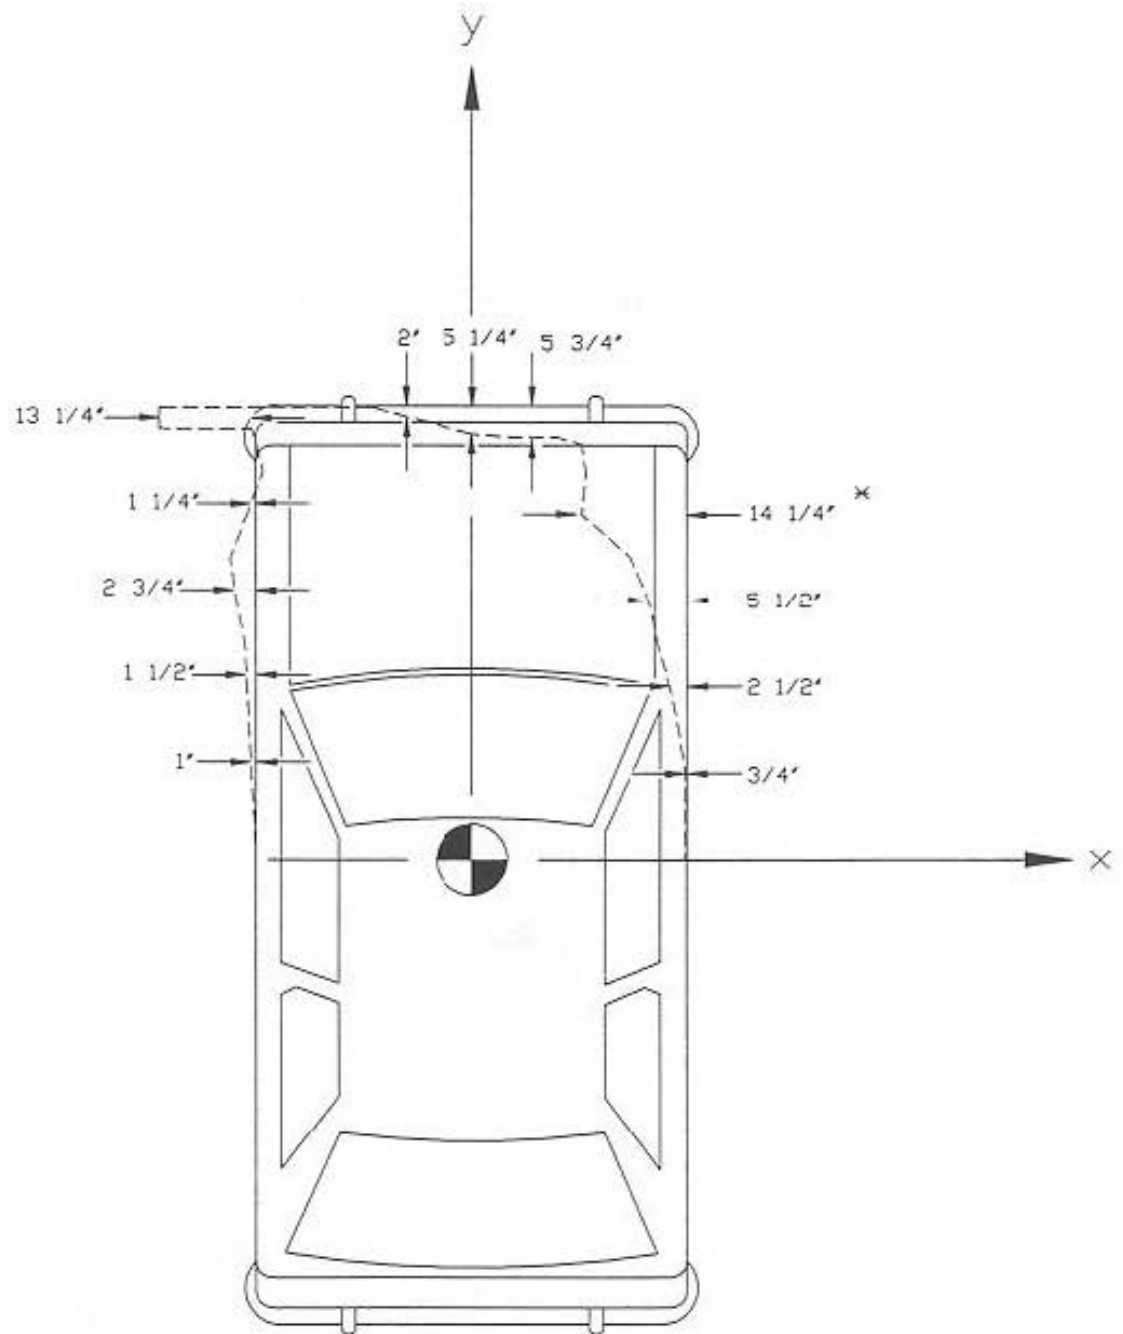
**Figure 73. Crush Depth Diagram, Test FPAR-1.**

The vehicle damage, shown in figure 72, included the crushing of the right-front corner of the vehicle, and minor scrapes and dents along the length of the passenger side. The right-front tire was blown out, and the rim was bent. The maximum crush deformation of 11.25 in (28.6 cm) is shown in figure 73.

\* - Maximum static crush distance of 14 1/4" occurred  
 at (15 3/4", 54")

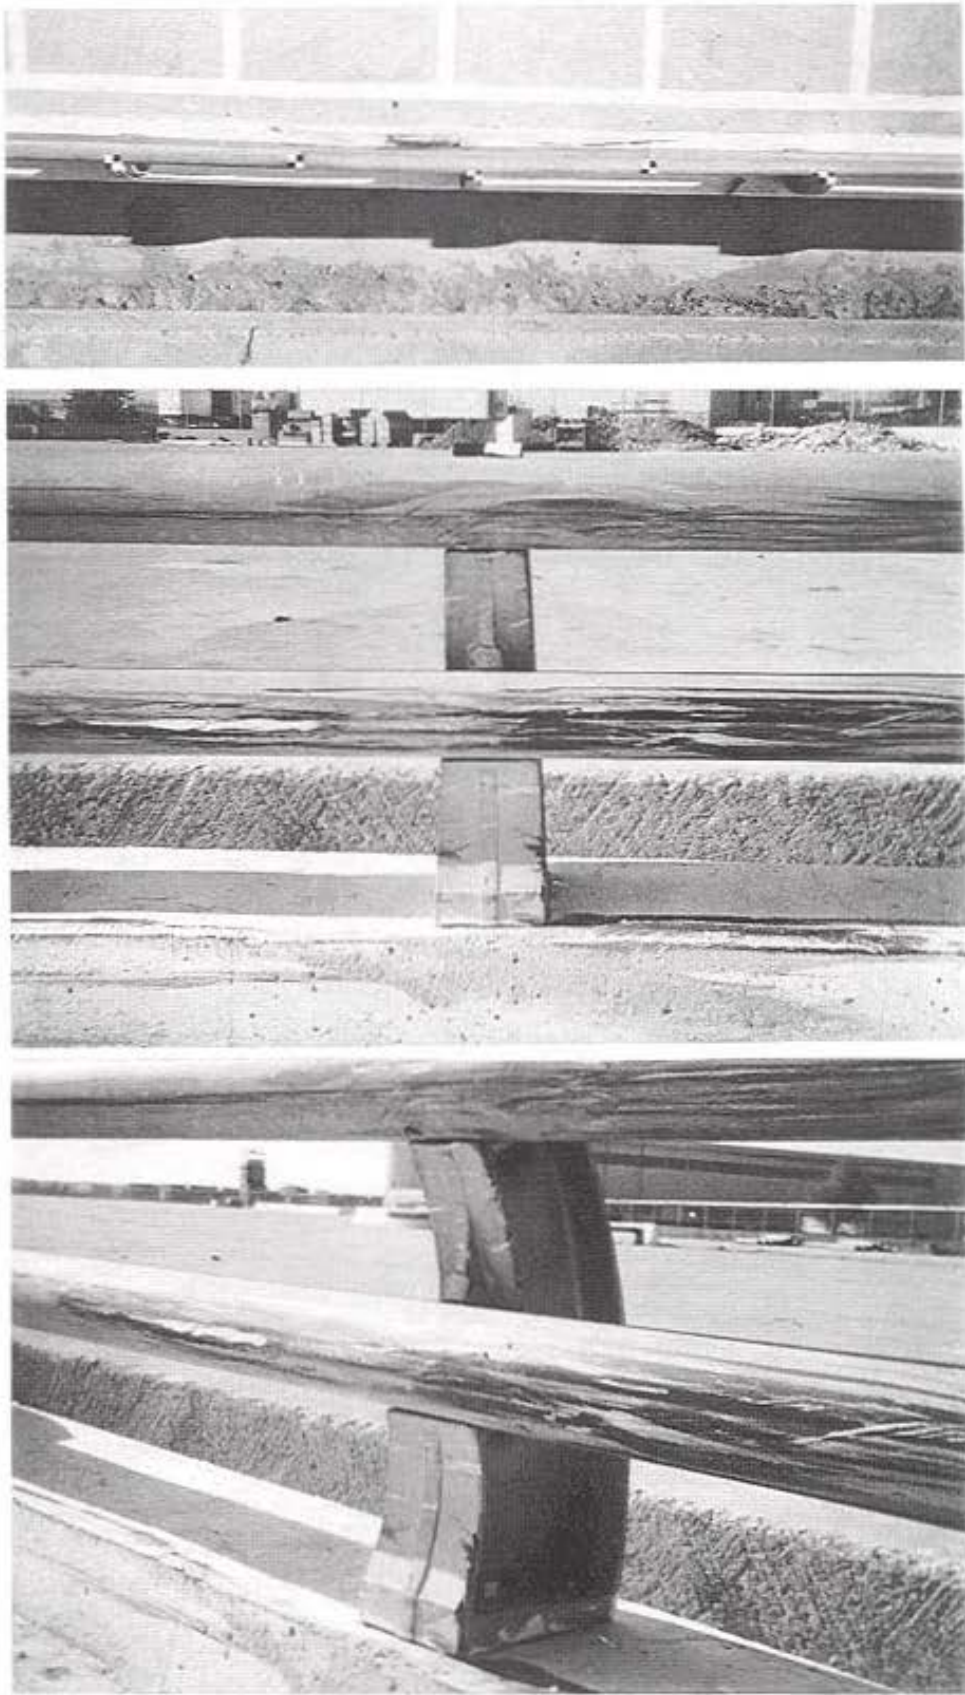
Figure 74. Bridge Rail Damage, Test FPAR-1.

The damage to the bridge rail was minor, with superficial scrapes on the curb and rail as shown in figure 74. The maximum permanent set deflection of 1 in (2.54 cm) occurred approximately 2 ft (0.61 m) downstream from impact on the lower rail. There was evidence of minor tire and hub contact between the curb and the lower rail on the first post downstream from impact (post no. 4). There was also evidence of crushed vehicle body contact between

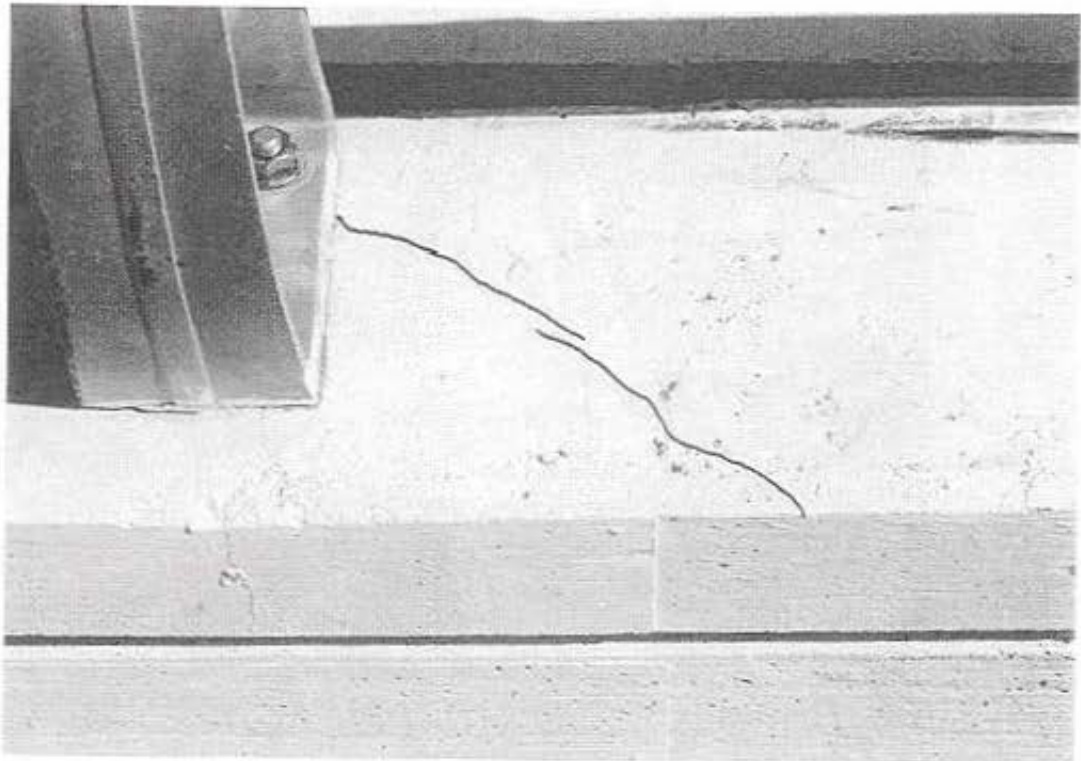
Figure 75. Cracking in Curb, Test FPAR-1 (outlined for clarity).

The only notable damage to the curb was a set of microcracks which started at the 1-in (2.54-cm) anchor bolts and extended to the back face of the curb at an angle of approximately 45 degrees. These cracks (outlined for clarity) are shown in figure 75. This was interpreted as being the beginning of a classic shear failure, and it was anticipated that the curb would fracture during the next, more severe pickup truck crash test. Therefore, the reinforcement in the curb was redesigned by FHWA engineers and replaced before Test FPAR-2.

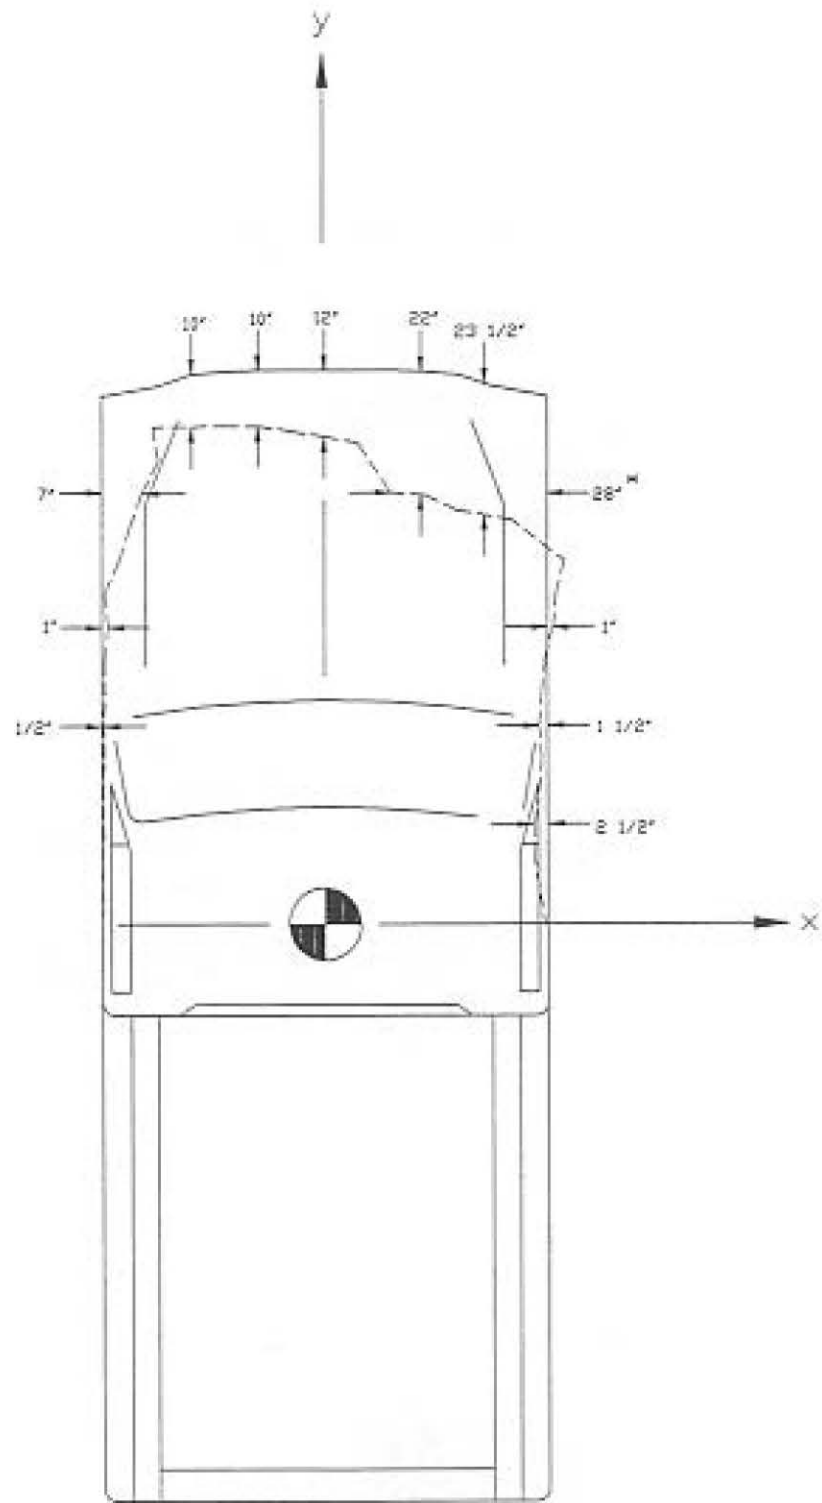
Figure 80. Crush Depth Diagram, Test FPAR-2.

The vehicle damage, shown in figure 79, included the crushing of the right-front corner of the vehicle and minor scrapes and dents along the length of the passenger side. The right-front tire was blown out, and the rim was bent. The maximum crush deformation of 26.5 in (67.3 cm) is shown in figure 80.

H-Maximum static crush distance of 28" occurred at (40,78°).

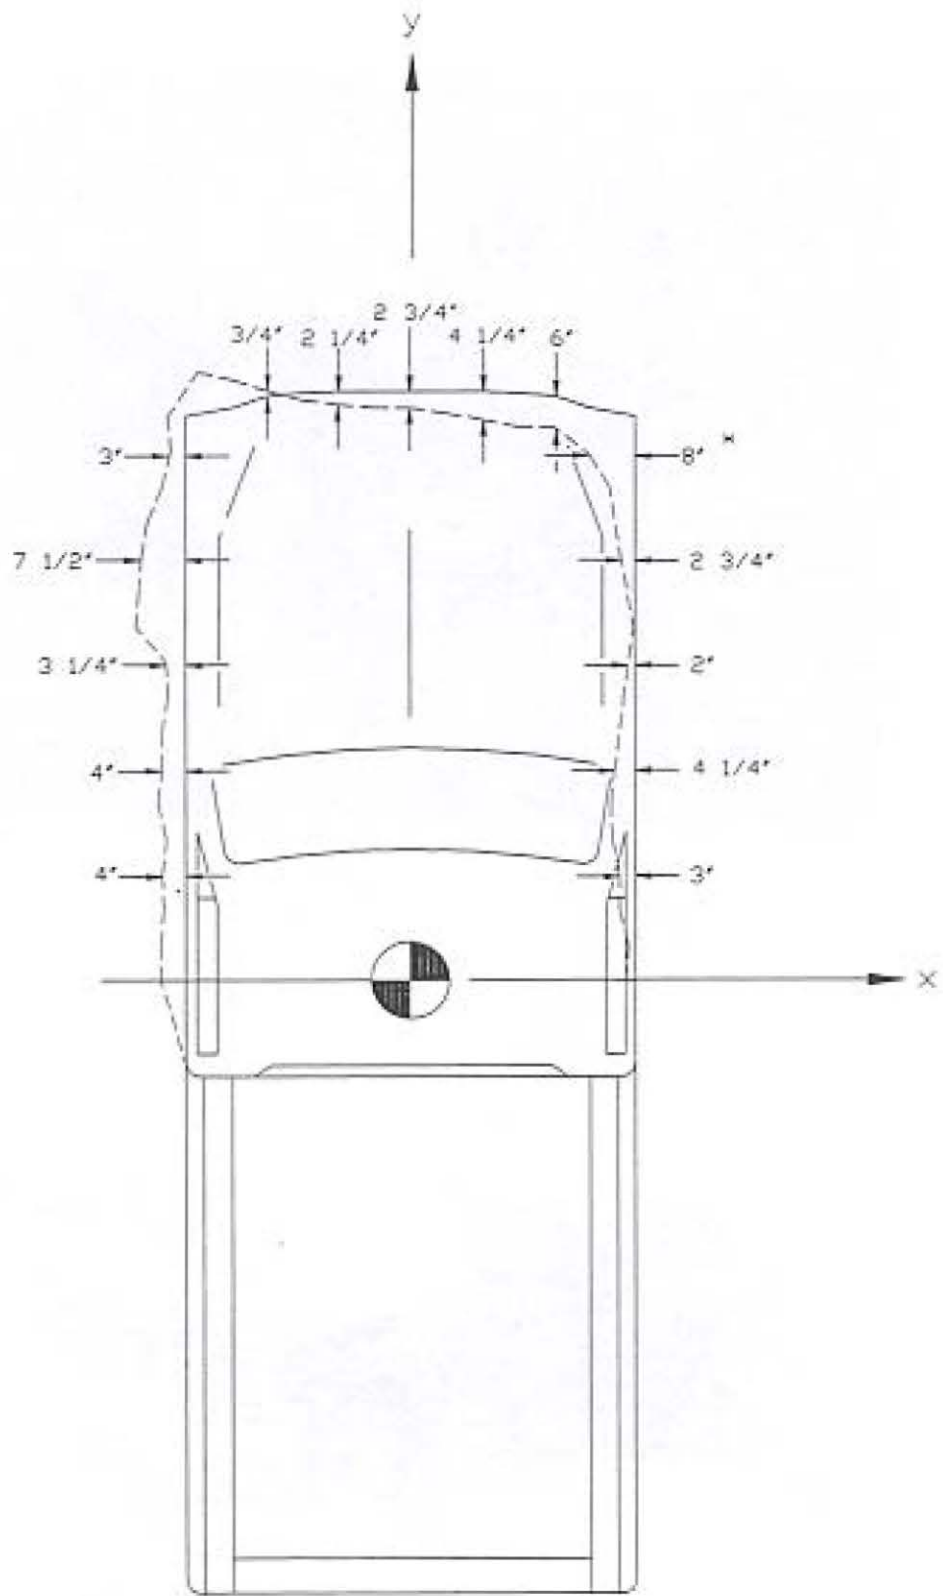
The vehicle damage, shown in figure 87, included the crushing of the right-front corner of the vehicle and scrapes and dents along the length of the passenger side. The right-front tire was blown out, and the rim was bent. The maximum crush deformation of 10.75 in (27.3 cm) is shown in figure 88.

\*-Maximum static crush distance of 8' occurred at (39°.89 1/4°)

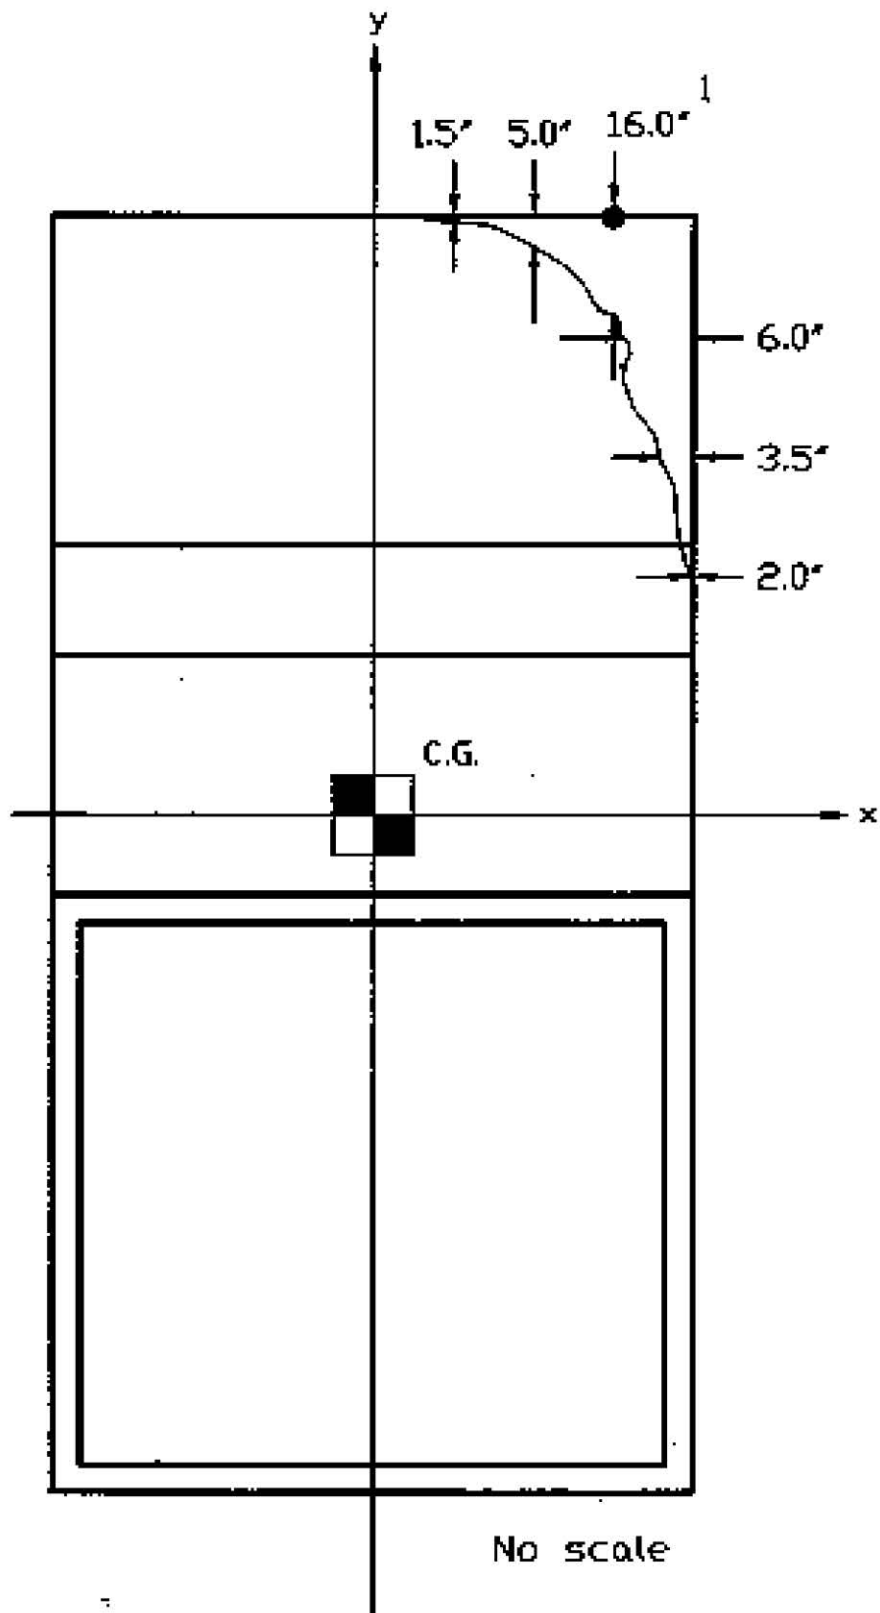
Figure 96. Crush Depth Diagram, Test NTBR-1.

<sup>1</sup>—Maximum static crush distance of 16" occurred at (24°, 90°) marked by the point.

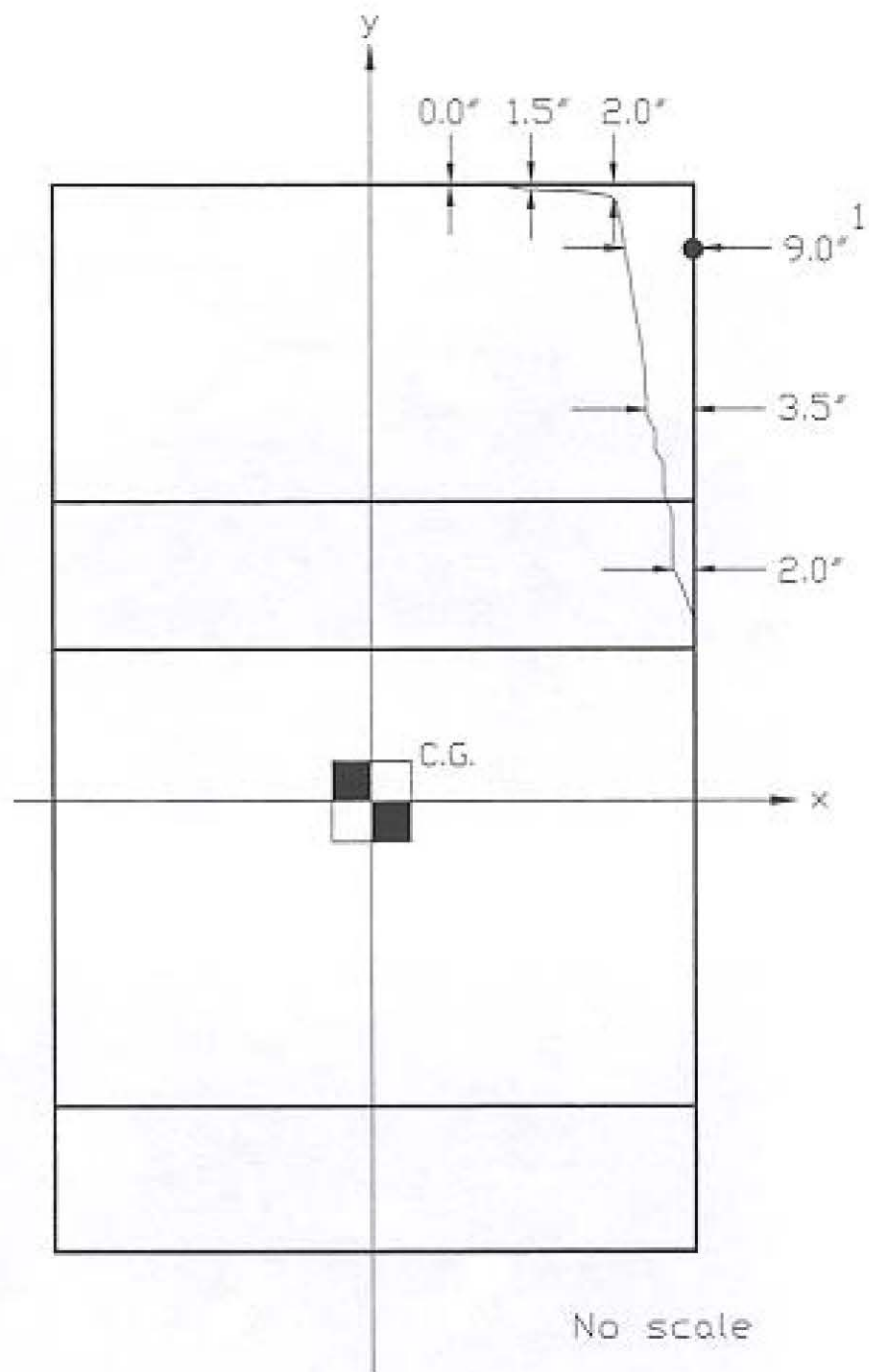
Figure 103. Crush Depth Diagram, Test NTBR-2.

<sup>1</sup>-Maximum static crush distance of 9" occurred at (24°,60°) marked by the point.

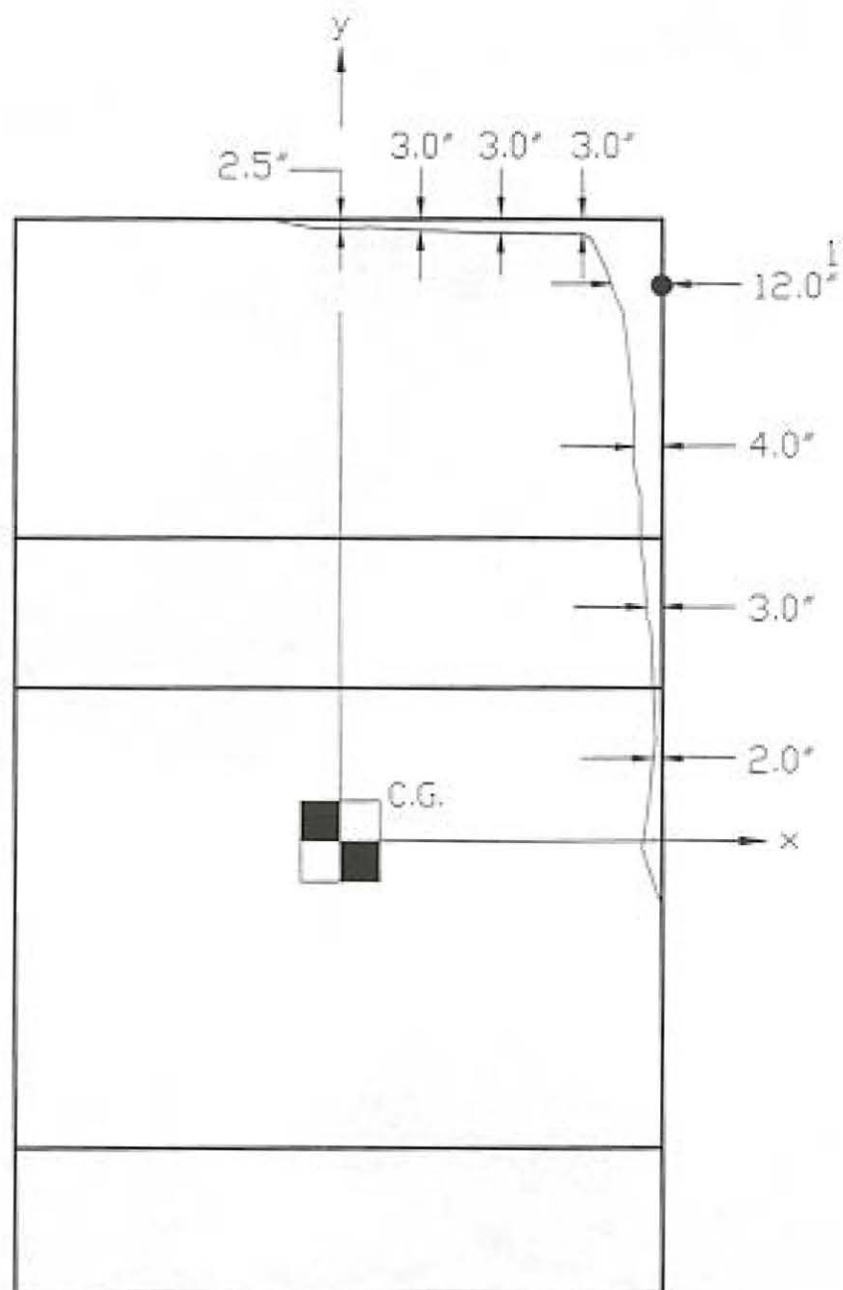
Figure 111. Crush Depth Diagram, Test SBLR-1.

<sup>1</sup>-Maximum static crush distance of 12" occurred at (24",54") marked by the point.

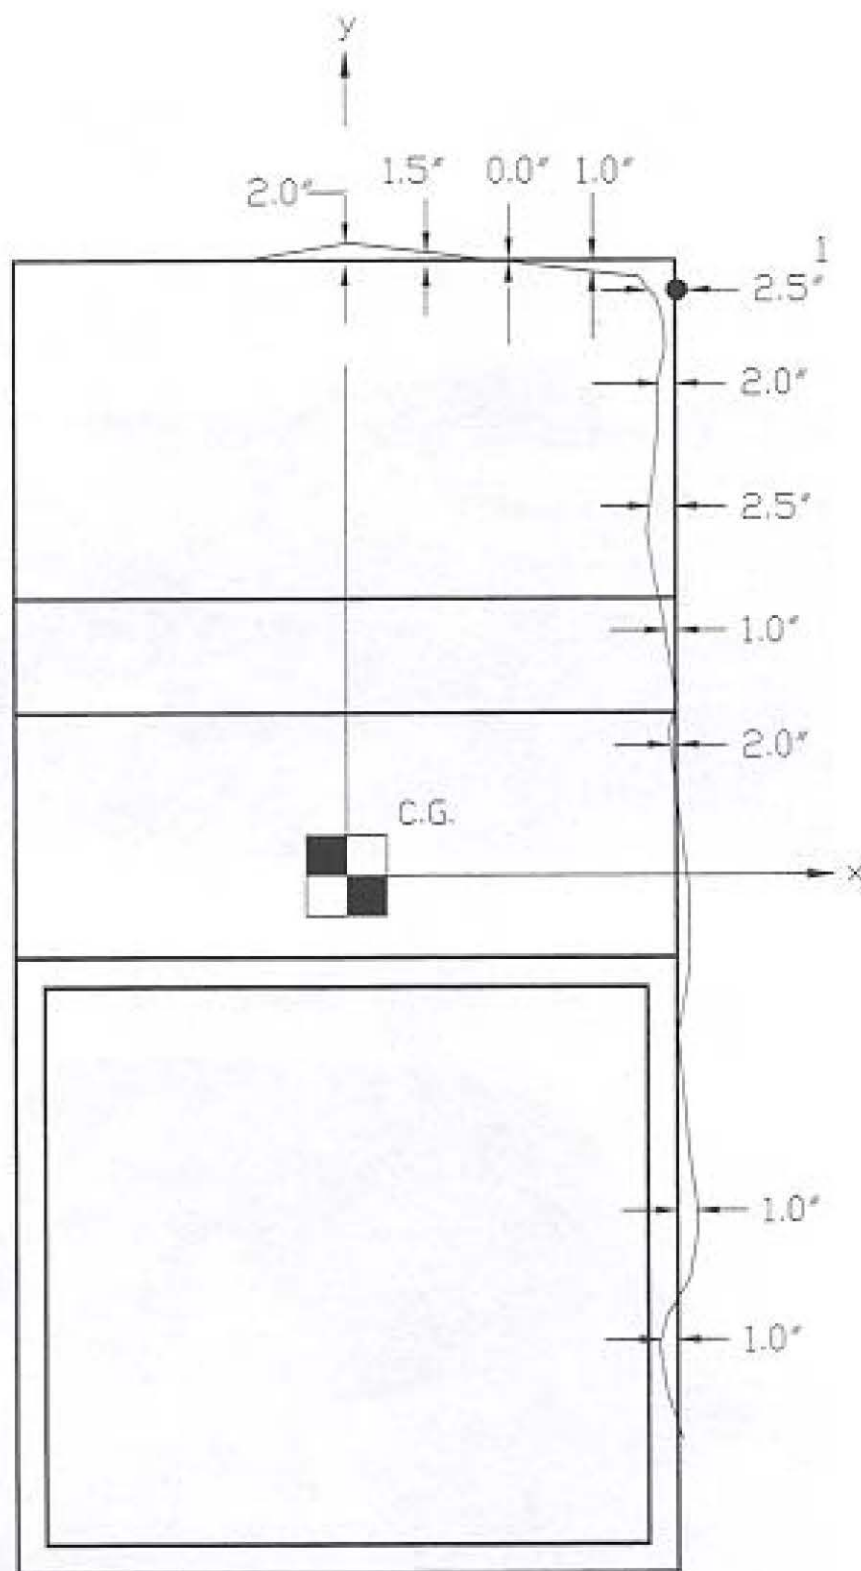
Figure 118. Crush Depth Diagram, Test SBLR-2.

<sup>1</sup>-Maximum static crush distance of 2.5" occurred at (36",96") marked by the point.

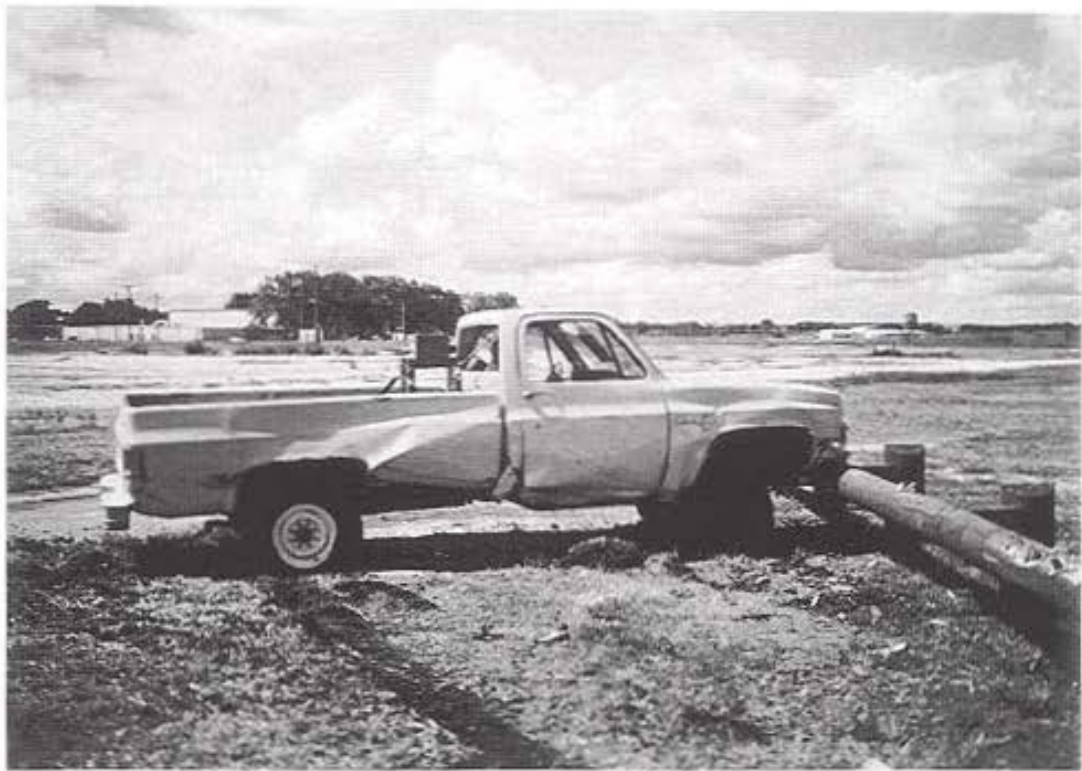
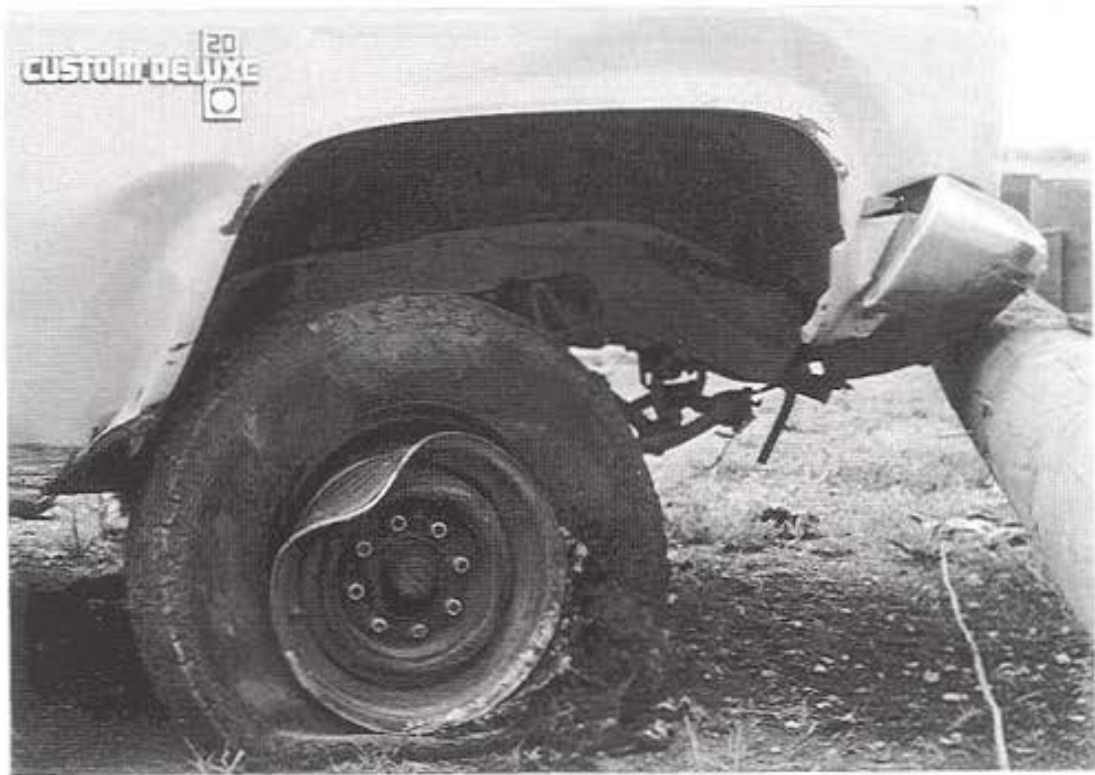
Figure 119. Log Rail Damage, Test SBLR-2.

Damage to the log rail consisted of scrapes and gouges along the traffic face and at some of the posts. A maximum permanent deflection of  $9\frac{1}{8}$  in (232 mm) was measured at post no. 3. The damaged barrier is shown in figure 119.
