1. Report No. FHWA-RD-96-199		2. Government Accession No.		3. Recipient's Catalog No.	
4. Title and Subtitle NCHRP REPORT 350 COMPLIANCE TEST 5-12 OF THE 1.07-m VERTICAL WALL BRIDGE RAILING				5. Report Date

6. Performing Organization Code	
7. Author(s) Dean C. Alberson, Richard A. Zimmer, and Wanda L. Menges				8. Performing Organization Report No. Project 405511-2

9. Performing Organization Name and Address Texas Transportation Institute The Texas A&M University System College Station, Texas 77843-3135				10. Work Unit No. 3A5B

11. Contract or Grant No. DTFH61-95-C-00136	
12. Sponsoring Agency Name and Address Office of Safety and Traffic Operations R&D Federal Highway Administration 6300 Georgetown Pike McLean, Virginia 22101-2296				13. Type of Report and Period Covered Final Report September 1995 - May 1996

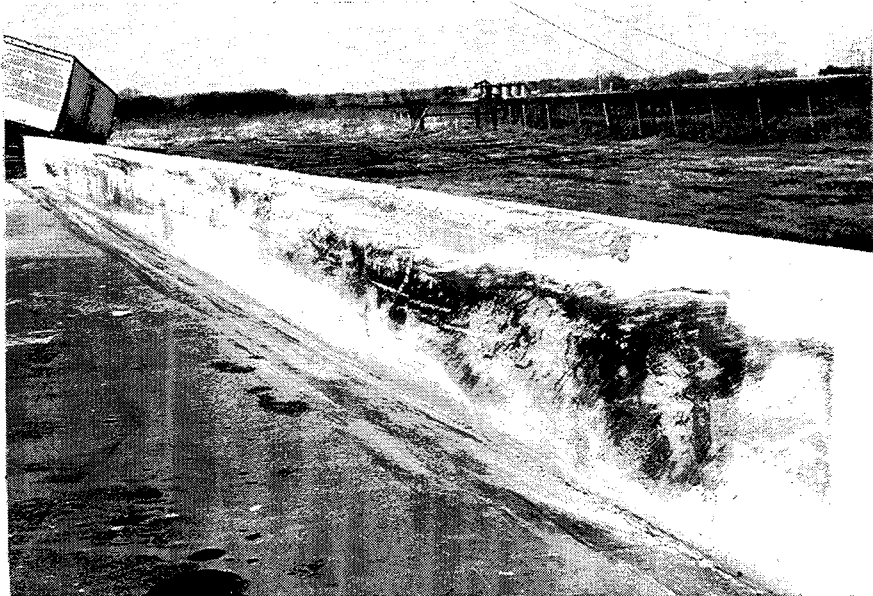
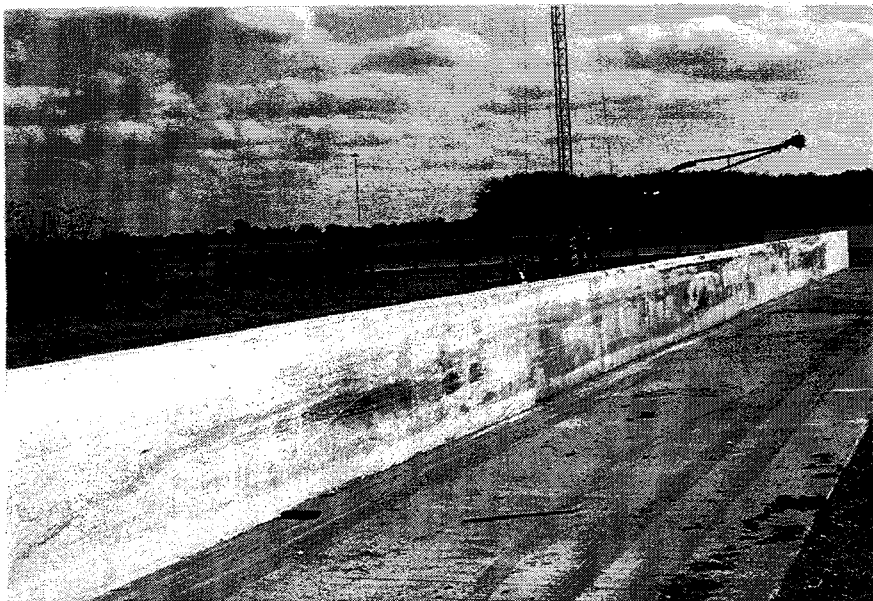
Figure 9. Installation after test 405511-2.

Damage to the vertical wall bridge railing was mostly cosmetic, as shown in figures 8 and 9. There were tire marks and gouging all along the face of the bridge railing. Some spalling of concrete along the top of the bridge railing was caused as the van trailer rode along the top. The total length of contact of the vehicle with the bridge railing was 34.6 m. There was no structural damage to the connection with the bridge deck.

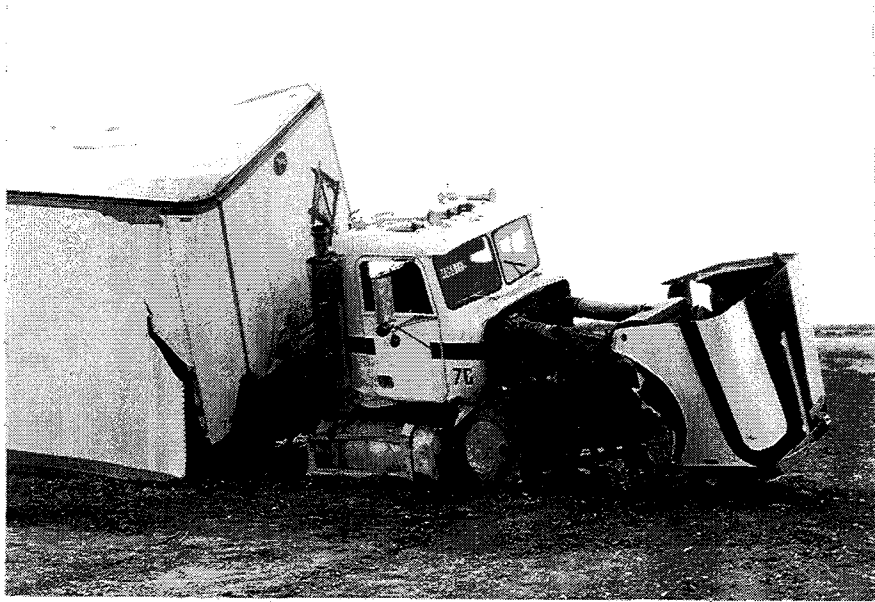
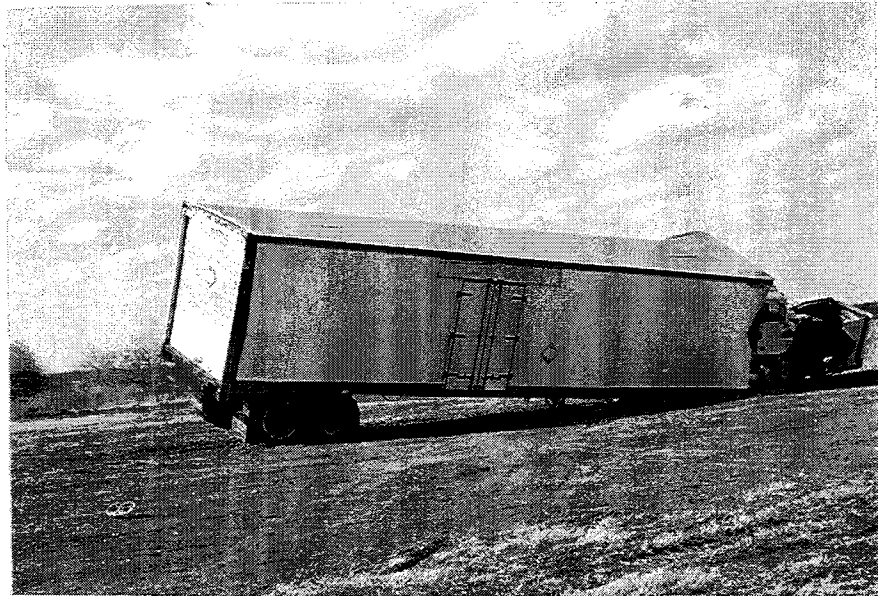
Figure 10. Right side of vehicle after test 405511-2.

Most of the damage to the vehicle was to the right side, as shown in figures 10 and 11. The following items were damaged on the tractor: the right front springs, U-bolts, mounts, shocks, and steering linkages; the right rear springs and mounts; the front axle; the right side fuel tank and mounts; the right side tires and rims; and the bumper, fan, radiator,

hood, and cab. Damage to the trailer included the fifth wheel frame, the dolly mounts, the rear axles, and the right side tires and rims. The right front corner of the van was also torn open.
