1. Report No. FHWA-RD-96-032	2. Government Accession No.	3. Recipient's Catalog No.	
4. Title and Subtitle CRASH TESTING AND EVALUATION OF RETROFIT BRIDGE RAILINGS AND TRANSITION		5. Report Date	6. Performing Organization Code

7. Author(s) C. Eugene Buth and Wanda L. Menges		8. Performing Organization Report No. Research Foundation 72070	
9. Performing Organization Name and Address Texas Transportation Institute The Texas A&M University System College Station, Texas 77843-3135		10. Work Unit No. NCP No.	11. Contract or Grant No. DTFH61-92-C-00025

12. Sponsoring Agency Name and Address Office of Safety & Traffic Operations R&D Federal Highway Administration 6300 Georgetown Pike McLean, Virginia 22101-2296		13. Type of Report and Period Covered Final Report May 1992 - August 1995

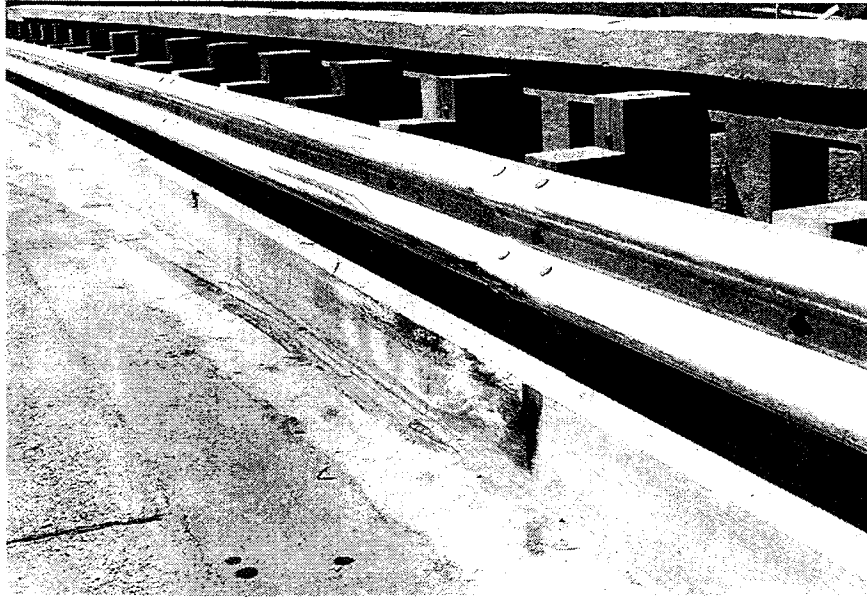
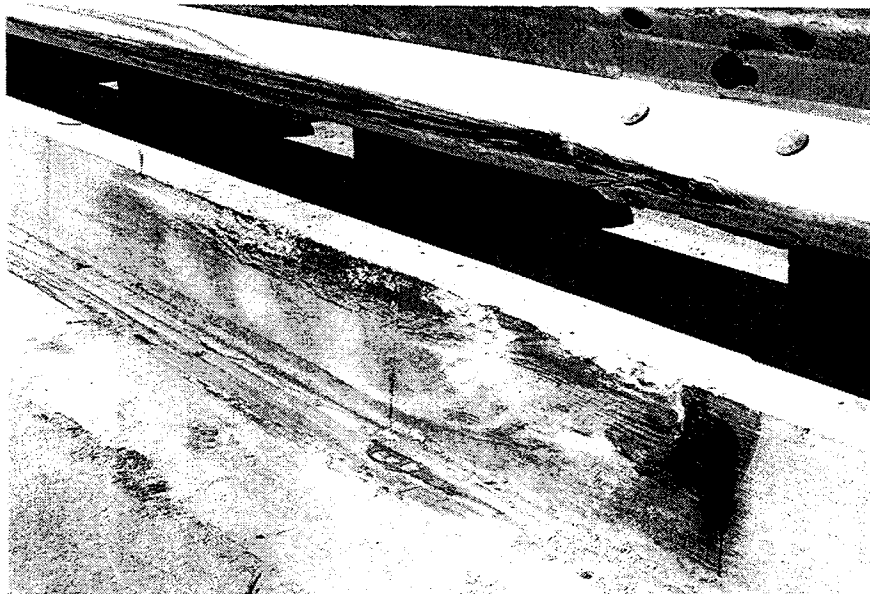
Figure 8. Damage to W-beam and curb after test 472070-1.

As can be seen in figures 7 and 8, the installation received minimal damage. The curb received cosmetic damages only. There was no evidence of lateral movement of the timber blockouts. The W-beam was marred by tire marks and there was no measurable permanent deformation of the W-beam. The vehicle was in contact with the installation for 2.5 m (8.3 ft).

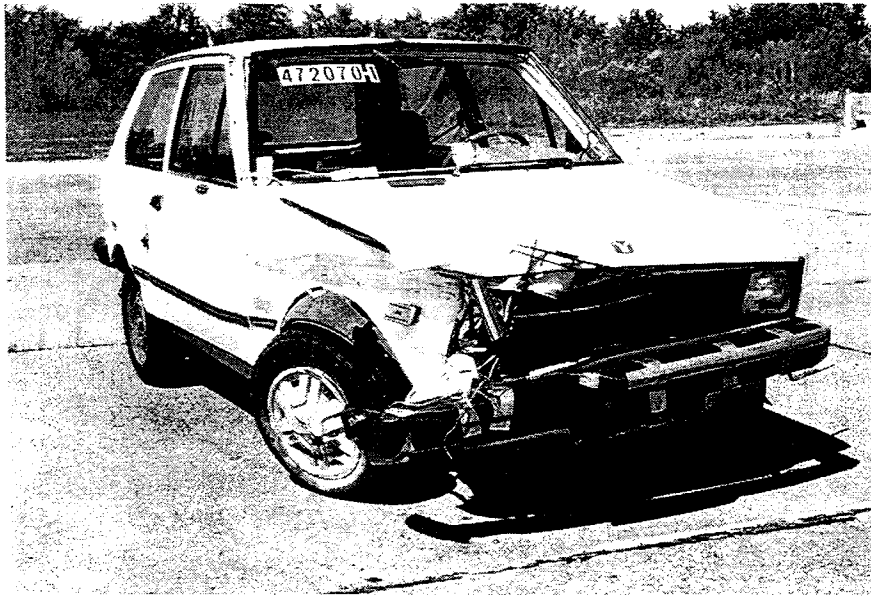
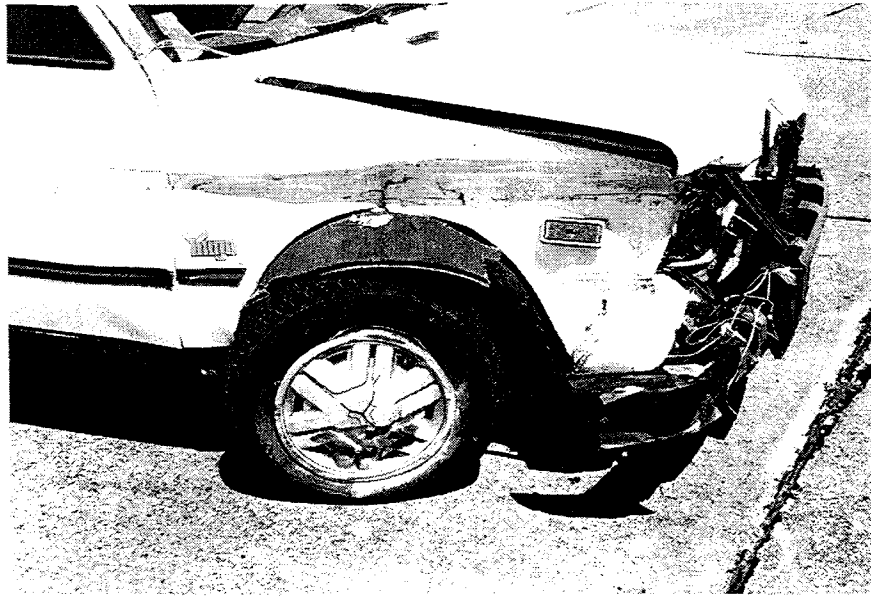
Figure 9. Vehicle after test 472070-1.

The vehicle sustained moderate damage to the front and right side as shown in figure 9. Maximum exterior crush at the right front corner at bumper height of the vehicle was 279 mm (11.0 in), and there was 13 mm (0.5 in) deformation into the occupant compartment at the right corner of the windshield frame. The sway bar and right side strut and lower control arm were bent. Damage was sustained by the front bumper, grill, hood, windshield, and right front wheel rim, and the entire right side was dented and scraped.

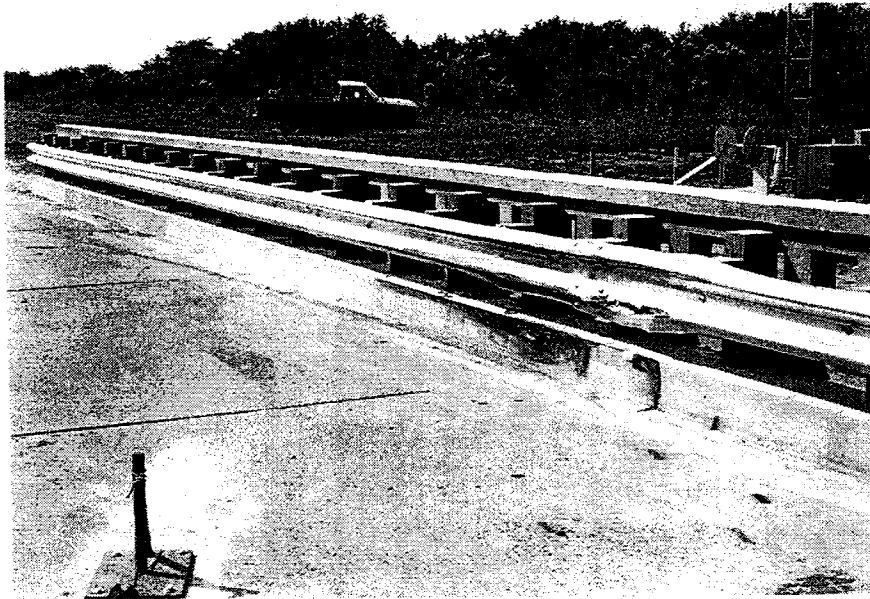
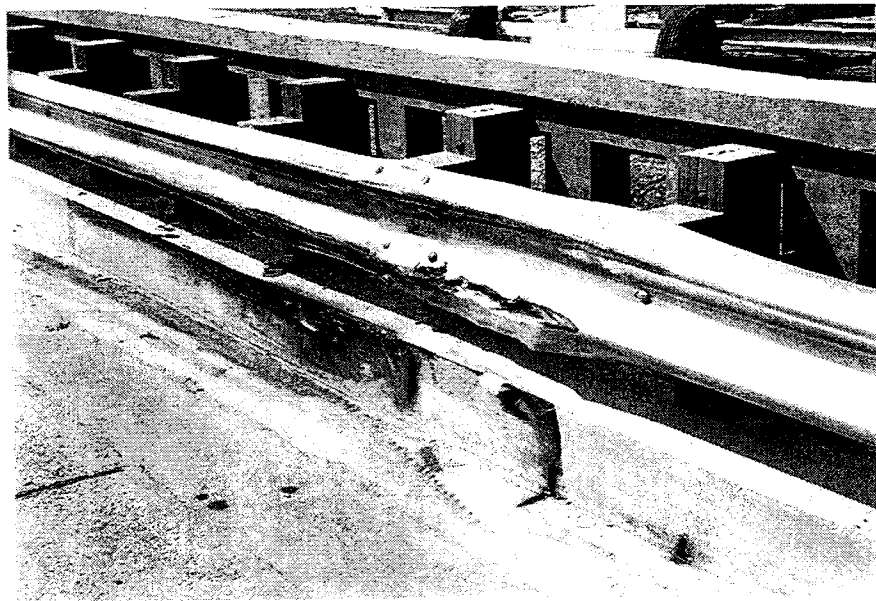
Figure 15. W-beam retrofit after test 472070-2.

As can be seen in figure 15, the installation received minimal damage. The curb received cosmetic damage only. There was no evidence of lateral movement of the timber blockouts and the W-beam was marred by tire marks, dents and scrapes. Maximum permanent deformation of the W-beam was 64 mm (2.5 in) between posts 8 and 9. The vehicle was in contact with the installation for 4.3 m (14 ft).

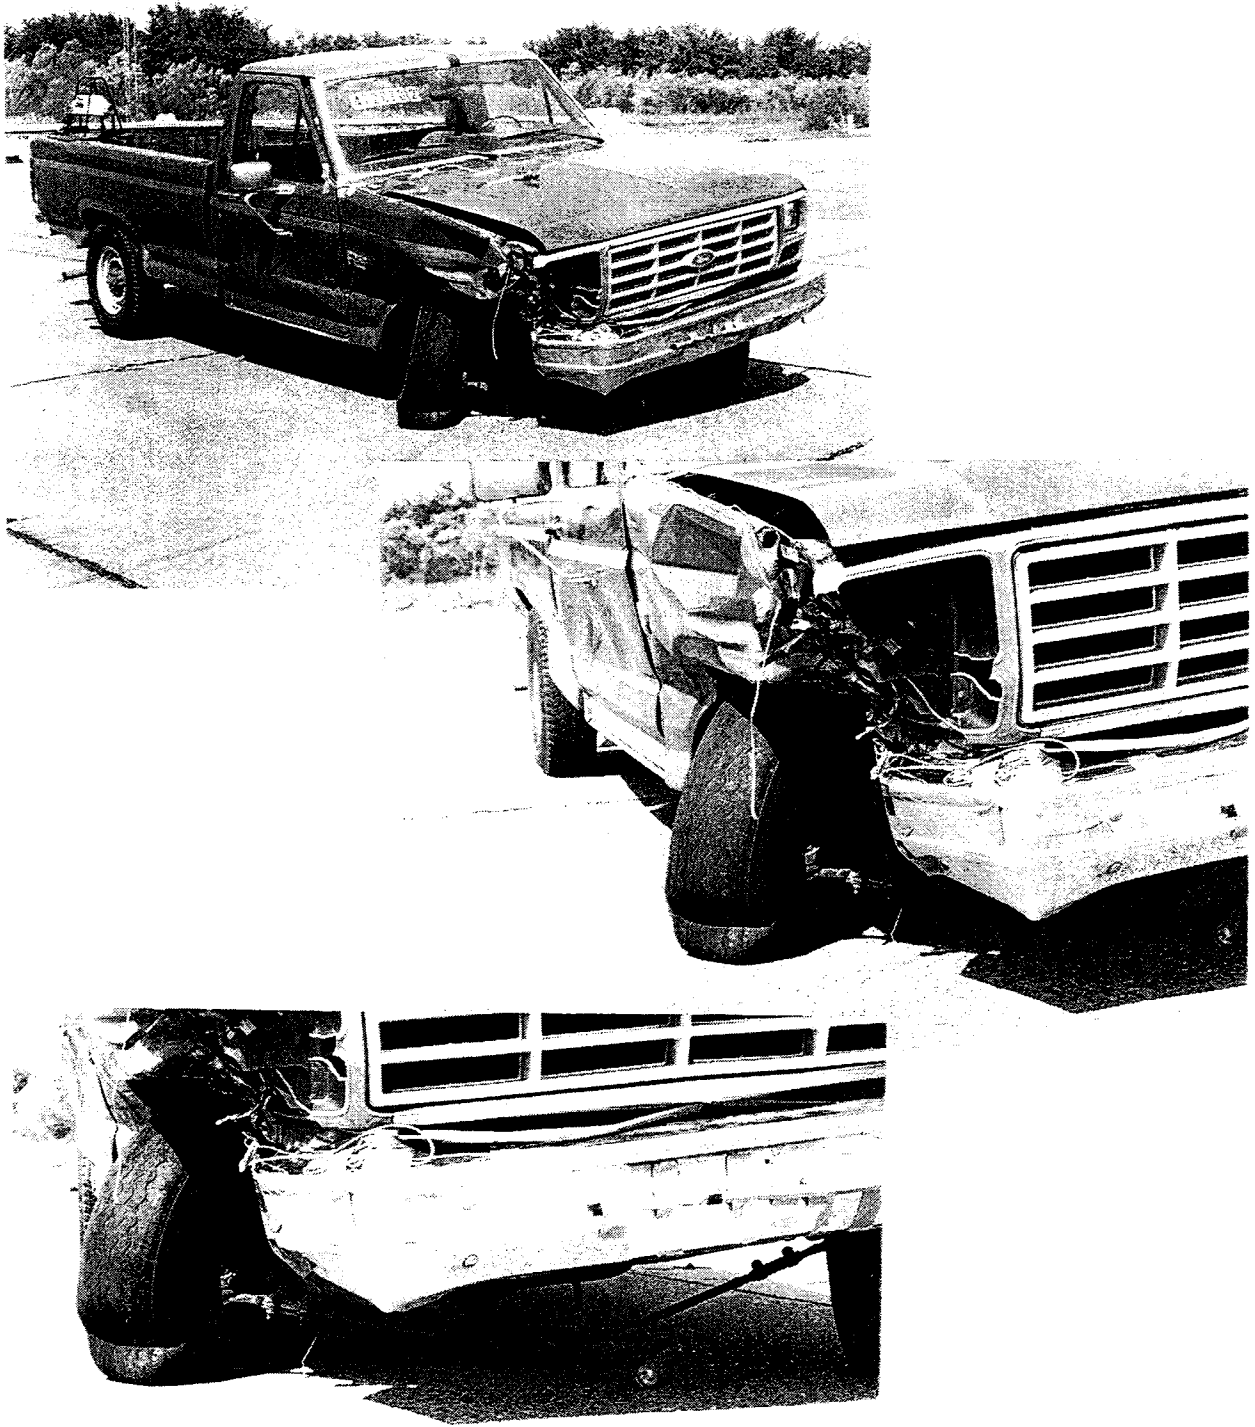
Figure 16. Vehicle after test 472070-2.

The vehicle sustained moderate damage to the right front quarter with minor damage to the right side as shown in figure 16. Maximum exterior crush at the right front corner at bumper height of the vehicle was 381 mm (15.0 in), and there was 13 mm (0.5 in) deformation into the occupant compartment at the firewall and between the lower instrument panel and the floor panel. The transmission tunnel and, on the right side, the frame, I-beam, torsion bar, tie rod and center link were deformed. Damage was sustained to the front bumper, grill, hood, windshield, and right front wheel rim, and the entire right side was dented and scraped.

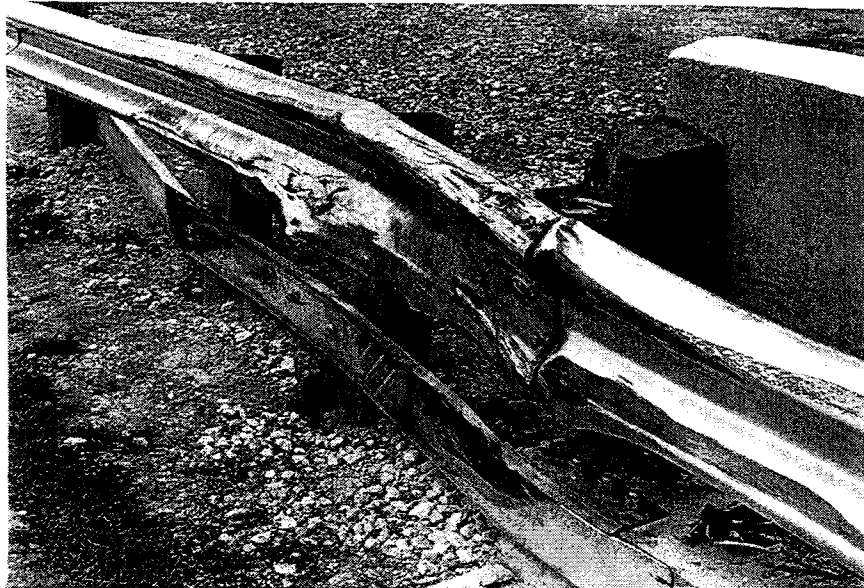
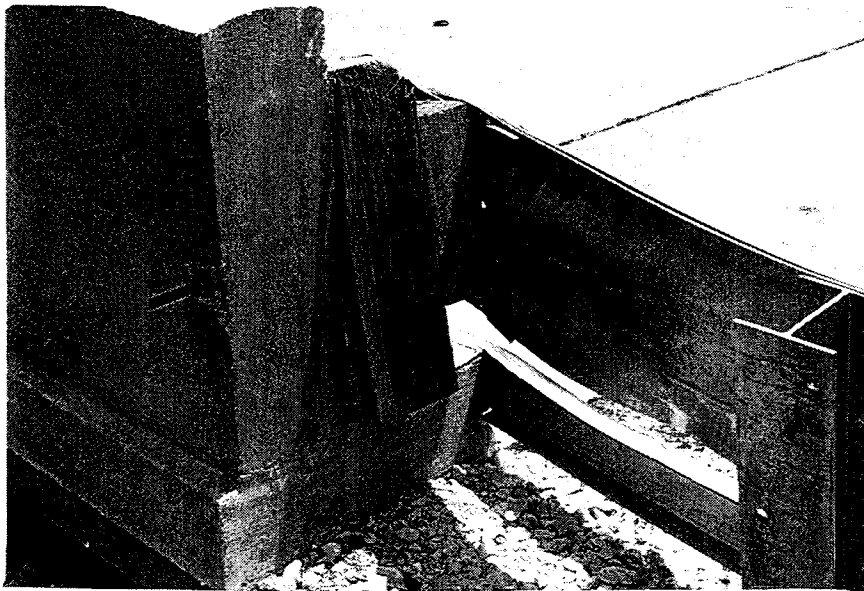
Figure 24. Damage to W-beam and bridge railing end post after test 472070-3.

As can be seen in figures 23 and 24, the installation received moderate damage. The first seven posts from the end of the bridge railing were displaced laterally toward the bridge rail. Maximum permanent deformation was 140 mm (5.5 in) at post 2. The first wood post and blockout on the bridge railing were damaged and the end of the concrete parapet was chipped. The vehicle was in contact with the installation for 3.8 m (12.4 ft).

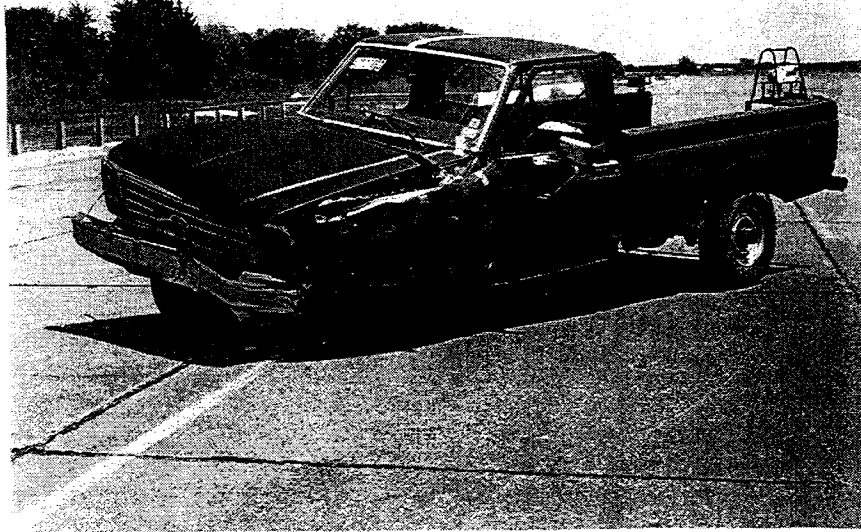
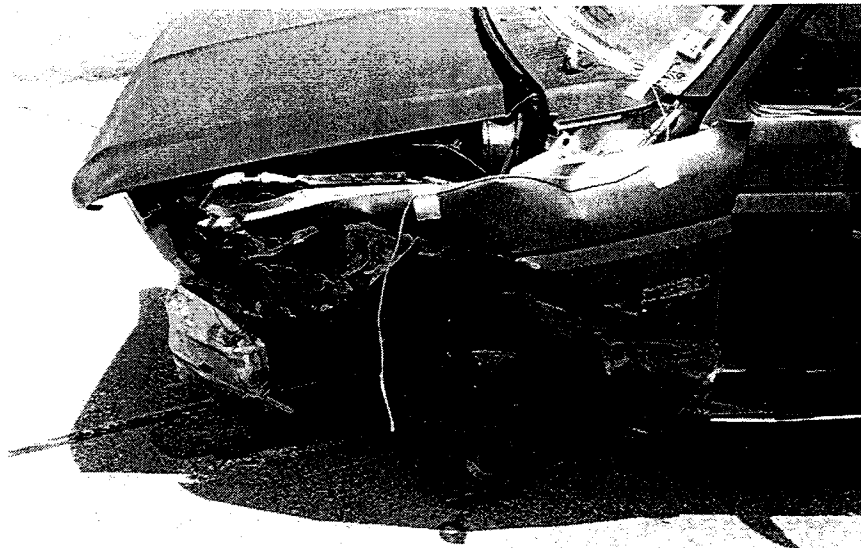
Figure 25. Vehicle after test 472070-3.

The vehicle sustained moderate damage to the front and left side as shown in figure 25. Maximum exterior crush at the right front corner at bumper height of the vehicle was 380 mm (15.0 in), and there was 24 mm (0.9 in) deformation into the occupant compartment at the center of the floorpan area. The left front wheel, caliper, and rotor were pulled off the vehicle as shown in figure 26. The left front frame, tie rod, shock, radius arm, and I-beam were bent. The steering shaft broke at the box to the pitman arm. There was also damage to the front bumper, hood, grill, radiator, left front quarter-panel, door, left rear quarter-panel and left rear wheel rim.

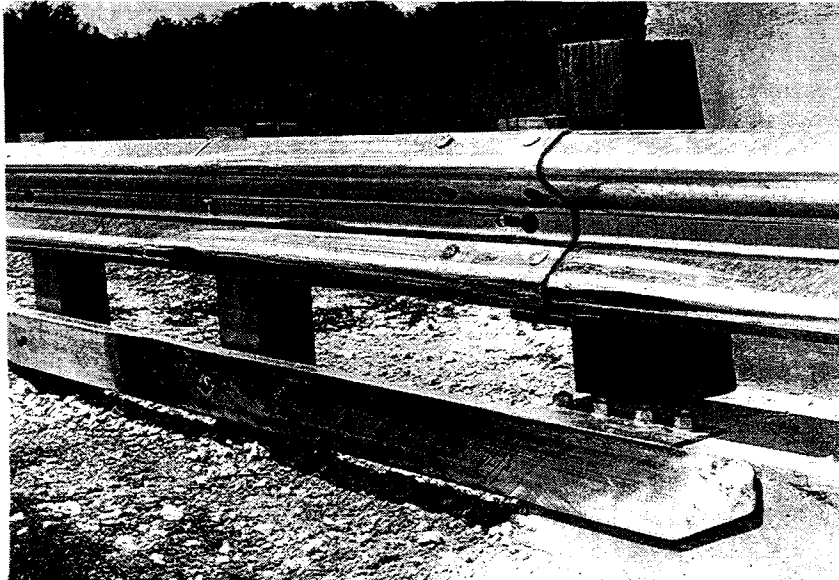
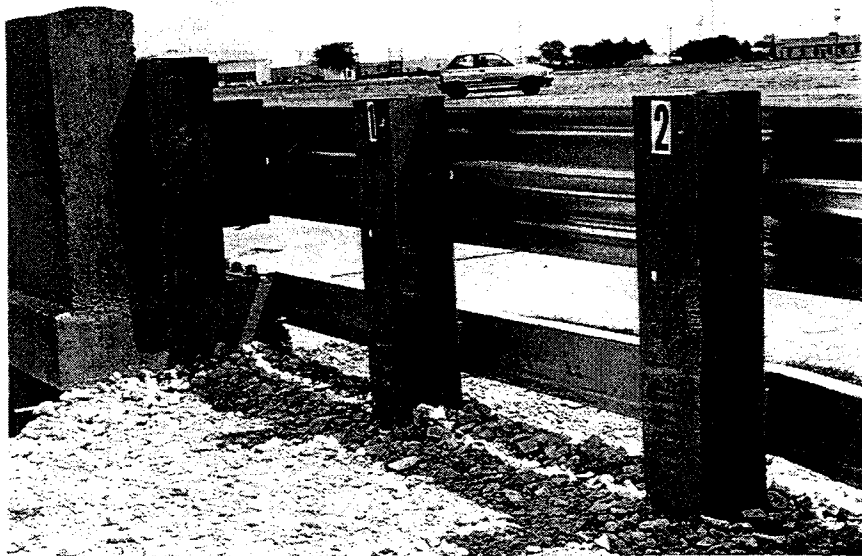
Figure 30. W-beam retrofit after test 472070-4.

As can be seen in figure 30, the installation received minimal damage, which was mostly cosmetic. Maximum permanent deformation of the W-beam was 6.4 mm (0.25 in) at post 1. The vehicle was in contact with the installation for 2.1 m (6.8 ft).

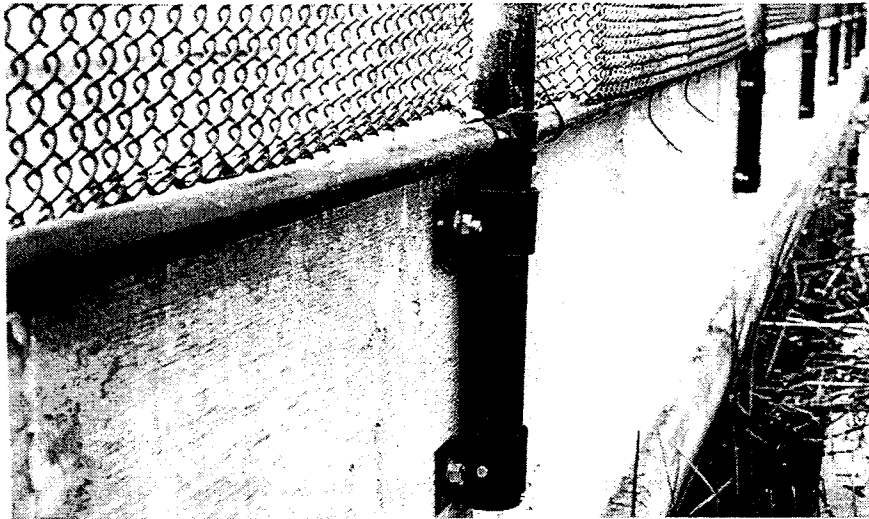
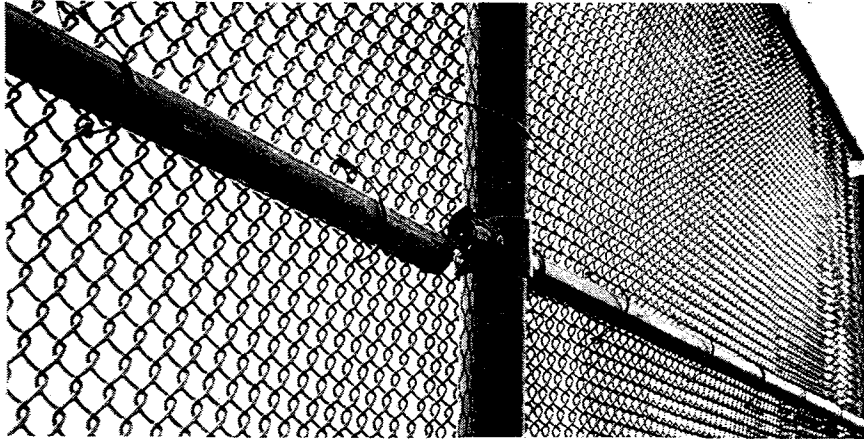
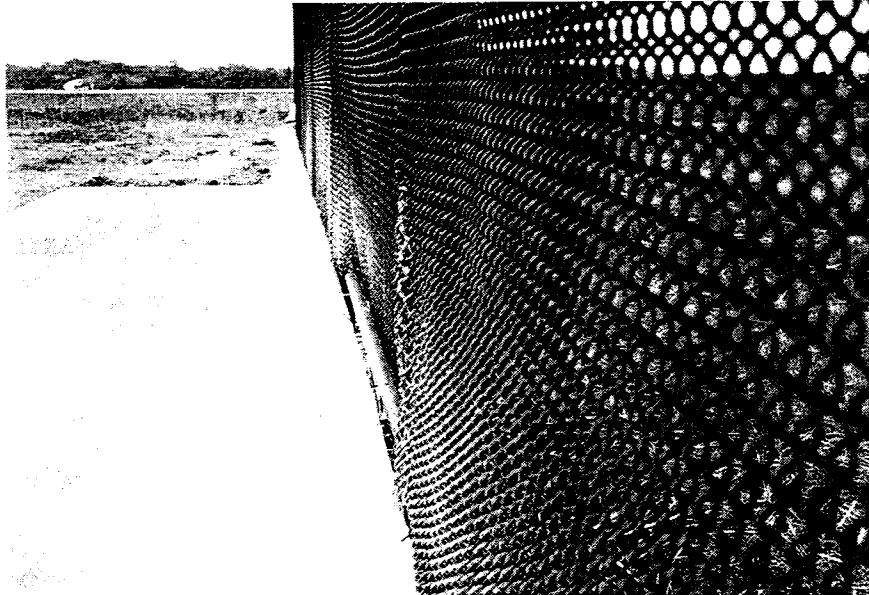
Figure 46. Damage to vandal protection fence after test 472070-6.

As seen in figure 45, the installation received minimal damage. There were tire marks on the face of the safety shape and the lower edge of the wire fabric was pushed behind the lower horizontal line rail between post 5 and 6. The middle horizontal line rail was disconnected on the upstream side at the post 5 location and the post 5 anchor was pushed back 13 mm (0.5 in) as shown in figure 46. Maximum dynamic deflection of the fence was 142 mm (5.6 in) (measured at the top of the rail) and maximum residual deformation was 76 mm (3.0 in). Total length of contact with the installation was 5.2 m (17.0 ft).
