Publication No. FHWA-RD-99-027

**FULL-SCALE CRASH EVALUATION OF THE NETC 4-BAR
SIDEWALK-MOUNTED STEEL BRIDGE RAILING**

7. Author(s) Kimball, C.E., Mayer, J.B.		6. Performing Organization Code	
9. Performing Organization Name and Address Southwest Research Institute 6220 Culebra Road San Antonio, Texas 78238-5166		8. Performing Organization Report No. 18-8518

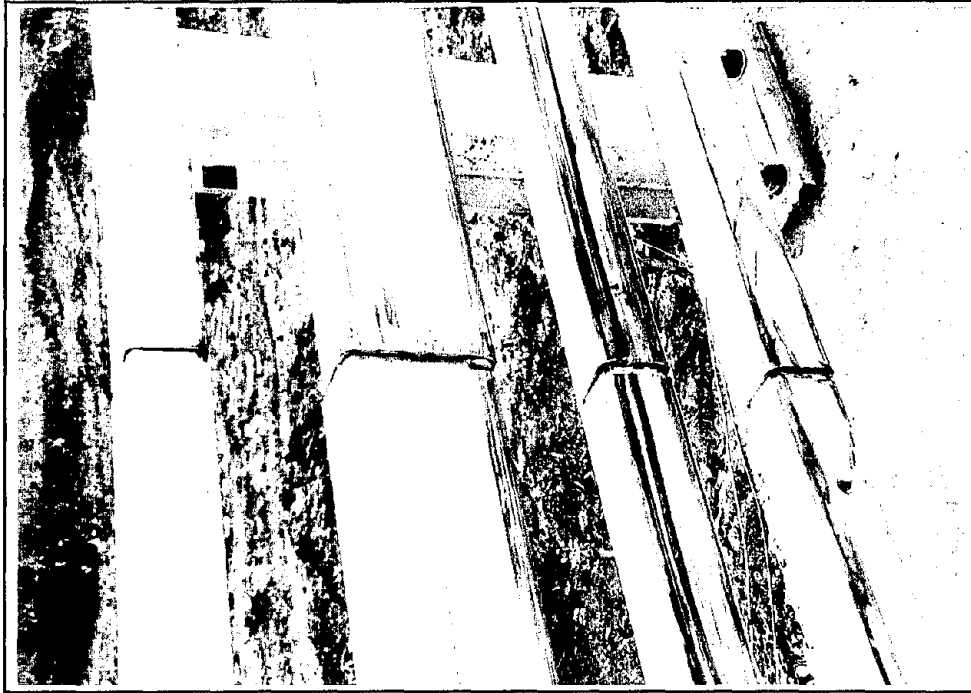
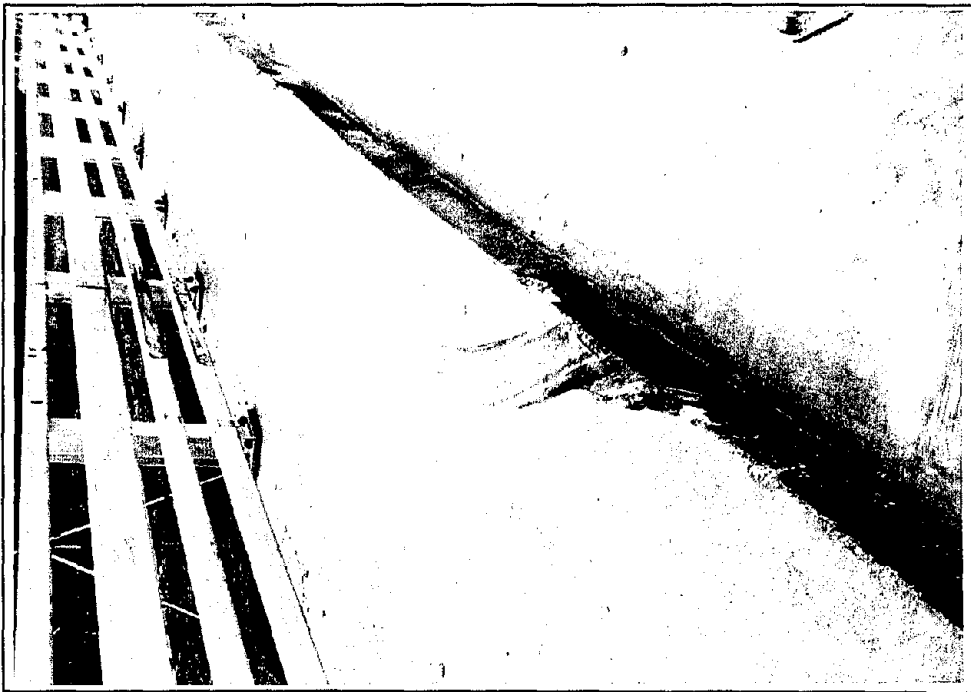
Figure 17. Barrier damage photographs - Test NEIC-1.

Test NETC-1. Damage to the barrier, as shown in figure 17, consisted of scuffing of the longitudinal rails which only required repainting prior to further testing. There was

no measurable dynamic or permanent deflection of the barrier.

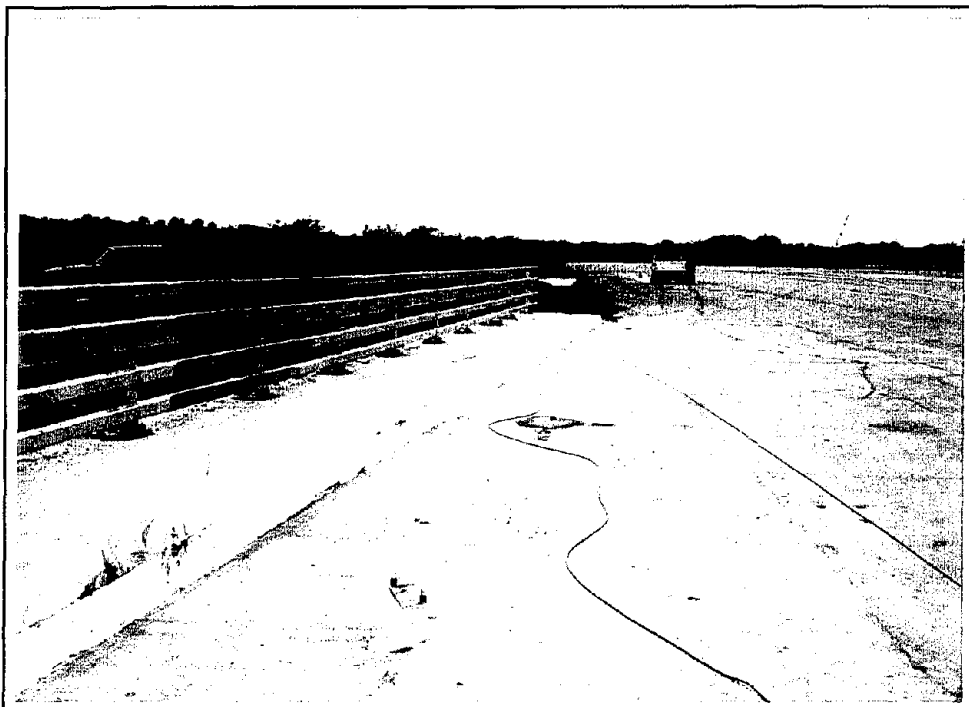
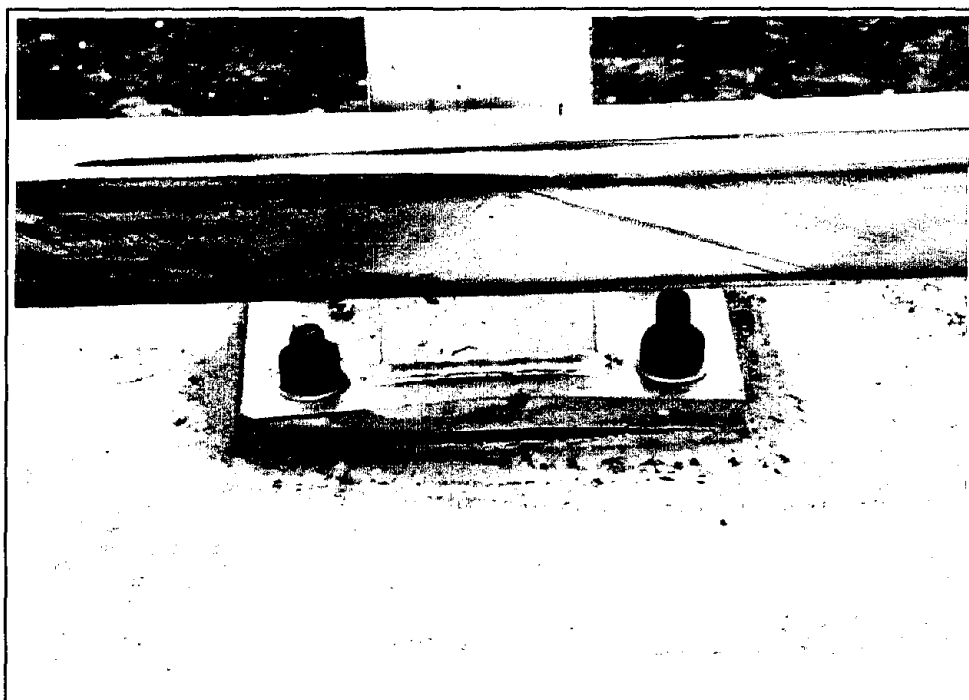
Figure 18. Barrier damage photographs - Test NETC-2.

Test NETC-2. Damage to the barrier, as shown in figure 18, occurred mostly at post 7. The top of post 7 and the top rail section attached to it had 13 mm of permanent deflection, and the baseplate of the post was raised upward at the center approximately 3.5 mm. The remainder of the damage consisted of scuffing of the longitudinal rails which only required repainting prior to further testing. The top rail was straightened, but post 7 required replacement prior to subsequent testing.

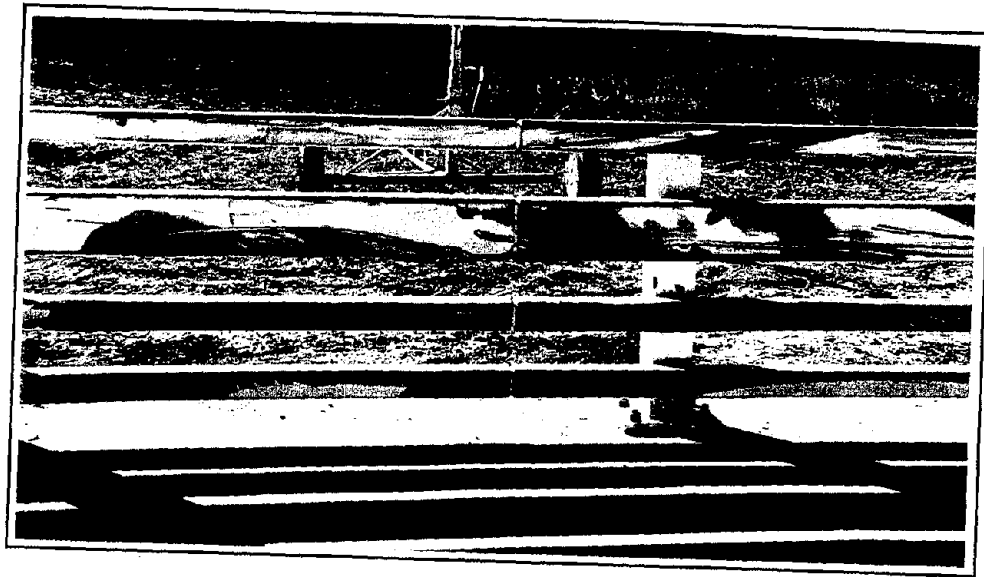
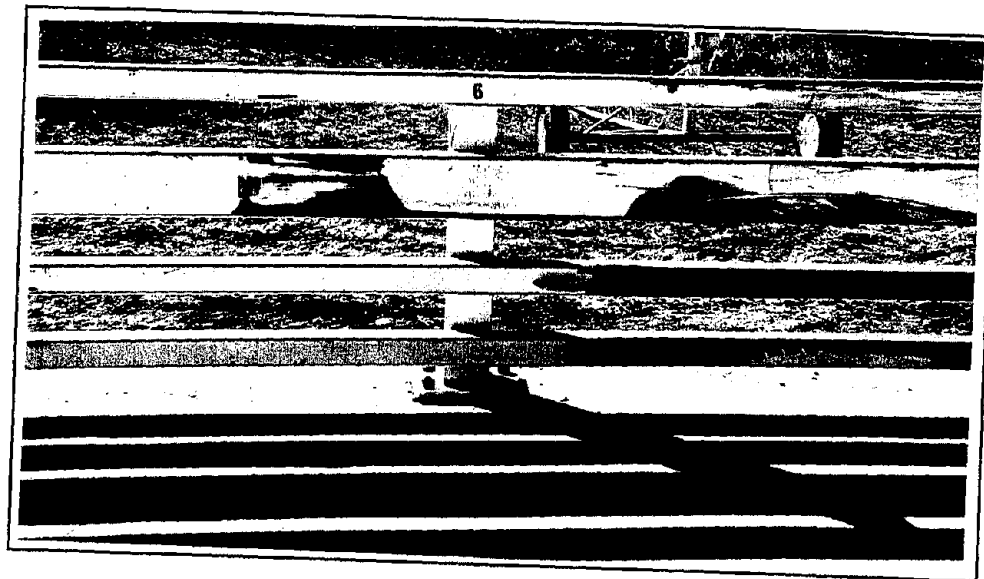
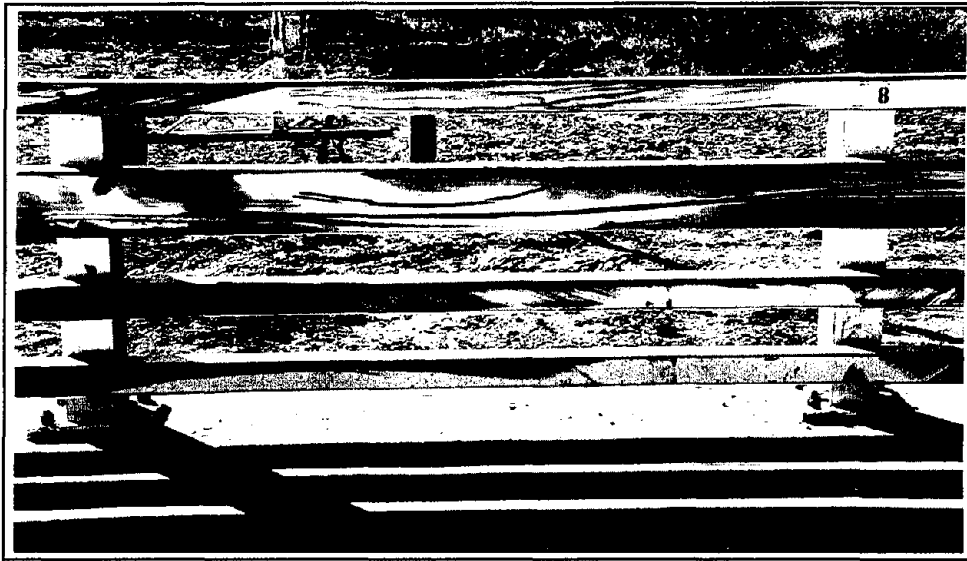
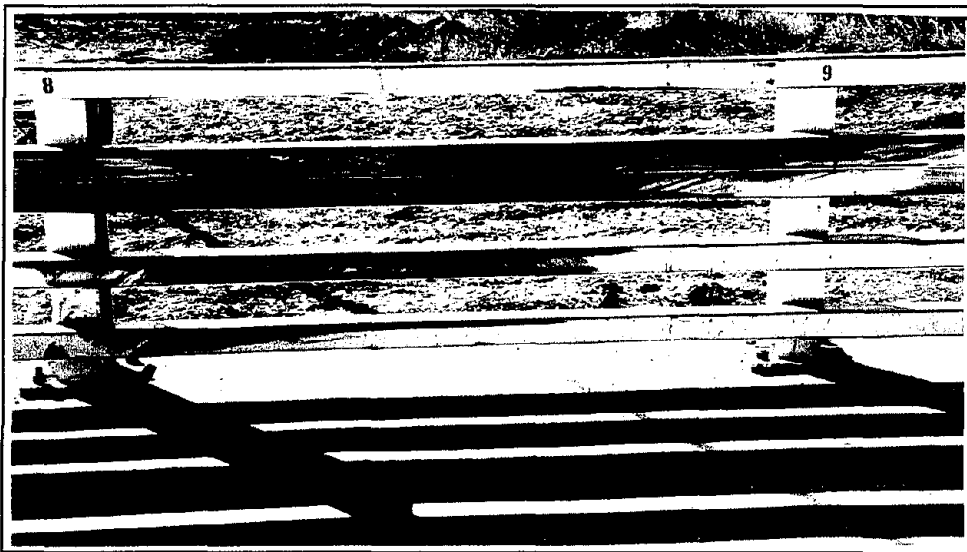
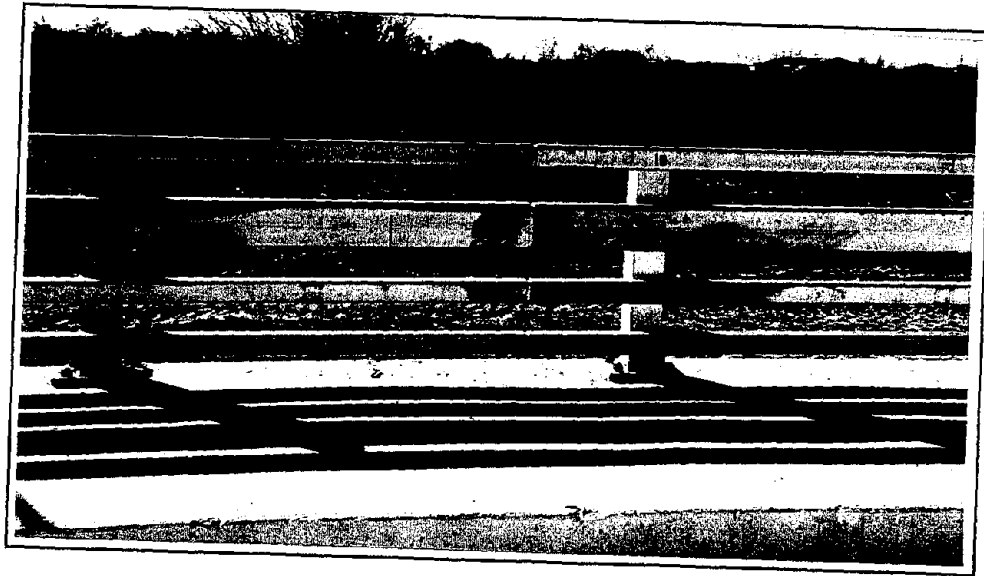
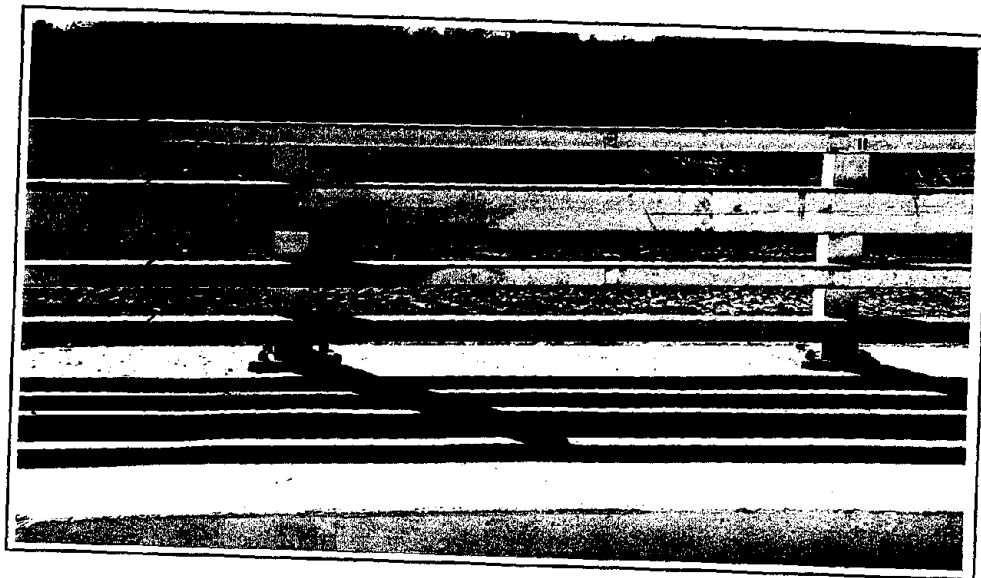
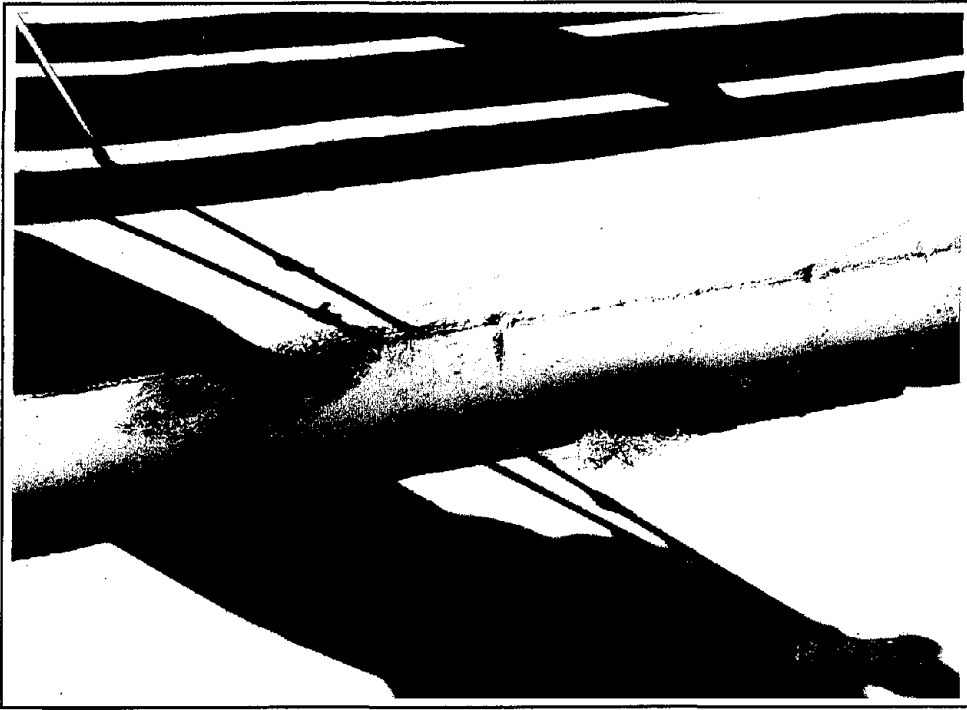
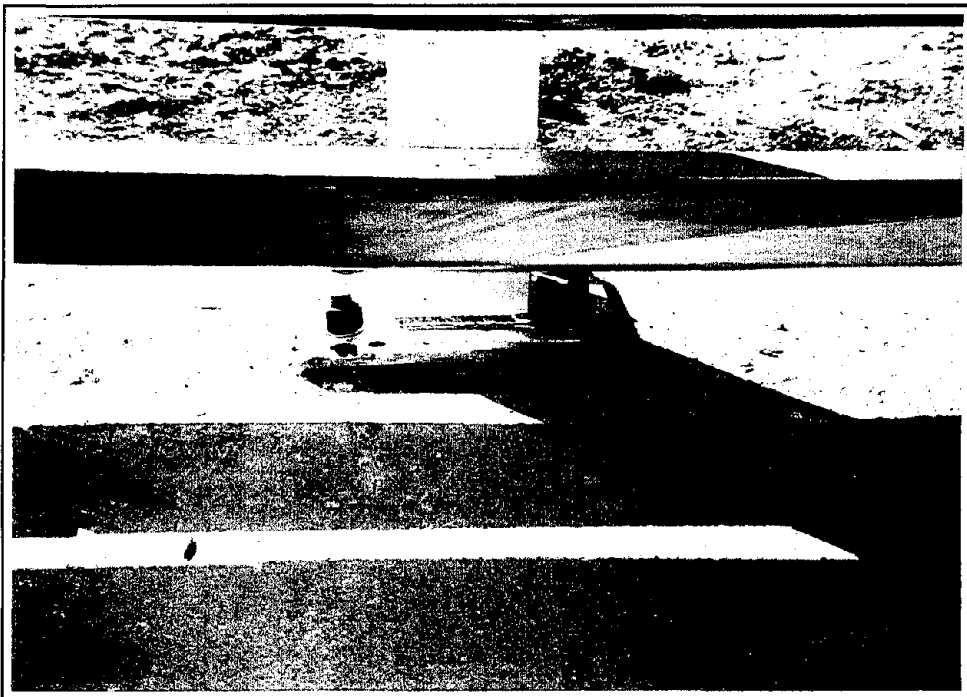
Figure 19. Barrier damage photographs - Test NETC-3.

Test NETC-3. Barrier damage is shown in figure 19. Maximum permanent rail deflection occurred at the splice upstream of post 7 and was measured as 13 mm. Two sections of the top rail had permanent deflection (deflection occurred between posts 6 and 7), and posts 6 and 7 were tilted back; the base plates of both posts were raised upward at the center approximately 3.5 mm. The remainder of the damage consisted of scuffing of all longitudinal rails between posts 6 and 11.

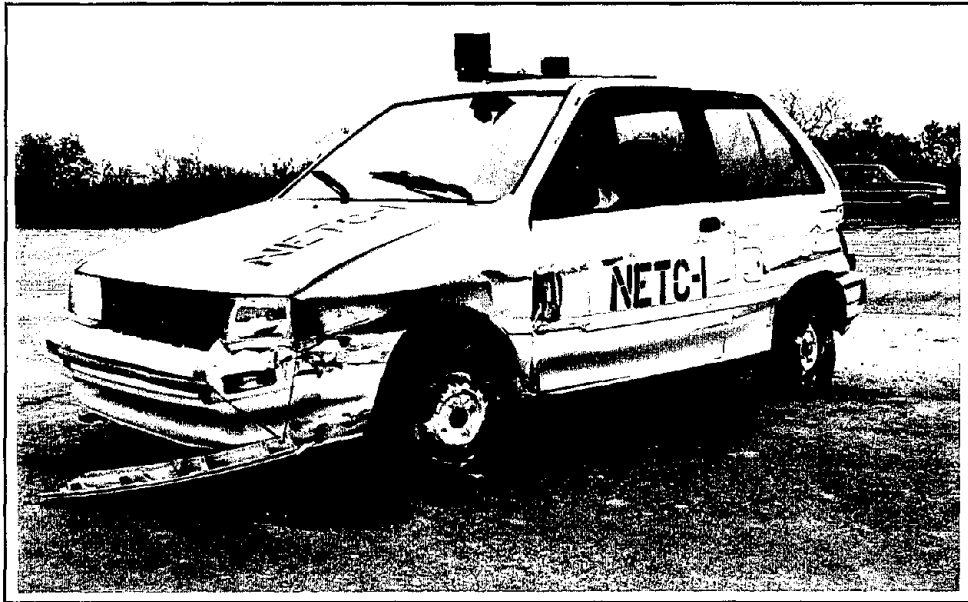
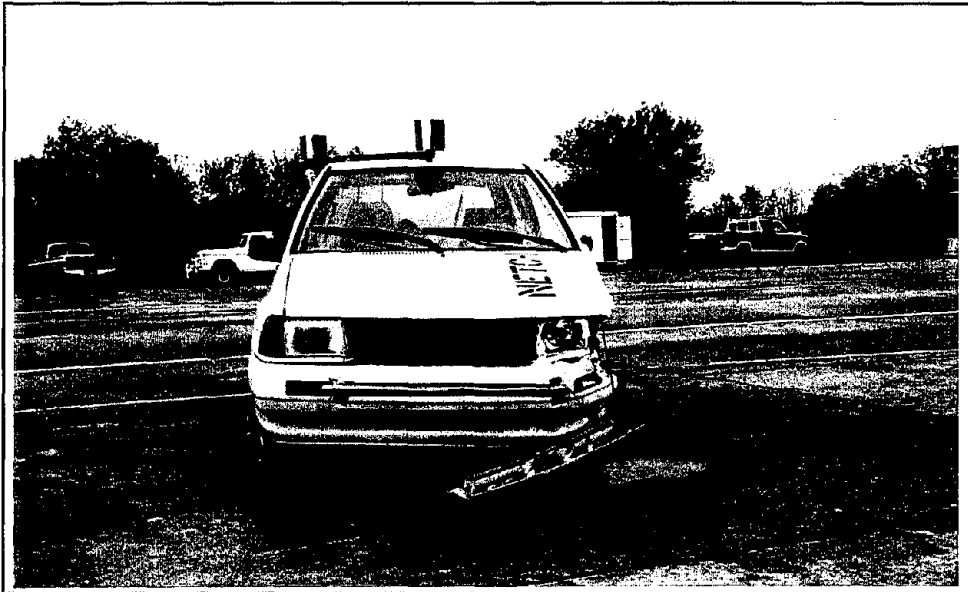
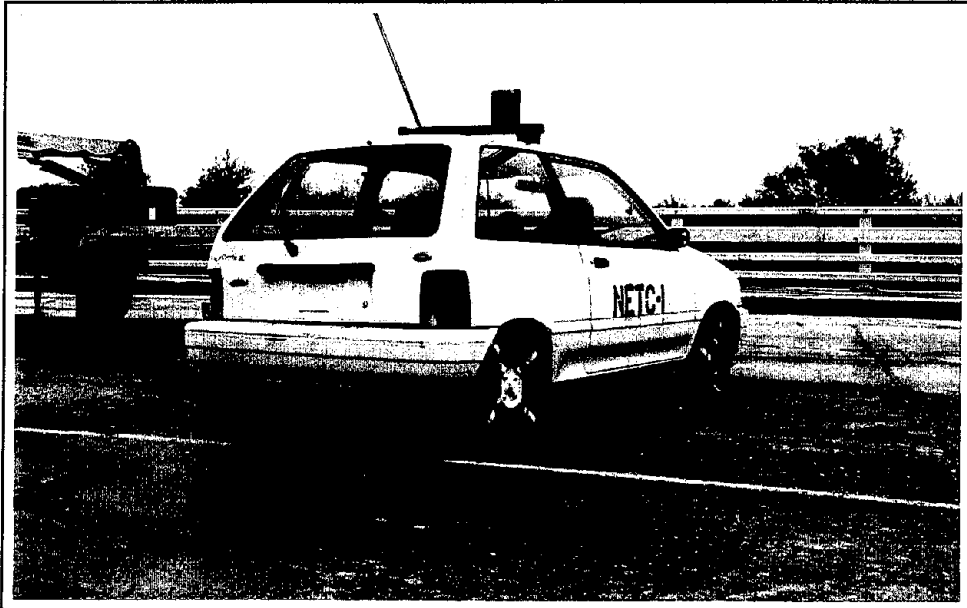
Figure 20. Vehicle damage photographs - Test NETC-1.

Test NETC-1. As shown in figure 20, the test vehicle sustained damage to the left front fender and along the left side, as well as damage to headlight/grill area. The left side of the front bumper was deformed rearward, and the left front suspension/wheel/tire displaced rearward. All tires except the right rear were either blown out or deflated as a result of the impact. The exterior vehicle damage scale was estimated to be 11-FL-2 using the VDS system and 11FLEE2 using the CDC system. The interior deformation of the occupant compartment was LF0000000 using the OCDI system. There was no deformation or intrusion into the occupant compartment.

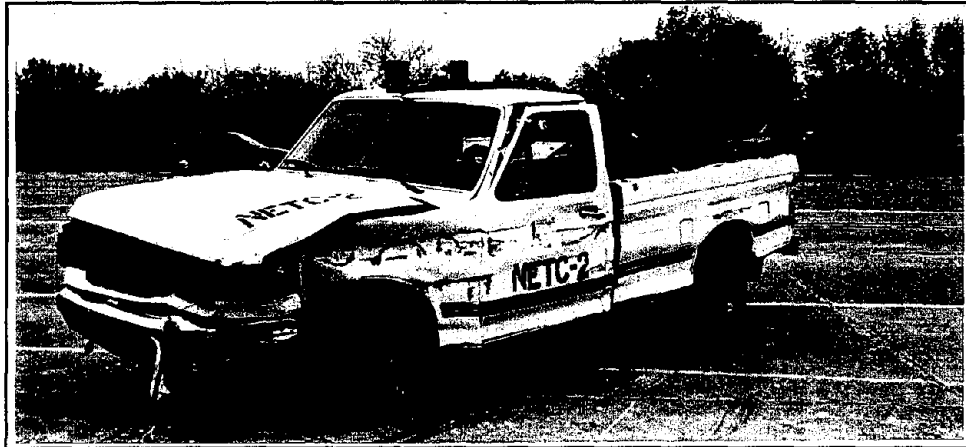
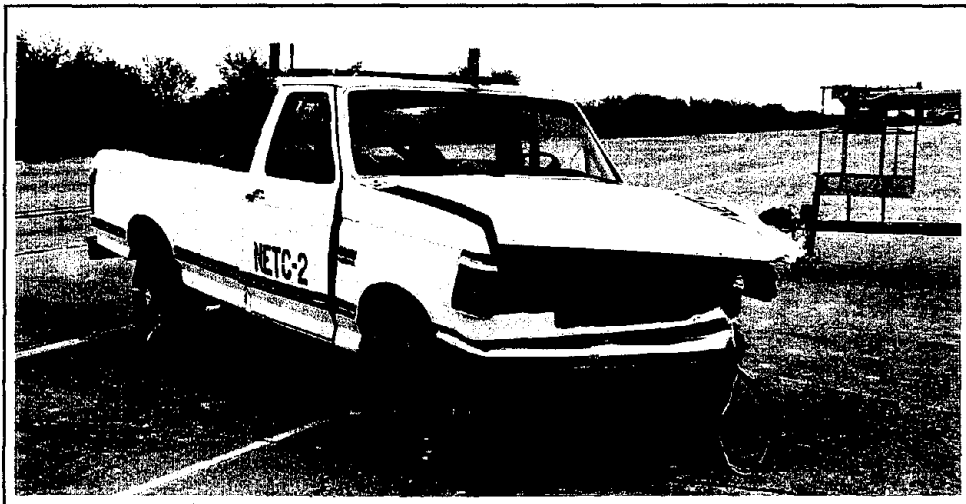
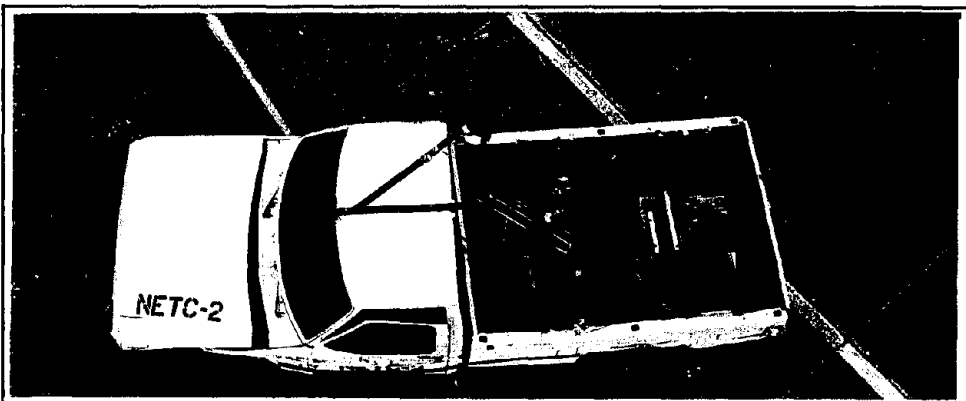
Figure 21. Vehicle damage photographs - Test NETC-2.

Test NETC-2. Figure 21 shows that the test vehicle sustained extensive damage to the left front fender and along the left side, as well as damage to the headlight/grille area. The left side of the front bumper was deformed rearward, and the left front suspension/wheel/tire displaced rearward. Contact with the edge of the sidewalk damaged the right front suspension also. All tires except the right rear were either blown out or deflated as a result of the impact. The exterior vehicle damage scale was estimated to be 11-FL-3 using the VDS system and 11FLEE3 using the CDC system. The interior deformation of the occupant compartment was LF000000 using the OCDI system. There was no deformation or intrusion into the occupant compartment.

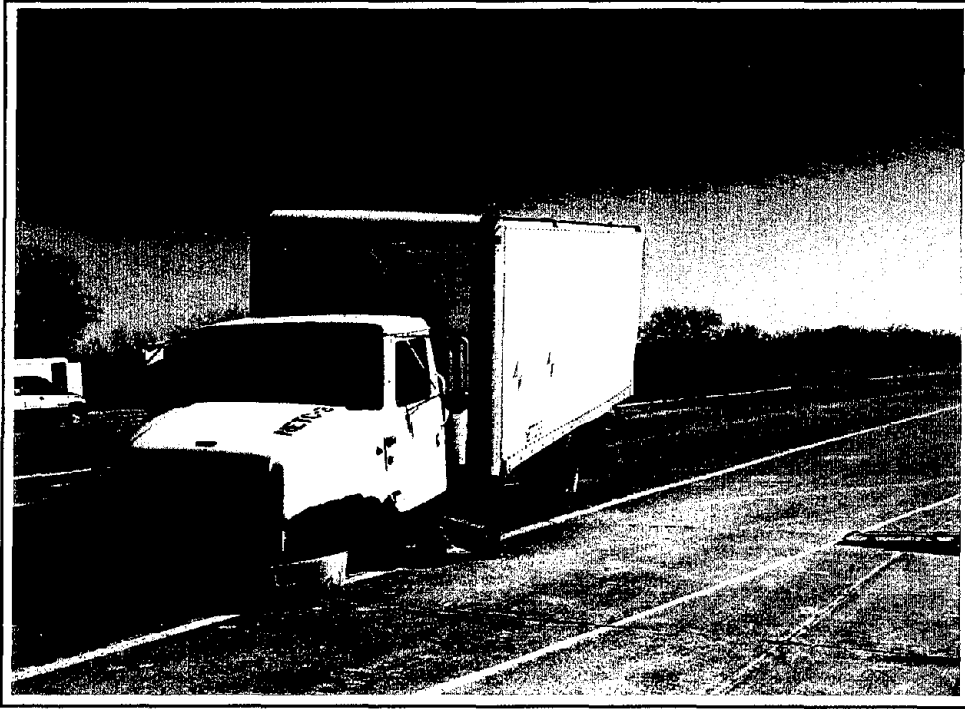
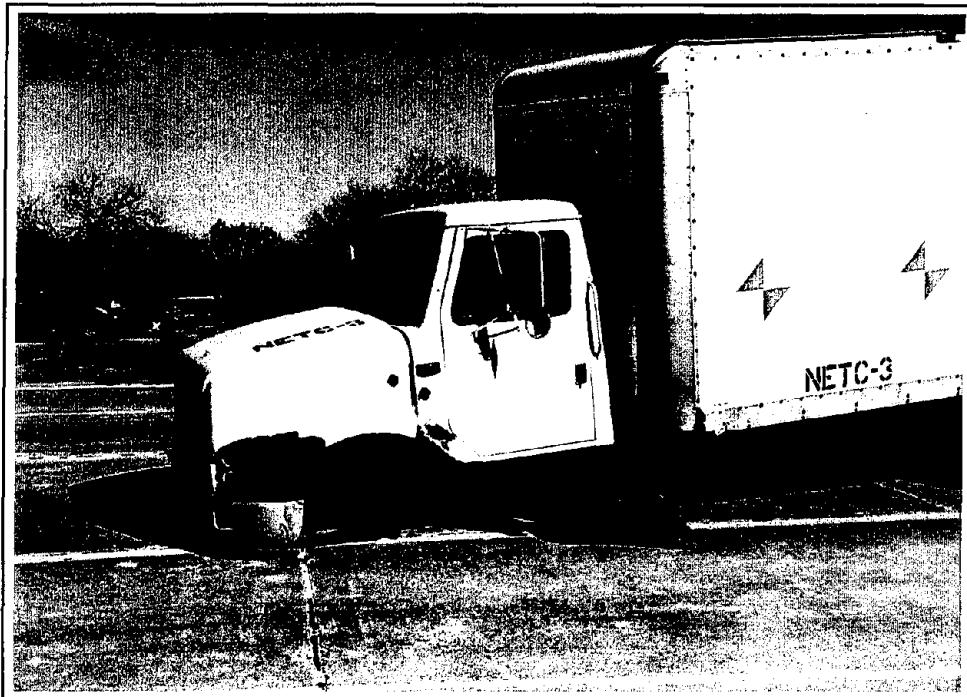
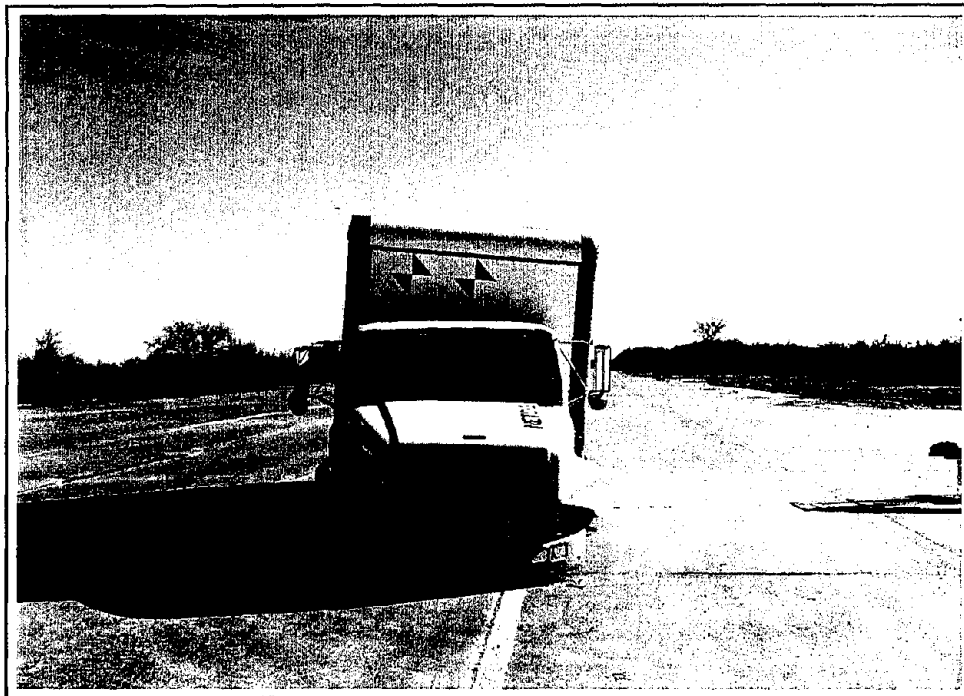
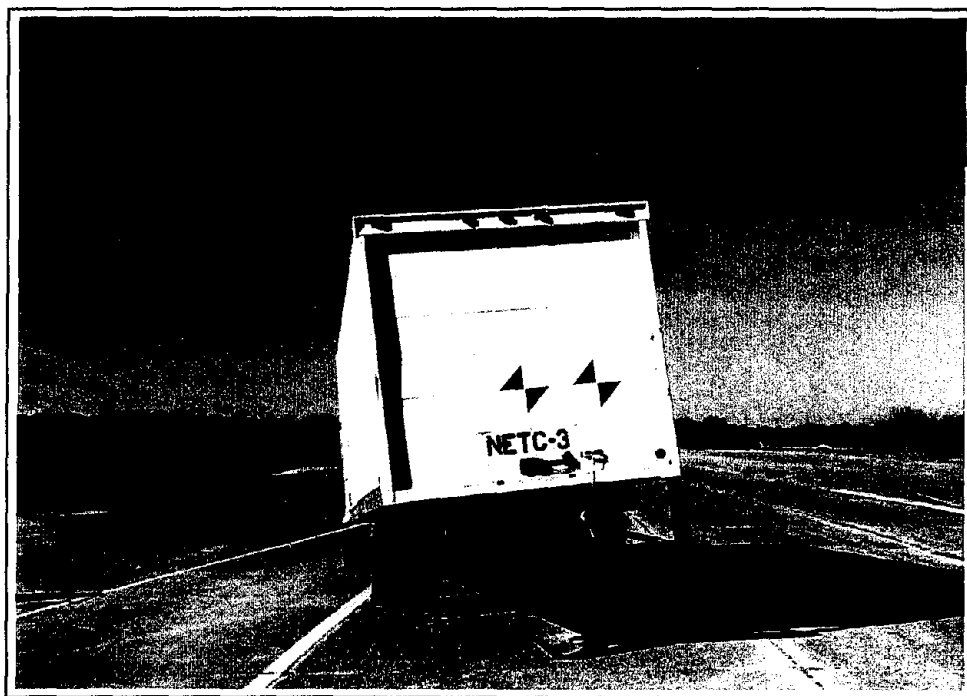
Figure 22. Vehicle damage photographs - Test NETC-3.

Test NETC-3. The test vehicle, as shown in figure 22, sustained extensive damage. As described previously, the entire front axle (axle/brakes/wheels/tires, etc.) was dislodged by the impact and later separated during vehicle run out. In addition, the left corner of the front bumper was deflected rearward, a portion of the left front fender was torn away (the vehicle had a one-piece, fiberglass front clip), the left step under the driver's door was torn away, the left rear, outside wheel was damaged, the cargo box was racked toward the left side, and the anti-underride assembly was fractured at the left rear corner. Since the exterior damage scales, i.e., the VDS system and the CDC system, are not applicable to this class of test vehicle, no assessment of that type was made. The OCDI system is also not applicable; however, there was no deformation or intrusion into the occupant compartment.
