FINAL REPORT ~ FHWA-OK-17-03

OVERTURNING FORCES AT BRIDGE ABUTMENTS AND THE INTERACTION OF HORIZONTAL FORCES FROM ADJACENT ROADWAYS

January 2018

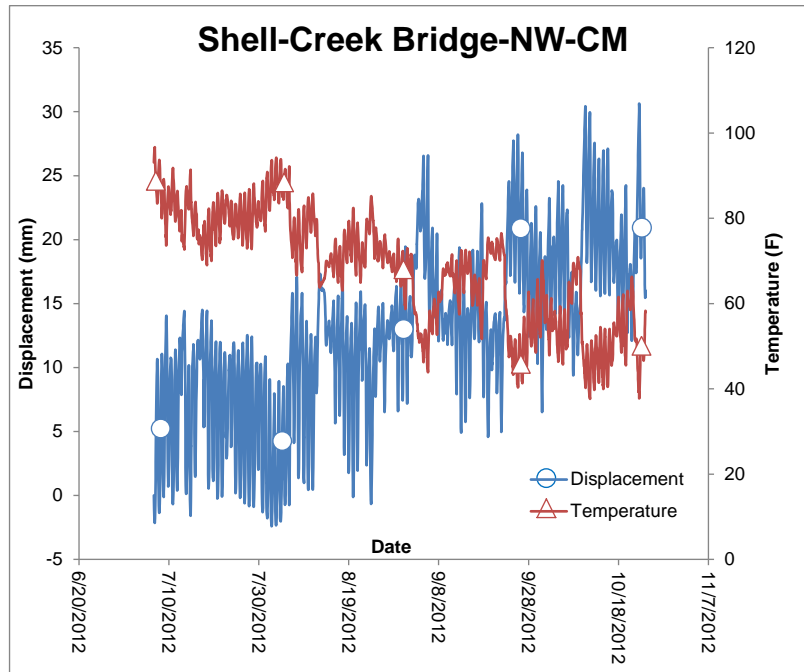
Figure 20. US 64 over Shell Creek Bridge – Northwest Crackmeter data (NW_CM)

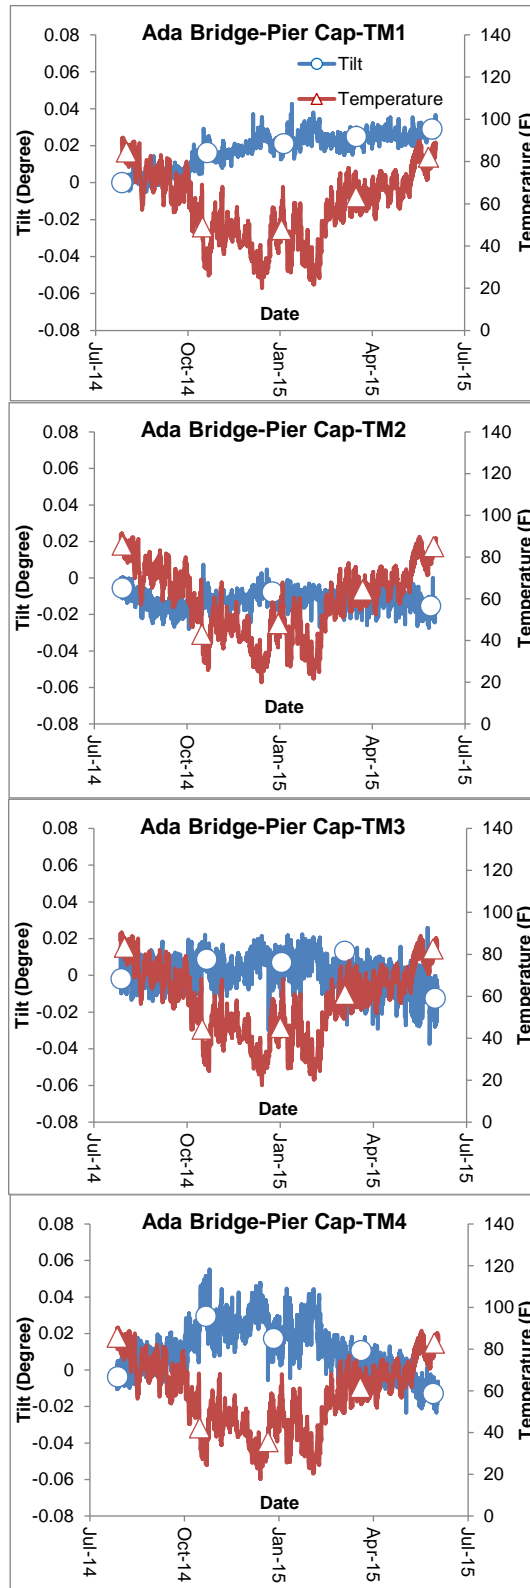
Figure 64. SH-3 north bridge over BNSF railroad – pier cap tiltmeter TM1-4 data before repairs

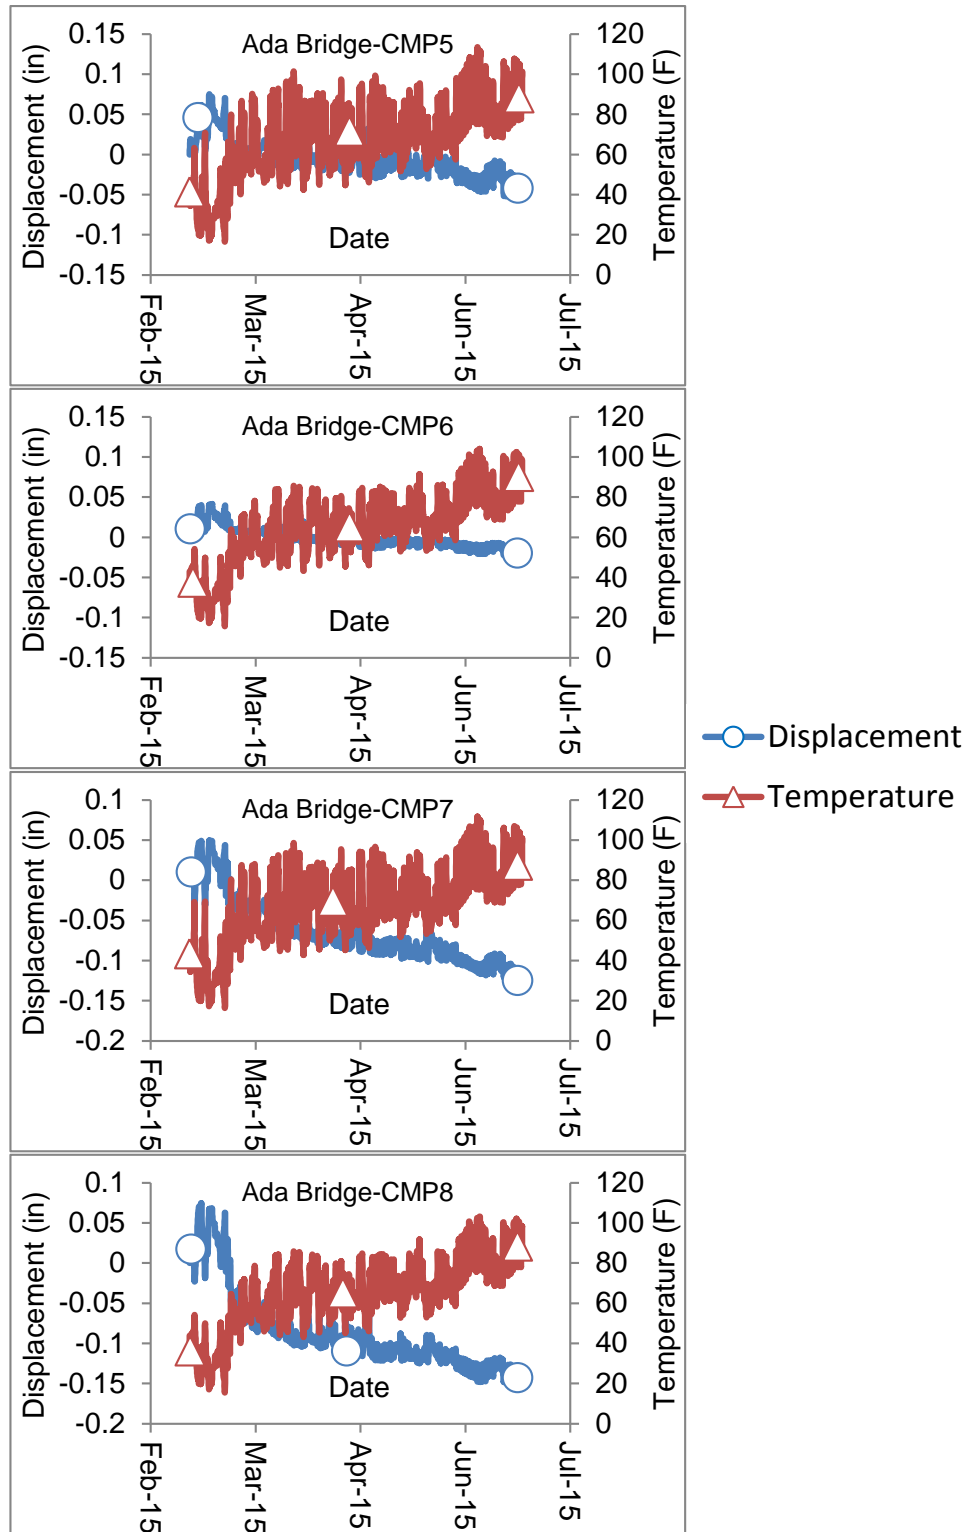
Expansion joint movements along with temperature variations for the western and eastern sections of the north bridge are shown in Figures 66 and 67, respectively. Based on the recorded data during the monitoring period, temperature varied between 15° F and 105° F. Measured displacements during this period were between 0.06"-0.23". However, the estimated displacement was 0.51" indicating that most of the expansion joints were practically locked before the repairs.

Figure 67. Expansion joints of SH-3 north bridge over BNSF railroad - CMP5-8 crackmeter data before repairs
