1. Report No. FHWA/TX-01/1458-3	2. Government Accession No.	3. Recipient's Catalog No.	
4. Title and Subtitle TESTING AND EVALUATION OF RECYCLED MATERIALS IN ROADSIDE SAFETY DEVICES		5. Report Date October 2000 Resubmitted: April 2001

# **TESTING AND EVALUATION OF RECYCLED MATERIALS IN ROADSIDE SAFETY DEVICES**

Report 1458-3  
Project Number 0-1458  
Research Project Title: Recycled Materials in Roadside Safety Devices

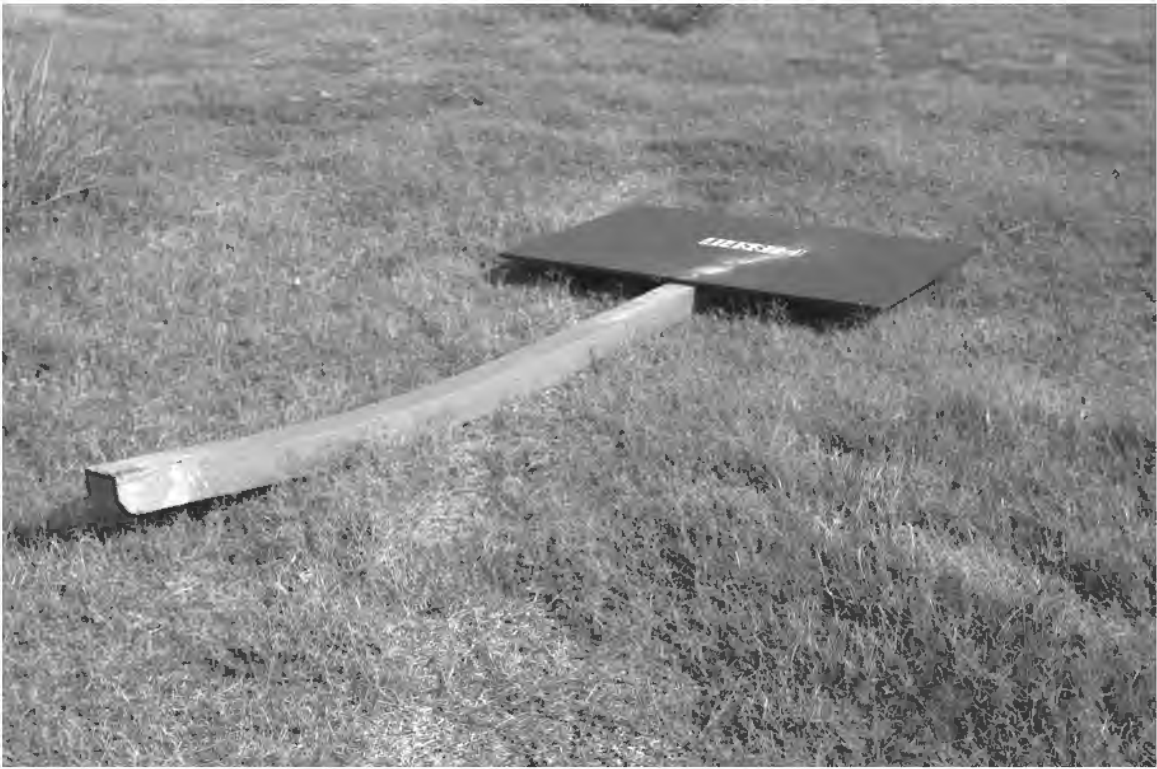
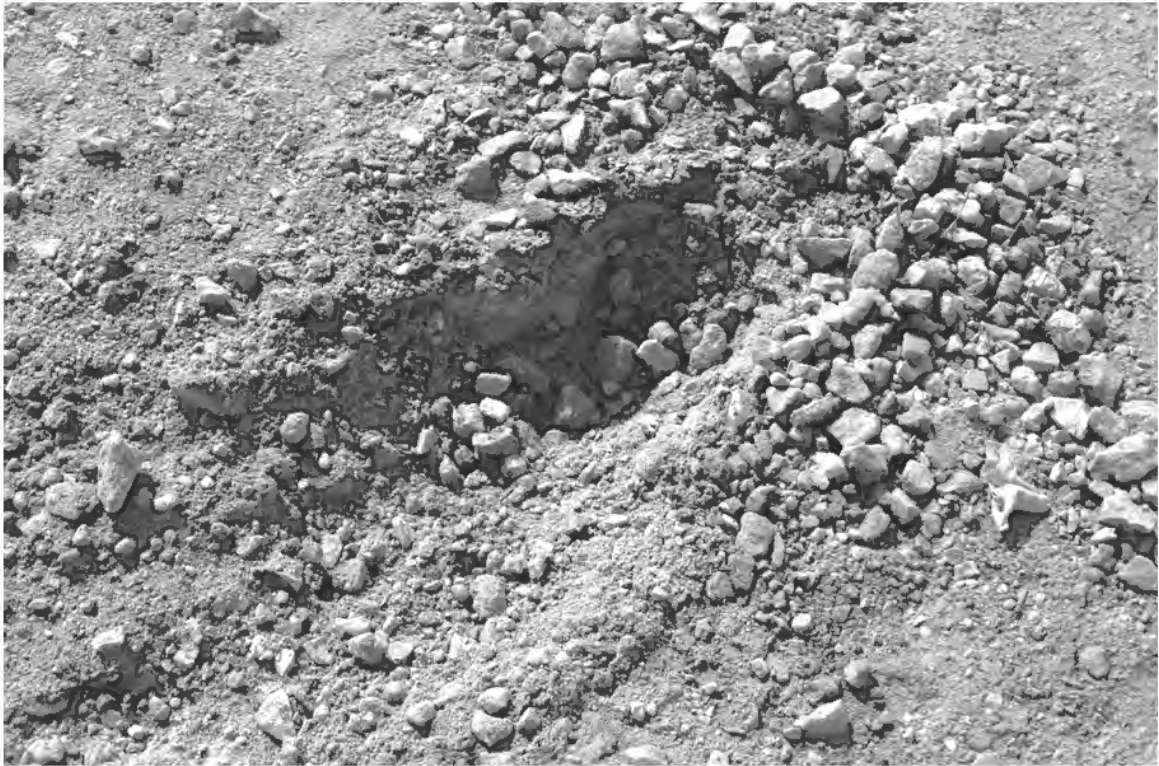
**Figure 8. Support After Test 414587-1.**

The sign support fractured 203 mm below ground level. The support and sign were dragged under the vehicle until the vehicle came to a stop. The sign support was not reusable. Damage to the sign installation is shown in [figures 7 and 8](#).

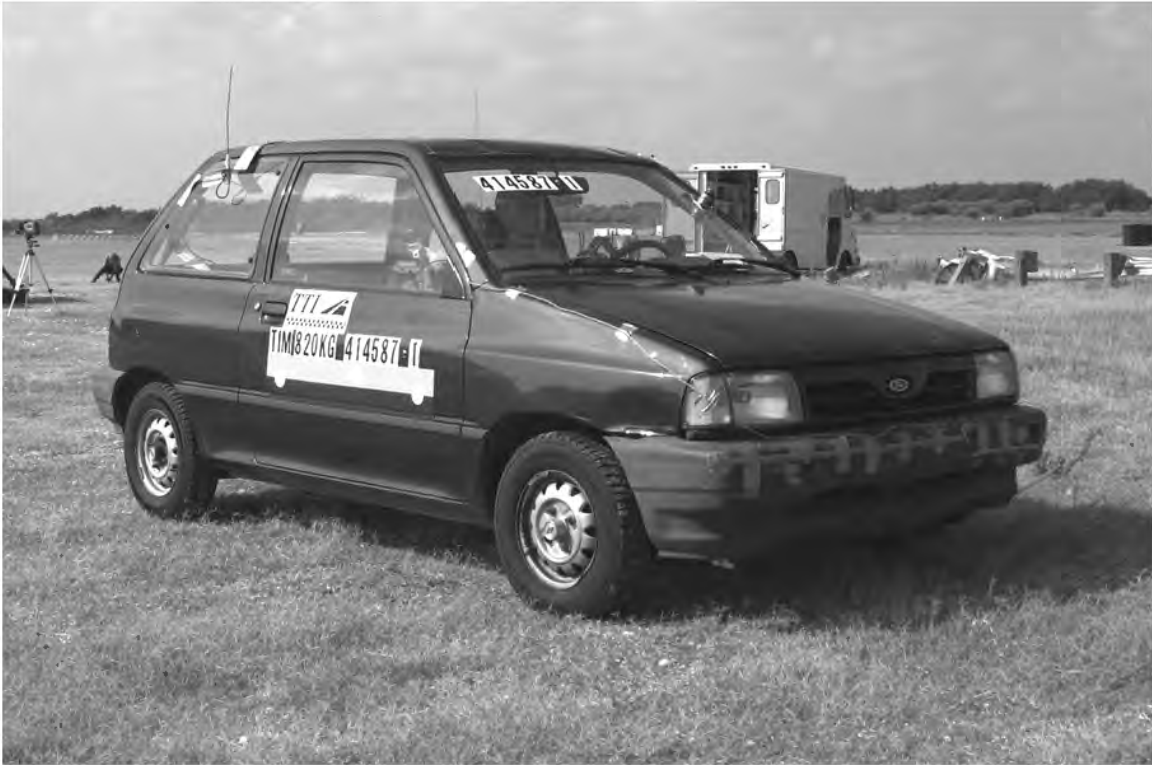
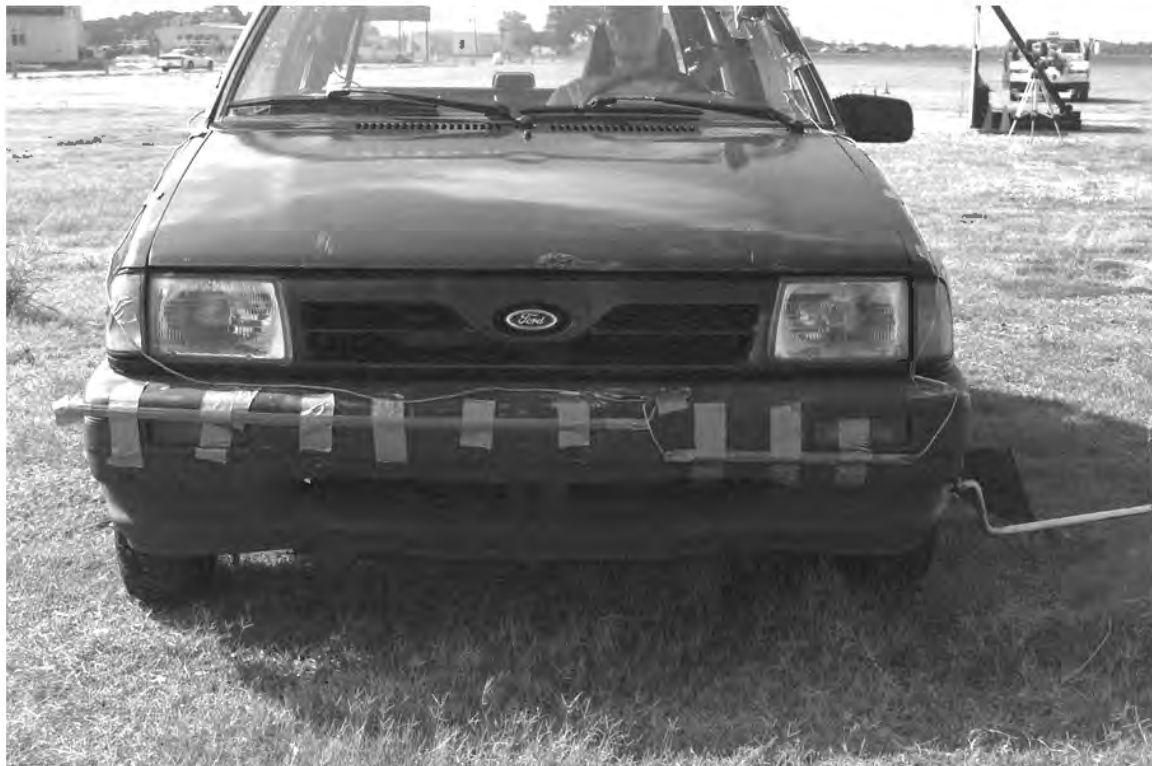
**Figure 9. Vehicle After Test 414587-1.**

As seen in [figure 9](#), no damage was sustained by the vehicle from its contact with the support. There was no measurable exterior crush, and no deformation or intrusion into the occupant compartment. Subsequent tests re-used the vehicle.

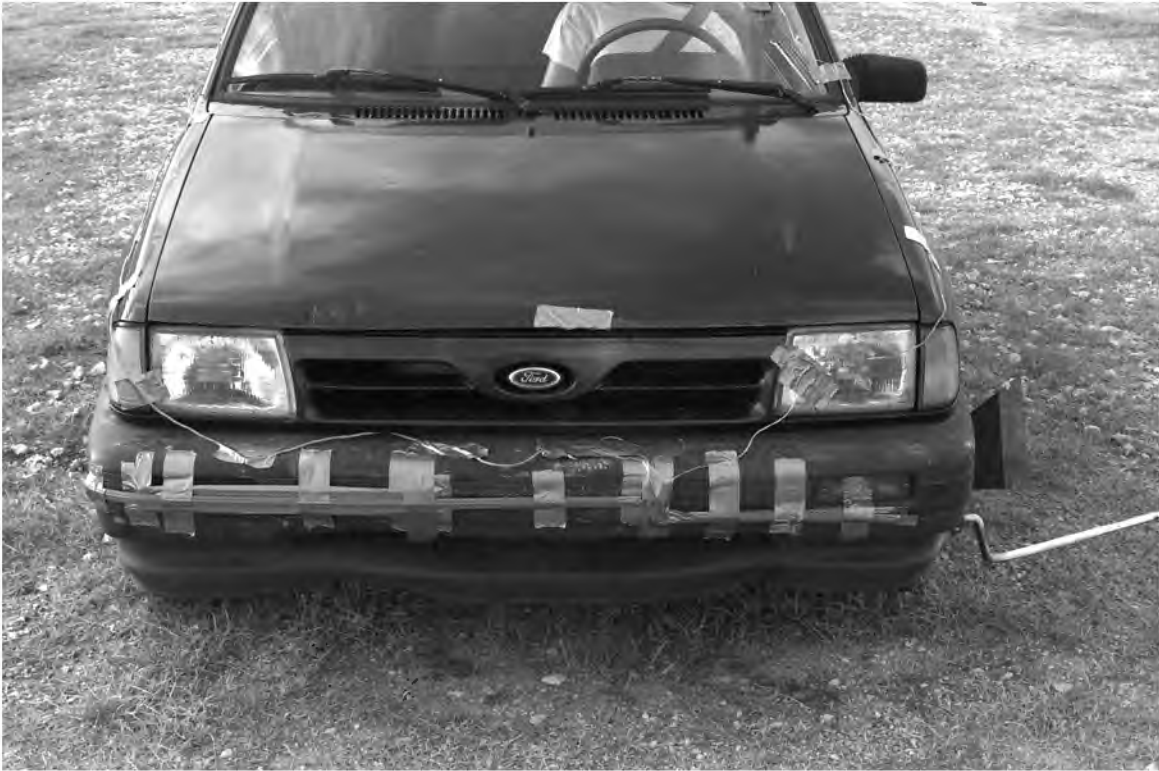
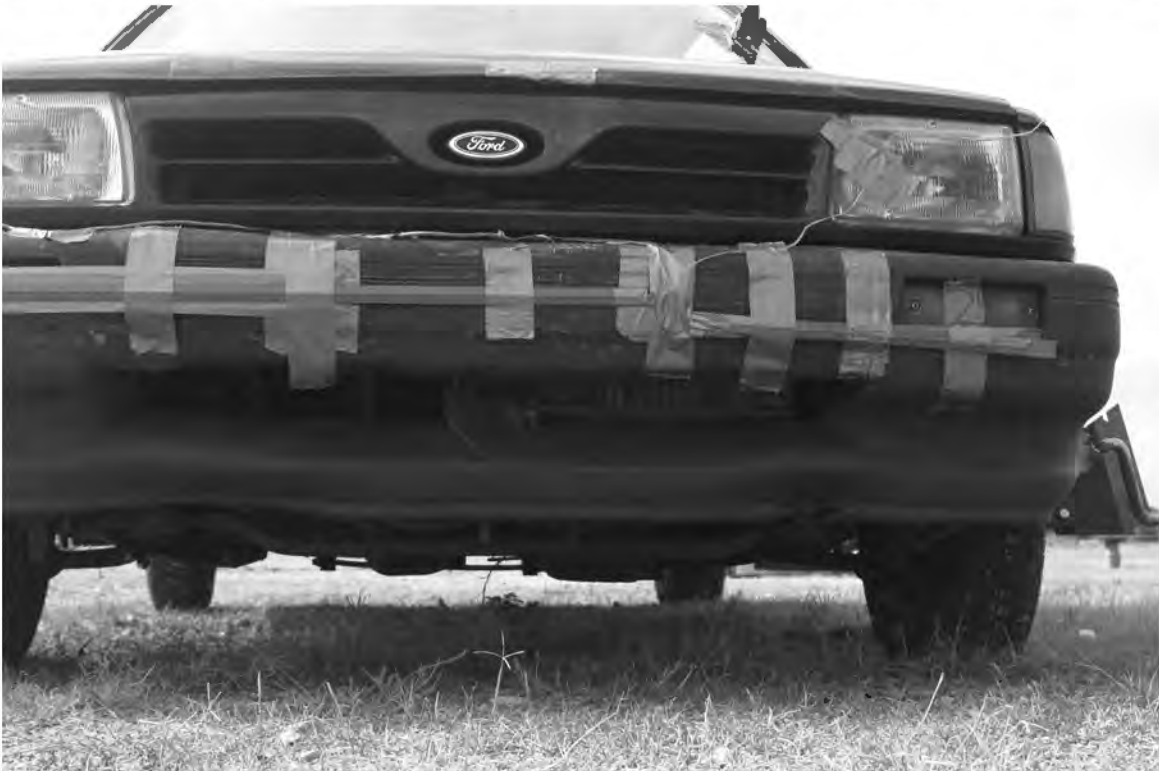
**Figure 23. Vehicle After Test 414587-3.**

Damage received by the vehicle was minor, as shown in [figure 23](#). The left front bumper showed no damage from contact with the support. A dent was noted on the lower left air deflector. No deformation or intrusion into the occupant compartment occurred. The vehicle was re-used in the next test.

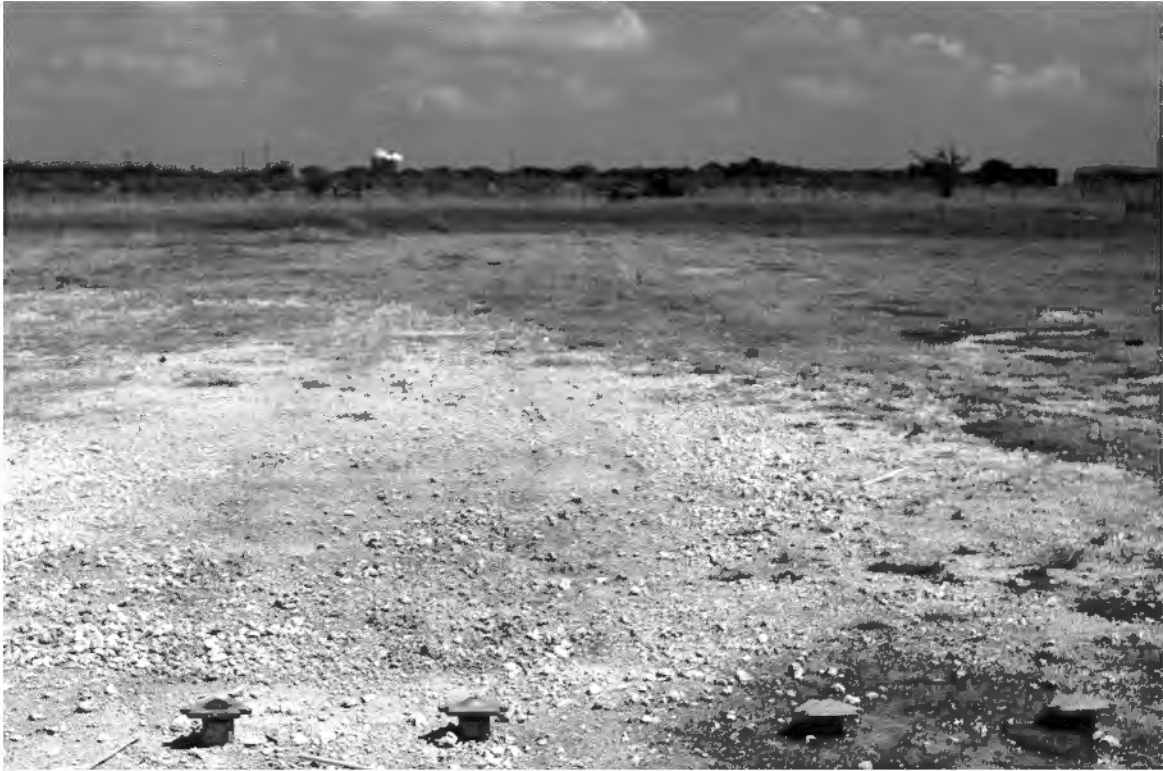
**Figure 28. After Impact Trajectory for Test 414587-4**

As can be seen in figures 28 and 29, the support pulled out of the ground without fracturing. The support was deformed from ground level to just above bumper height. The sign panel was split and separated from the support.

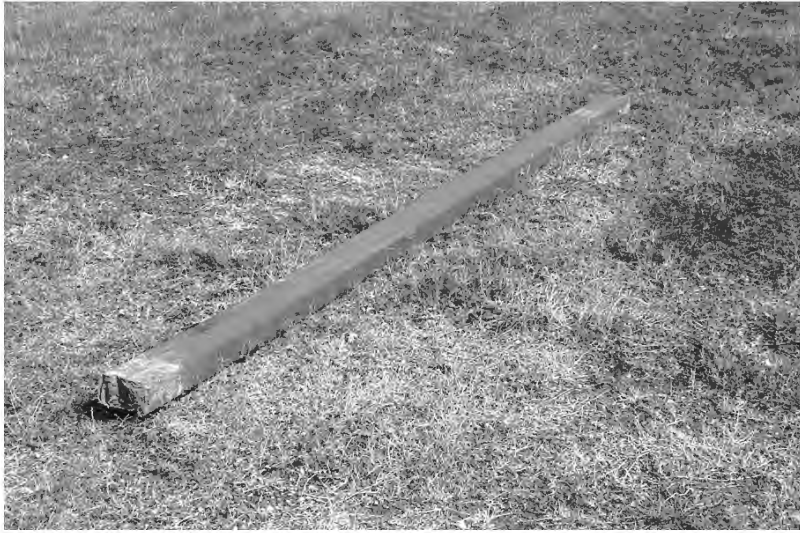
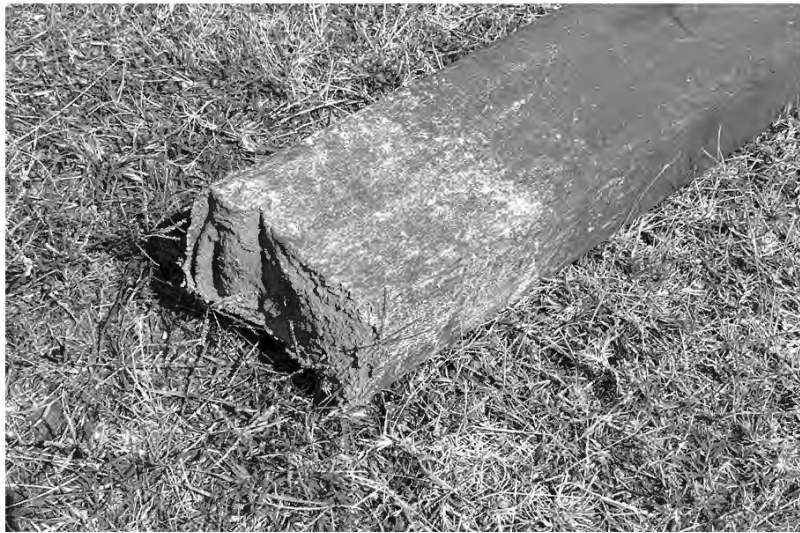
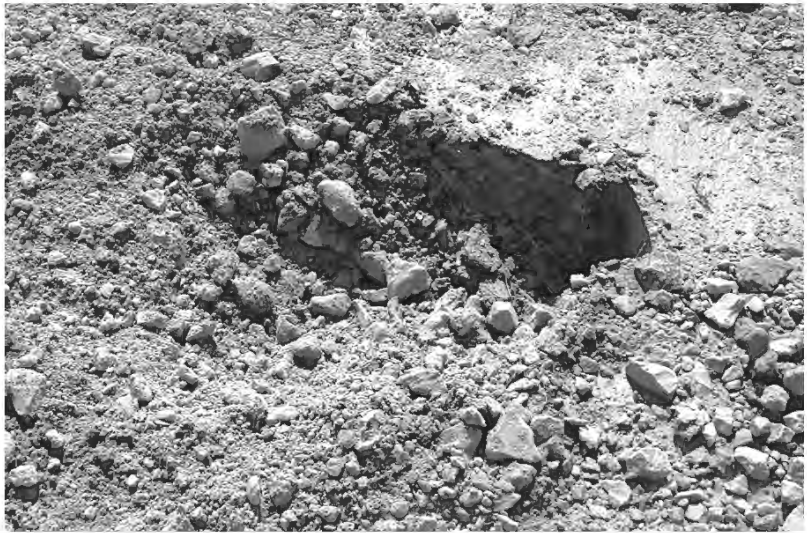
**Figure 36. Support After Test 414588-2.**

As can be seen in figures 35 and 36, the support fractured just below ground level leaving 788 mm below the ground. The sign panel was separated from the support.

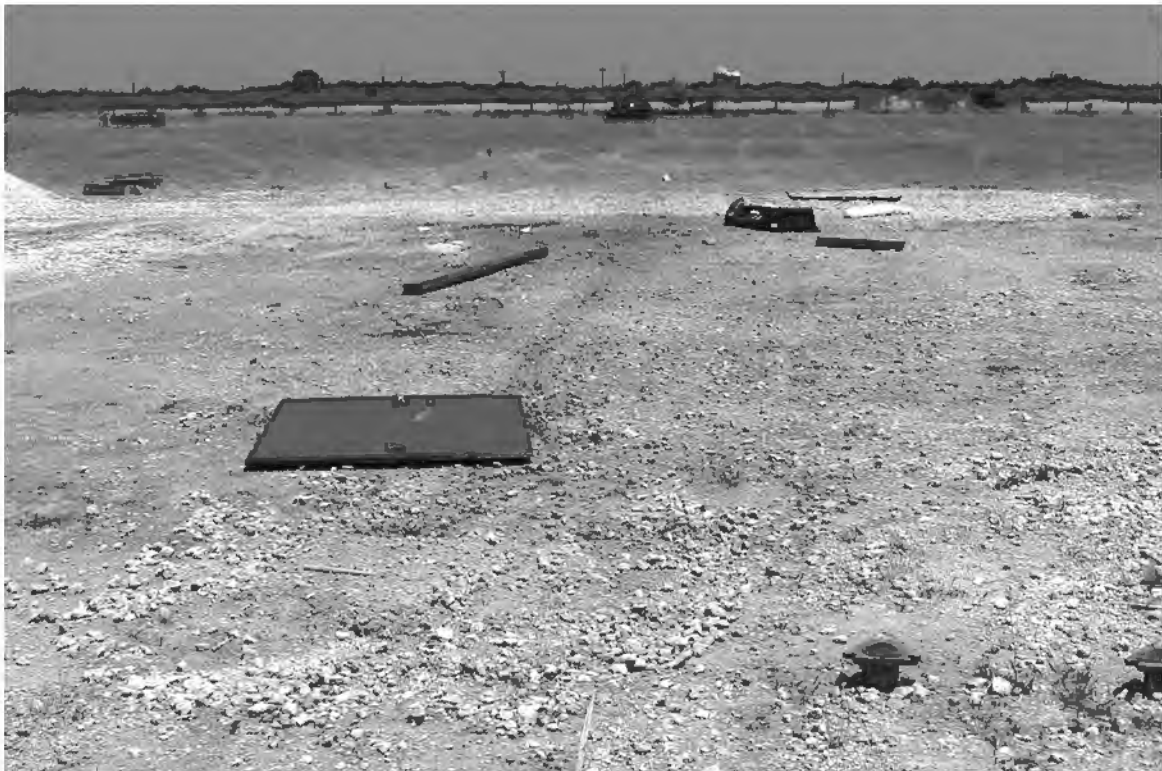
**Figure 42. After Impact Trajectory for Test 414588-3.**

As can be seen in figures 42 and 43, the support fractured into three pieces. A piece 680 mm long remained below ground. The other fragments were 920 mm long and 2920 mm long. The sign panel was separated from the support.
