1. Report No. FHWA/TX-01/1792-6	2. Government Accession No.	3. Recipient's Catalog No.	
4. Title and Subtitle TESTING AND EVALUATION OF MOLDED PLASTIC MAILBOXES		5. Report Date September 2001

TESTING AND EVALUATION OF MOLDED PLASTIC MAILBOXES

Report 1792-6
Project Number 0-1792
Research Project Title: Roadside Safety Hardware
for Traffic Control Devices

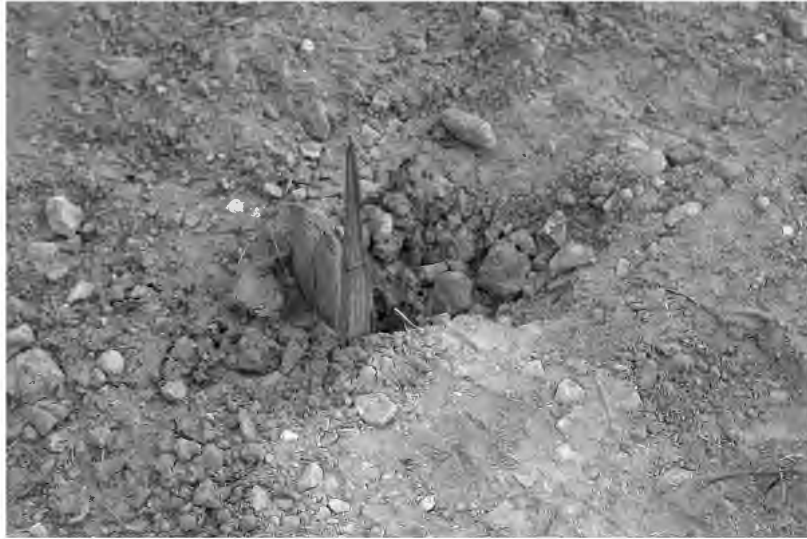
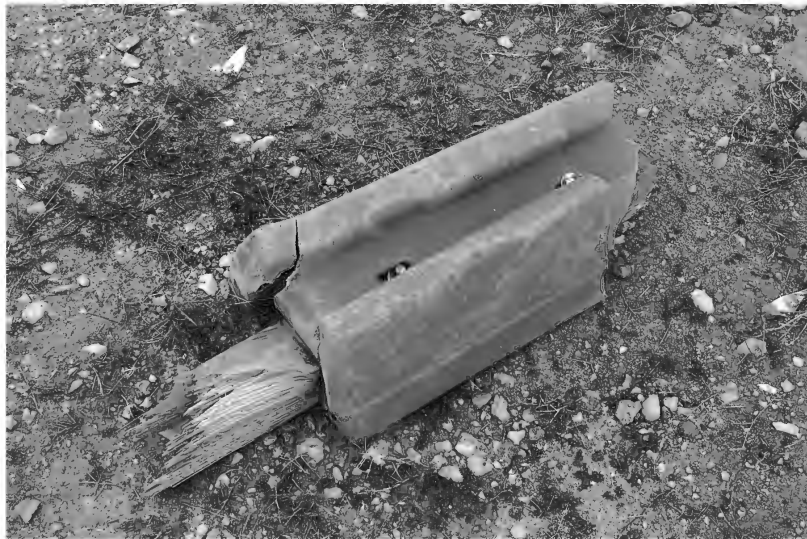
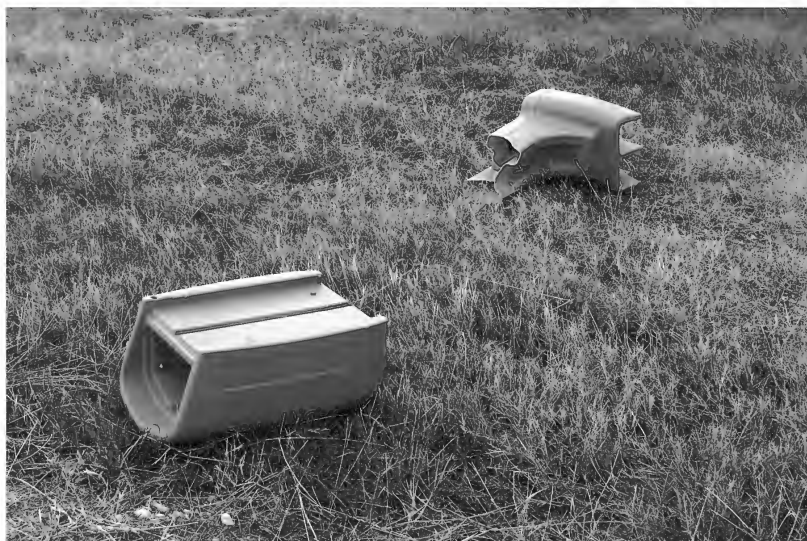
Figure 10. Step 2 Mailbox on Timber Post after Test 417921-2.

Figures 9 and 10 show damage to the test installation. The 4×4 timber support pulled out of the ground 3.5 in. before fracturing flush with ground level. The mailbox separated into several pieces, the heaviest of which weighed 12 lb-2 oz. The debris pattern extended 77.5 ft downstream, 20.0 ft to the left, and 25 ft to the right of the point of impact.

Results: The 4×4 timber post on which the Step 2 mailbox was mounted fractured at ground level. (*pass*)

Results: The timber post fractured at ground level, and the mailbox separated into several pieces. The largest, heaviest piece was the lower base portion of the mailbox attached to the upper section of the fractured wooden support post, which had a combined weight of 12 lb-2 oz. However, neither this piece nor any of the

Results: The change in velocity was 4.25 ft/s. The timber post fractured at ground level leaving only splinters projecting upward. (*pass*)

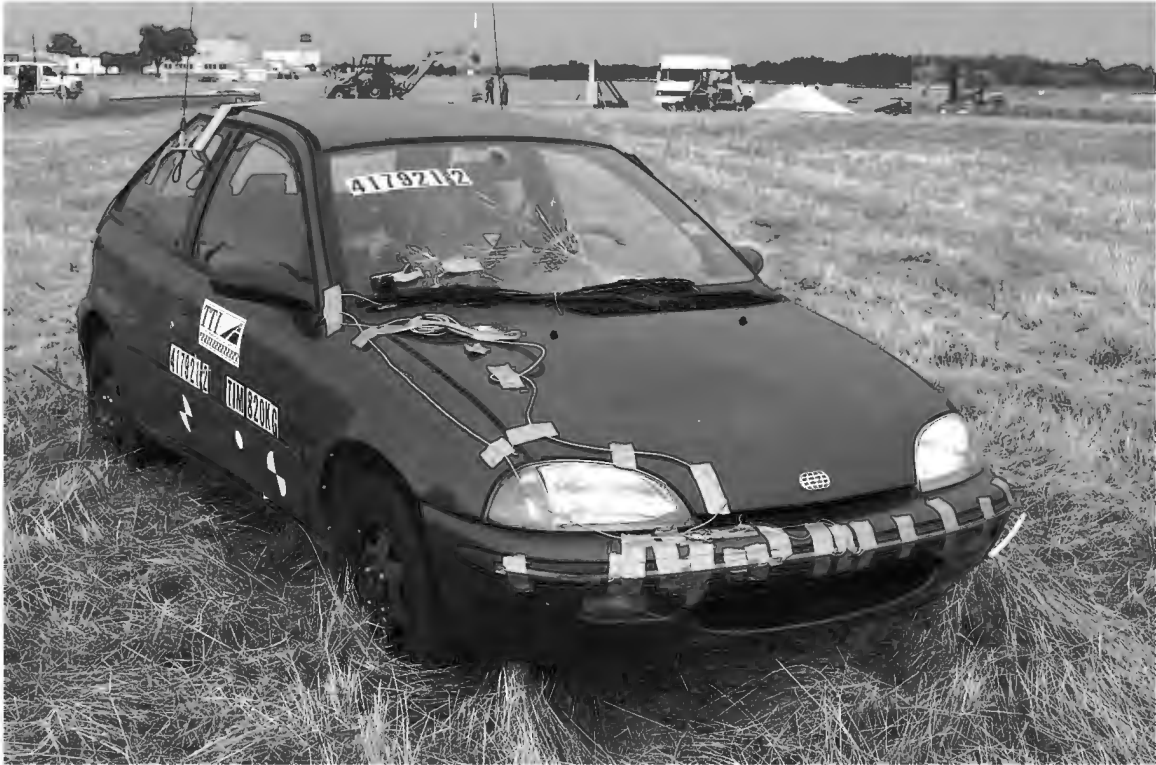
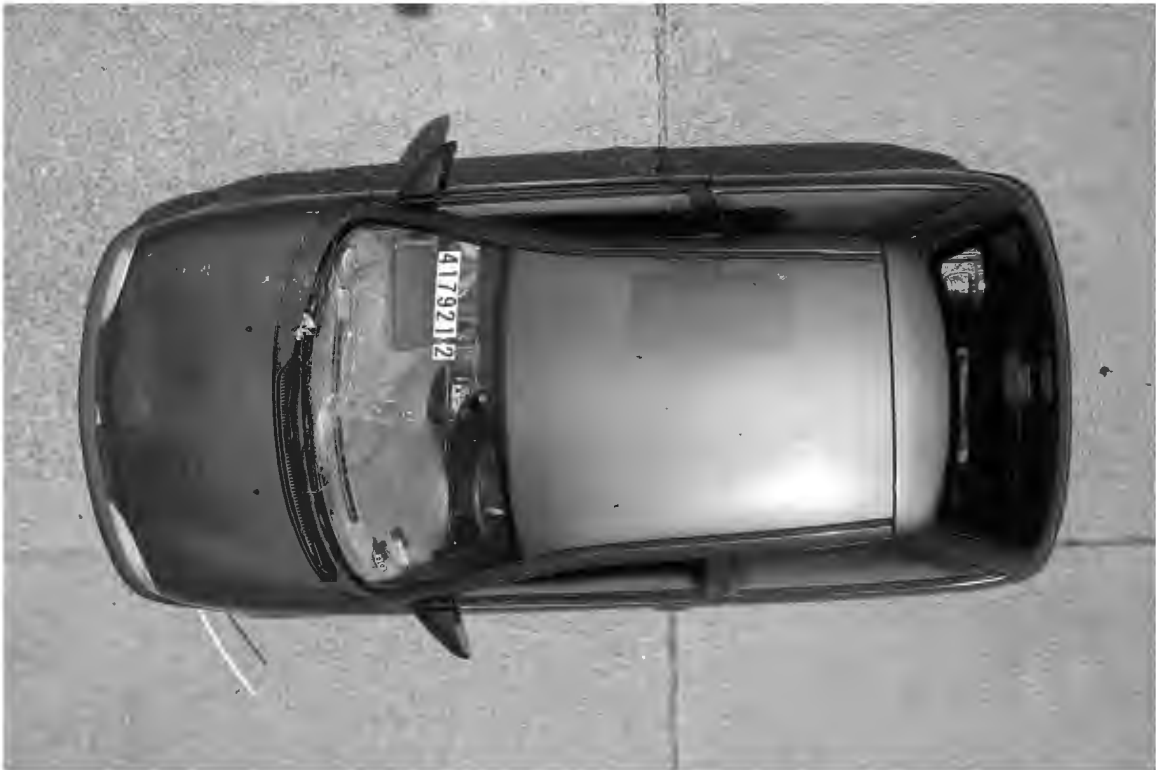
Figure 11. Vehicle after Test 417921-2.

As shown in [Figure 11](#), damage to the vehicle was minimal. The windshield was cracked (Case 4 of the Federal Highway Administration (FHWA) Windshield Damage Guidance) due to contact with the upper portion of the mailbox unit. However, there were no holes in the windshield nor any deformation of the windshield into the passenger compartment, and visibility was not restricted. No other occupant compartment deformation was noted. The hood was deformed over an area 16 in. long × 19.68 in. wide × 0.40 in. deep. Photographs of the interior of the vehicle are shown in [Figure 12](#). Exterior crush measurements and occupant compartment measurements are provided in [Appendix B, Tables 4 and 5](#).

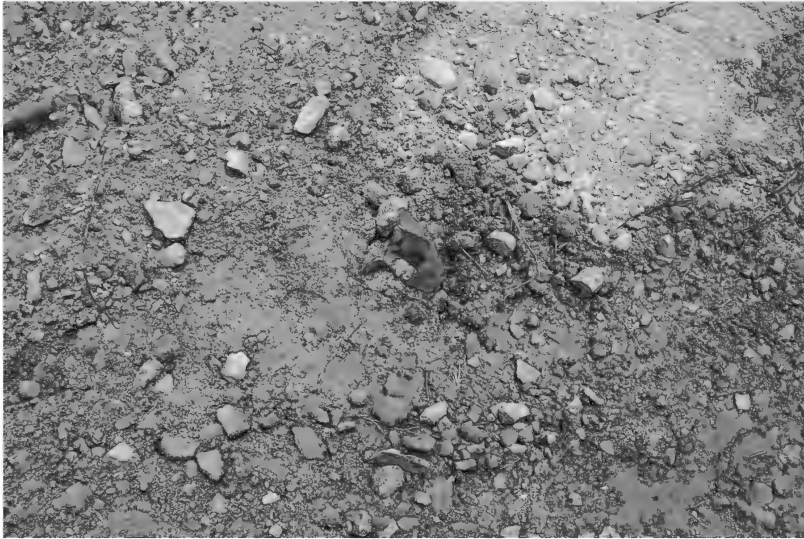
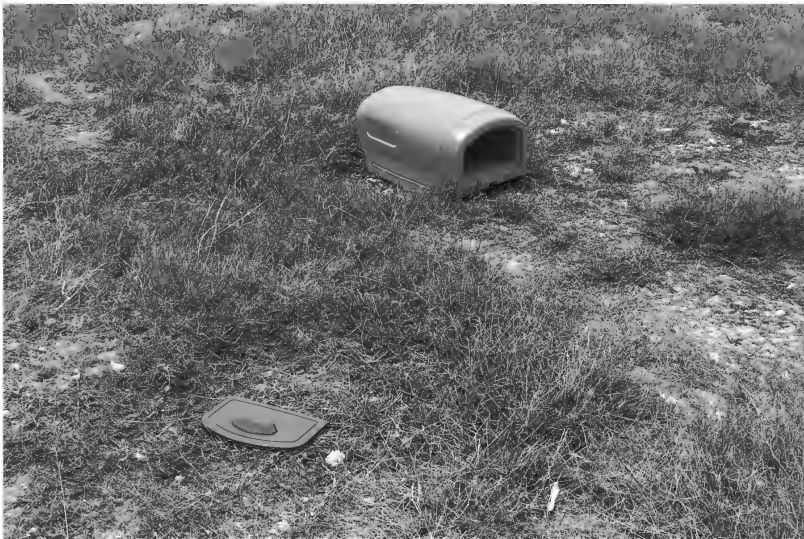
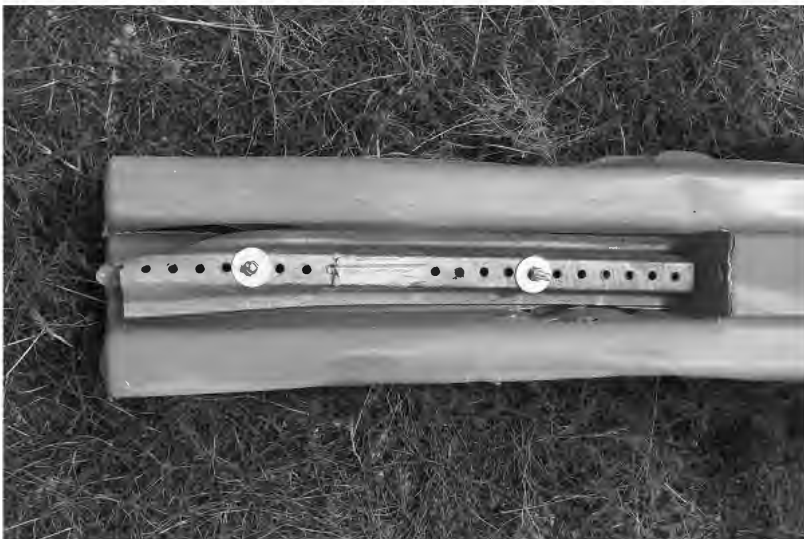
Figure 17. Step 2 Mailbox on Steel U-Channel after Test 417921-3.

Damage to the test installation is shown in Figures [16](#) and [17](#). The impact caused the upper portion of the mailbox unit to separate from the lower base portion. The steel U-channel fractured at ground level with the lower molded plastic base portion still attached. The ground stub remaining from the U-channel projected 1.75 in. above ground level. The molded plastic mailbox separated into several pieces, the heaviest of which weighed 13 lb-8 oz. The debris pattern extended 80.0 ft downstream and 15.0 ft to the left of the point of impact.

Results: The steel U-channel on which the MailMaster Deluxe mailbox was mounted fractured at ground level. *(pass)*

Results: The upper portion of the mailbox separated from the lower base section upon impact. The lower base section remained attached to the U-channel support post and had a combined weight of 13 lb-8 oz. However, this piece and several smaller pieces of the mailbox did not penetrate nor show potential for penetrating the occupant compartment. Further, these pieces remained near the vehicle path and did not present undue hazard to others in the area. Maximum occupant compartment deformation was 1.5 in. in the windshield area. *(pass)*

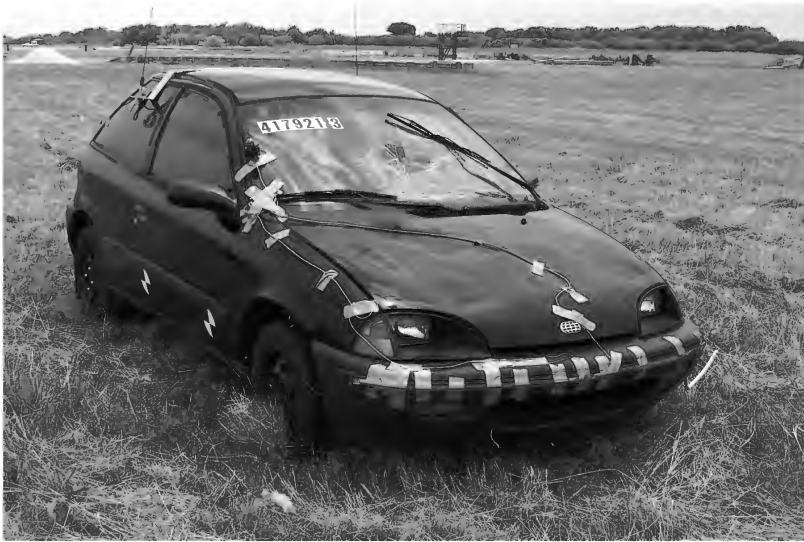
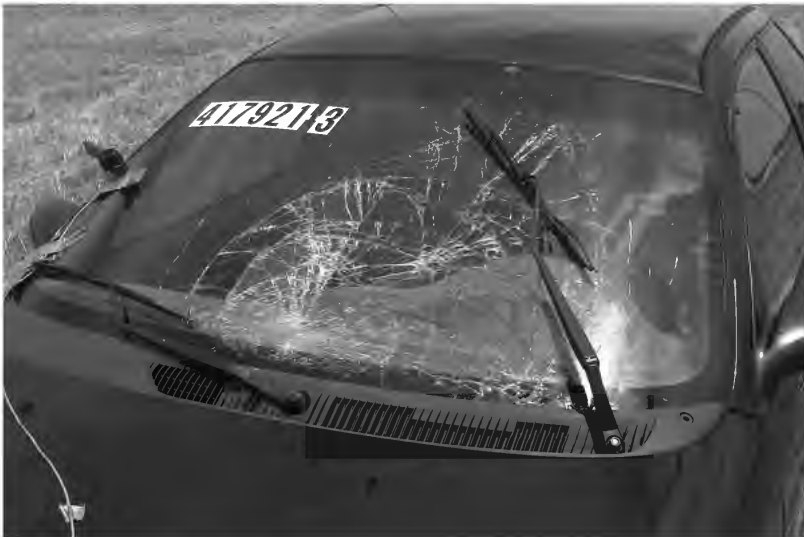
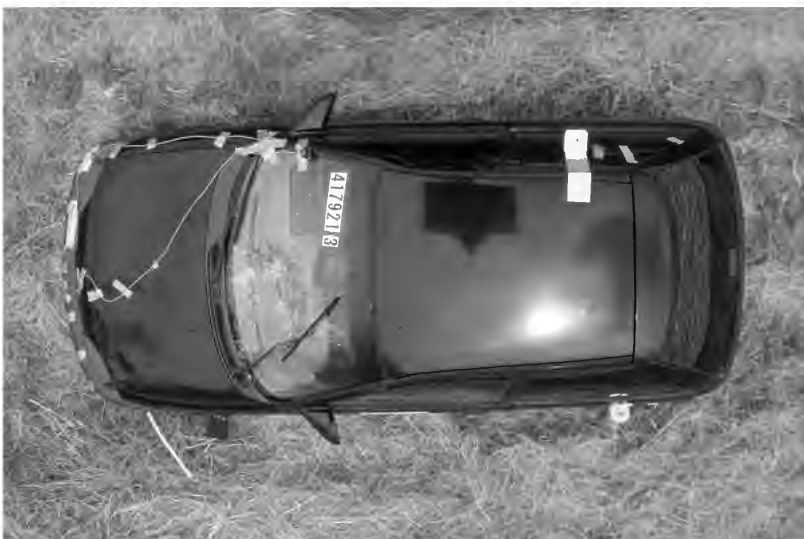
Figure 18. Vehicle after Test 417921-3.

As shown in [Figure 18](#), damage to the vehicle was minimal. The windshield was cracked and deformed inward 1.5 in. (Case 4 of the FHWA Windshield Damage Guidance), but there was no hole and visibility was not restricted. No other occupant compartment deformation was noted. The hood was deformed over an area 13.00 in. long \times 20.87 in. wide \times 0.20 in. deep. Photographs of the interior of the vehicle are shown in [Figure 19](#). Exterior crush measurements and occupant compartment measurements are detailed in [Appendix B](#), Tables [6](#) and [7](#).

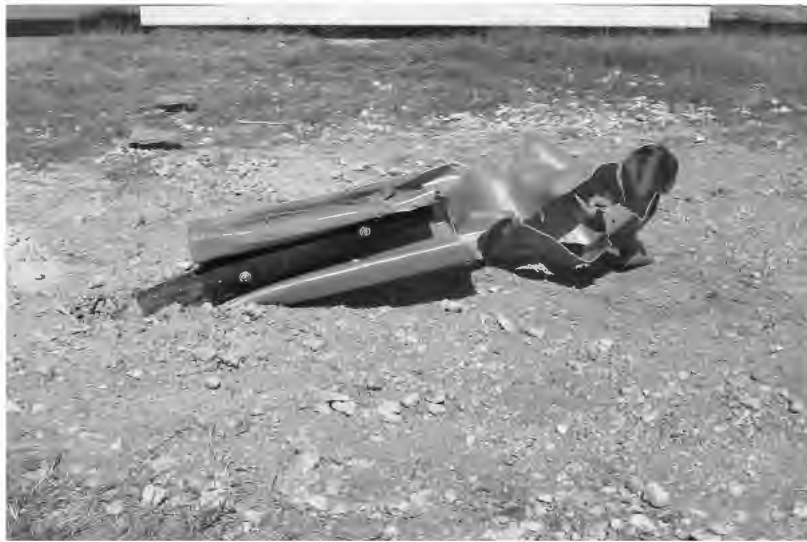
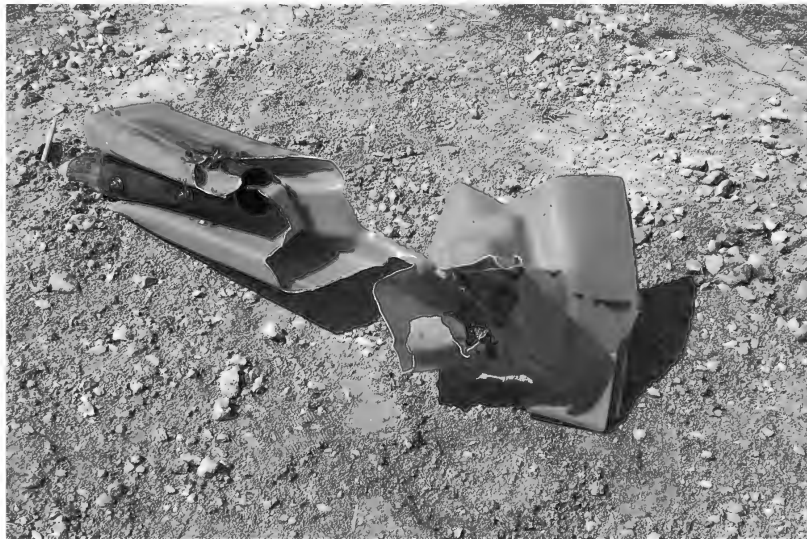
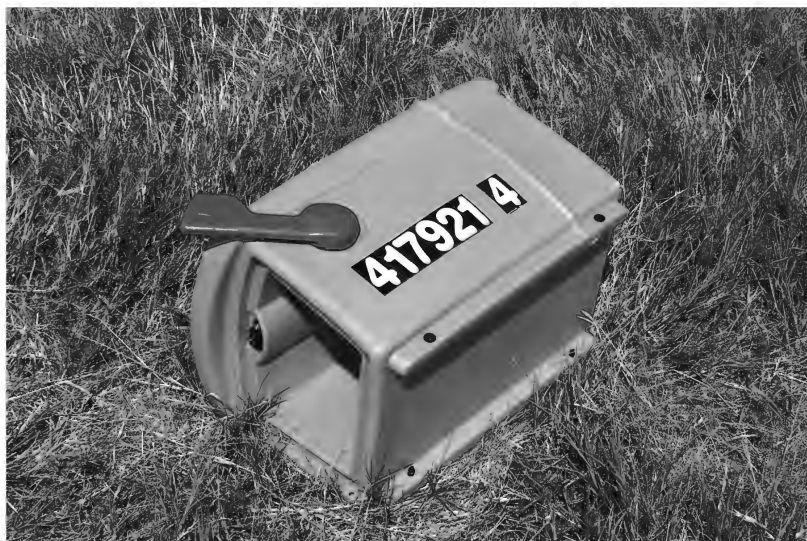
Figure 24. Rubbermaid Mailbox on Steel Pipe after Test 417921-4.

Damage to the test installation is shown in [Figures 23 and 24](#). The steel pipe support yielded and bent near ground level. As the vehicle rode over the pipe support, most of the lower molded plastic base section of the mailbox was pulled off the support post. The upper portion of the deformed steel pipe had a maximum height of 5.1 in. above ground level. The mailbox separated into several pieces, none of which was considered heavy enough to cause physical threat. The debris pattern extended 45.0 ft downstream, 18 ft left, and 10 ft right of the point of impact.

Results: The change in velocity was 7.72 ft/s. The steel pipe yielded and laid over as the vehicle rode over it. The pipe remained laid over at a maximum height of 5.1 in. at the upper end of the pipe. Because the pipe laid over in the direction of vehicle travel, it did not constitute a snagging hazard for the vehicle undercarriage. However, if the damaged pipe was subsequently hit by another vehicle from the opposite direction before it could be repaired, it could potentially snag on the vehicle undercarriage. (*marginal*)

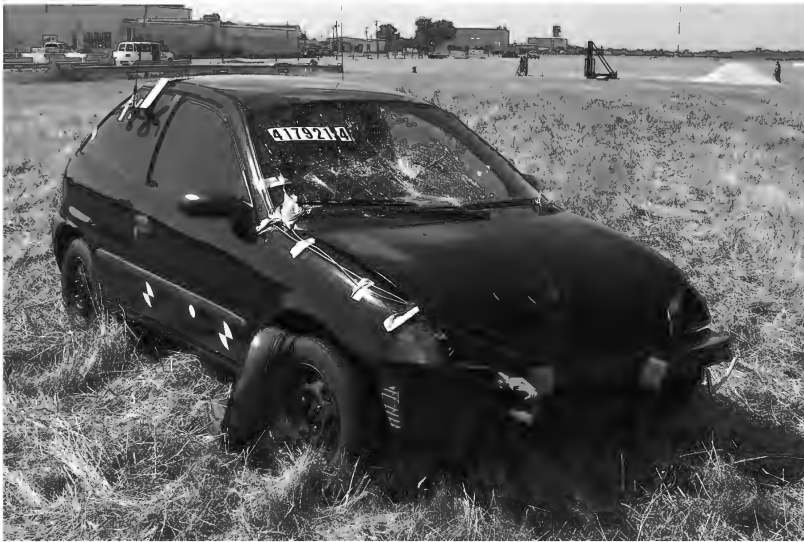
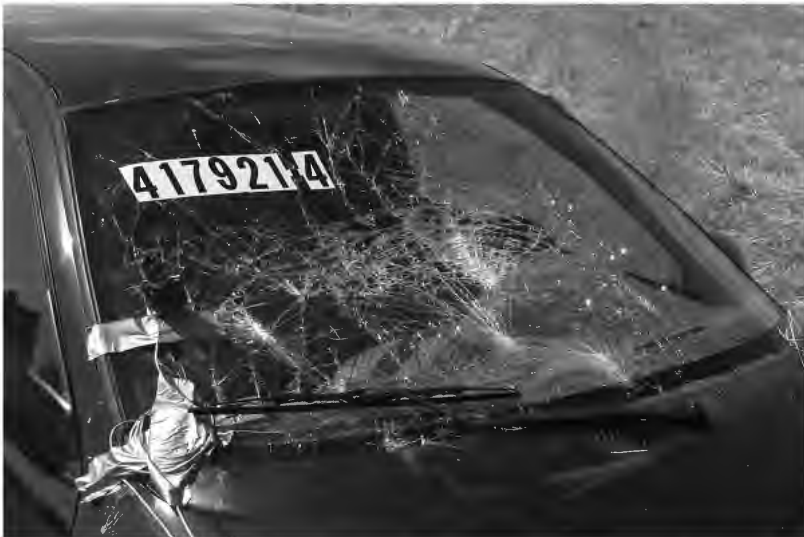
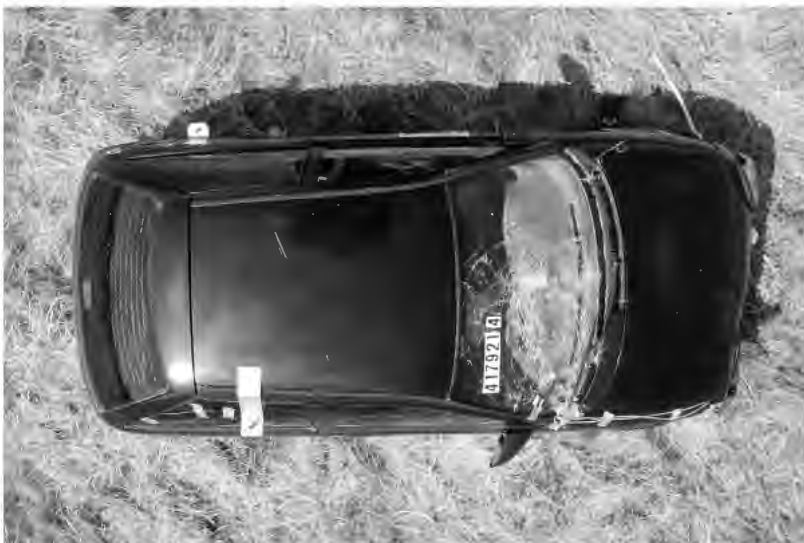
Figure 25. Vehicle after Test 417921-4.

Damage to the vehicle is shown in [Figure 25](#). A 0.5-in. long tear was noted in the windshield, and the windshield was deformed inward 2.75 in (Case 1 of the FHWA Windshield Damage Guidance). Visibility was not restricted. No other occupant compartment deformation was noted. The right motor mount and radiator support were damaged and there was a dent in the oil pan. Also damaged were the front bumper, hood, radiator, compressor, and condenser. Maximum exterior crush to the vehicle was 9.8 in. at the right front quarter point. Photographs of the interior of the vehicle are shown in [Figure 26](#). Exterior crush measurements and occupant compartment measurements are detailed in [Appendix B, Tables 7 and 8](#).

Results: The upper portion of the mailbox separated from the lower base section and contacted the windshield. This contact caused the windshield to deform inward 2.75 in. and induced a small tear (0.5 in. long) in the windshield. No other deformation of the occupant compartment was noted. None of the pieces of debris from the mailbox were considered heavy enough to cause physical threat. (*marginal*)
