Testing of State Roadside Safety Systems Volume I: Technical Report

PUBLICATION NO. FHWA-RD-98-036

APRIL 1999

6. Performing Organization Code	
7. Author(s) King K. Mak, Roger P. Bligh, and Wanda L. Menges				8. Performing Organization Report No. Research Foundation 471470-Vol. I

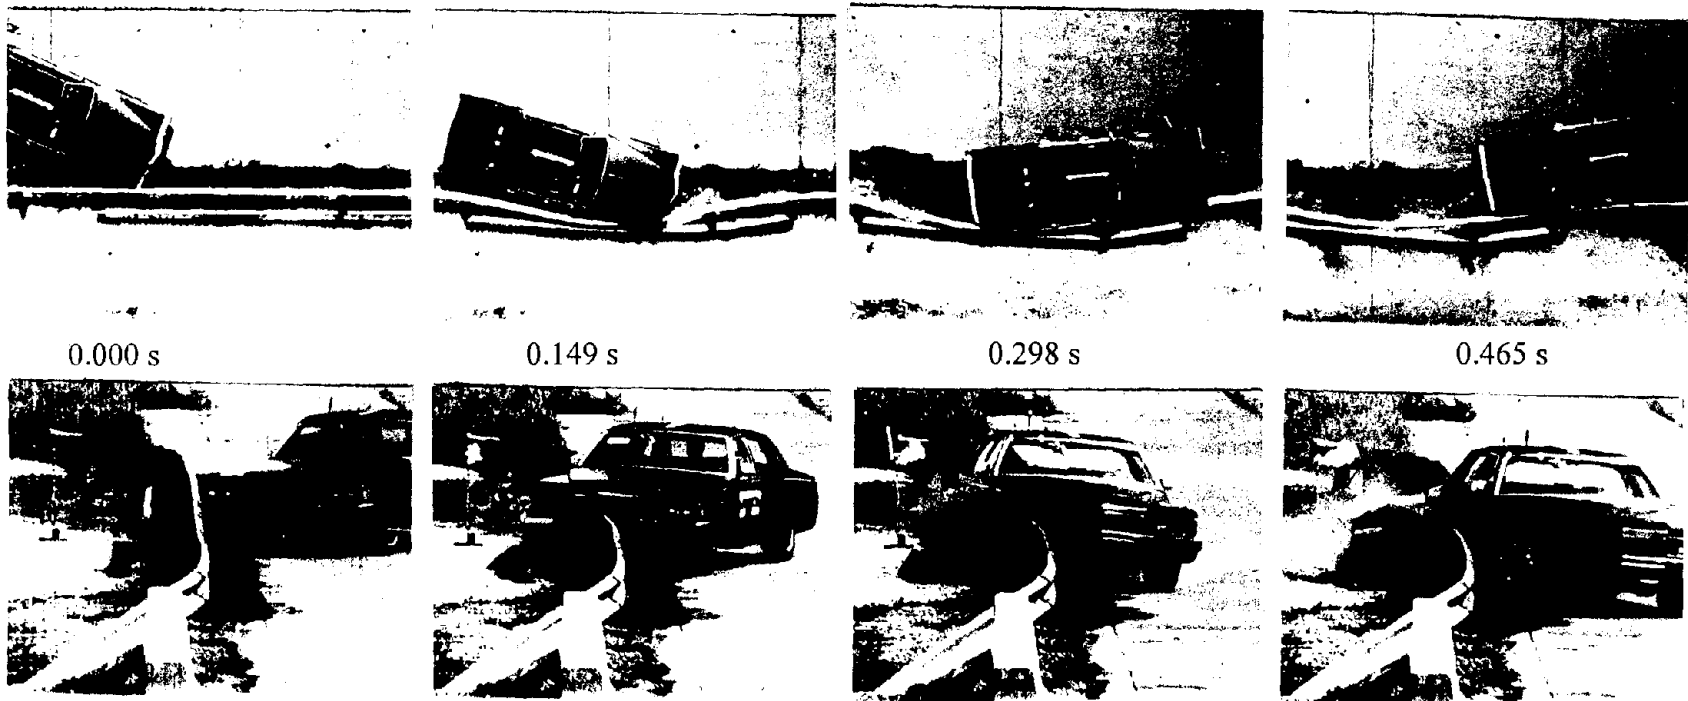
The maximum permanent deformation of the W-beam rail element was 0.8 m (2.5 ft), located approximately in the center of the long span. Post 12 was pushed back 419 mm (16.5 in) at ground level and 584 mm (23.0 in) at the center of the W-beam rail element. The

One suggested improvement is to increase the length of the nested rail from the minimum of 7.62 m (25 ft) to 11.43 m (37 ft, 6 in) and add a W-beam rail section to the rear of the system to overlap the long span and provide added strength. This suggested change would not affect the impact performance of the system to any degree, but would eliminate the need to have a splice in the middle of the long span, which could be mistaken as a missing post.

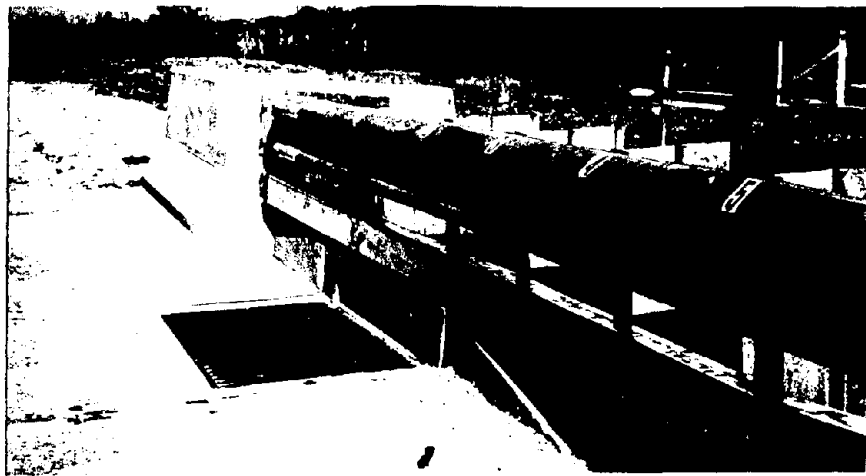
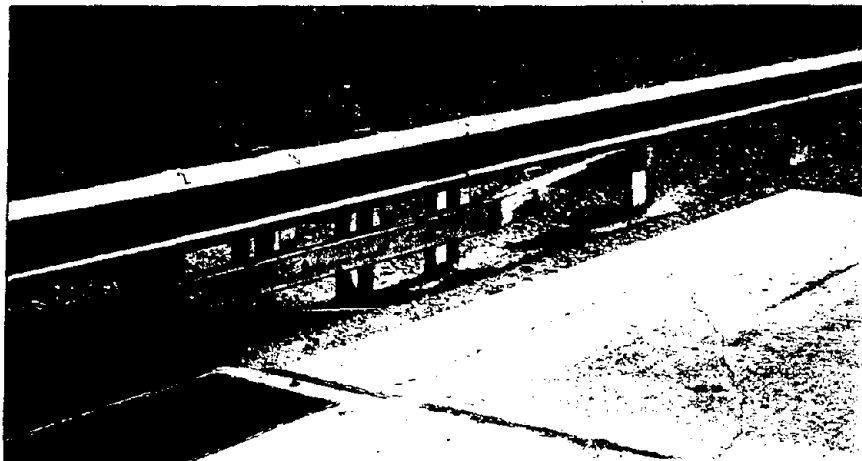
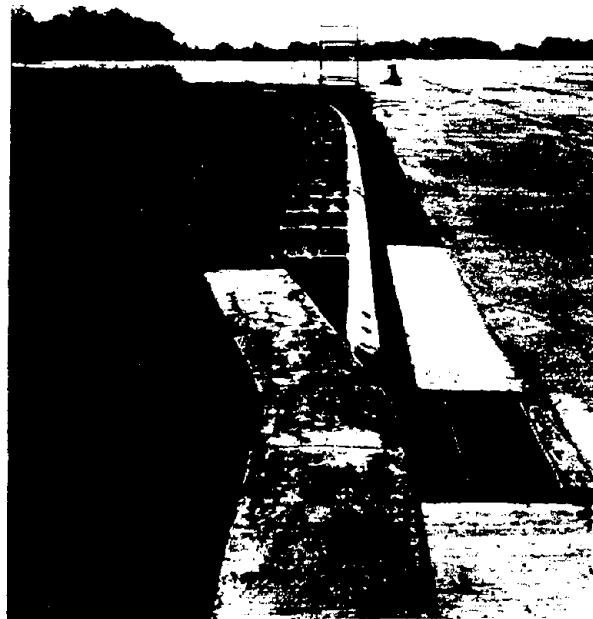
Figure 17. Photographs of test installation 471470-3.

The total length of contact of the vehicle with the transition system was 5.3 m (17.5 ft). The maximum permanent deformation of the W-beam rail element was 191 mm (7.5 in), located at the end of the wingwall. The lower corrugation of the W-beam had been flattened against the wingwall. The tilting movement of the concrete safety shape caused the concrete foundation to move and subsequently to settle 13 mm (0.5 in) above ground level and was pushed backwards a distance of 13 mm (0.5 in). The drainage inlet was also pushed back a distance of 16 mm (5/8 in).

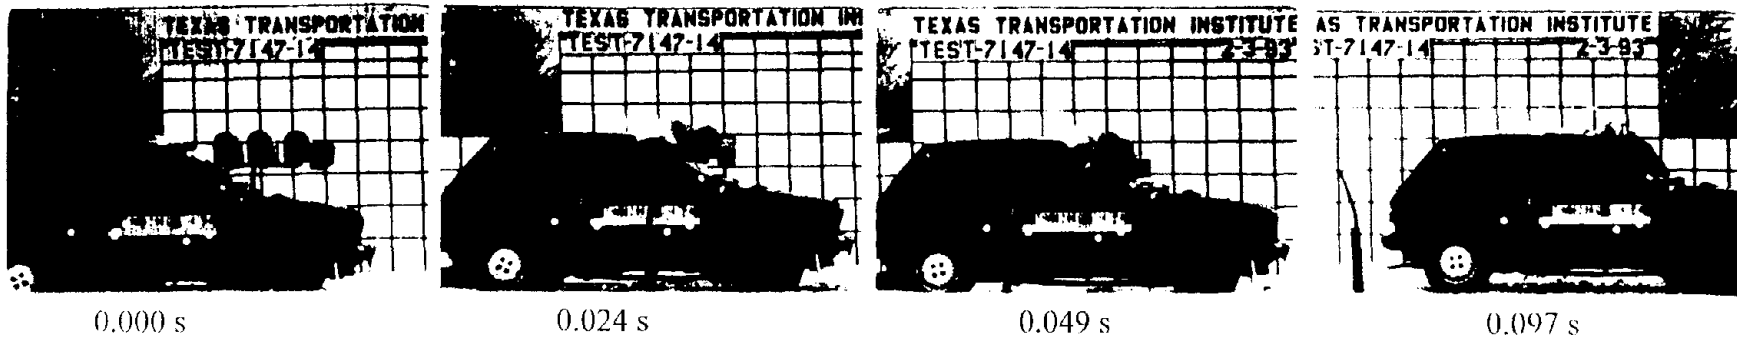
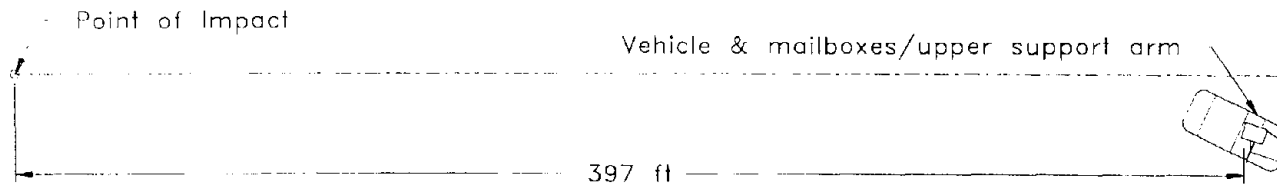
The vehicle sustained damage around the windshield area and in the occupant compartment. The mailbox assemblies intruded into the occupant compartment through the windshield and remained partially in the compartment throughout the test period. The roof of the vehicle was deformed upward from inside the vehicle approximately 50 mm (2 in). The passenger's side door was pushed out 40 mm (1.6 in) and the glass was shattered. The A-pillar and door post on the passenger's side were also deformed. The windshield was inside the vehicle.

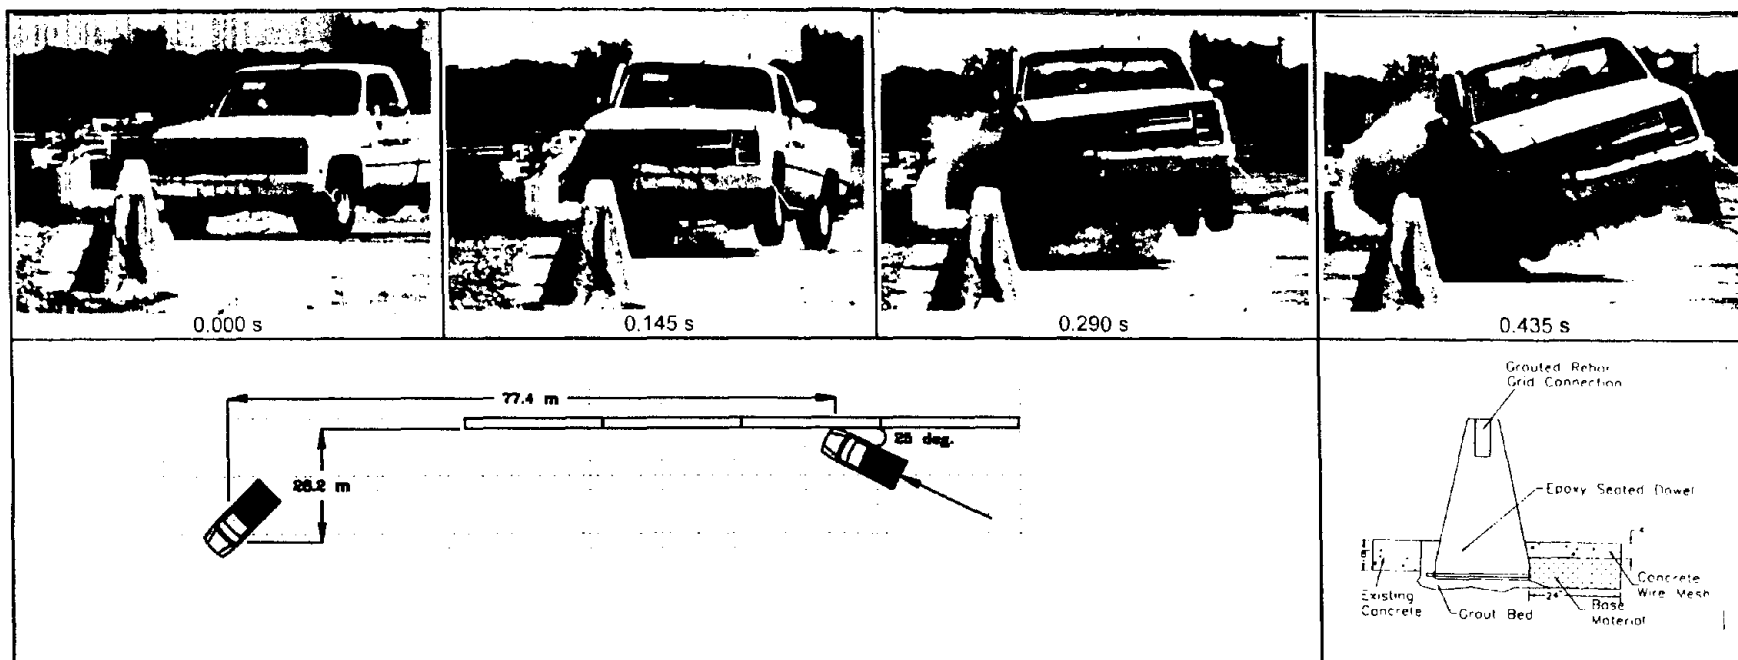
Figure 41. Summary of results for test 471470-15.

The barrier received only cosmetic damage (i.e., gouges, scrapes, and tire marks). Maximum permanent movement of the barrier was 2 mm (0.1 in) at the impact area. The vehicle was in contact with the barrier for 15.6 m (51.2 ft). The vehicle sustained extensive damage to the front suspension. Maximum crush at the right front corner of the vehicle was 178 mm (7.0 in). The front axle was separated from the vehicle and the spring shackles, U-bolts, shocks, mounts, tie rods, and steering arm were damaged. In addition, damage was sustained by the front bumper, the right front quarter panel, and the right and left running boards. The windshield was cracked and the fuel tank was scraped.

For the pickup truck test (test no. 471470-15), the single slope concrete bridge rail contained and smoothly redirected the vehicle. There were no detached elements or debris to cause undue hazard to occupants of the vehicle or to adjacent traffic. The vehicle sustained moderate damage with minor deformation into the occupant compartment. The vehicle remained upright and relatively stable during the collision period; however, there was some
