**Federal Railroad
Administration**

A Study of Environmental and Track Factors that Contribute to Abrasion Damage of Concrete Ties

9. SPONSORING/MONITORING AGENCY NAME(S) AND ADDRESS(ES) U.S. Department of Transportation Federal Railroad Administration Office of Railroad Policy and Development Office of Research, Development and Technology Washington, DC 20590			10. SPONSORING/MONITORING AGENCY REPORT NUMBER DOT/FRA/ORD-19/38

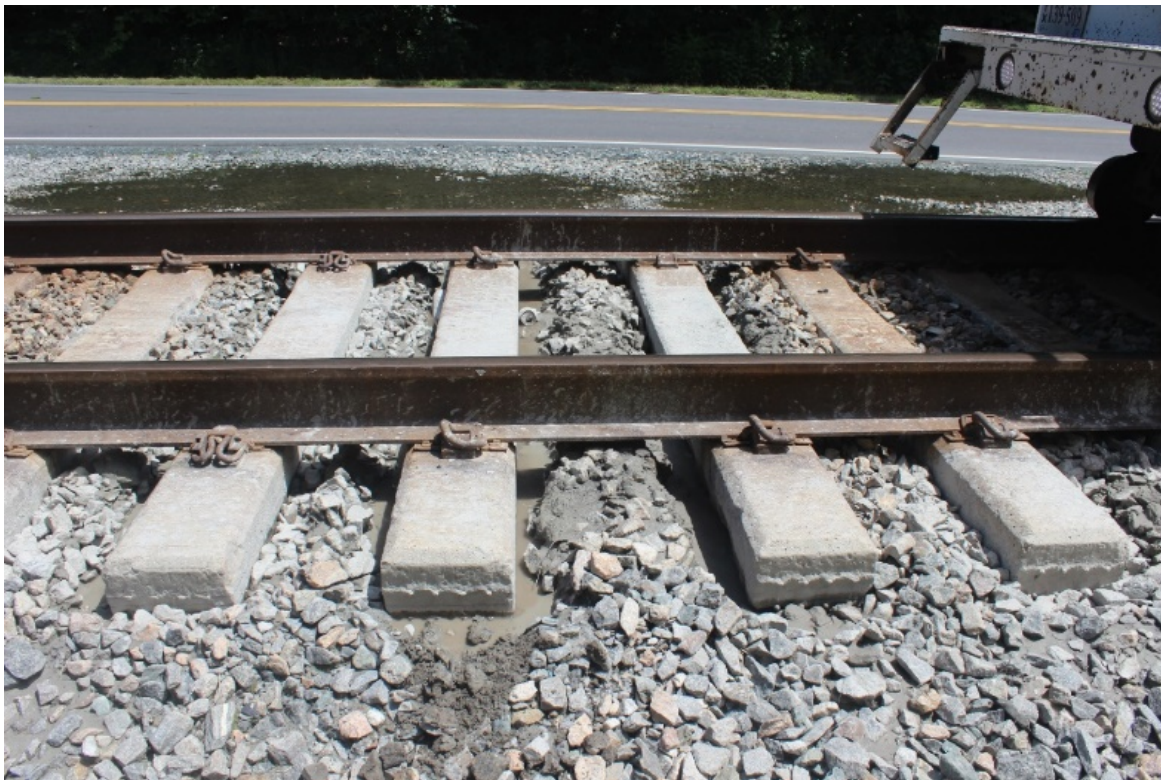
Figure 3-5: Water ponding in track, contributing to mud pumping

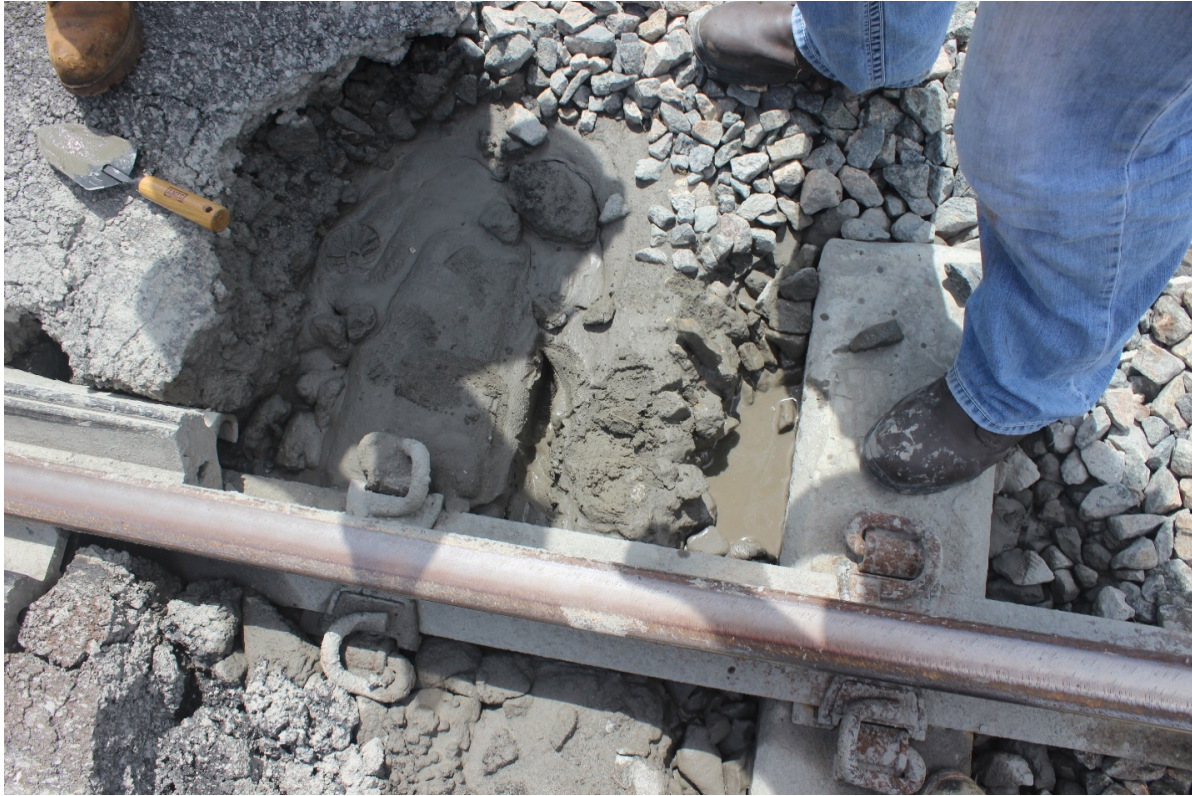
Figure 3-6: Mud spot at an asphalt crossing

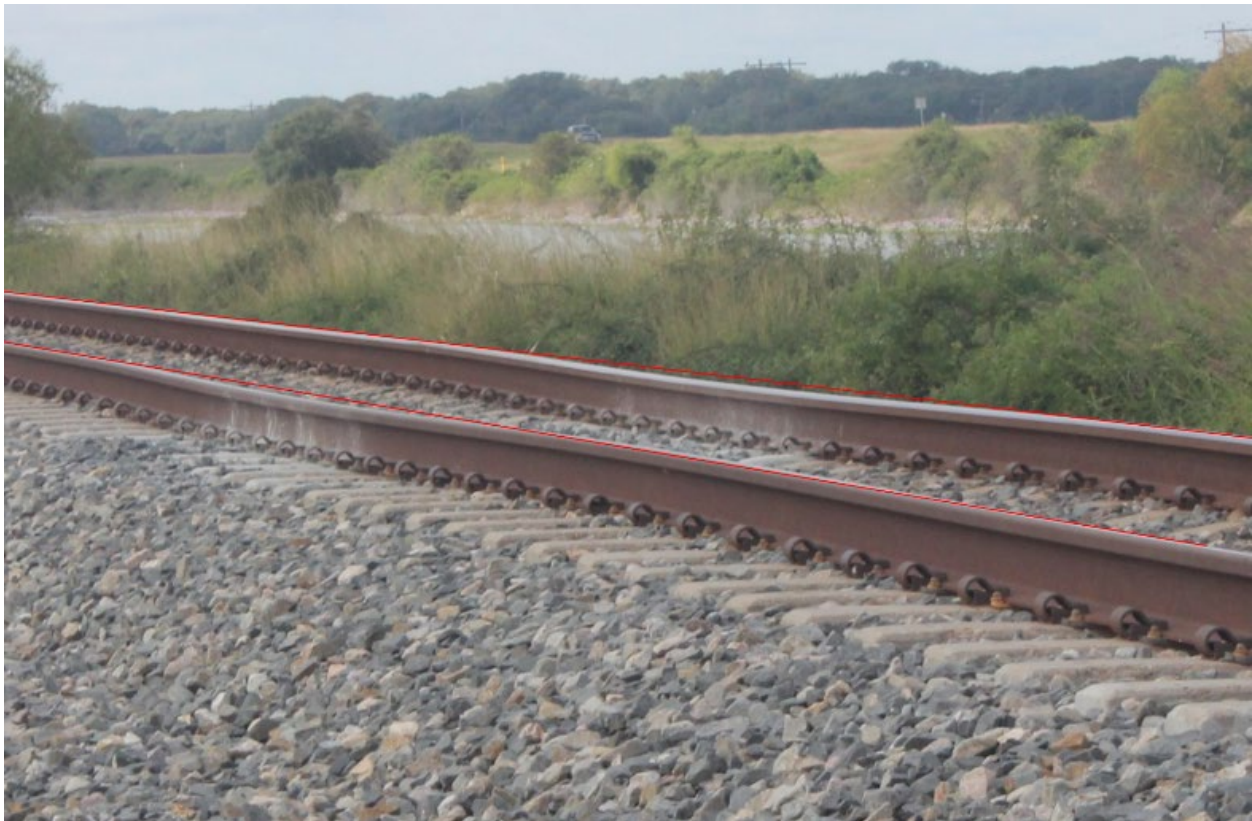
Figure 3-17: Rail surface profile variation for track built on an old concrete highway. Red lines show the more than 1.3 in. of surface profile variation measured by the ATIP geometry car approximately 2 years before the picture was taken

Surfacing issues were seen by the research team at the locations of the gray mud. [Figure 3-17](#) shows a picture of the track at a mud spot on the western end of the bridge. Red lines are drawn in the figure to enhance the view of the vertical profile dip in track. Gray mud is shown on the rail sides at the location of the surfacing issue, highlighting the cause of the surfacing issue.

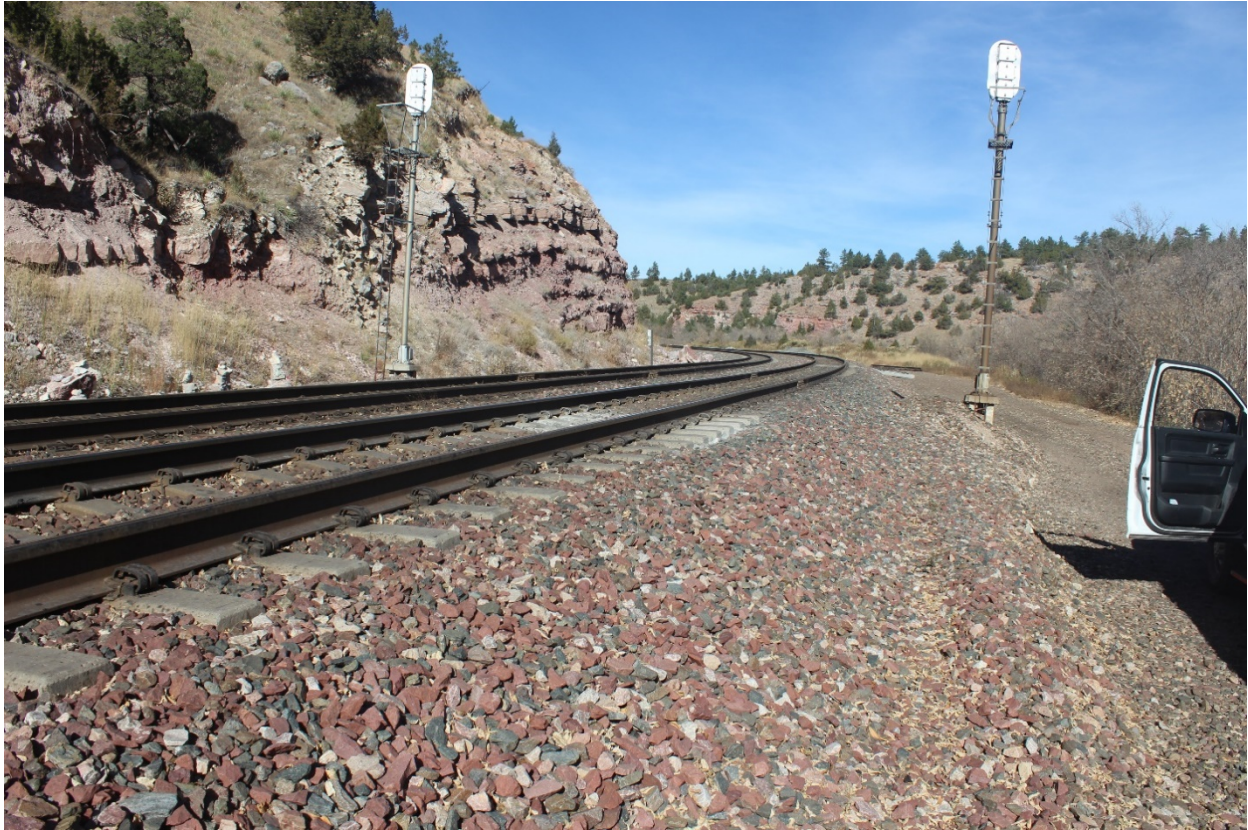
Figure 3-18: Curve #4

Concrete tie abrasion may contribute to track alignment instability as shown in Curve #4, described in [Appendix D.4](#), and shown in [Figure 3-18](#). The ties in this location were scheduled for replacement because the ties were having difficulty keeping the curve radius constant during rail temperature changes. Ties in Curve #4 were made without scallops and had minor abrasion damage that may have reduce the lateral stability of the curve. Scallops may help prevent track misalignment.

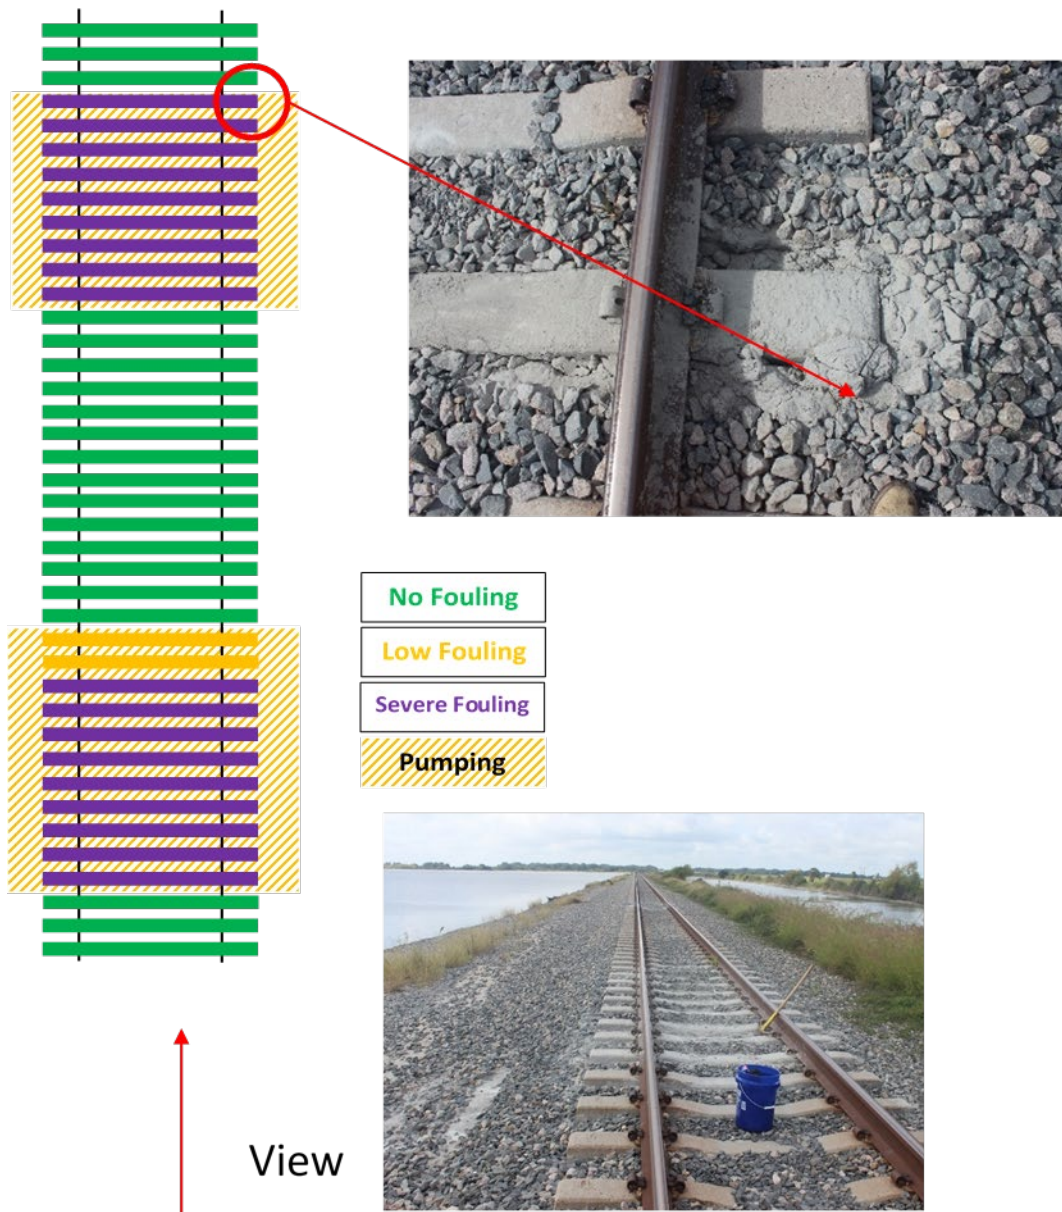
Figure 3-19: Abrasion damage at Bridge Approach #2

According to the maintenance crew, this site has constant maintenance issues. [Figure 3-19](#) shows an example of the type of maintenance issues experienced on-site. The site was undercut two years before the research team visit. Gray mud was observed during the visit. The ballast appeared to be less than 12 in. at the mud spots. Low ballast levels in these locations may have contributed to high stresses in ballast and ties, causing breakdown and fouling. Some center-binding cracking and surfacing issues were seen at the site. Figure A-23 shows the round shaped tie on the site with fines under it that looks like they are more from concrete because of the color. Fines on the side of the track are shown in Figure A-24.

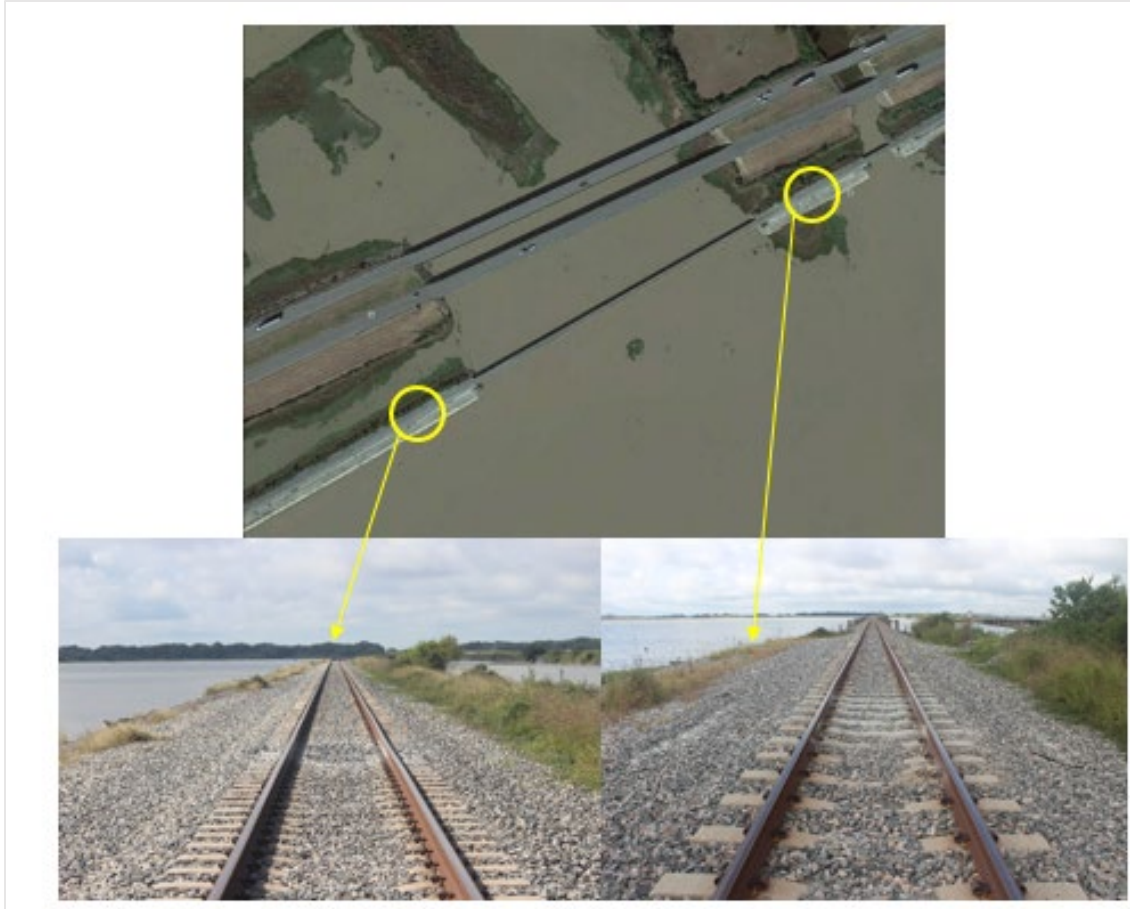
Figure 3-20 shows locations with tie abrasion damage in relation to a bridge (Bridge Approach #2, [Appendix A, Section A.5](#)). For the track section built over the old concrete highway, fines in track could not have come from mud or sub-ballast because of the presence of the highway in the track structure. In these locations, the ballast fouling was clearly caused by ballast and concrete tie breakdown. The fines were comprised of crushed ballast and ground concrete. Additionally, these locations have a thinner ballast layer. The thinner ballast yields higher ballast stress levels and consequently more ballast breakdown.

Figure 3-20: Bridge Approach #2, built over old concrete highway

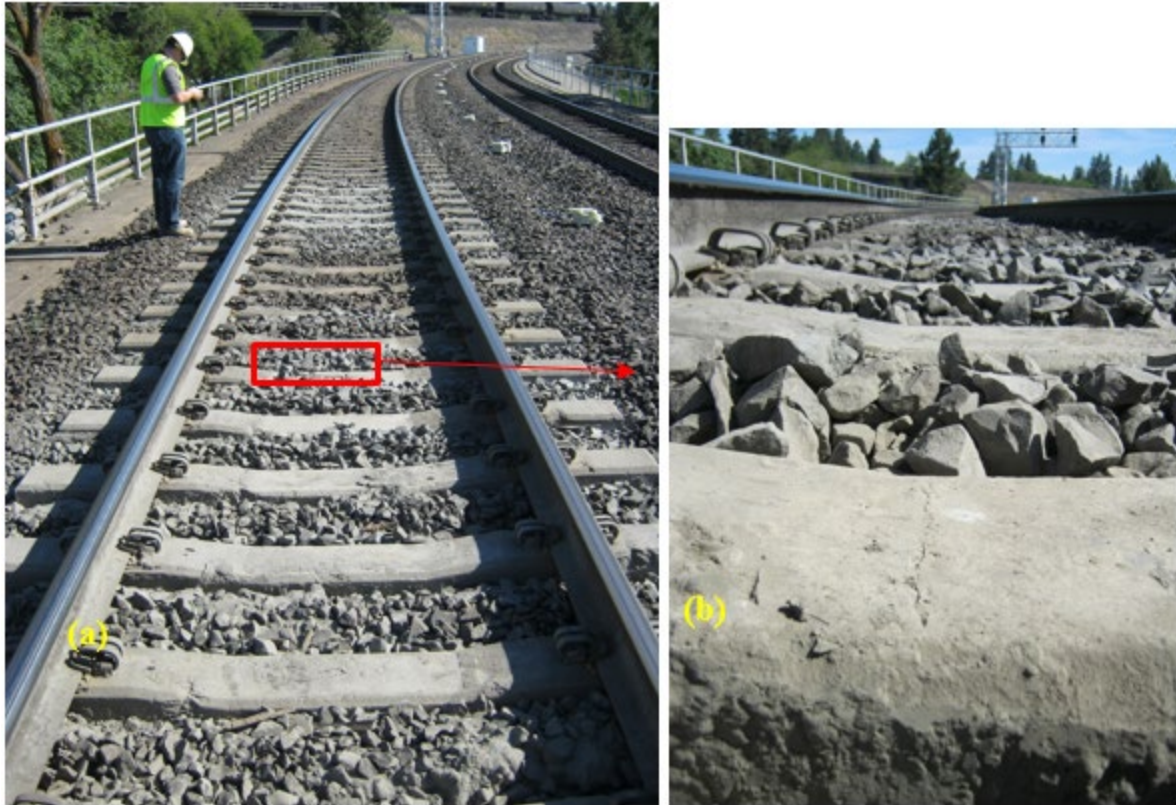
Figure A-4: Moderate binding cracking on ties, Bridge #1

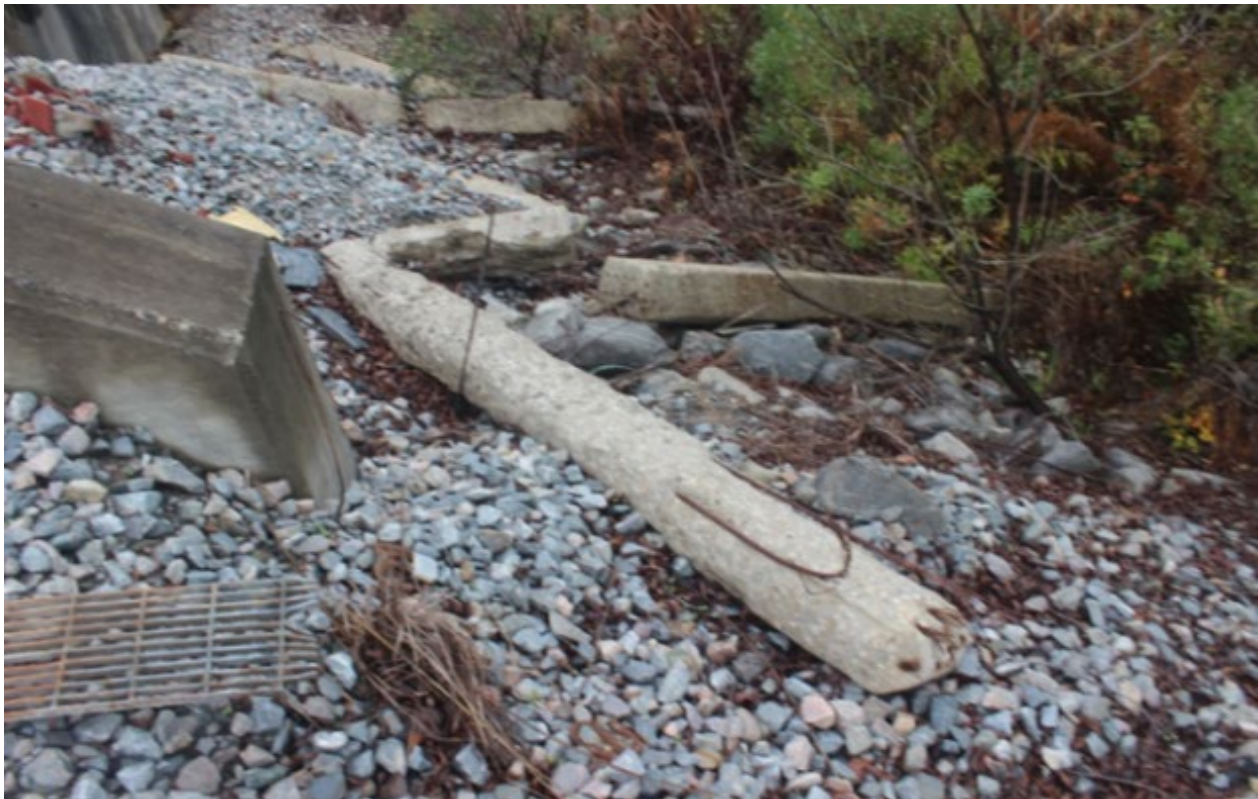
Figure A-14: Discarded tie with high abrasion, Bridge #3

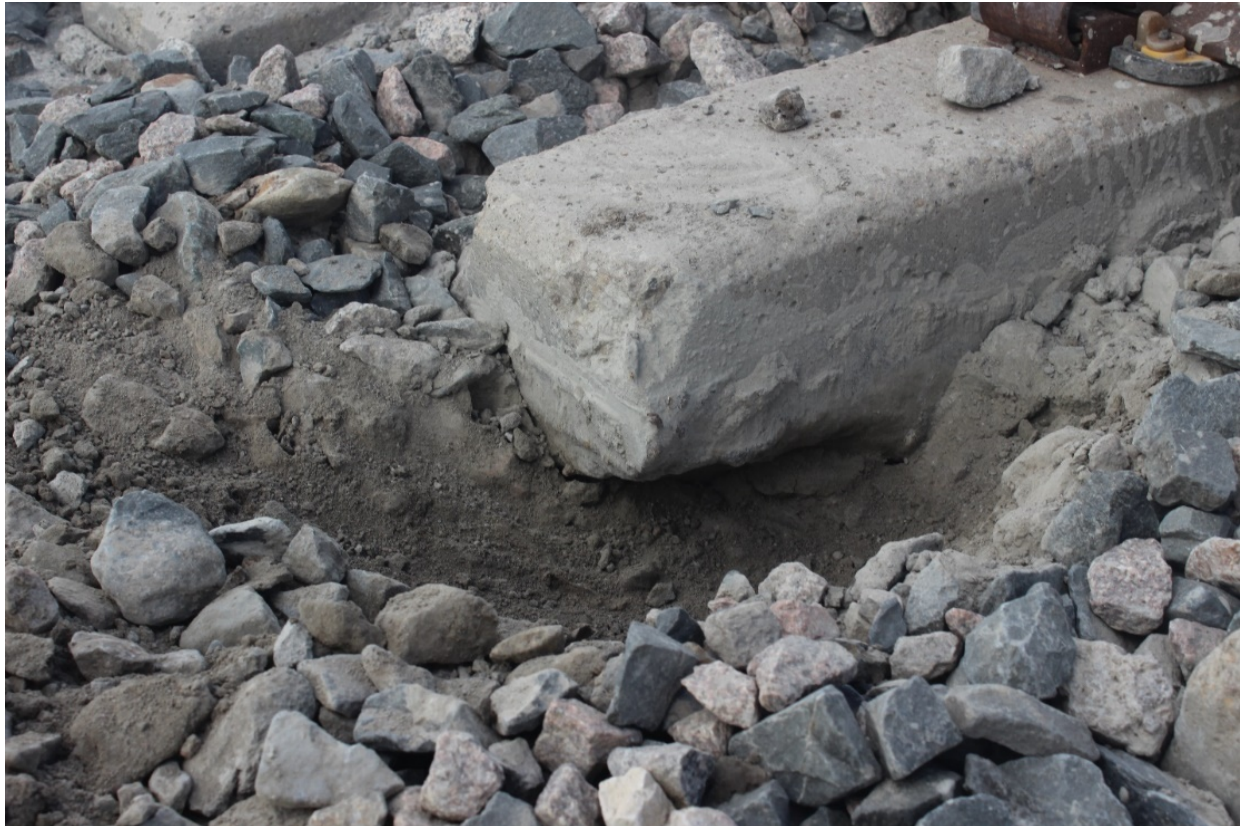
Figure A-23: Rounding of tie bottom, Bridge Approach #2

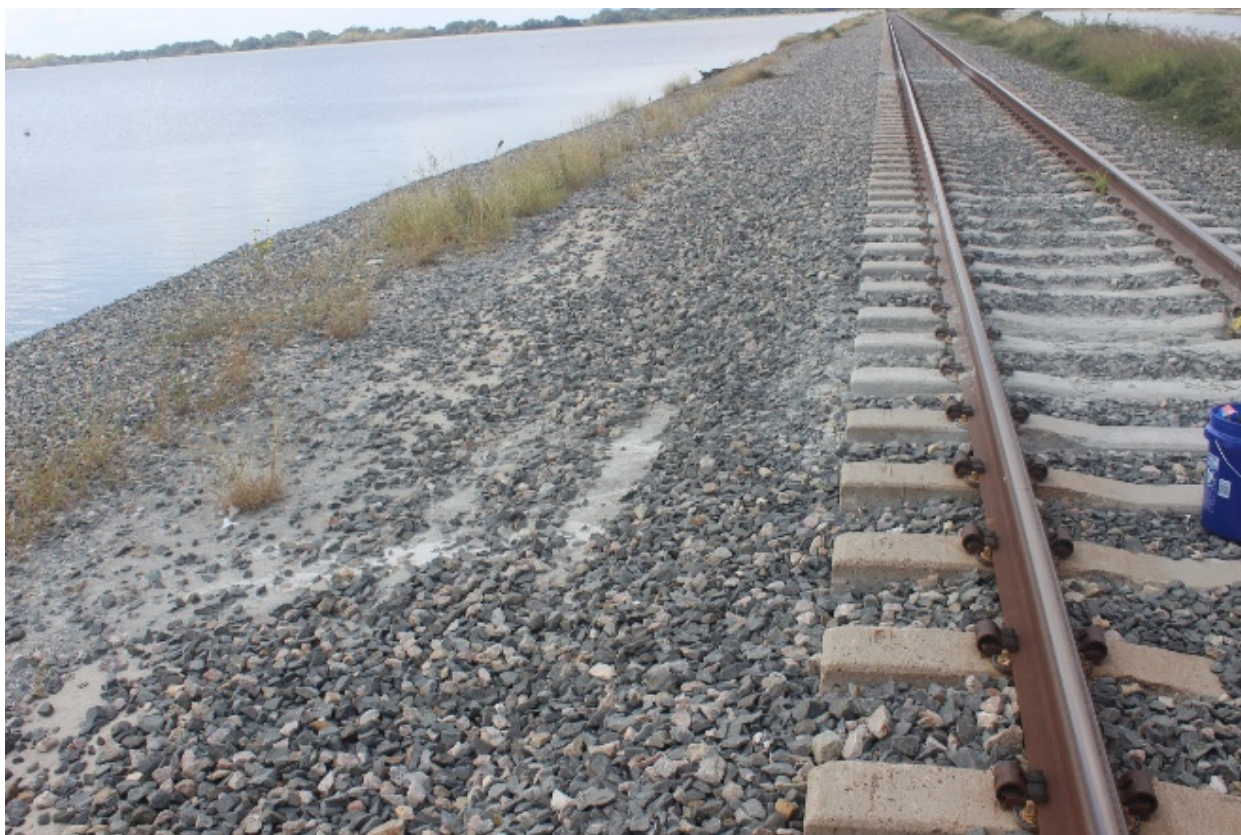
Figure A-24: Fines on the side of track, Bridge Approach #2

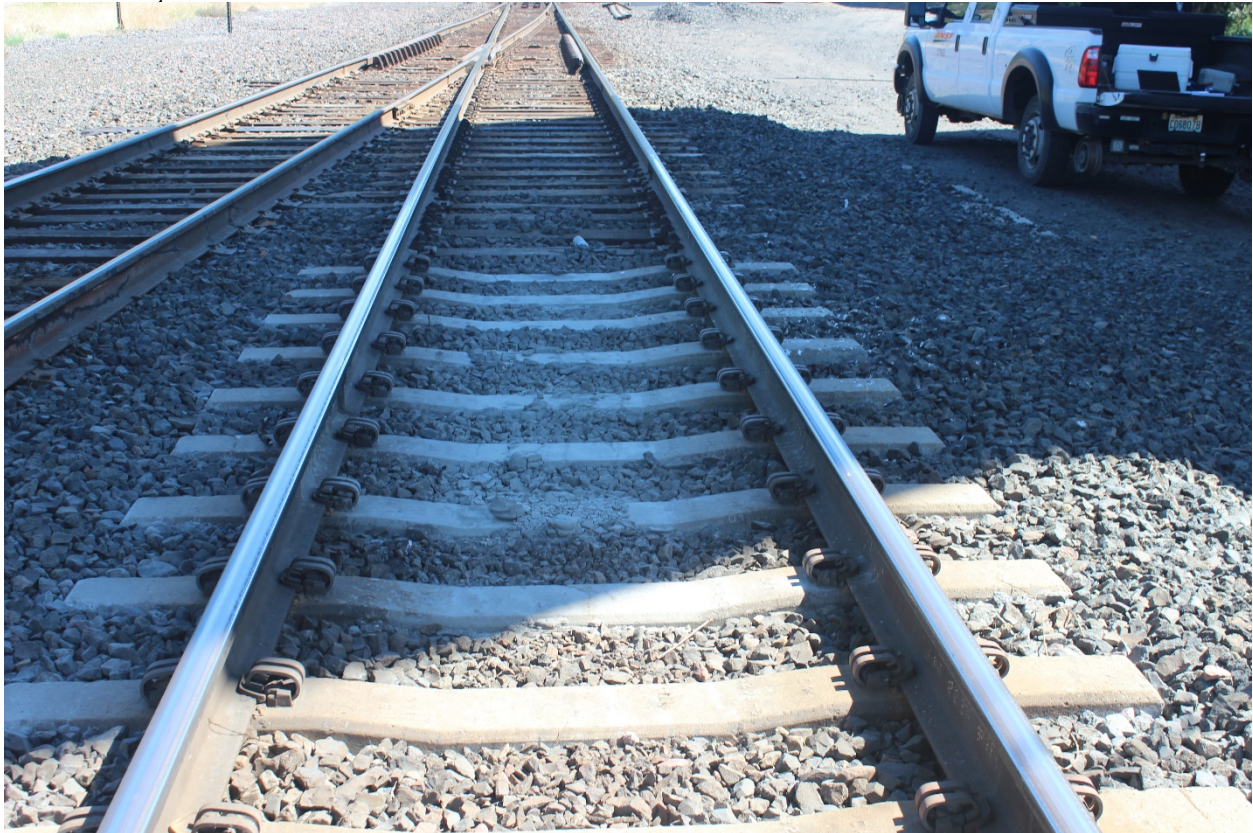
A section of track right after the transition from wood ties showed evidence of fouled ballast and center-binding cracking, as shown in Figure B-2. Center-binding cracking was seen in seven ties after the transition. This is indicative of variations in track stiffness and support conditions often present at transitions. Figure B-2 also shows the shadow from the bridge. It is likely that water flowing off the bridge causes an increase in water availability in track. Some moisture was seen in ballast at the tie bottom. Water loving grass and plants were seen next to track as shown in Figure B-3, indicating that water is more present in this location than in the general

Figure B-2: Fouled ballast immediately after wood-to-concrete tie transition, Switch #1

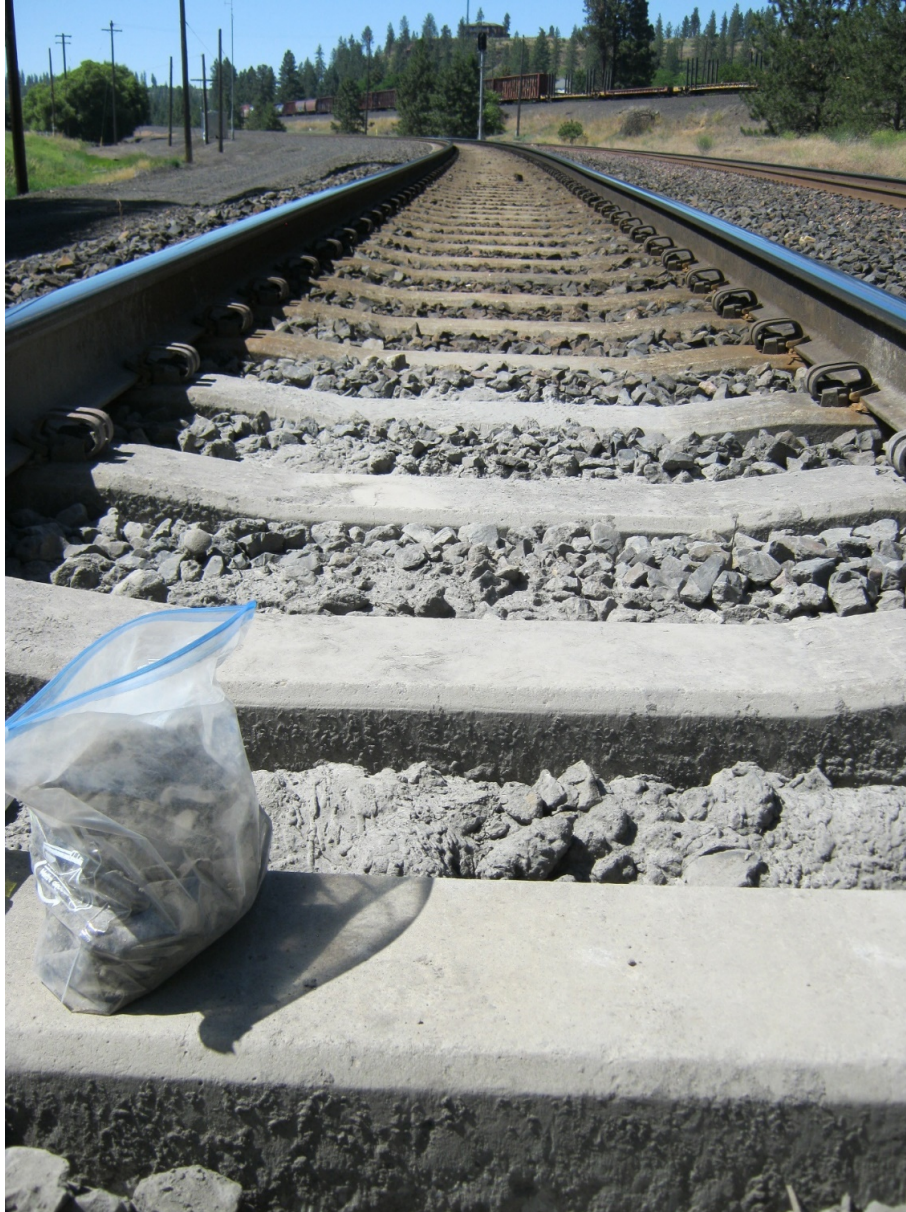
A second gray-mud section of track was seen a short distance away from the switch, as shown in Figure B-4. It is possible that the change in track stiffness seen at the transition caused train vertical movement that caused large vertical forces on the track at the second fouled ballast location.

Figure B-4: Gray mud in track, Switch #1

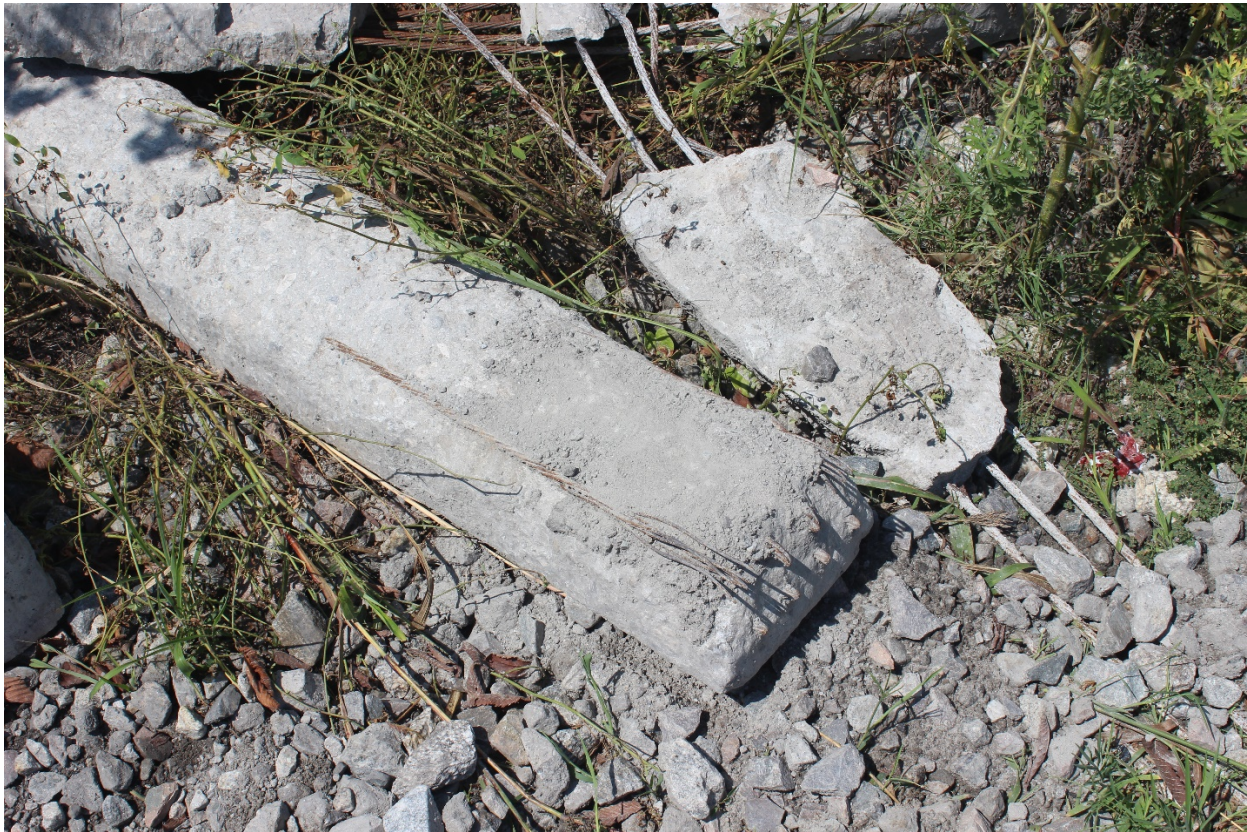
Several ties were replaced the week before the site visit and were still on the side of the road. These ties had large amounts of abrasion damage on the bottom and sides, see Figure B-13.

Figure B-13: Removed ties with abrasion damage, Signal #2

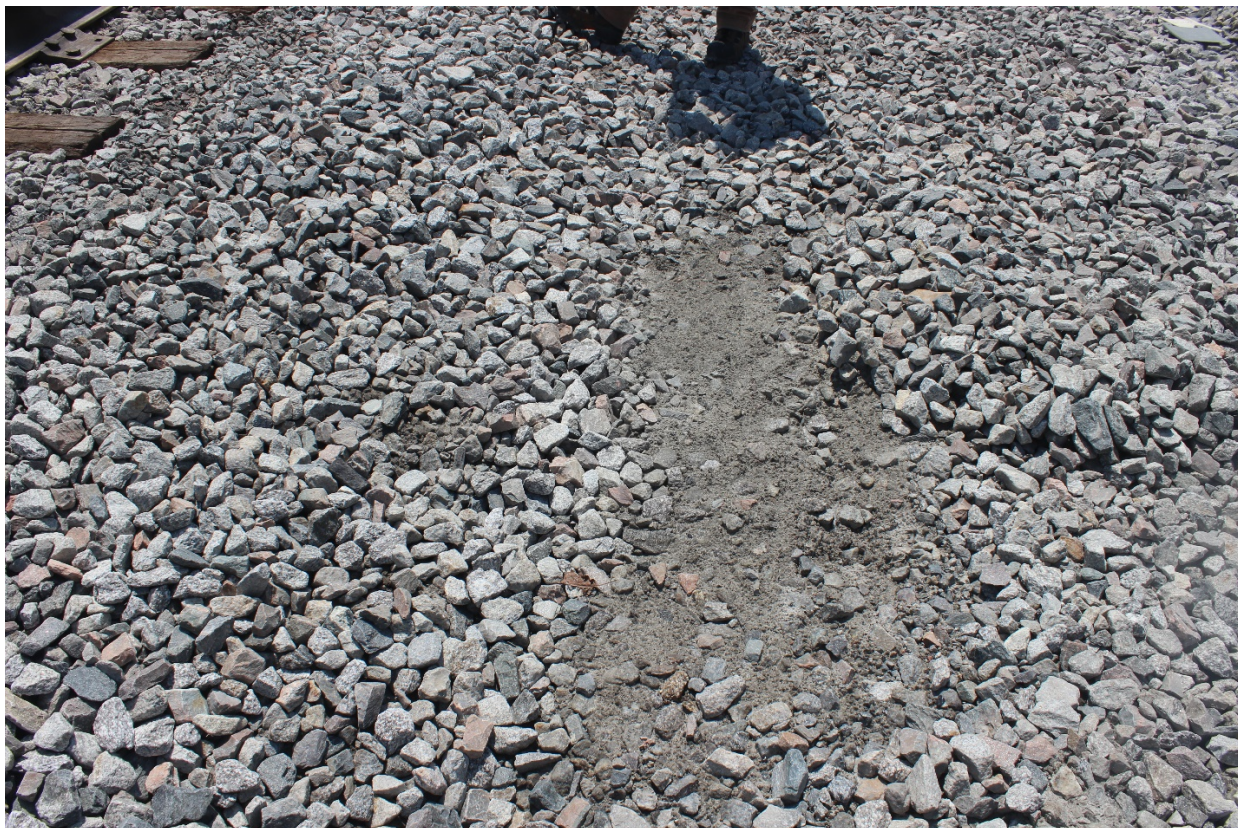
Figure B-15: Mud pumping in adjacent ballast, Signal #2

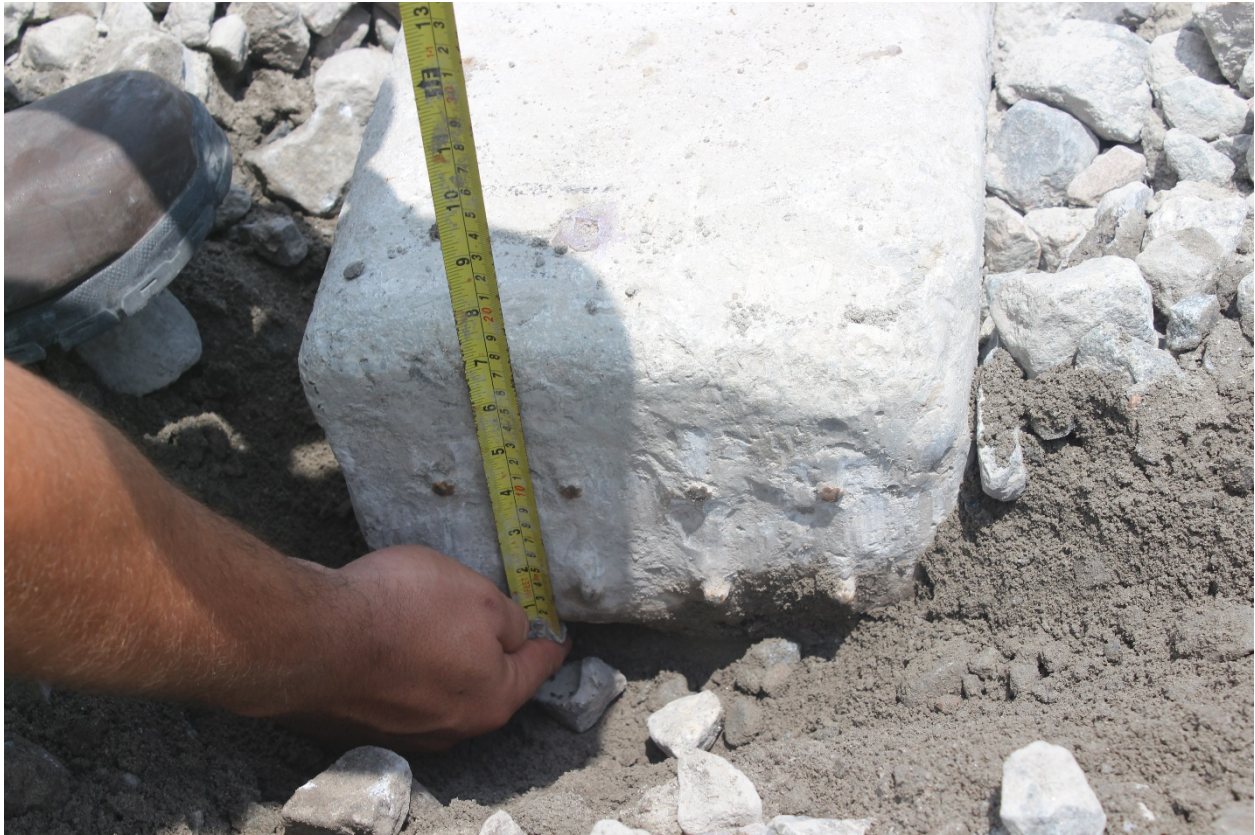
abrasion wear. One tie end had 1 in. of abrasion wear, see Figure B-16. A second tie was taken from track the following day and measured by the research team. The tie thickness for the second tie is shown in Table B-5.

Figure B-16: One-inch tie abrasion, Signal #2

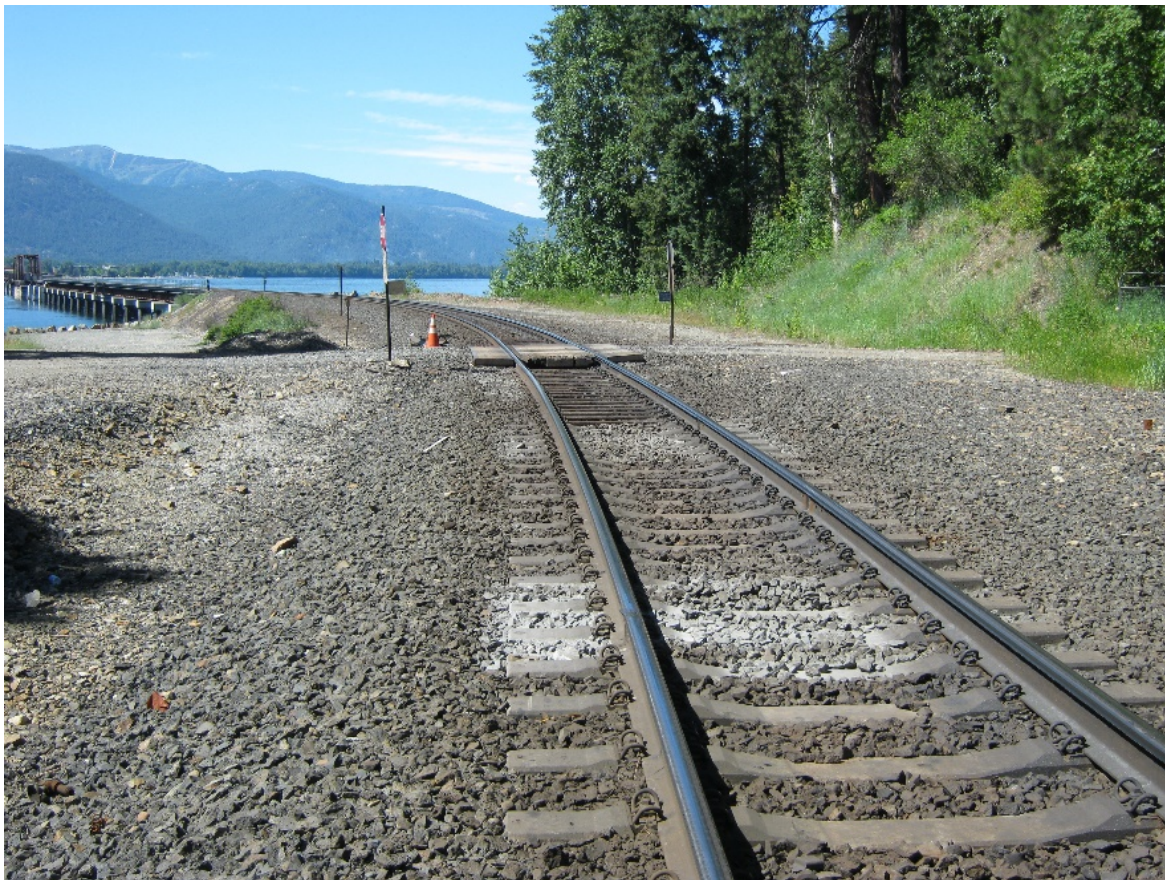
Figure C-3: Pumping area near curve, Crossing #1

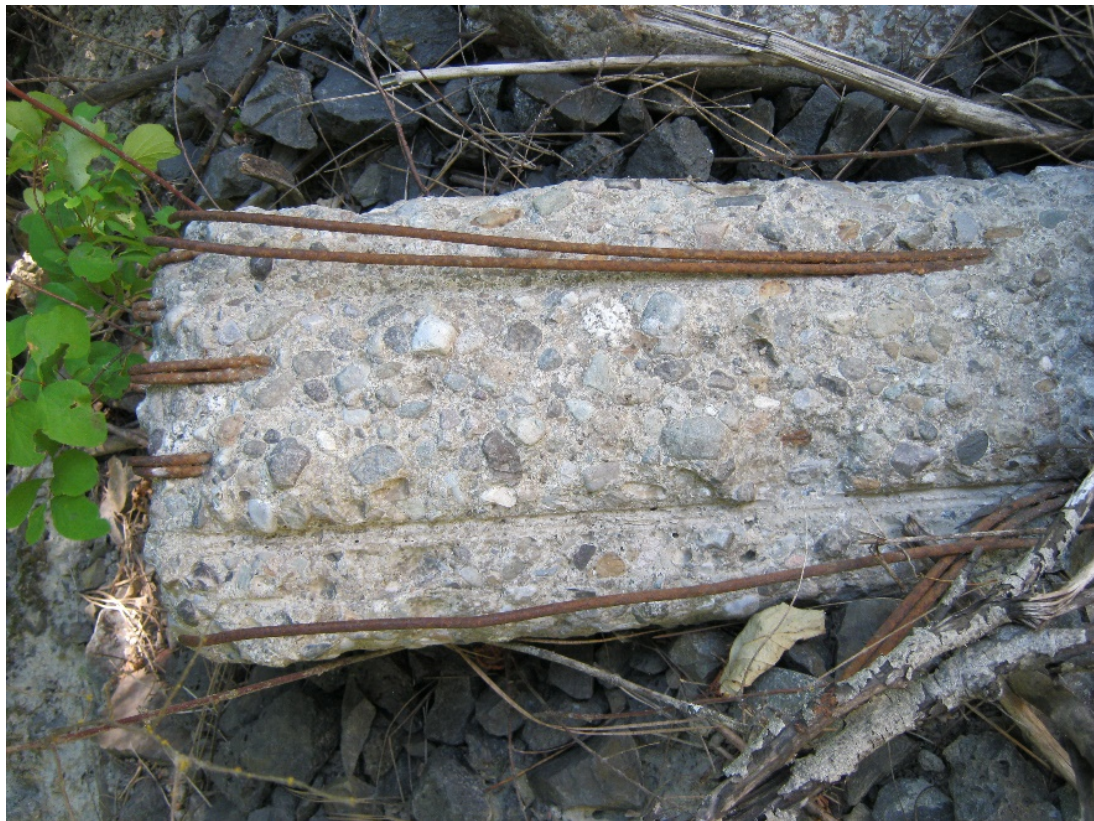
Figure C-5: Tie with abrasion removed from track, Crossing #1

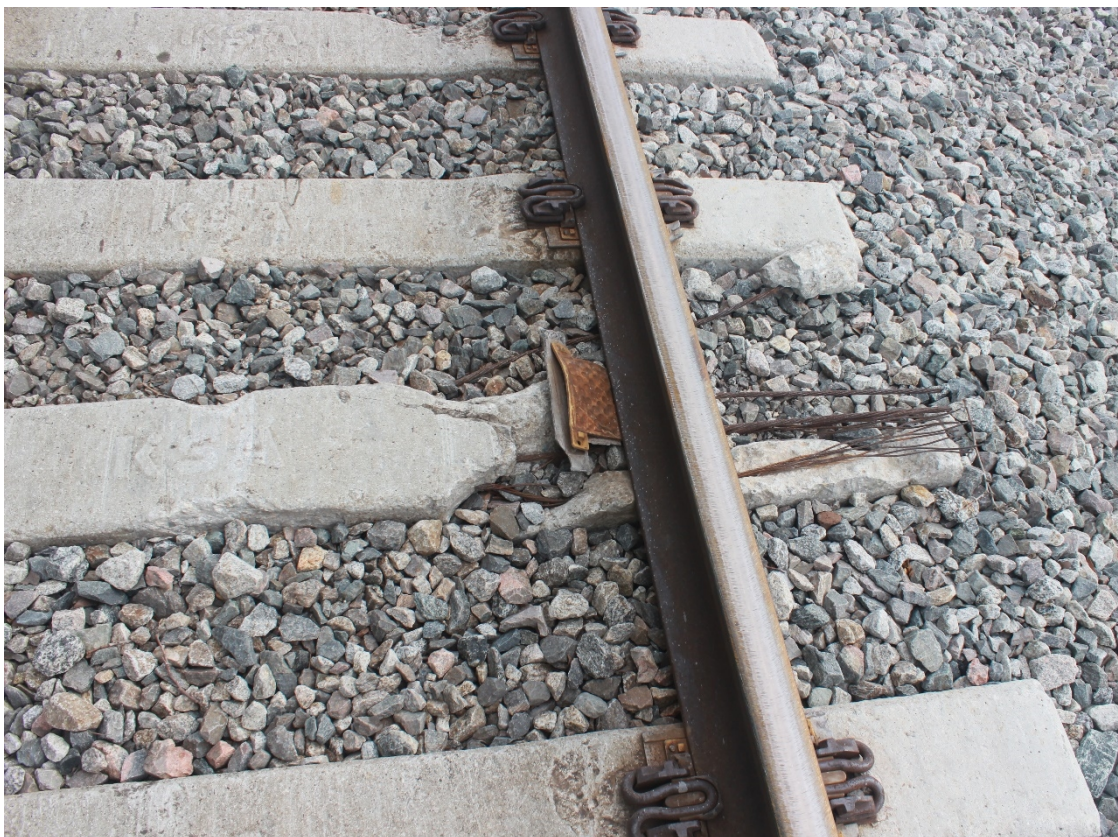
Figure C-15: Damaged tie from broken axle derailment, Crossing #3

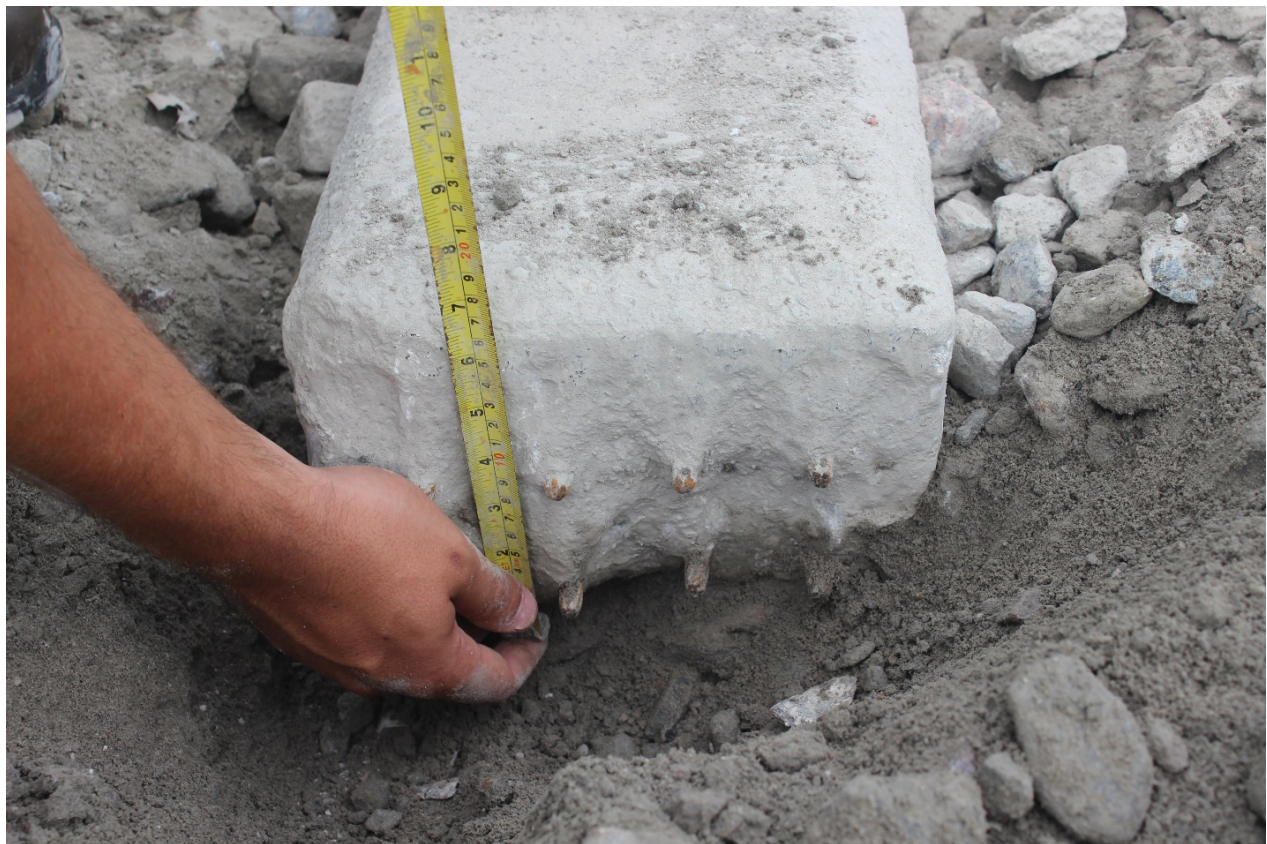
Location	Design thickness at location (in.)	Measured thickness (in.)	Estimated wear (in.)
Tie End	8.25	7.25	1.0
Center	7	5.5	1.5
Tie end	8.25	7.25	1.0

Figure C-17: One-inch abrasion on bottom of the tie. Crossing #3

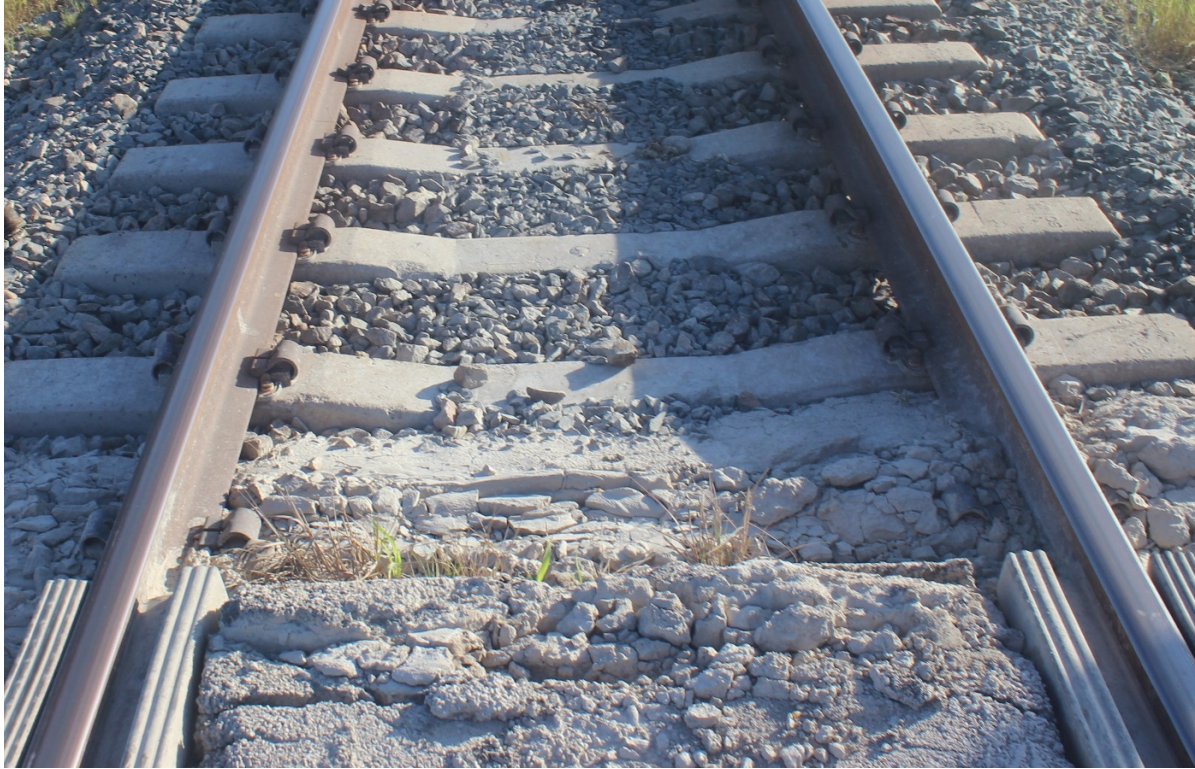
Gray mud was present in track on one end of the crossing. The surface grading on the end with gray mud was not as good as the opposite end, demonstrating how critical good drainage is to the long-term performance of railroad track structures. The railroad maintenance crew reported that the drainage pipes in the crossing require regular cleaning. Grass was growing in track indicating the presence of water, see Figure C-22. The asphalt crossing itself showed evidence of water intrusion, settling, and deterioration, as shown in Figure C-23. This is further evidence that the grading on site was not optimal.

Figure C-22: Excessive pumping and vegetation, Crossing #4

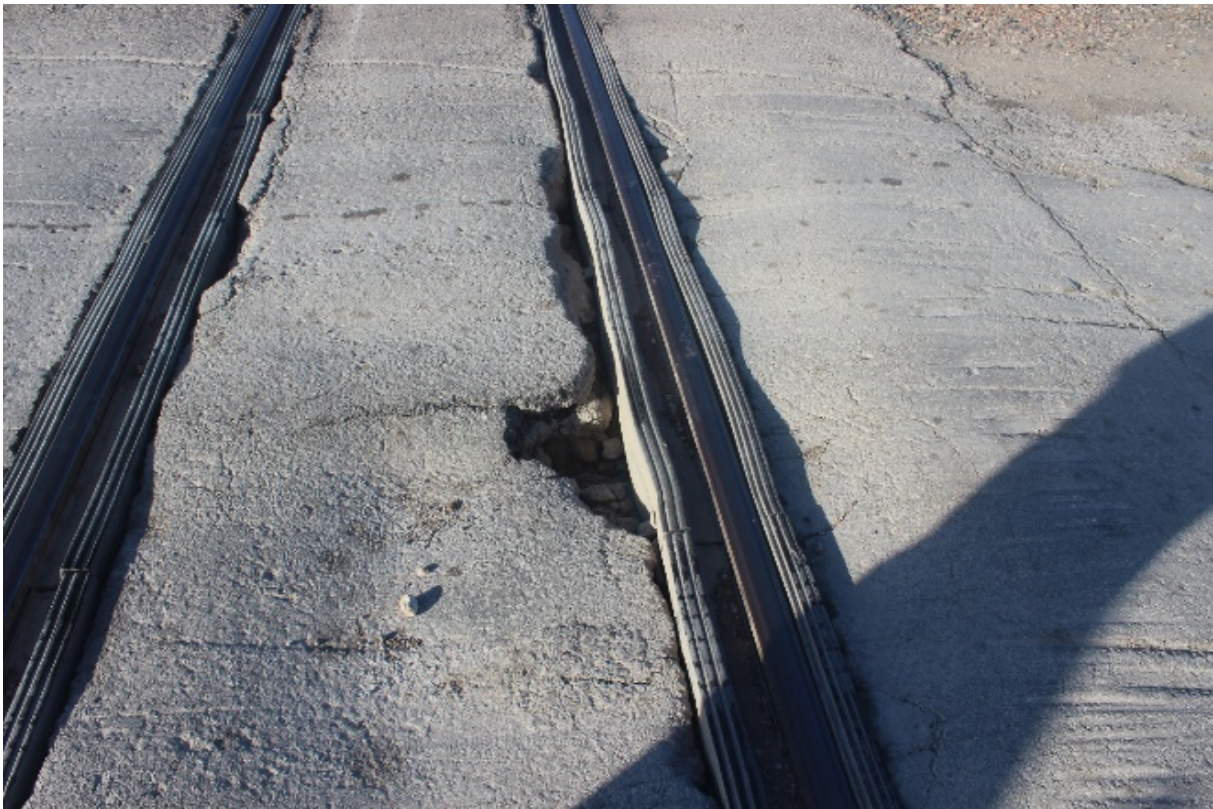
Figure C-23: Asphalt crossing defects, Crossing #4
