**Federal Railroad
Administration**

A Study of Environmental and Track Factors that Contribute to Abrasion Damage of Concrete Ties

9. SPONSORING/MONITORING AGENCY NAME(S) AND ADDRESS(ES) U.S. Department of Transportation Federal Railroad Administration Office of Railroad Policy and Development Office of Research, Development and Technology Washington, DC 20590			10. SPONSORING/MONITORING AGENCY REPORT NUMBER DOT/FRA/ORD-19/38

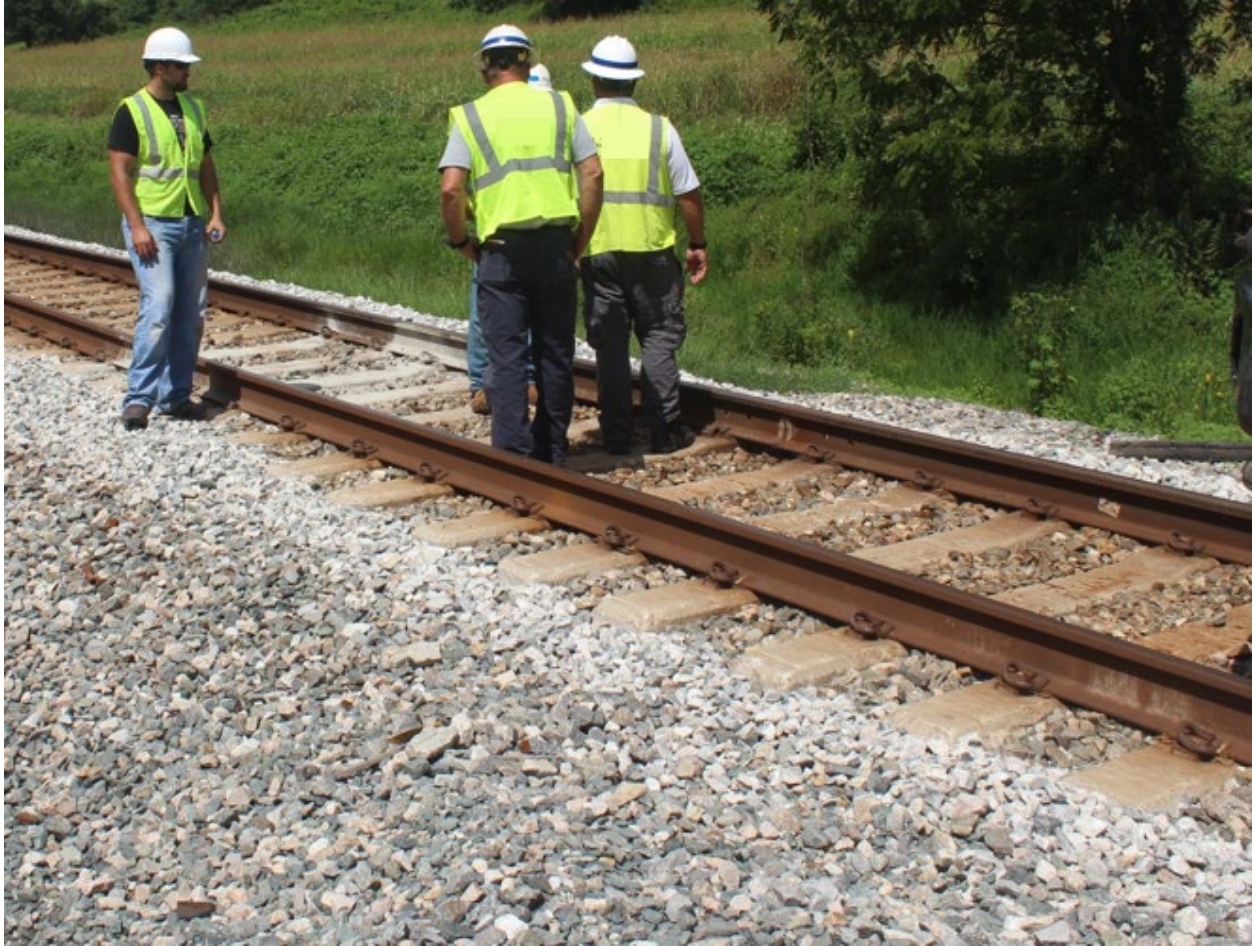
Figure C-37: Ballast fouling seen in track on four ties, Crossing #6

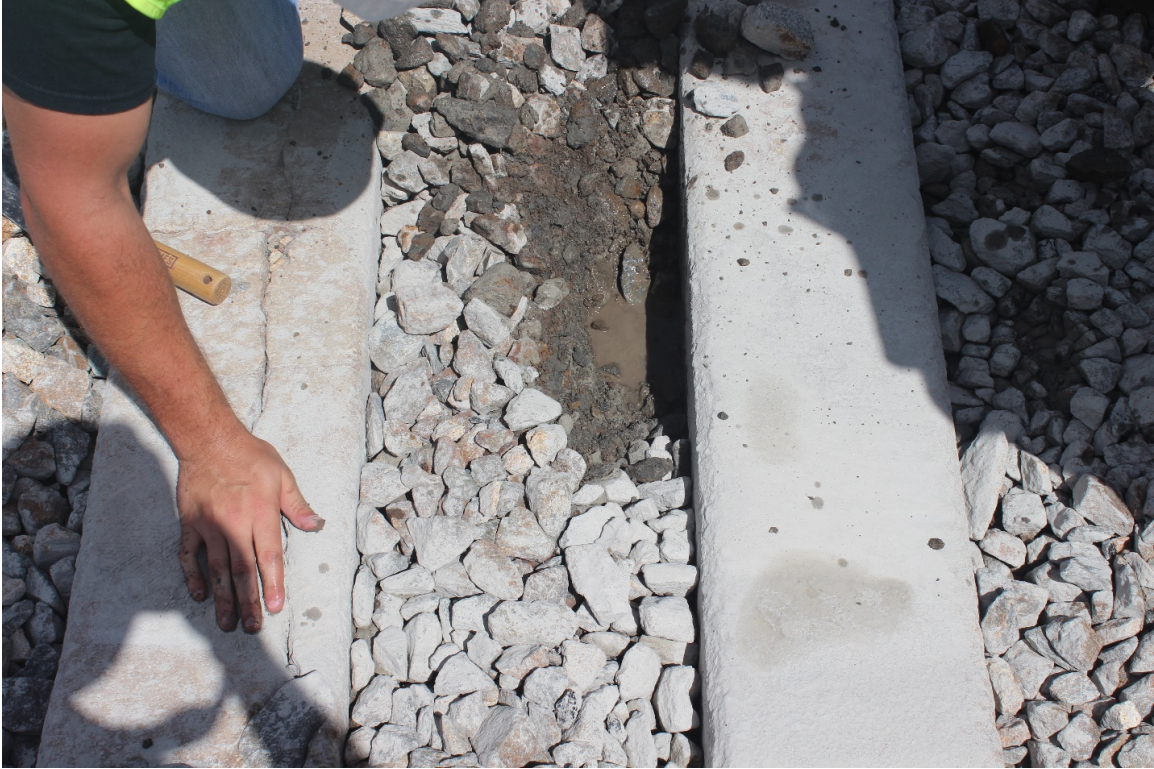
Figure C-38: Mud pumping adjacent to cracked tie, Crossing #6

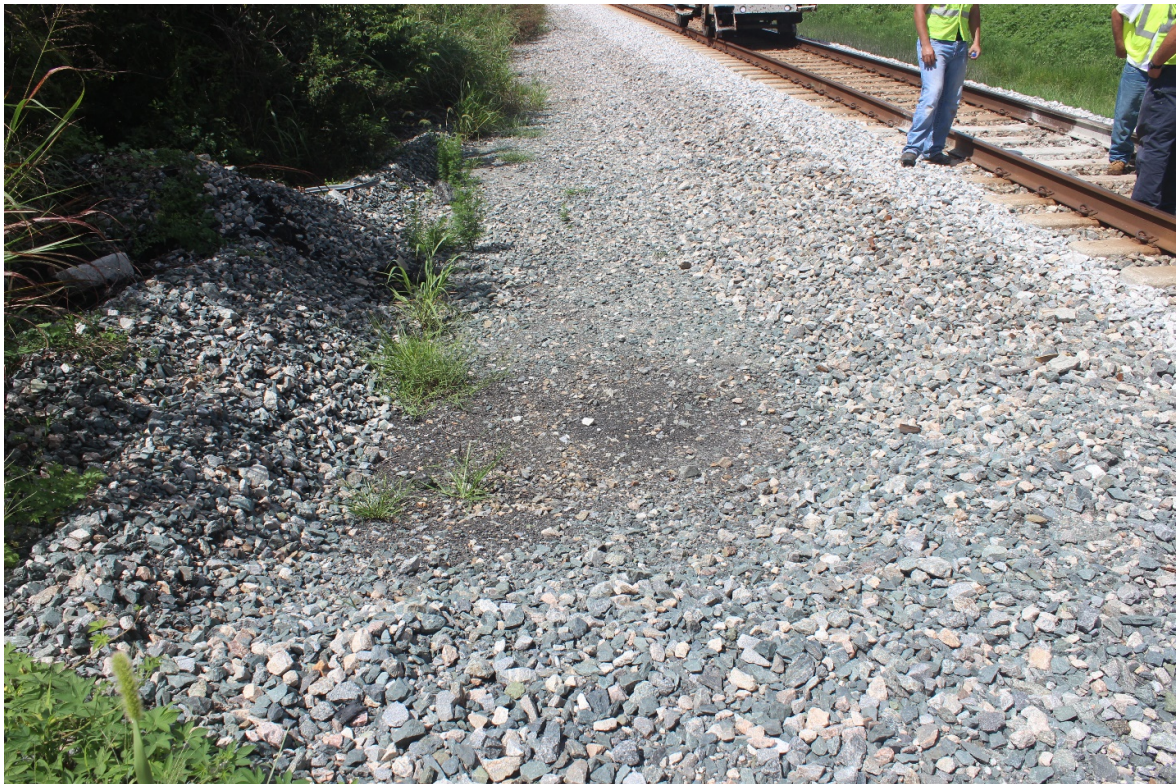
Figure C-39: Fines seen on the ballast shoulders, Crossing #6

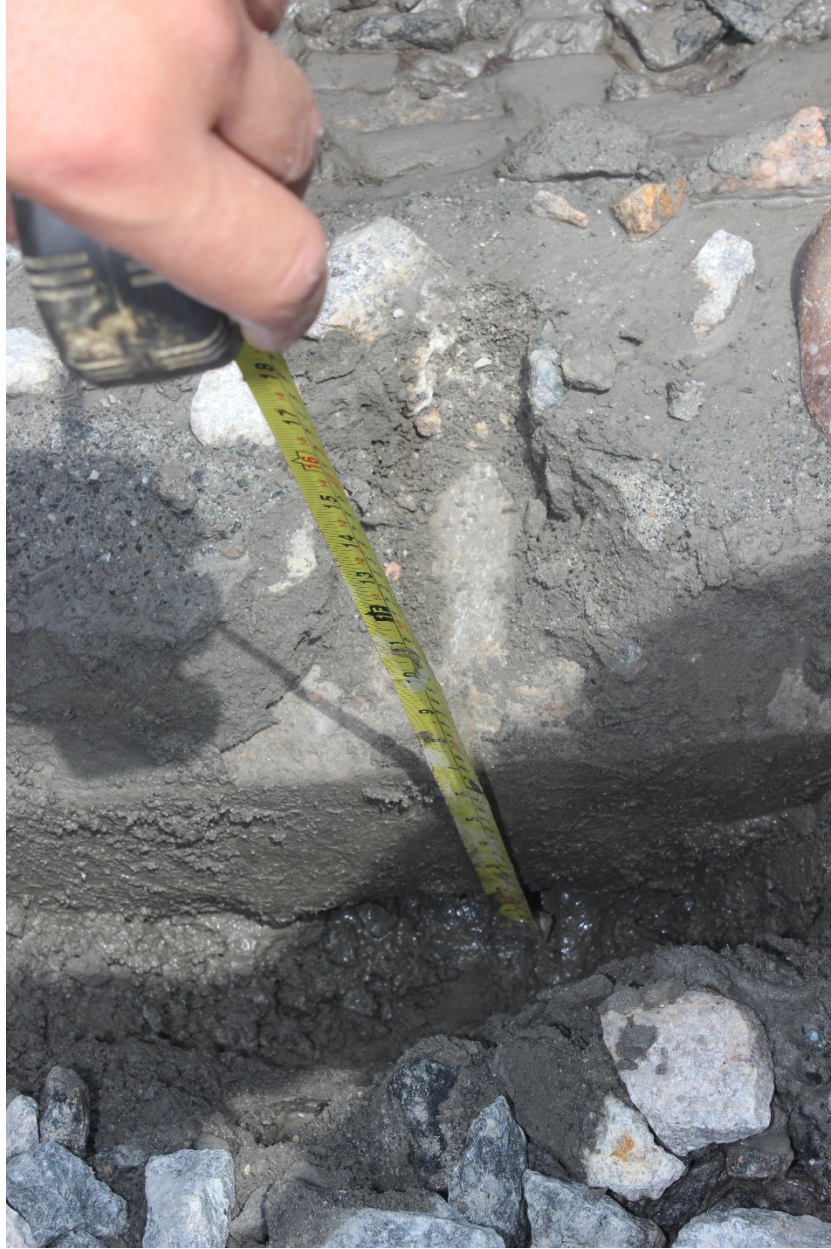
Location	Design thickness at location (in.)	Measured thickness (in.)	Estimated wear (in.)
Tie End	8.25	6.75	1.5

Figure C-48: Tie thickness measurement, Crossing #8

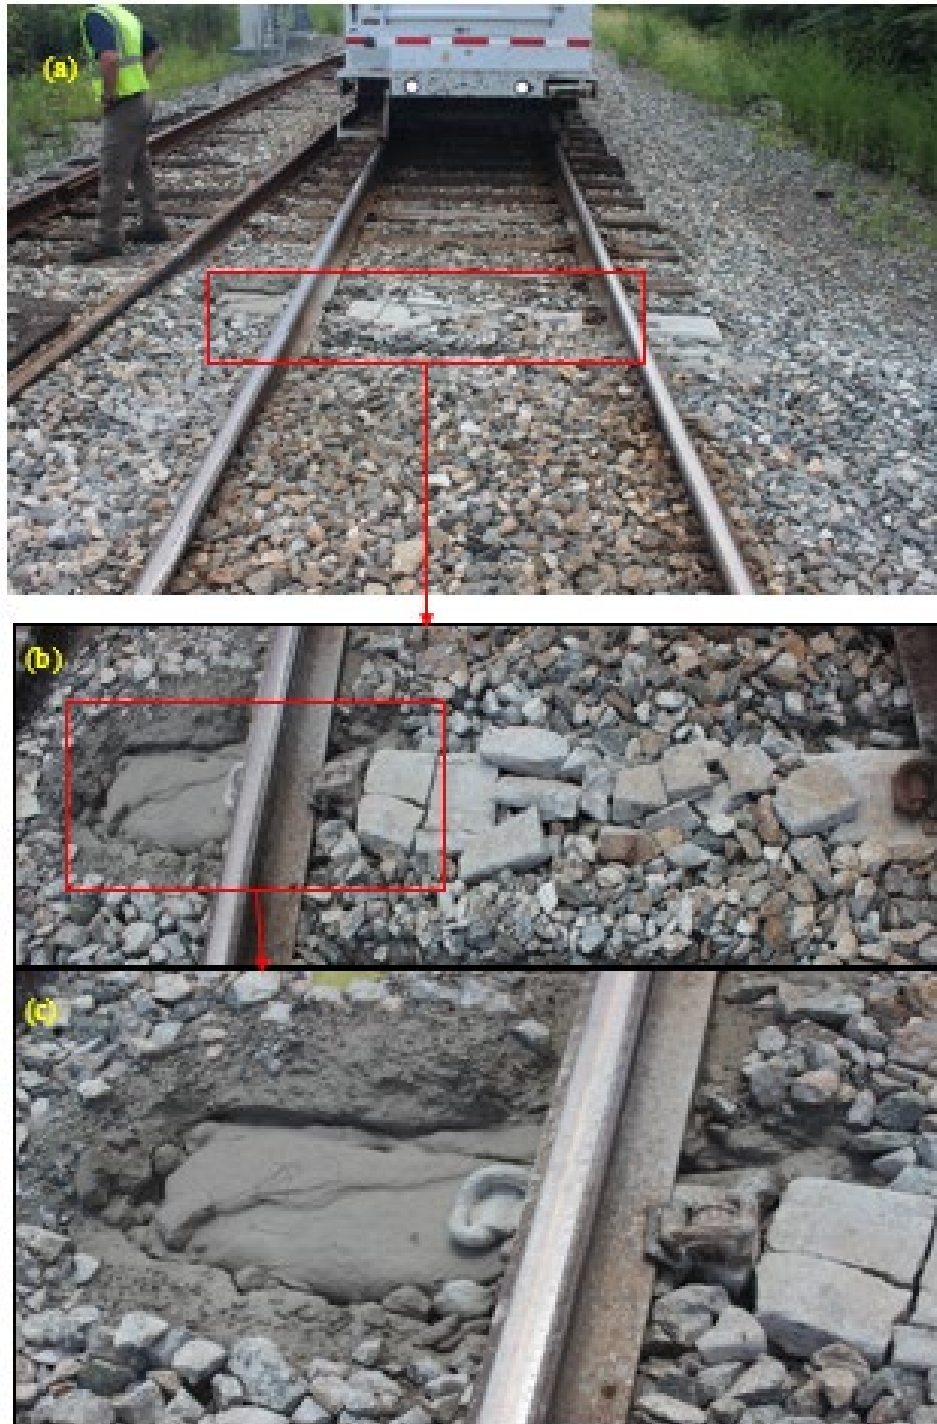
Figure C-53: Shattered tie in transition to wood, Crossing #9

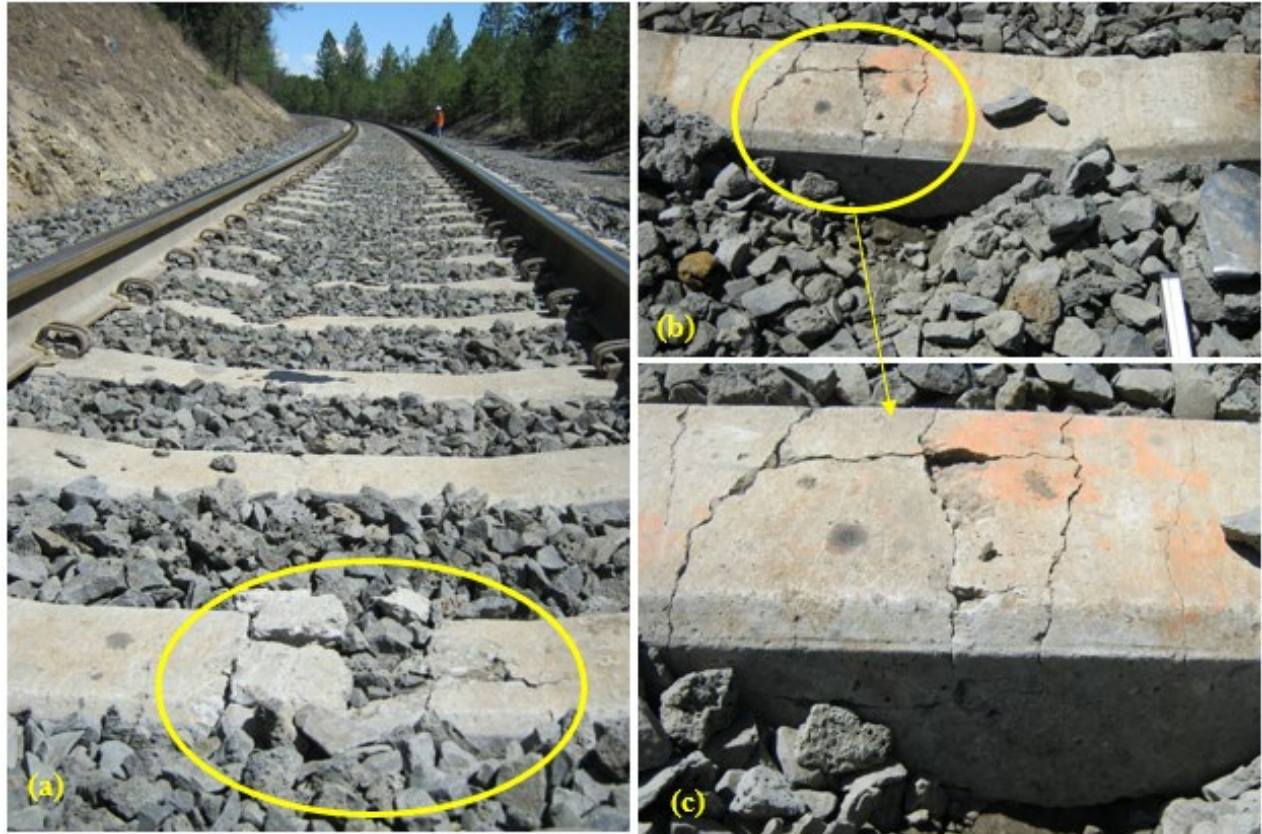
Figure D-3: Severe center binding cracking, Curve #1

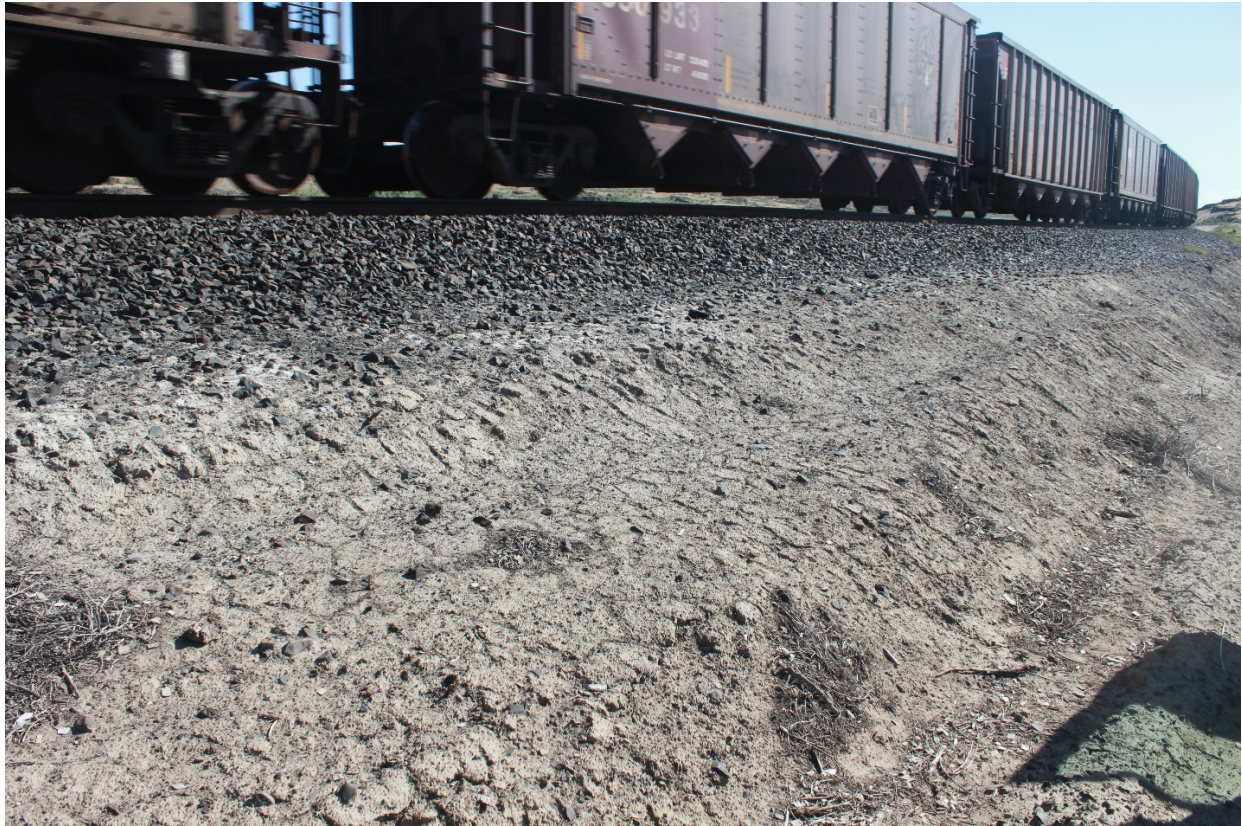
Figure D-12: Mud-flat cracking on track embankment, Curve #2

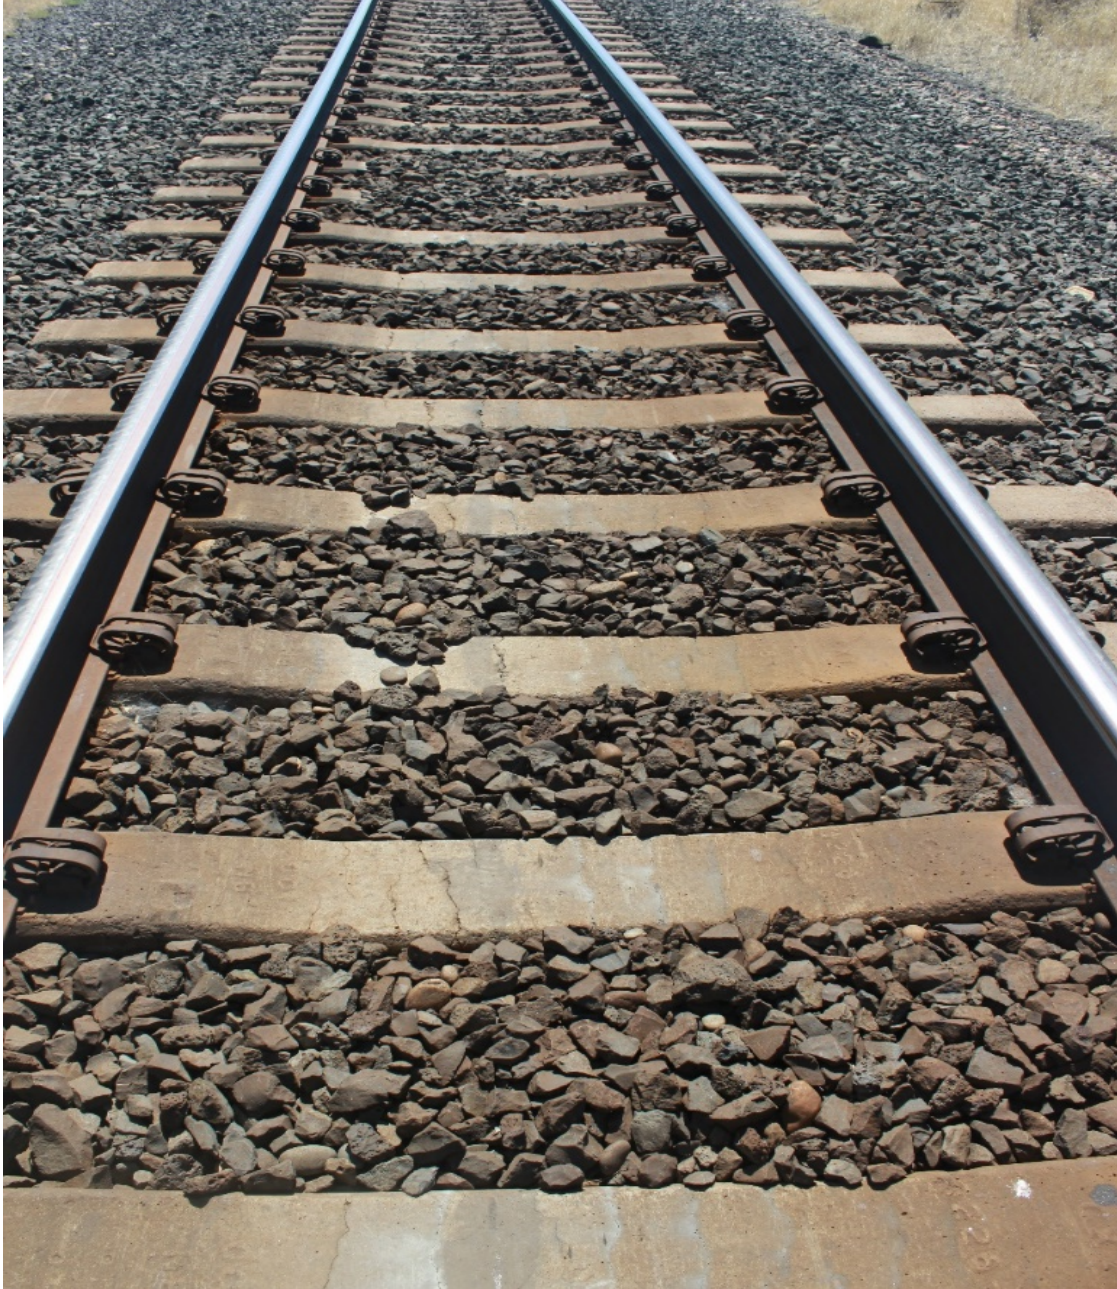
Figure D-16: Center-binding cracking, Curve #3

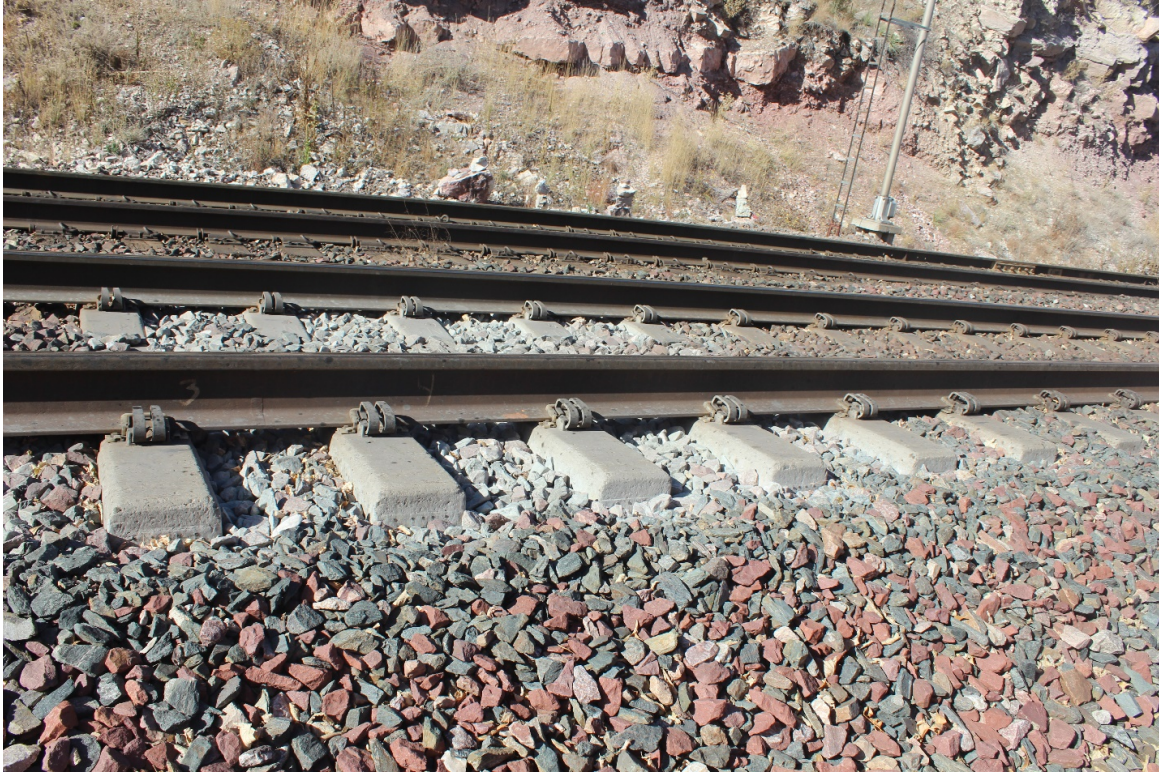
Figure D-17: Ballast churn seen on-site

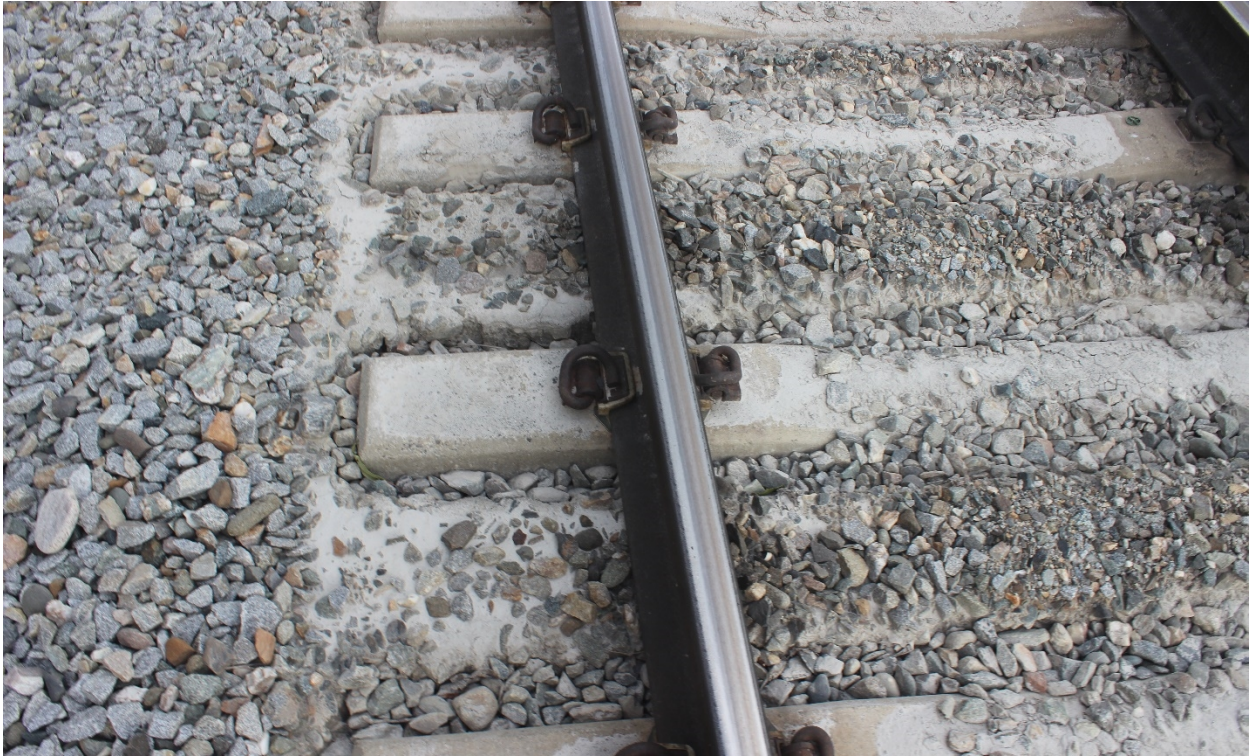
Figure D-23: Pumping seen in track, Curve #5

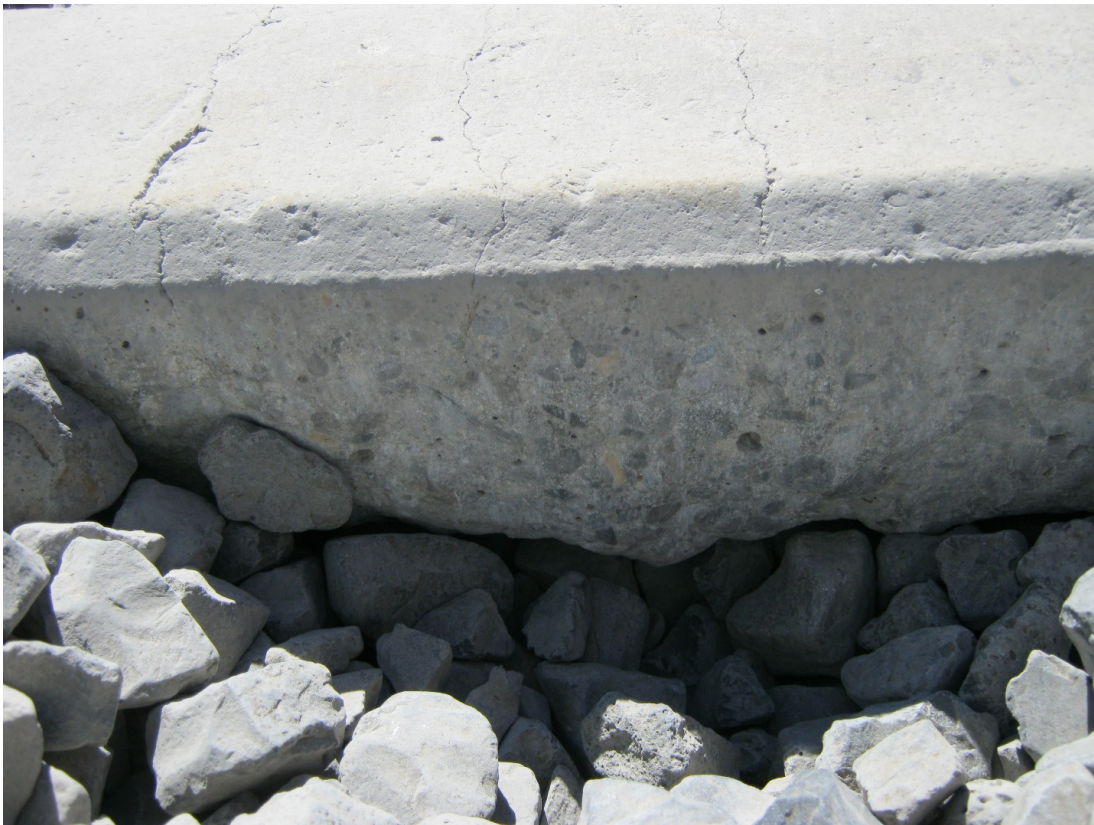
Figure E-7: Center binding cracking and tie rounding, Tangent #2

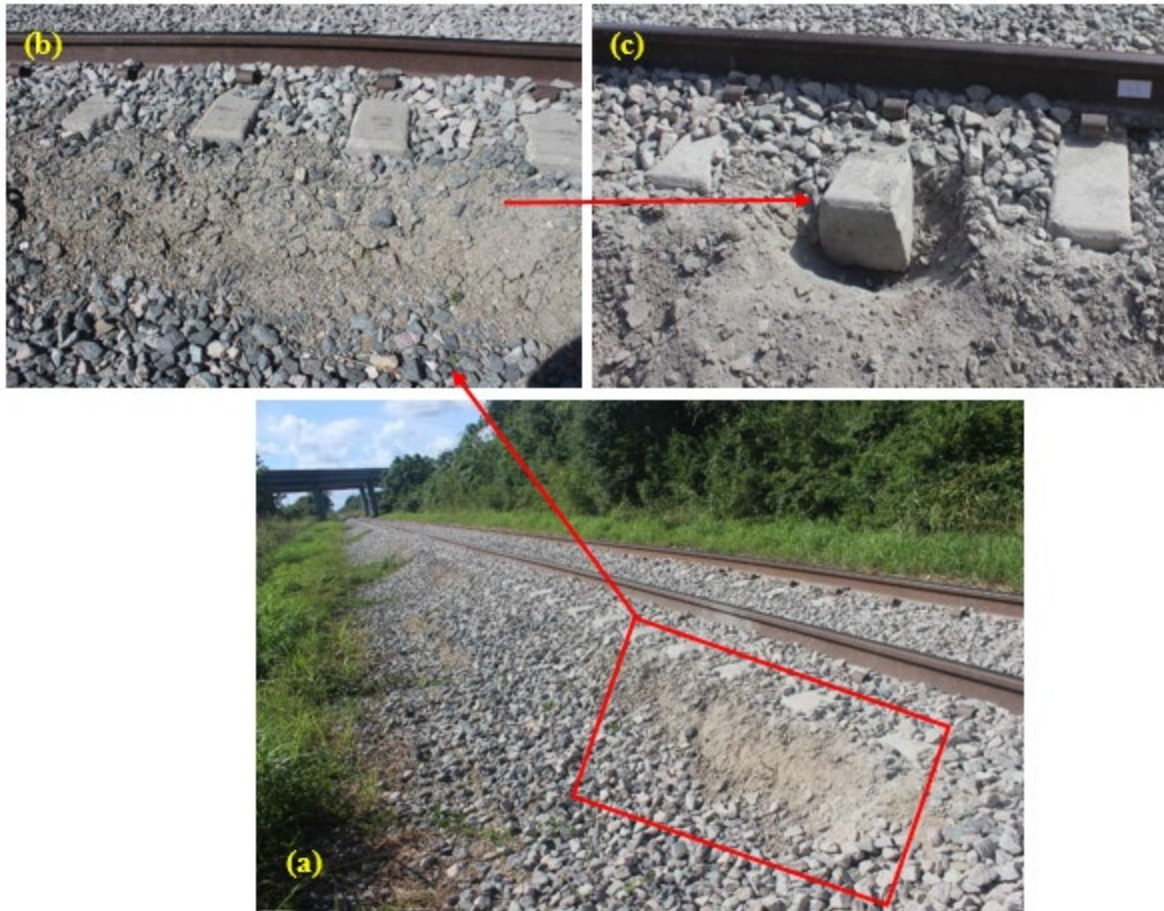
Figure E-11: Pumping on the sides of the track, Tangent #3

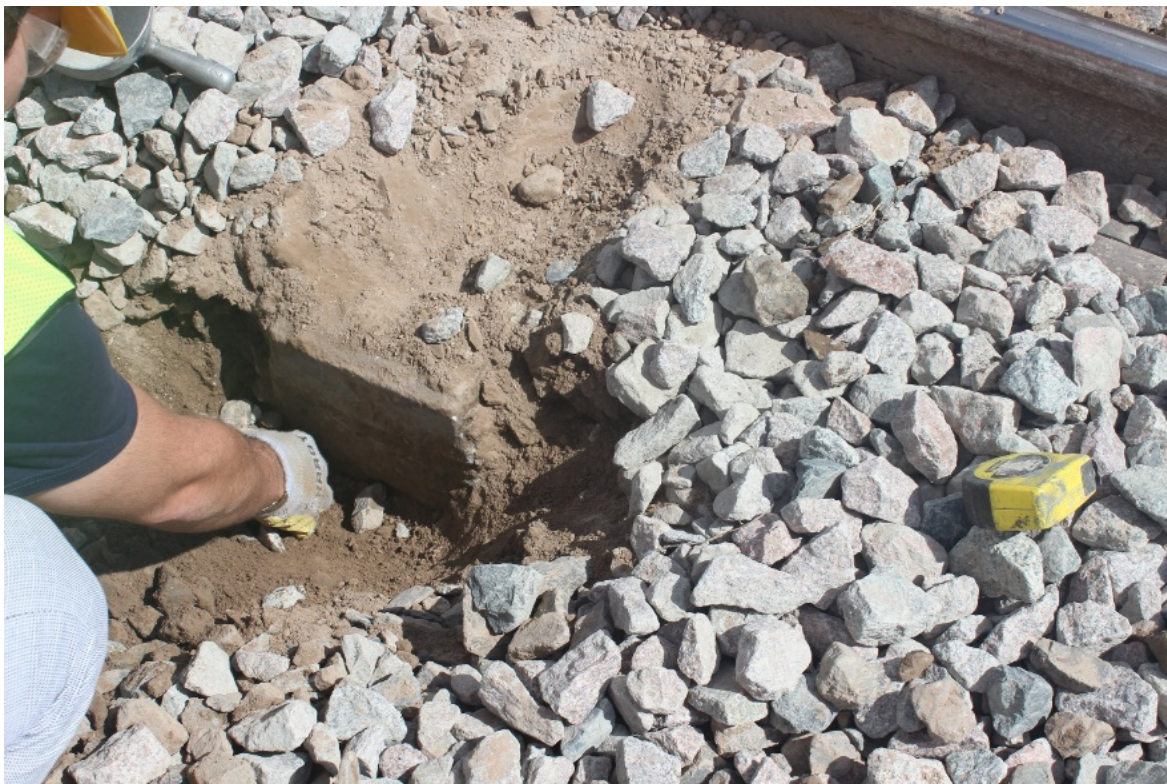
Figure E-16: Pumping due to the insufficient ballast layer thickness, Tangent #4

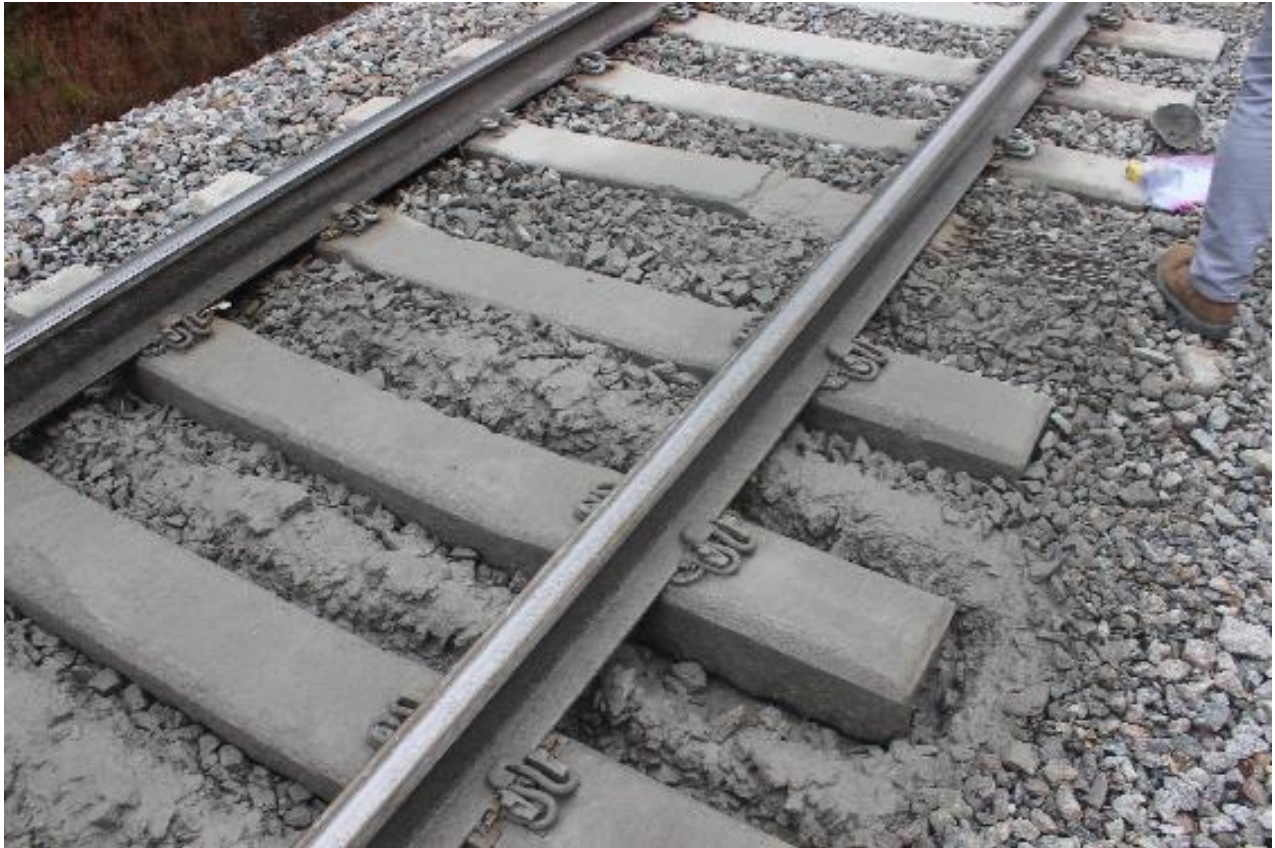
Figure E-23: Mud spot in track, Tangent #6

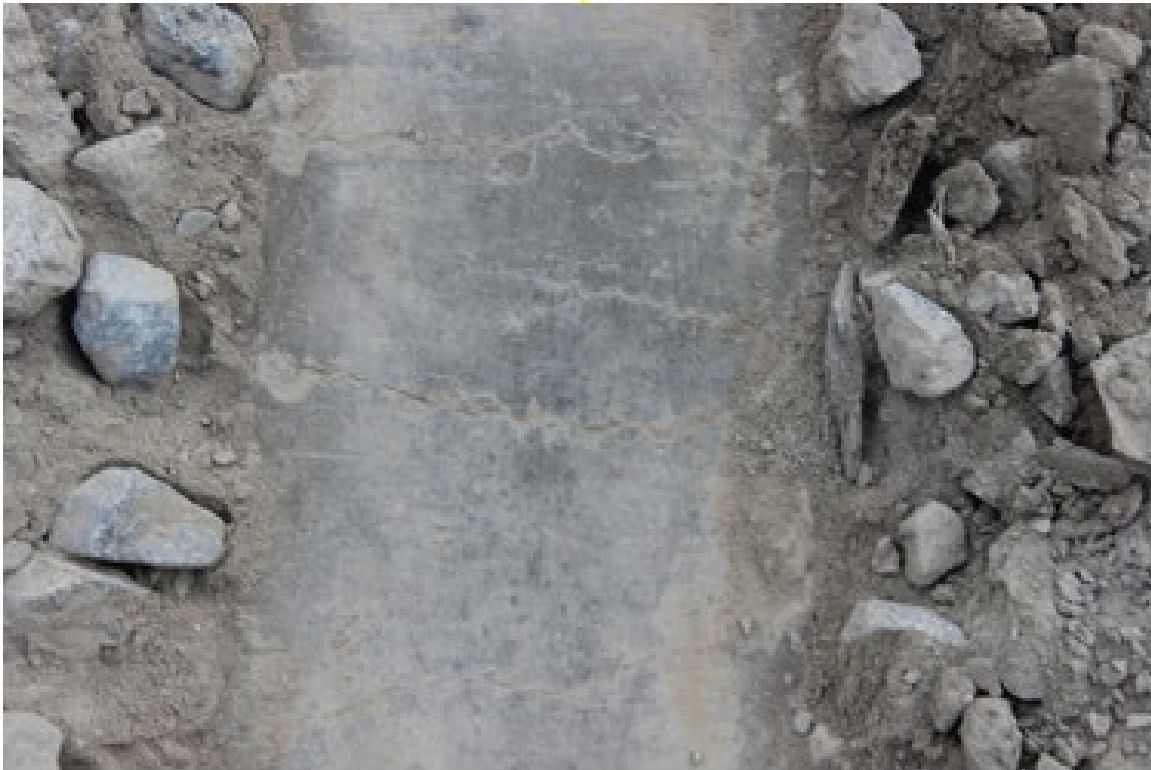
Figure E-34: Tie cracking, Tangent #7

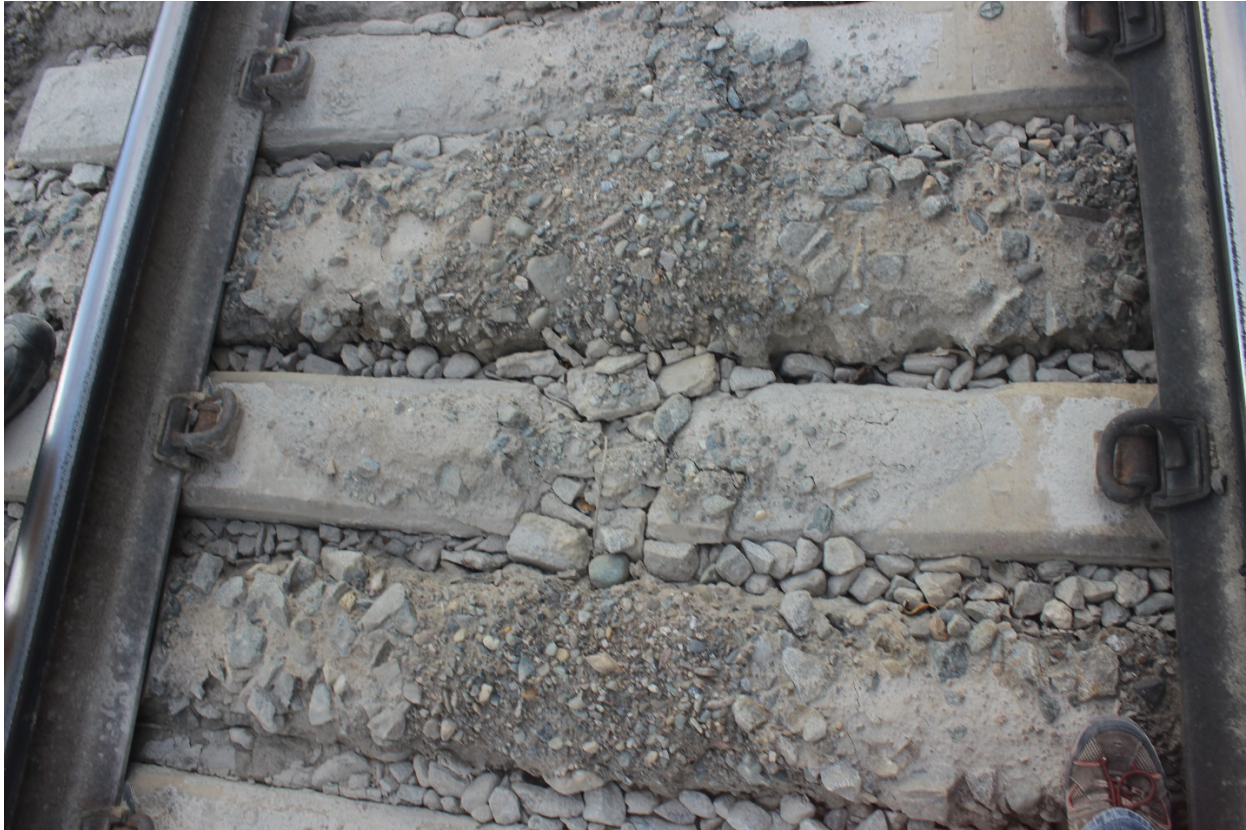
Figure E-35: Shattered tie, Tangent #7

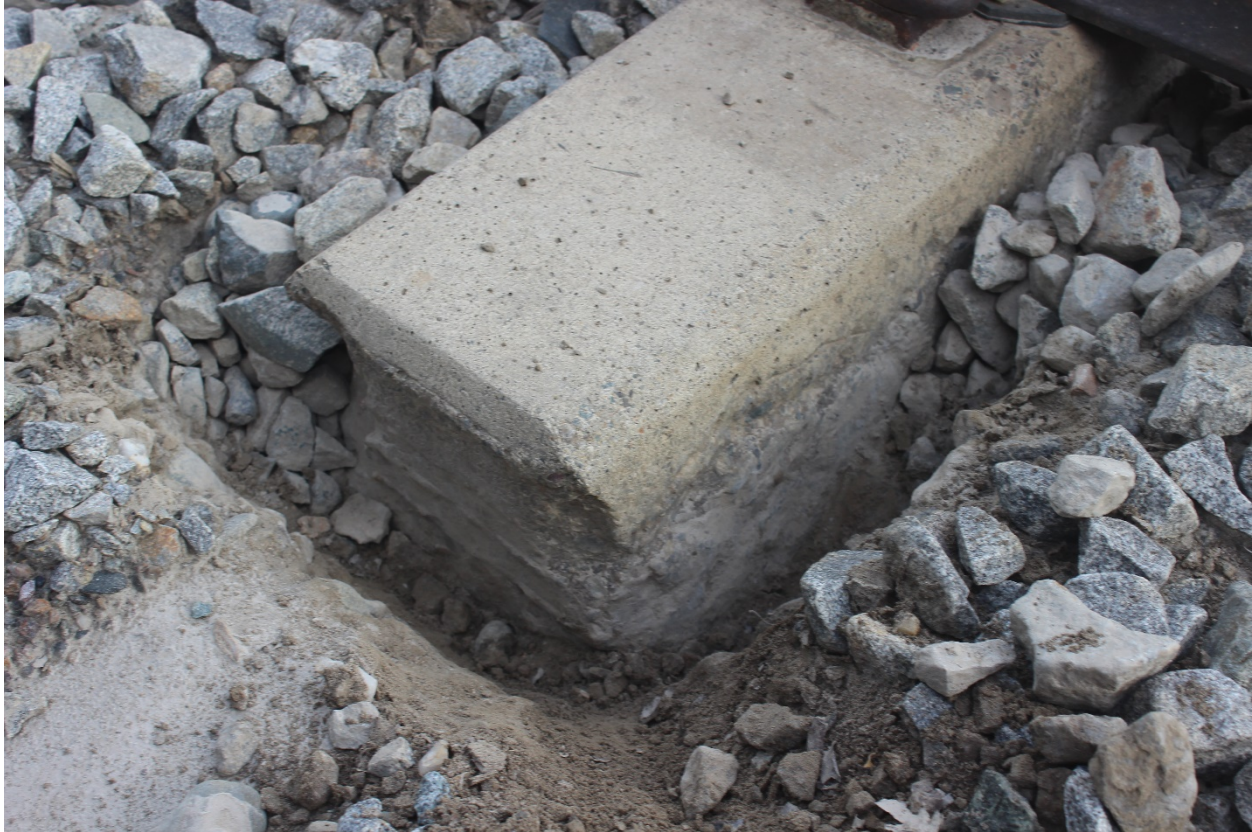
Figure E-40: Tie end wear, Tangent #7

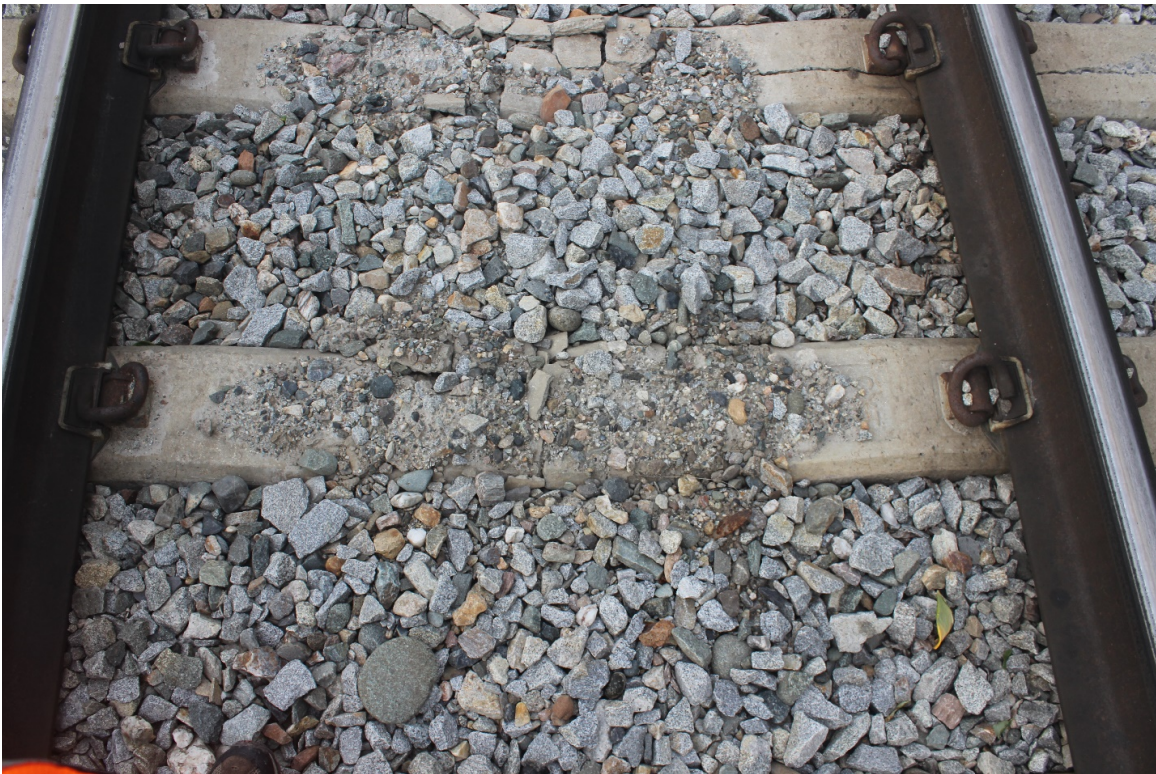
Figure E-47: Damaged ties, Tangent #9

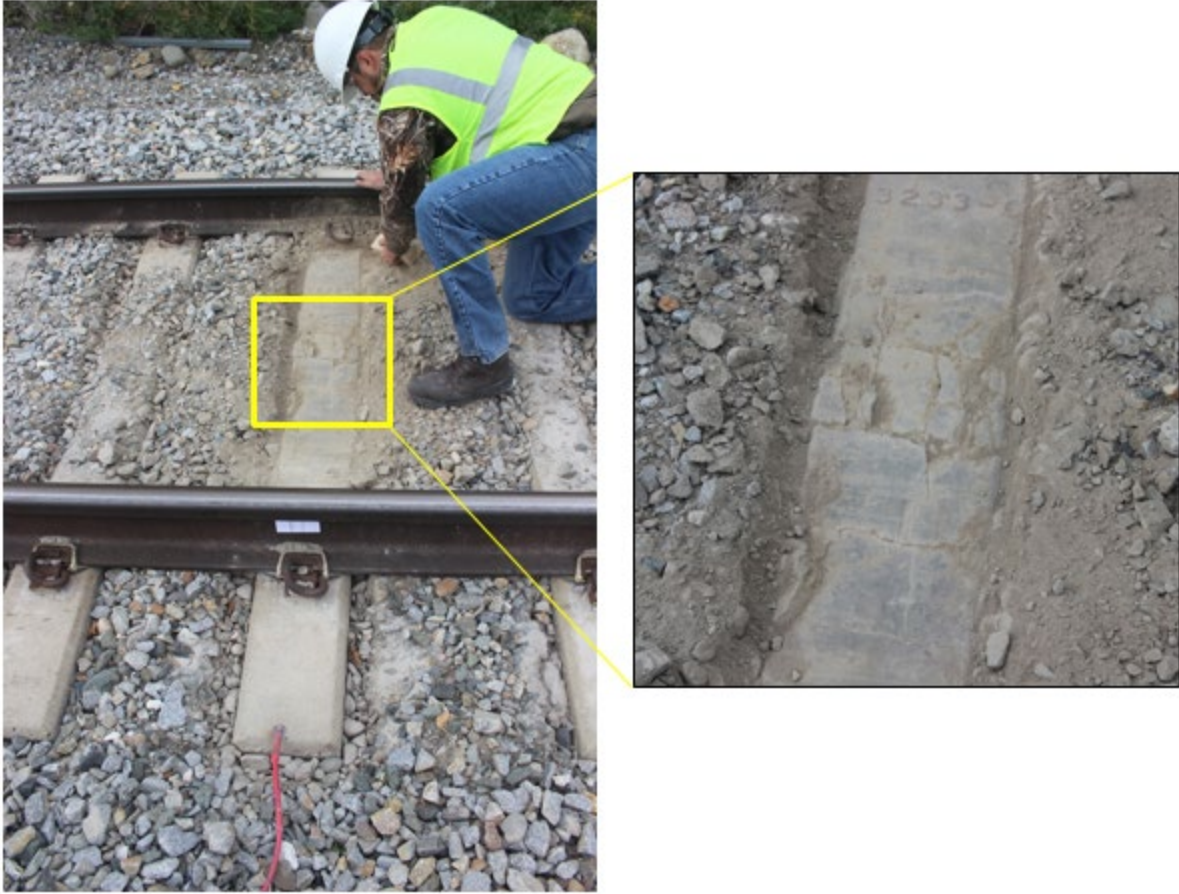
Figure E-48: Tie center binding cracks, Tangent #9

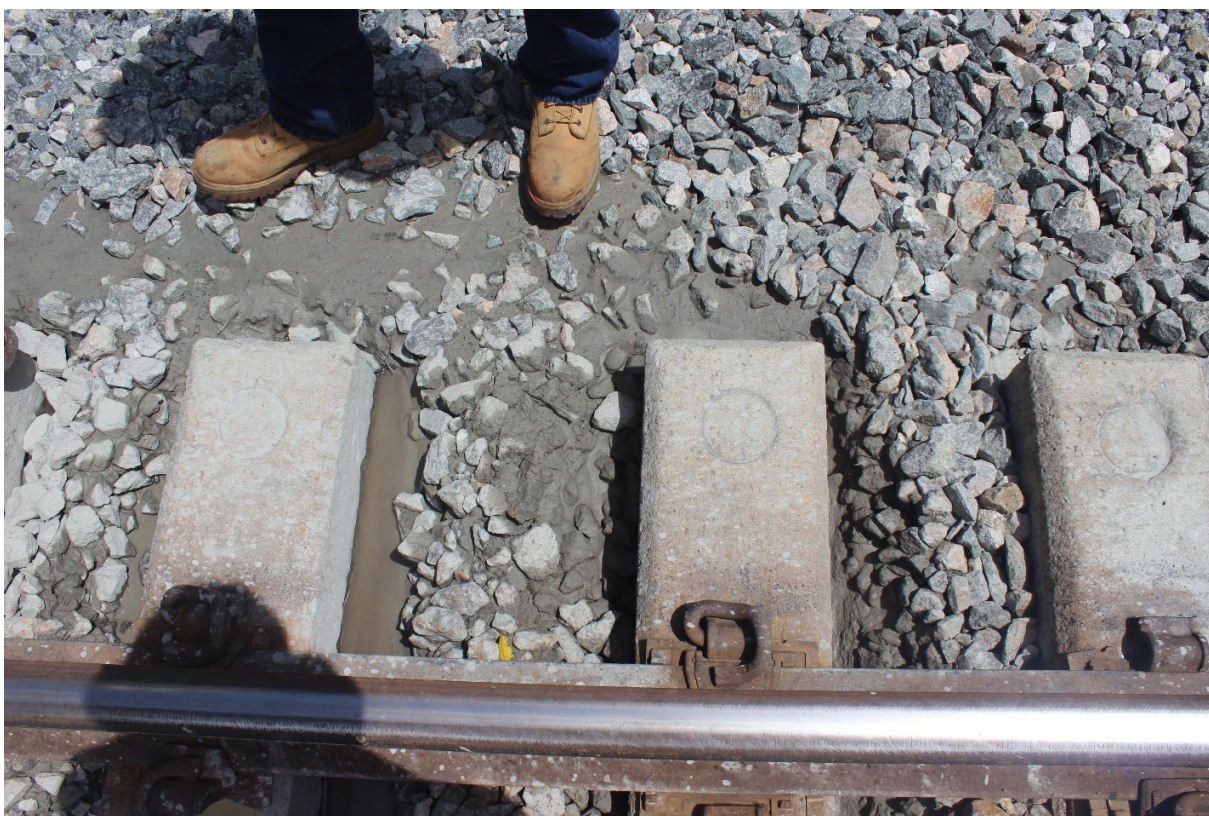
Figure E-54: Fine particles and water in track, Tangent #10

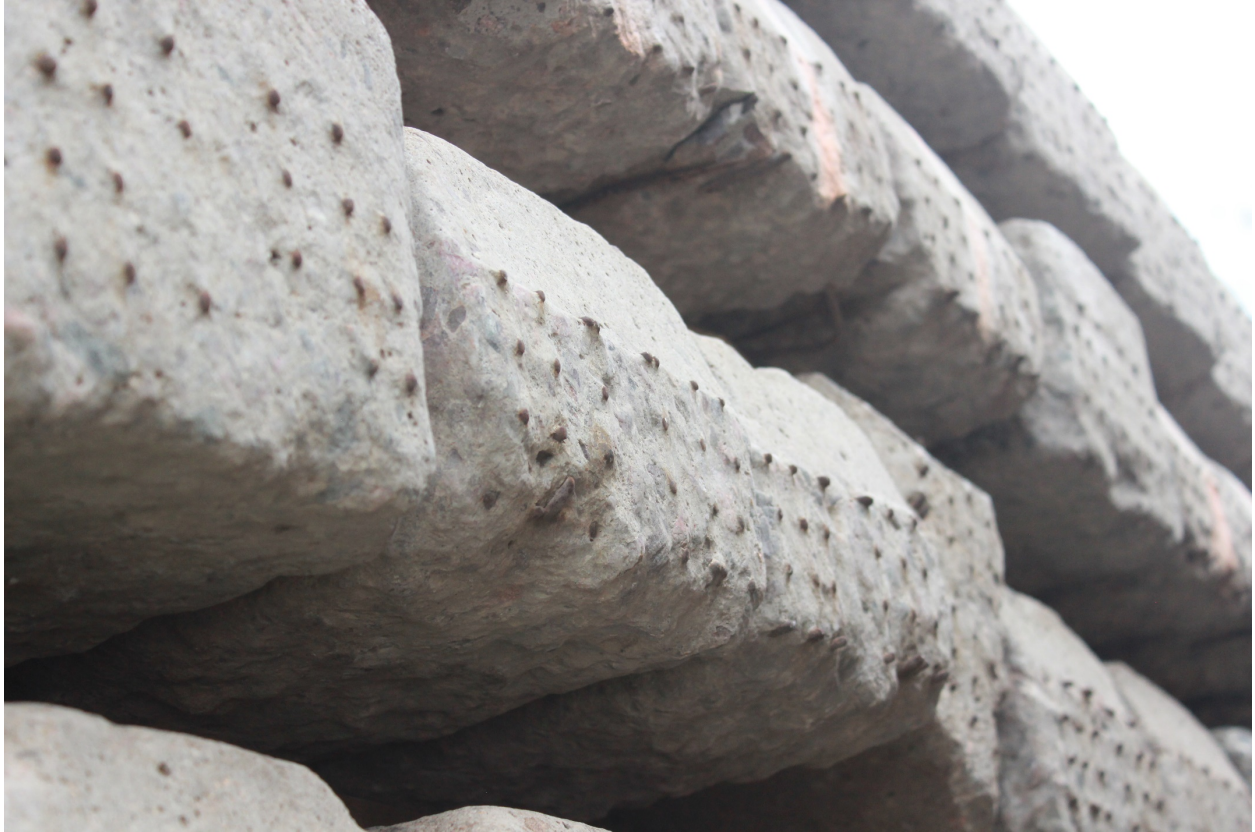
Figure F-5: Tie ends with minor-to-moderate bottom abrasion damage, Boneyard #1
