**Federal Railroad
Administration**

A Study of Environmental and Track Factors that Contribute to Abrasion Damage of Concrete Ties

9. SPONSORING/MONITORING AGENCY NAME(S) AND ADDRESS(ES) U.S. Department of Transportation Federal Railroad Administration Office of Railroad Policy and Development Office of Research, Development and Technology Washington, DC 20590			10. SPONSORING/MONITORING AGENCY REPORT NUMBER DOT/FRA/ORD-19/38

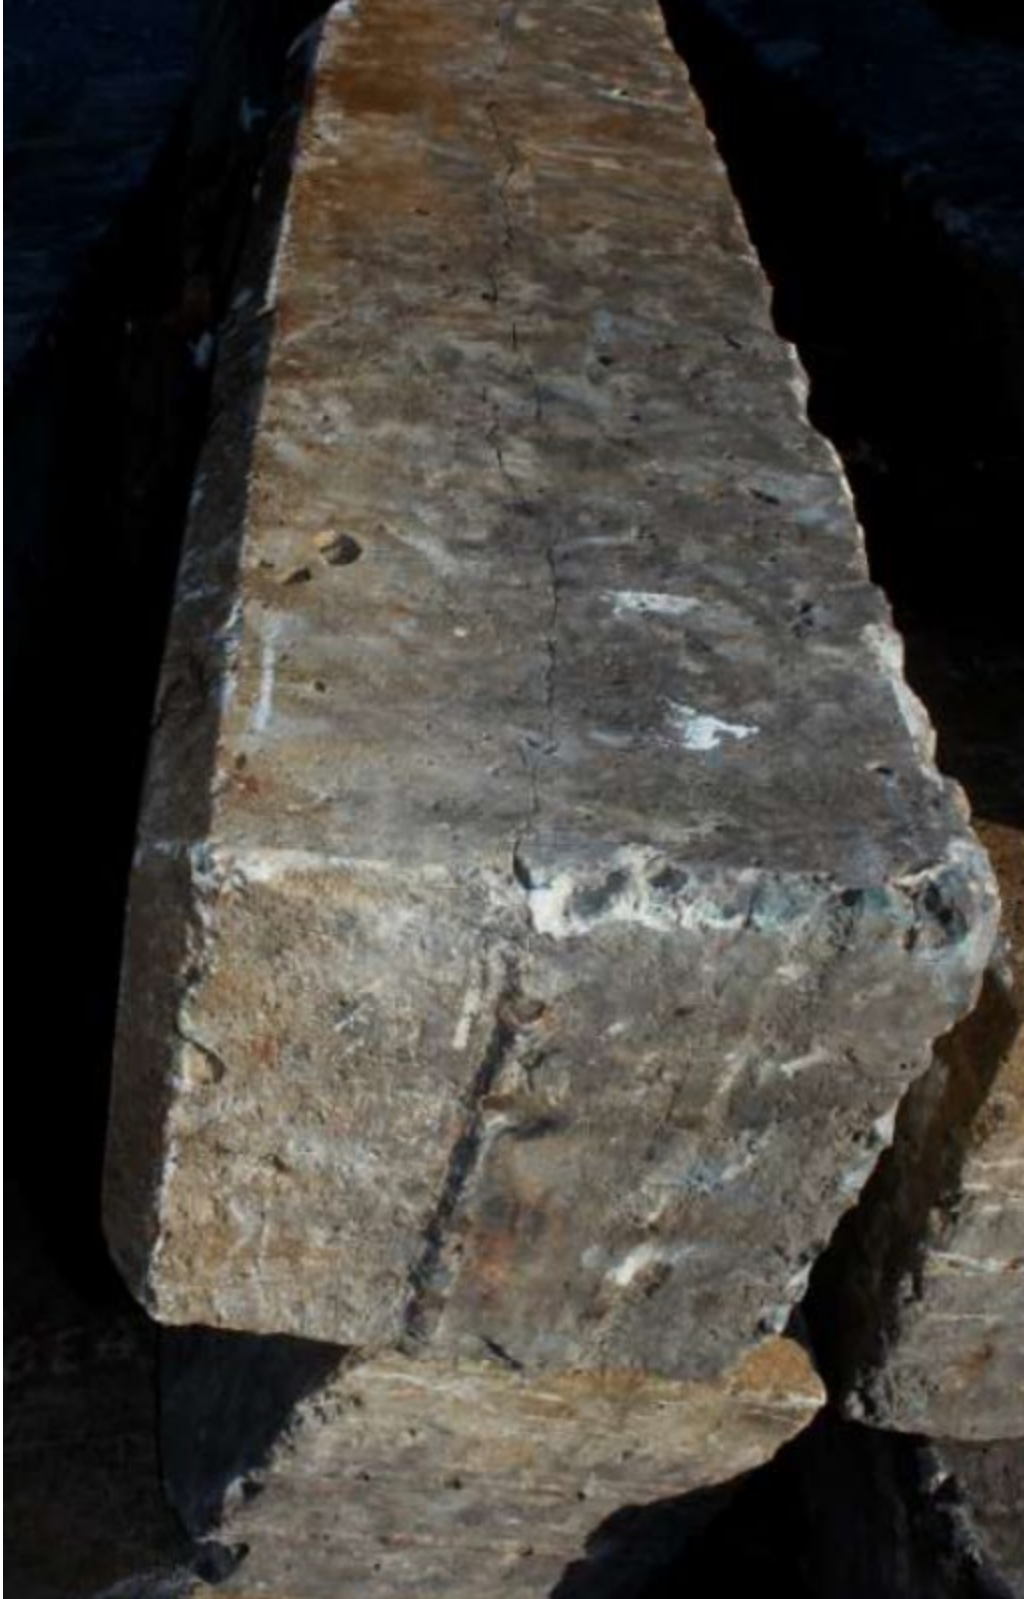
Figure F-9: Longitudinal splitting cracking seen in tie in stack 1, Boneyard #2

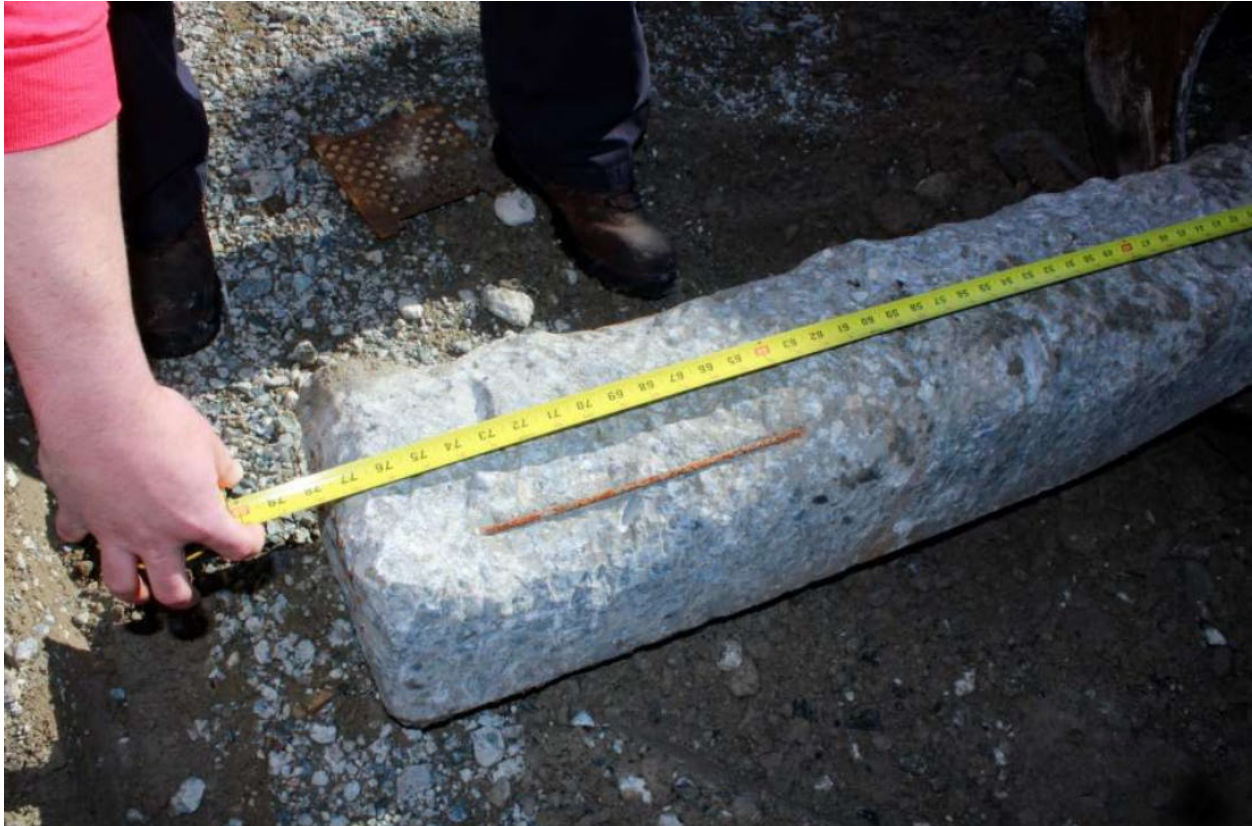
Figure F-10: Tie with severe abrasion wear in stack 2, Boneyard #2

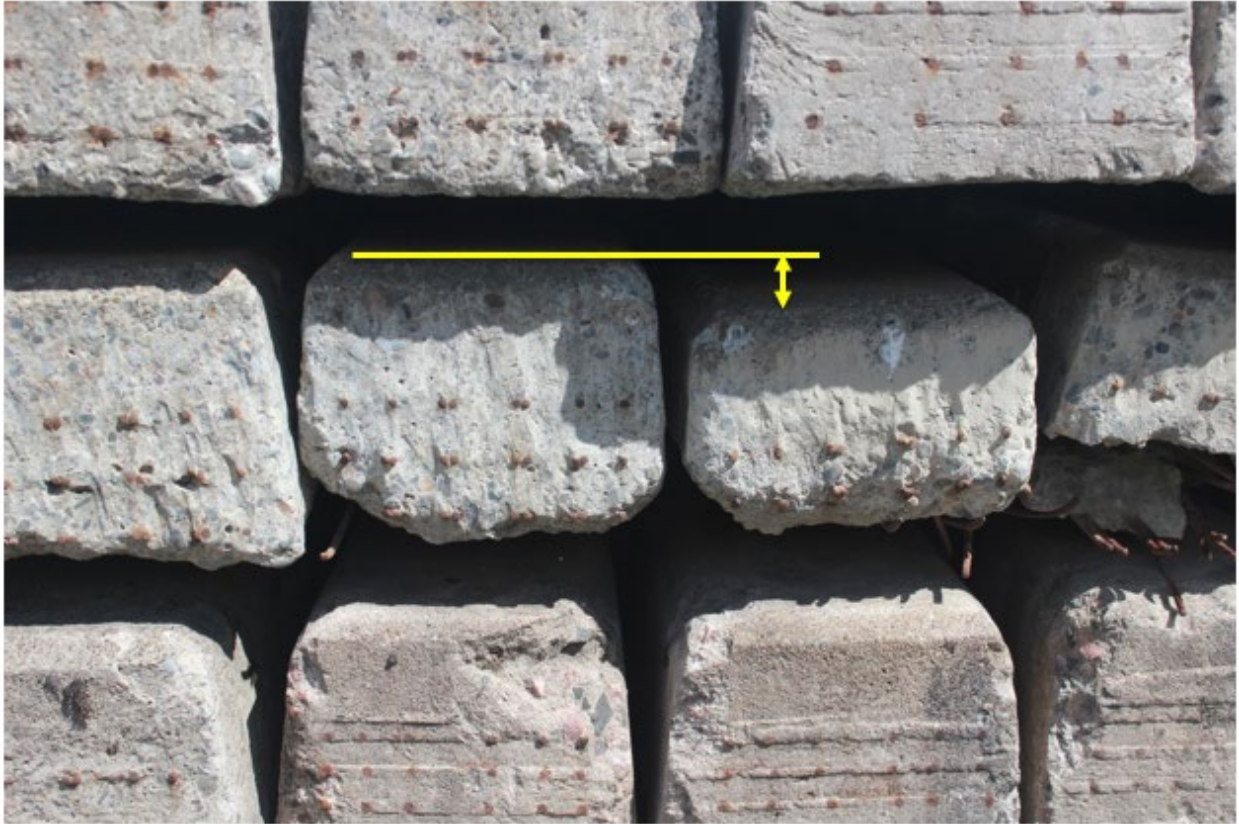
Figure F-13: Rounding of tie bottom corners seen in some ties, Boneyard #3
