# **Evaluation of Bridge Decks Using Non-Destructive Evaluation (NDE) at Near Highway Speeds for Effective Asset Management – Implementation for Routine Inspection (Phase III)**

**Element Level Condition State Assessment,  
Comparison to Traditional Methods, and Cost and  
Time Comparison Analysis mini reports**

October 09, 2018

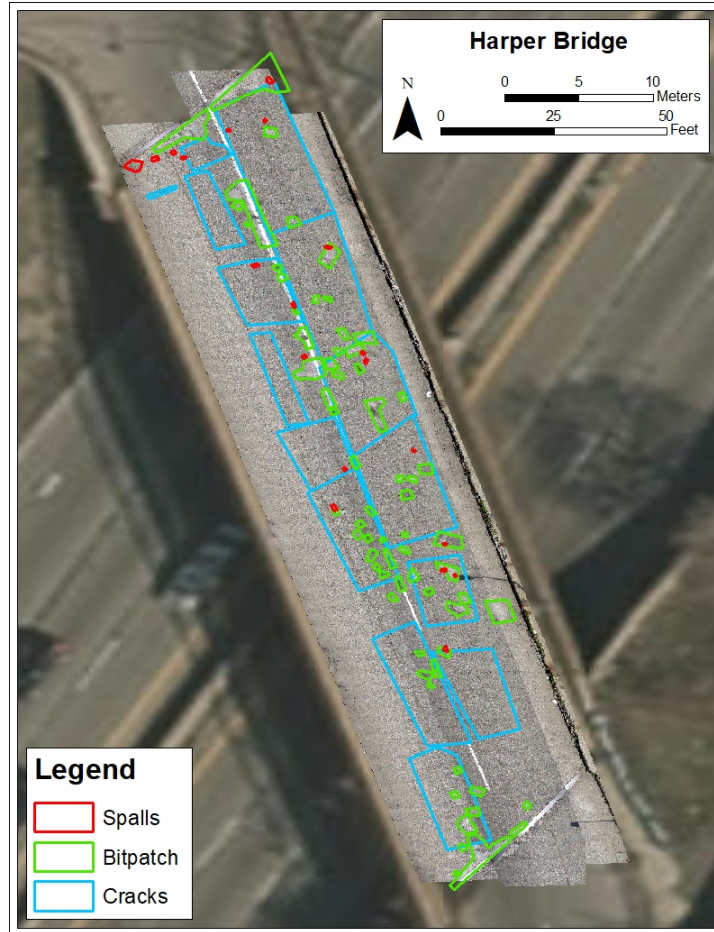
The Harper Road bridge (Str 11223) is located in Detroit, Michigan and passes over Interstate 94. The total area of the bridge deck is approximately 6,836 sq. ft. and has two spans. After processing the optical imagery, analysts were able to identify spalls, bitpatch, and cracks (Figure 2). The total area of the distresses are as follows:

- Spalls - 11 sq. ft
- Bitpatch - 379 sq. ft
- Concrete Patching - 0 sq. ft
- Cracks - 2,454 sq. ft

**Figure 2. Identified distresses on the Harper Road bridge.**

Since a DEM could not be created for the Harper Road bridge, visual inspection of the merged output was conducted to determine if any rebar could be detected within each of the spalls. If there was rebar, the spall was classified as “Condition State 3 - Poor”. However, if rebar could not be detected and the spall was smaller than six inches in diameter, the spall was classified as “Condition State 2 - Fair”.

Table 1 shows the results from processing the distresses through the BDCS algorithm. For Elem. Key 1080 (spalls and bitpatch), there was one spall that had visible rebar, placing it into the “poor” category. Otherwise, the other spalls were classified as “fair”. Bitpatch distresses were also classified as “poor” condition. For Elem. Key 1130 (cracks), some of the crack detected regions were classified as “insignificant” and therefore rated as “good”. The cracked regions that were classified as “unsealed - moderate” were rated as “fair” and lastly, those classified as “unsealed - wide/heavy” were rated as “poor”. Overall, the condition of the bridge deck was rated “Good” at 67%, “Fair” at 11%, and “Poor” at 23%.

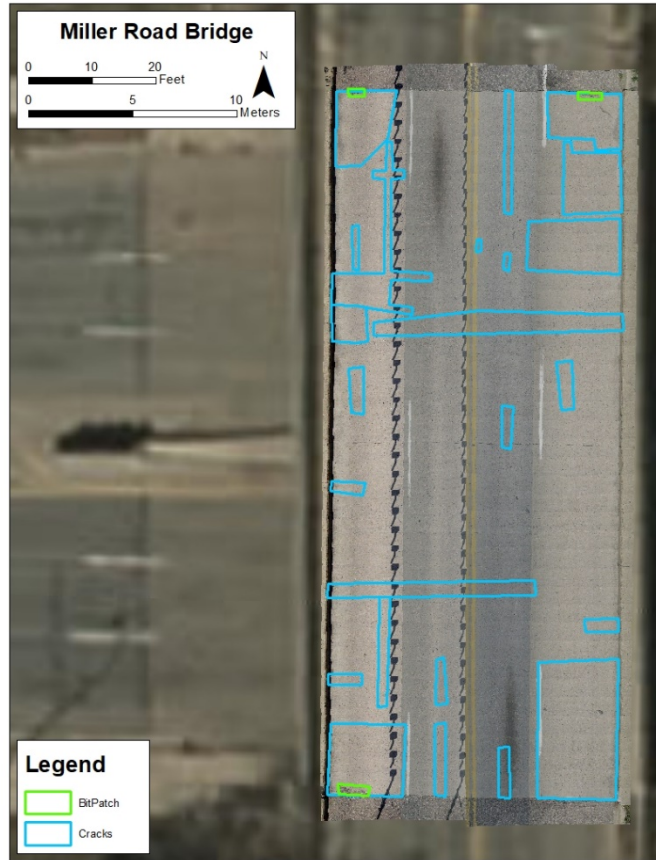
The Miller Road bridge (Str 11334) is located in Dearborn, Michigan and passes over M-153 (Ford Road). The total area of the bridge deck is approximately 6,000 sq. ft. and has two spans. After processing the optical imagery, analysts were able to identify bitpatch and cracks (Figure 3). The total area of the distresses are as follows:

- Spalls - 0 sq. ft
- Bitpatch - 14 sq. ft
- Concrete Patching - 0 sq. ft
- Cracks - 1,286 sq. ft

**Figure 3. Identified distresses on the Miller Road bridge.**

Table 2 shows the results from processing the distresses through the BDCS algorithm. For Elem. Key 1080 (bitpatch), the bitpatch areas were all placed into the “poor” category. All of the identified cracks were classified as “unsealed - moderate”, which were placed in condition state “fair”. Although there is a large area of the bridge deck that is cracked, none of the cracks appear to be in a “poor” condition. Overall, the condition of the bridge deck was rated “Good” at 78% and “Fair” at 21%.

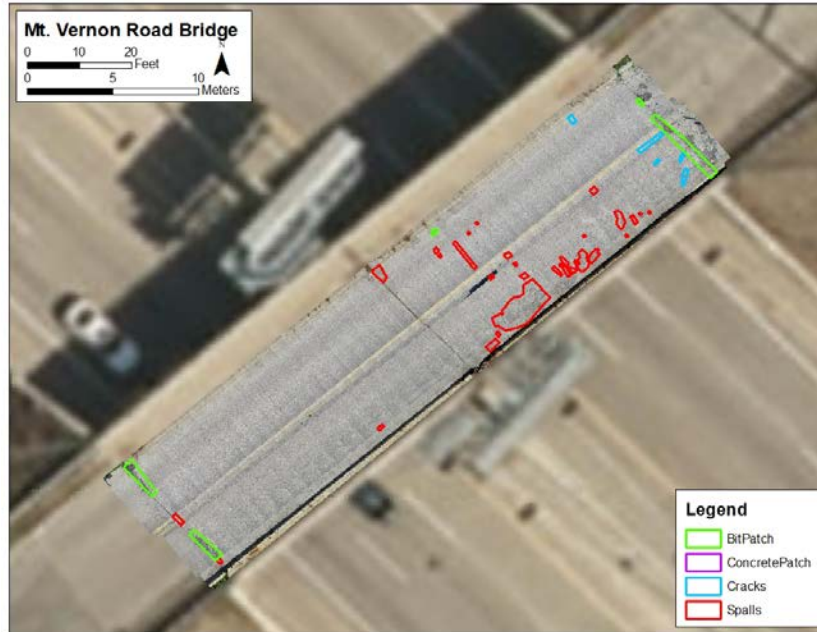
The Mt. Vernon bridge (Str 7882) is located in Southfield, Michigan and passes over M-10, the Lodge. The total area of the bridge deck is approximately 4,685 sq. ft. and has two spans. After processing the optical imagery, analysts were able to identify spalls, bitpatch, and cracks (Figure 4). The total area of the distresses are as follows:

- Spalls - 94 sq. ft
- Bitpatch - 51 sq. ft
- Concrete Patching - 0 sq. ft
- Cracks - 9 sq. ft

**Figure 4. Identified distresses on the Mt. Vernon Road bridge.**

Table 3 shows the results from processing the distresses through the BDCS algorithm. None of the identified spalls had rebar showing, placing each of the spalls into a “fair” category. All of the bitpatch distresses were classified as “poor” condition. Lastly, the cracks on the deck were all rated as “insignificant”, resulting in a classification of “fair”. Overall, the condition of the bridge deck was rated “Good” at 97%, “Fair” at 2%, and “Poor” at 1%

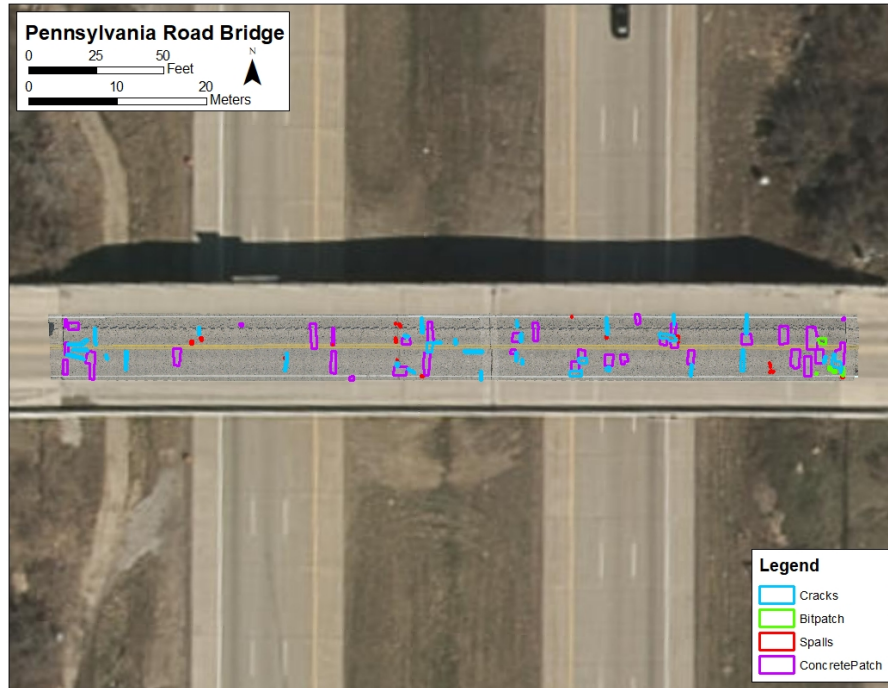
The Pennsylvania bridge (Str 11902) is located in Romulus, Michigan and passes over I-275. The total area of the bridge deck is approximately 13,939 sq. ft. and has two spans. After processing the optical imagery, analysts were able to identify spalls, bitpatch, concrete patches, and cracks (Figure 5). The total area of the distresses are as follows:

- Spalls - 11 sq. ft
- Bitpatch - 11 sq. ft
- Concrete Patching - 402 sq. ft
- Cracks - 135 sq. ft

**Figure 5. Identified distresses on the Pennsylvania Road bridge.**

Table 4 shows the results from processing the distresses through the BDCS algorithm. For Elem. Key 1080 (spalls, bitpatch, and concrete patches), the bitpatch areas were all placed into the “poor” category. None of the identified spalls had rebar showing, placing each of the spalls into a “fair” category. All concrete patches were assigned a “fair” category. For Elem. Key 1130 (cracks), most of the cracked areas were determined to be insignificant / “good”. However, some cracks were moderate or heavy, resulting in ratings of “fair” or “poor”. Overall, the condition of the bridge deck was rated “Good” at 97% and “Fair” at 3%.

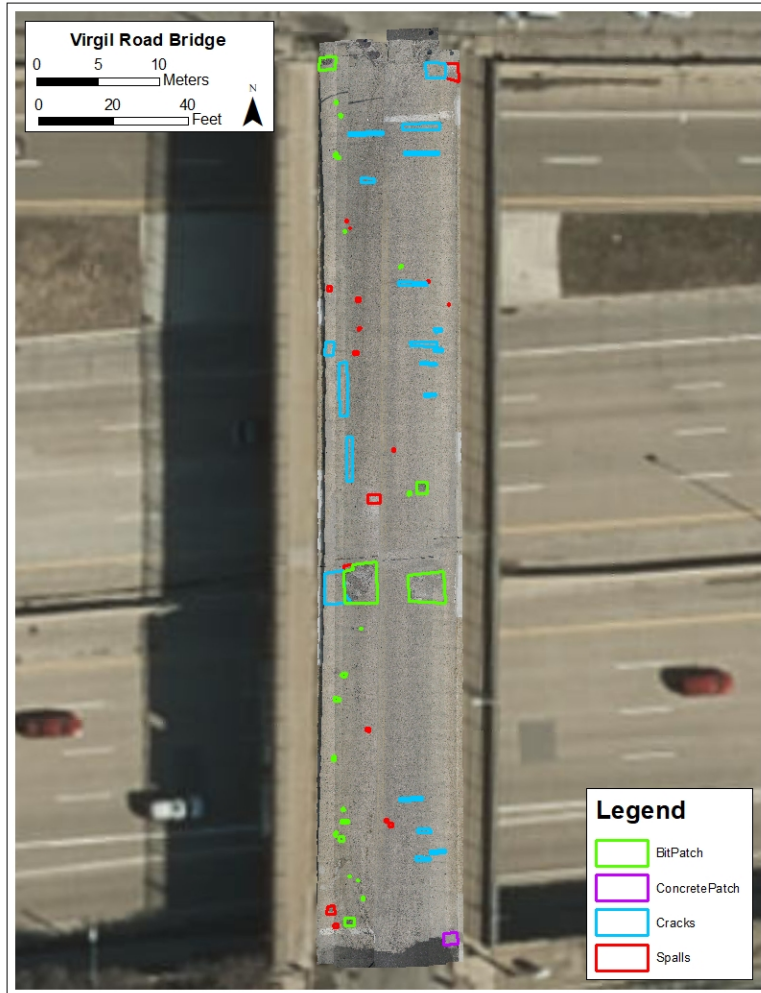
The Virgil Road bridge (Str 11508) is located in Detroit, Michigan and passes over I-96. The total area of the bridge deck is approximately 14,185 sq. ft. and has two spans. After processing the optical imagery, analysts were able to identify spalls, bitpatch, concrete patches, and cracks (Figure 6). The total area of the distresses are as follows:

- Spalls - 38 sq. ft
- Bitpatch - 201 sq. ft
- Concrete Patching - 11 sq. ft
- Cracks - 193 sq. ft

**Figure 6. Identified distresses on the Virgil Road bridge.**

Table 5 shows the results from processing the distresses through the BDCS algorithm. For Elem. Key 1080 (spalls, bitpatch, and concrete patches), the bitpatch areas were all placed into the “poor” category. None of the identified spalls had rebar showing, placing each of the spalls into a “fair” category. All of the concrete patches were assigned a category of “fair”. For Elem. Key 1130 (cracks), most of the cracked areas were determined to be insignificant / “good”. However, some cracks were moderate or heavy, resulting in ratings of “fair” or “poor”. Overall, the condition of the bridge deck was rated “Good” at 97%, “Fair” at 1%, and “Poor” at 2%.

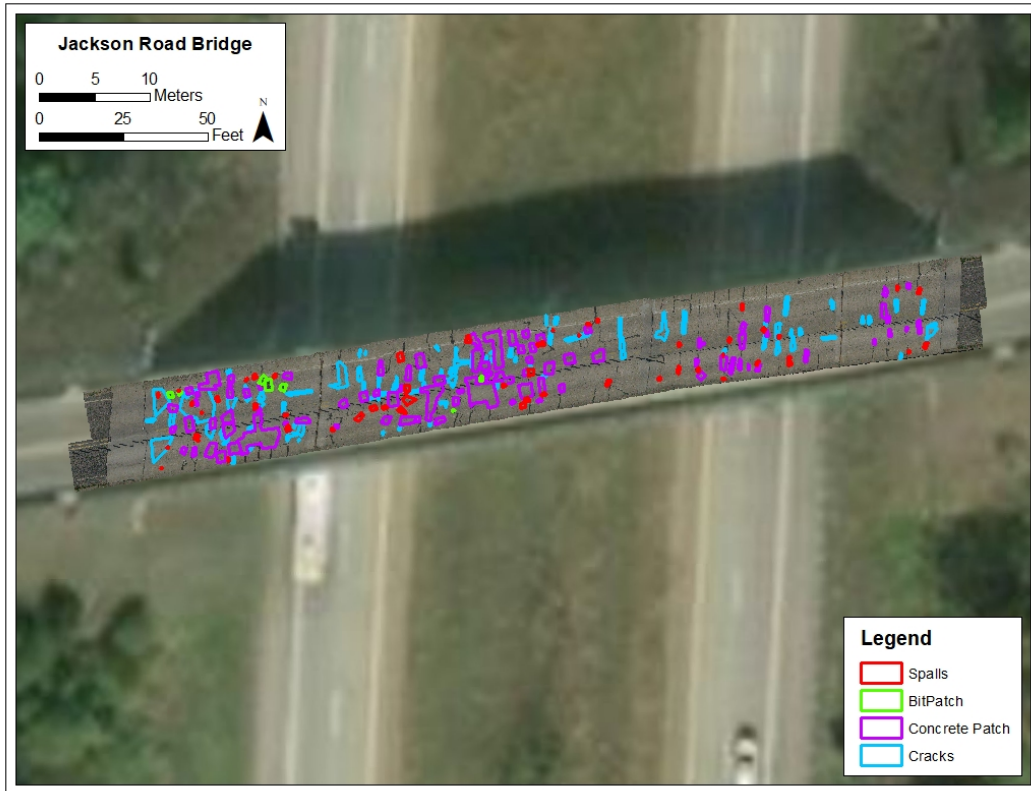
The Jackson bridge (Str 1224) is located in Tekonsha, Michigan and passes over I-69. The total area of the bridge deck is approximately 8,261 sq. ft. and has four spans. After processing the optical imagery, analysts were able to identify spalls, bitpatch, concrete patches, and cracks (Figure 7). The total area of the distresses are as follows:

- Spalls - 66 sq. ft
- Bitpatch - 18 sq. ft
- Concrete Patching - 574 sq. ft
- Cracks - 318 sq. ft

**Figure 7. Identified distresses on the Jackson Road bridge.**

Table 6 shows the results from processing the distresses through the BDCS algorithm. For Elem. Key 1080 (spalls, bitpatch, and concrete patches), the bitpatch areas were all placed into the “poor” category. Two spalls had rebar showing and were therefore assigned a “poor” condition. The remaining spalls were assigned a “fair” condition. All concrete patches were assigned a “fair” category. For Elem. Key 1130 (cracks), most of the cracked areas were determined to be insignificant / in “good” condition. However, some cracks were moderate or heavy, resulting in a “fair” category. Overall, the condition of the bridge deck was rated “Good” at 92% and “Fair” at 8%.

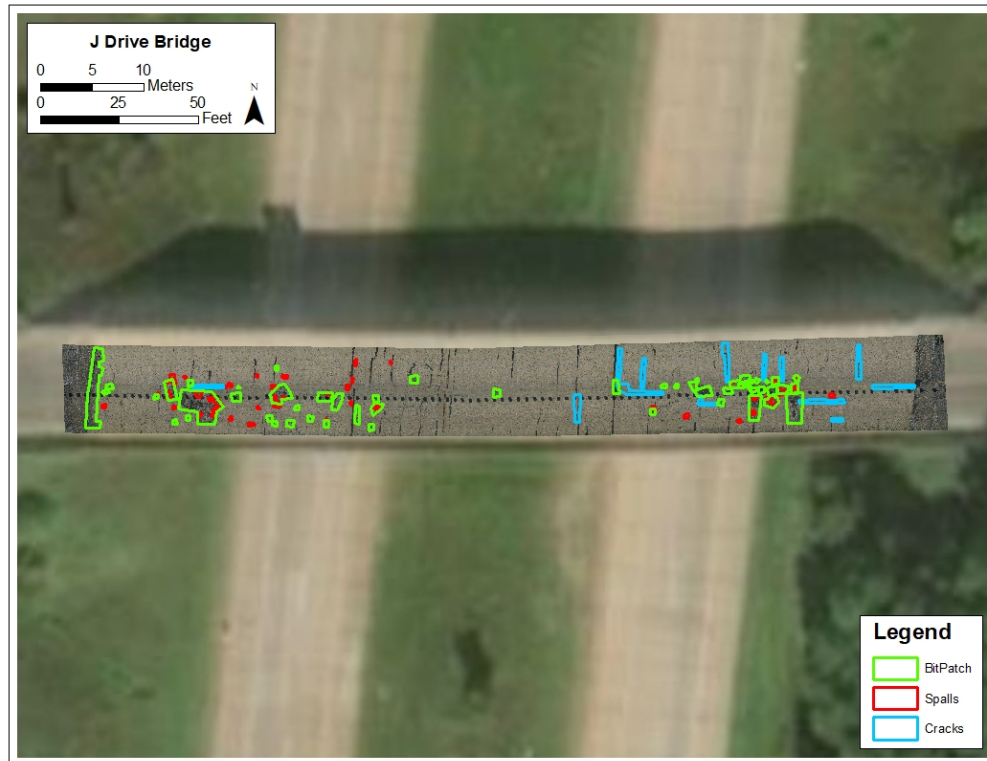
The J-Drive bridge (Str 1241) is located in Marshall, Michigan and passes over I-69. The total area of the bridge deck is approximately 10,127 sq. ft. and has two spans. After processing the optical imagery, analysts were able to identify spalls and bitpatch (Figure 8). The total area of the distresses are as follows:

- Spalls - 38 sq. ft
- Bitpatch - 500 sq. ft
- Concrete Patching - 0 sq. ft
- Cracks – 146 sq. ft

**Figure 8. Identified distresses on the J Drive Road bridge.**

Table 7 shows the results from processing the distresses through the BDCS algorithm. For Elem. Key 1080 (spalls and bitpatch), the bitpatch areas were all placed into the “poor” category. Four spalls had rebar showing and were therefore placed assigned a “poor” condition. The remaining spalls were assigned a “fair” condition. For Elem. Key 1130 (cracks), most of the cracked areas were determined to be insignificant / in “good” condition. However, some cracks were moderate or heavy, resulting in a “fair” category. Overall, the condition of the bridge deck was rated “Good” at 94%, “Fair” at 1%, and “Poor” at 5%.

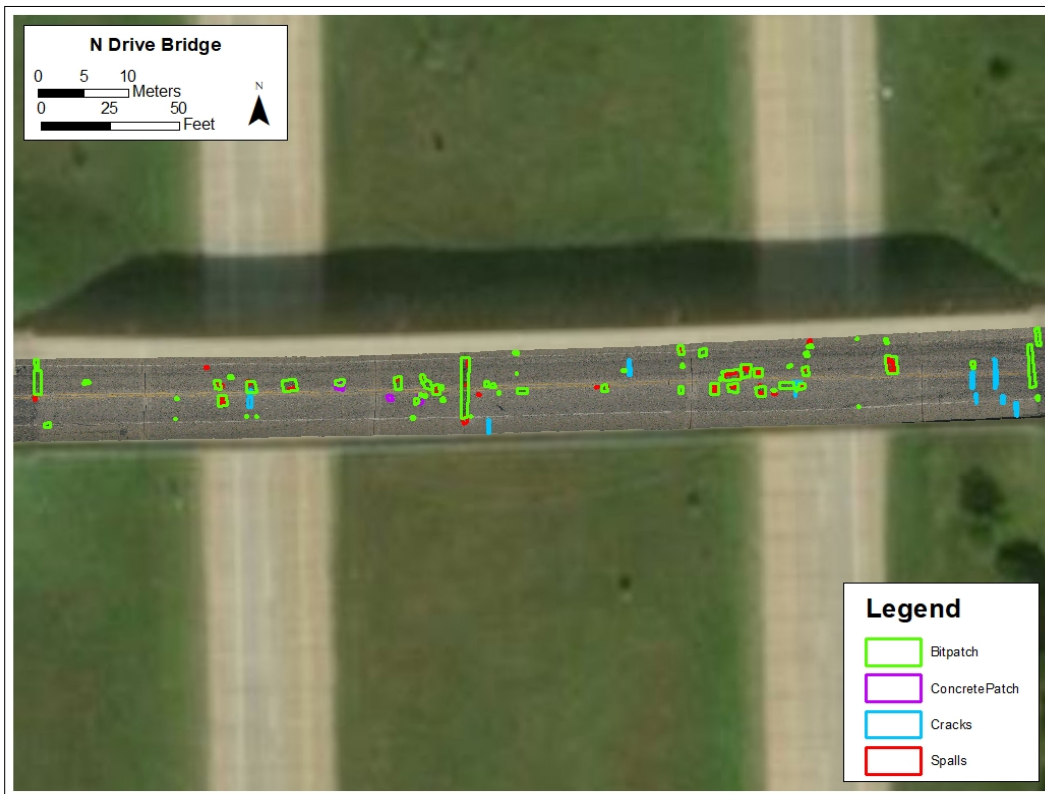
The N-Drive bridge (Str 1243) is located in Marshall, Michigan and passes over I-69. The total area of the bridge deck is approximately 15,441 sq. ft. and has five spans. After processing the optical imagery, analysts were able to identify spalls, bitpatch, concrete patching, and cracks (Figure 9). The total area of the distresses are as follows:

- Spalls - 56 sq. ft
- Bitpatch - 413 sq. ft
- Concrete Patching - 17 sq. ft
- Cracks - 46 sq. ft

**Figure 9. Identified distresses on the N Drive Road bridge.**

Table 8 shows the results from processing the distresses through the BDCS algorithm. For Elem. Key 1080 (spalls, bitpatch, and concrete patches), the bitpatch areas were all placed into the “poor” category. None of the spalls had any rebar showing and were therefore assigned a “fair” condition. Since concrete patches were identified on the bridge, all were assigned a “fair” rating. For Elem. Key 1130 (cracks), half the cracked areas were determined to be insignificant / in “good” condition. However, the other half of the cracked areas were moderate or heavy, resulting in both “fair” and “poor” ratings. Overall, the condition of the bridge deck was rated “Good” at 97% and “Poor” at 3%.

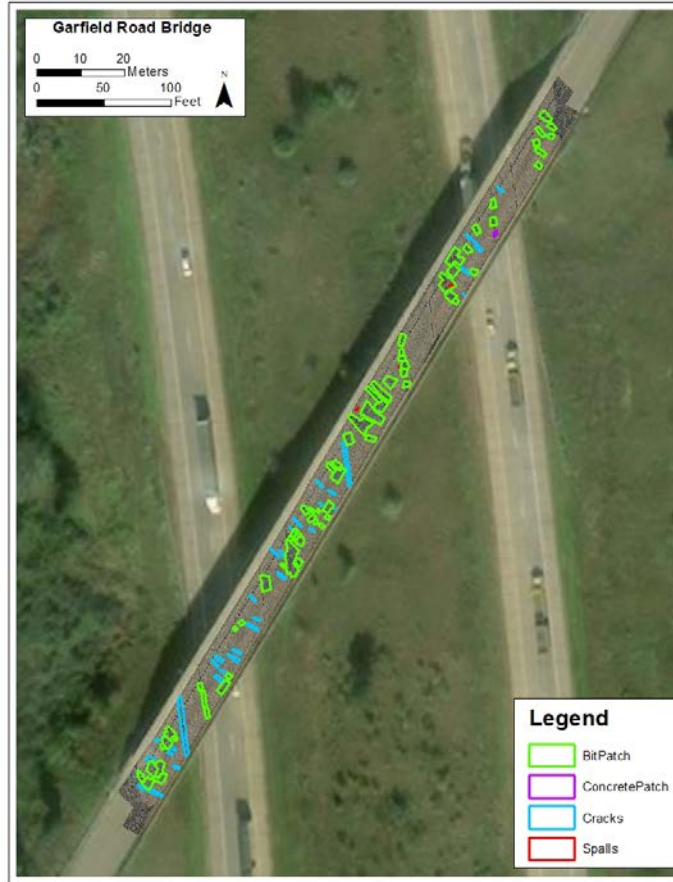
The Garfield bridge (Str 1244) is located in Marshall, Michigan and passes over I-69. The total area of the bridge deck is approximately 23,129 sq. ft. and has six spans. After processing the optical imagery, analysts were able to identify spalls, bitpatch, concrete patching, and cracks (Figure 10). The total area of the distresses are as follows:

- Spalls - 10 sq. ft
- Bitpatch - 2,341 sq. ft
- Concrete Patching - 6 sq. ft
- Cracks - 438 sq. ft

Figure 10. Identified distresses on the Garfield Road bridge.

Table 9 shows the results from processing the distresses through the BDCS algorithm. For Elem. Key 1080 (spalls, bitpatch, and concrete patches), the bitpatch areas were all placed into the “poor” category. One spall had rebar showing and were therefore placed assigned a “poor” condition. The remaining spalls were assigned a “fair” condition. All of the concrete patches were assigned a “fair” category. For Elem. Key 1130 (cracking), most of the cracked areas were determined to be insignificant / in “good” condition. However, some cracks were moderate, resulting in ratings of “fair”. Overall, the condition of the bridge deck was rated “Good” at 89%, “Fair” at 1%, and “Poor” at 10%.

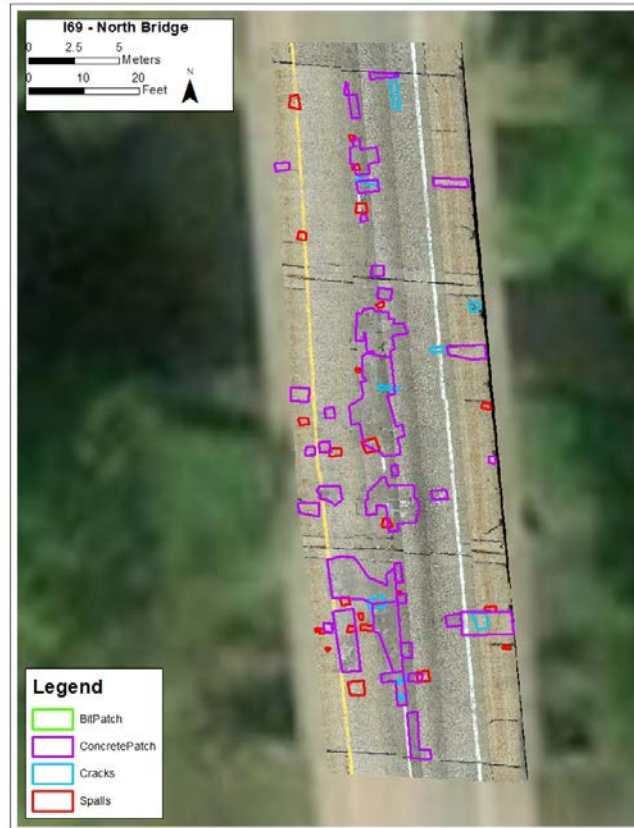
The I-69 North bridge (Str 1215) is located in Tekonsha, Michigan and passes over the St. Joseph River. The total area of the bridge deck is approximately 5,494 sq. ft. and has three spans. After processing the optical imagery, analysts were able to identify spalls, concrete patching, and cracks (Figure 11). The total area of the distresses are as follows:

- Spalls - 48 sq. ft
- Bitpatch - 0 sq. ft
- Concrete Patching - 585 sq. ft
- Cracks - 16 sq. ft

**Figure 11. Identified distresses on the I-69 North bridge.**

Table 10 shows the results from processing the distresses through the BDCS algorithm. For Elem. Key 1080 (spalls and concrete patches), two spalls had rebar showing and were therefore placed assigned a “poor” condition. The remaining spalls were assigned a “fair” condition. All concrete patches were assigned a “fair” condition. For Elem. Key 1130 (cracking), most of the cracked areas were determined to be insignificant / in “good” condition. However, one area of cracking was moderate, resulting in a rating of “fair”. Overall, the condition of the bridge deck was rated “Good” at 89% and “Fair” at 11%.

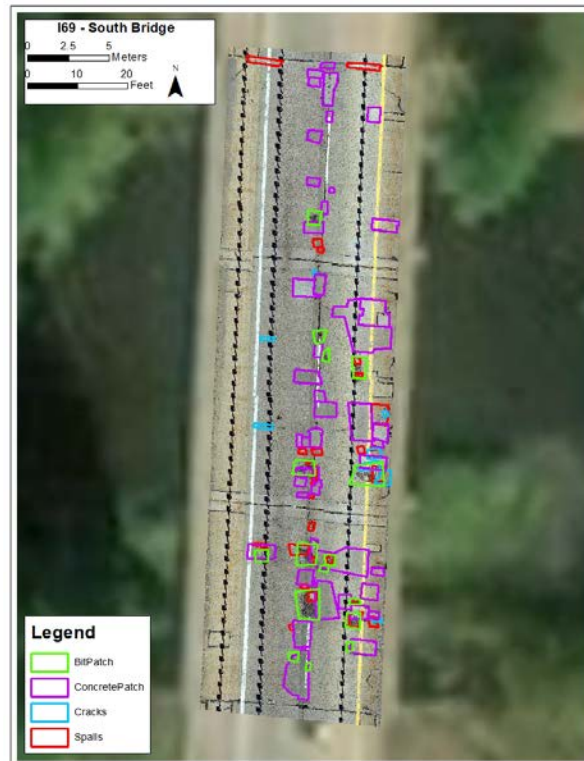
The I-69 South bridge (Str 1213) is located in Tekonsha, Michigan and passes over the St. Joseph River. The total area of the bridge deck is approximately 5,625 sq. ft. and has three spans. After processing the optical imagery, analysts were able to identify spalls, bitpatch, concrete patching, and cracks (Figure 12). The total area of the distresses are as follows:

- Spalls - 63 sq. ft
- Bitpatch - 125 sq. ft
- Concrete Patching - 488 sq. ft
- Cracks - 18 sq. ft

**Figure 12. Identified distresses on the I-69 South bridge.**

Table 11 shows the results from processing the distresses through the BDCS algorithm. For Elem. Key 1080 (spalls, bitpatch, and cracking), the bitpatch areas were all placed into the “poor” category. Three spalls had rebar showing and were therefore placed assigned a “poor” condition. The remaining spalls were assigned a “fair” condition. All concrete patches were assigned a rating of “fair”. For Elem. Key 1130 (cracking), half of the cracked areas were determined to be insignificant / in “good” condition. However, some cracks were moderate or heavy, resulting in “poor” and “fair” ratings. Overall, the condition of the bridge deck was rated “Good” at 88%, “Fair” at 10%, and “Poor” at 3%.
