MASH TEST 3-11 EVALUATION OF MODIFIED TxDOT ROUND WOOD POST GUARDRAIL SYSTEM

Test Report 0-6968-R4

Report 0-6968-R4
Project 0-6968

Project Title: Roadside Safety Device Analysis, Testing, and Evaluation Program

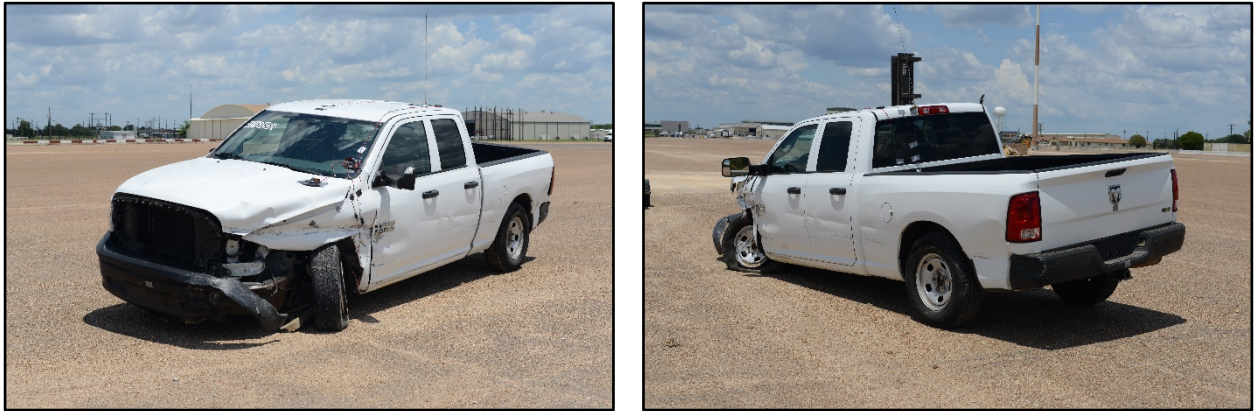
Figure 5.4. Test Vehicle after Test No. 469688-5-1.

Figure 5.4 shows the damage sustained by the vehicle. The front bumper, hood, grill, left headlight, left front fender, left front tire and rim, left front lower A-arm, and left front door were damaged. Maximum exterior crush to the vehicle was 11.0 inches in the horizontal at bumper height. No measurable occupant compartment deformation occurred. Figure 5.5 shows the interior of the vehicle.
