MPC 19-389 | S. Rimal, B. Kidd, M. Tazarv, J. Seo, and N. Wehbe

Methodology for Load Rating Double-Tee Bridges

Department of Civil and Environmental Engineering
South Dakota State University
Brookings, South Dakota

July 2019

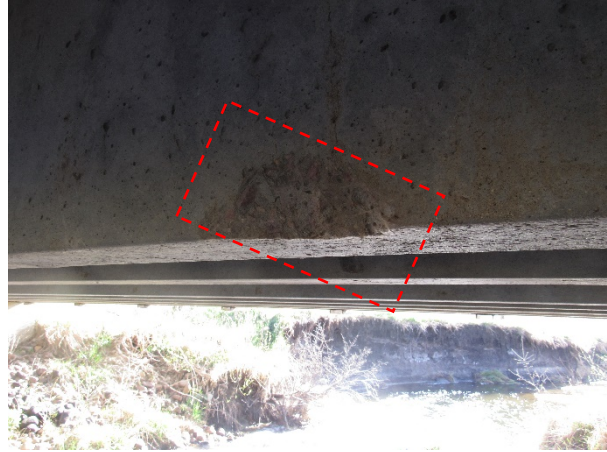
(b) Spalling at bottom of Stem, G4

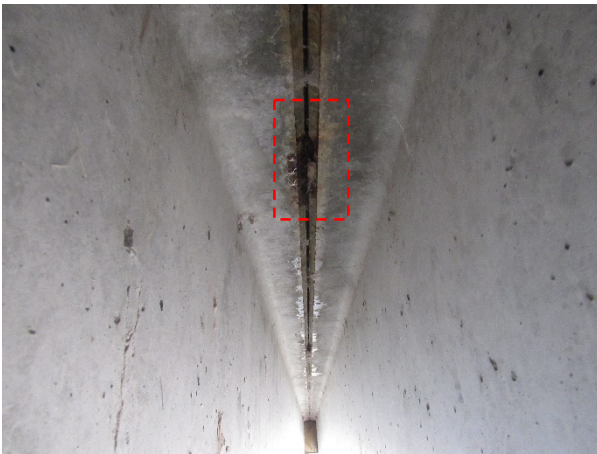
(c) Corrosion of Steel Plate

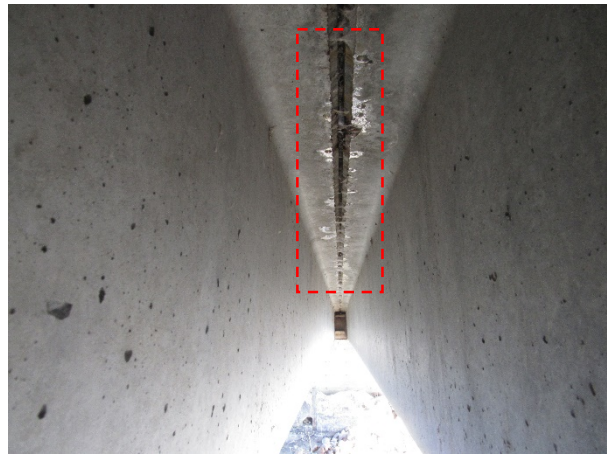
(d) Leakage in Joint

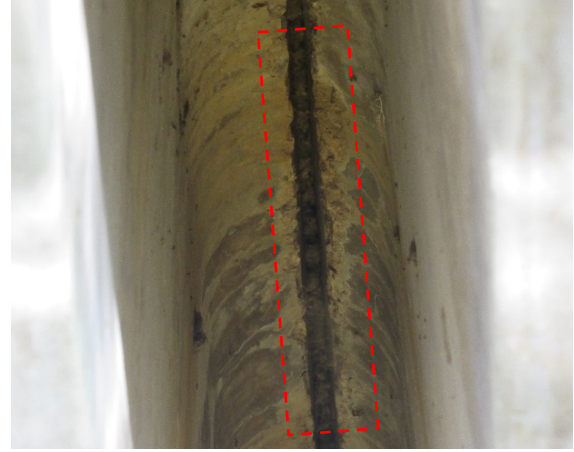
(b) Stains from Minor Corrosion of Steel Plates

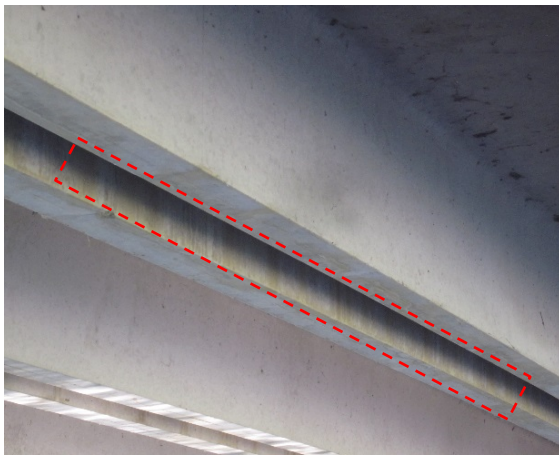
(c) Sign of Water Leak b/w Deck Units

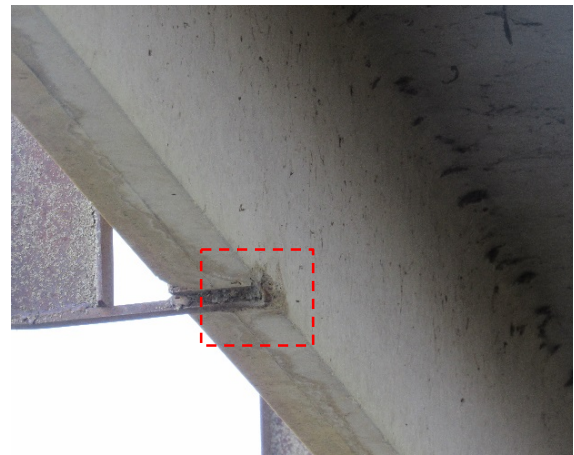
(d) Concrete Spalling at Railing

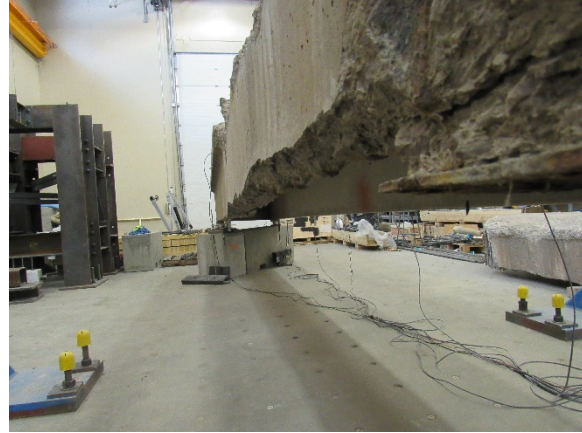
(b) Stem Cover Deterioration for 50-ft (15.24-m) Girder

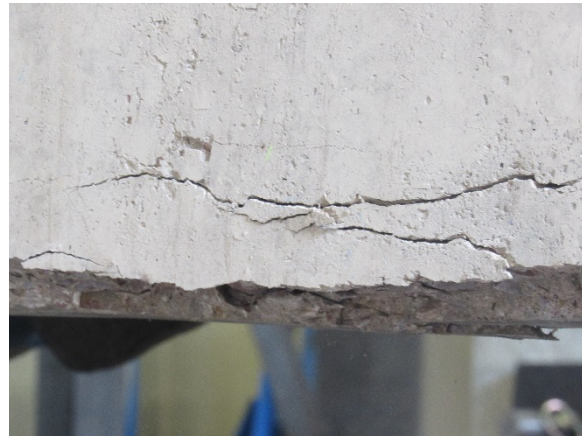
(d) Damage of 50-ft (15.24-m) Girder during Unloading

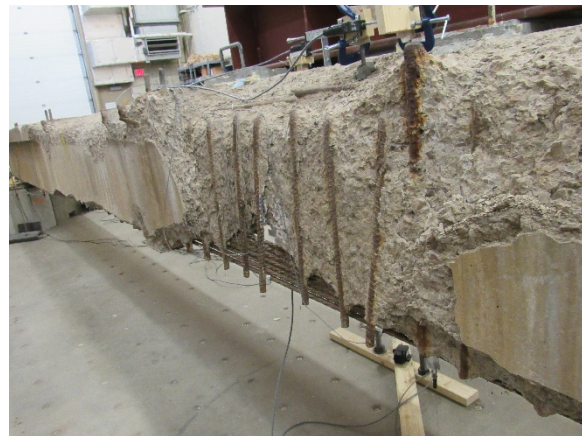
(f) Exposure of Strands and Transverse Bars on Stem of 50-ft (15.24-m) Girder

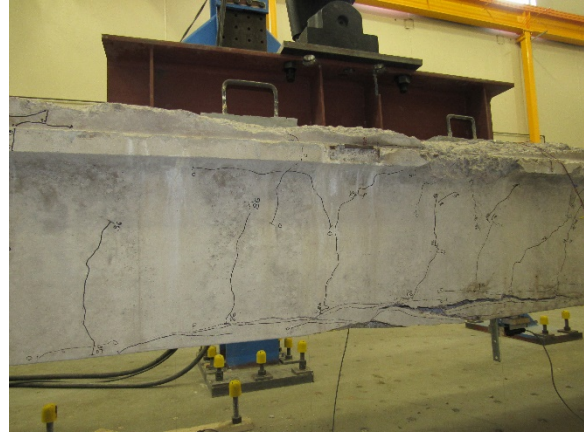
(b) Extension of Flexural cracks

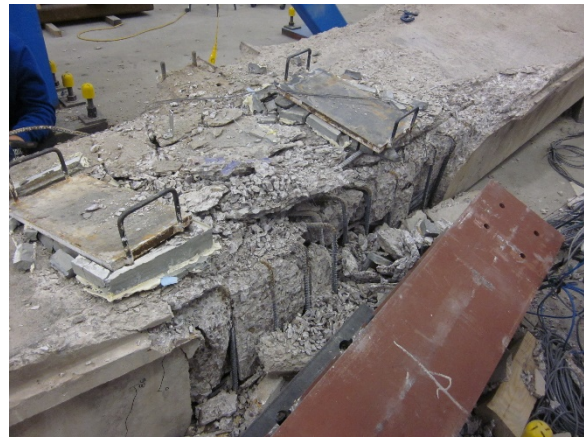
(d) Brittle Failure at Midspan

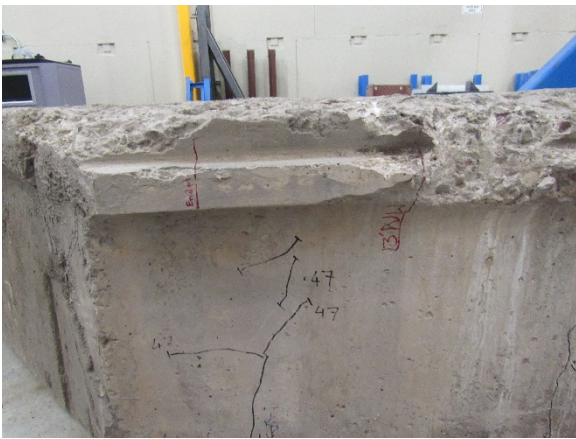
(c) Shear Crack Near North End

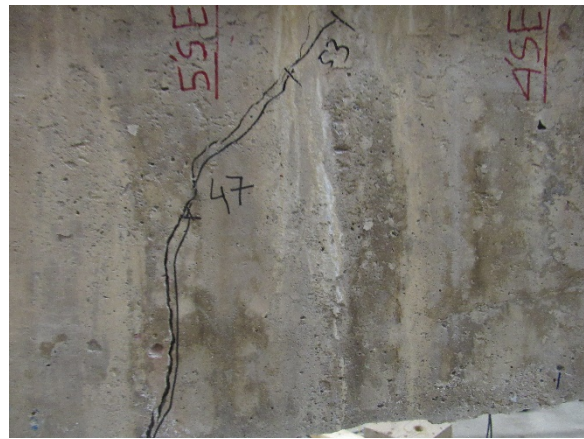
(d) Extension of Crack Width

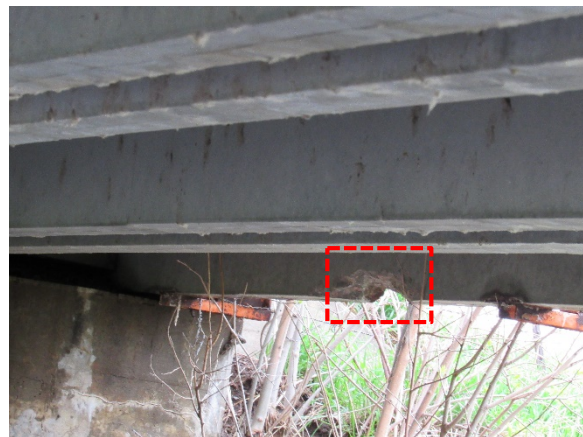
(d) Deterioration at bottom of stem

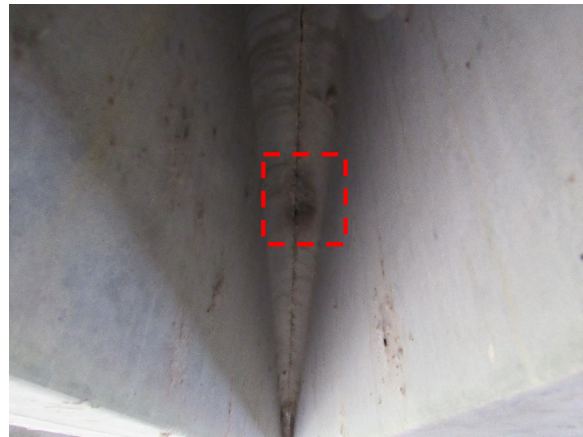
(f) Reddish color, sign of corrosion

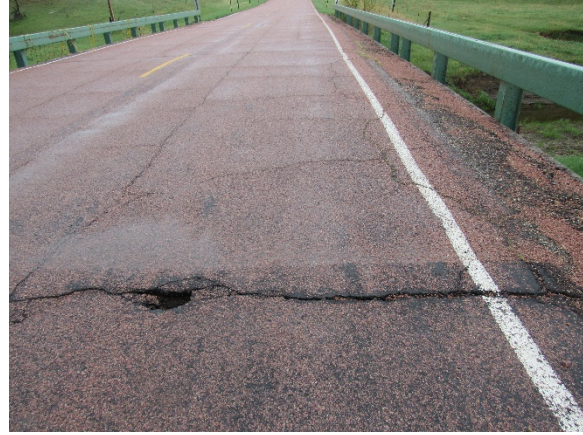
(b) Cracking on pavement over the bridge

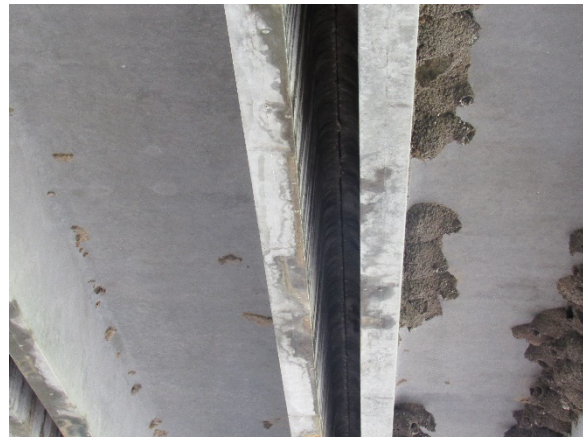
(d) Leakage from joint

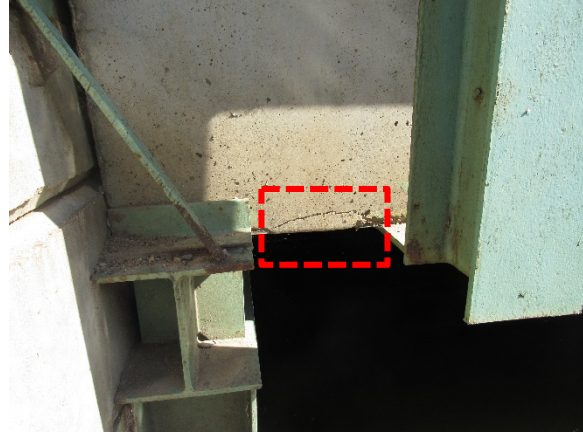
(b) Cracking at bottom of exterior girder

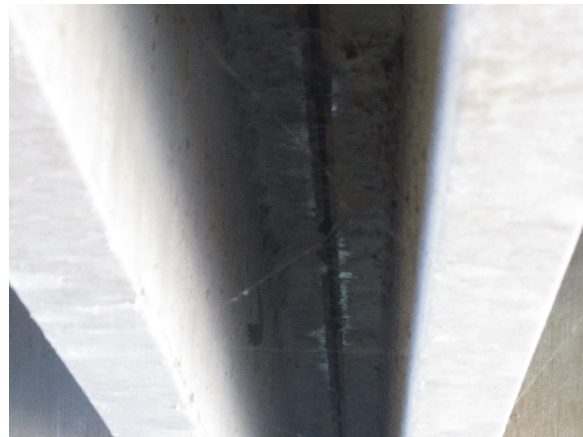
(d) Efflorescence in joint

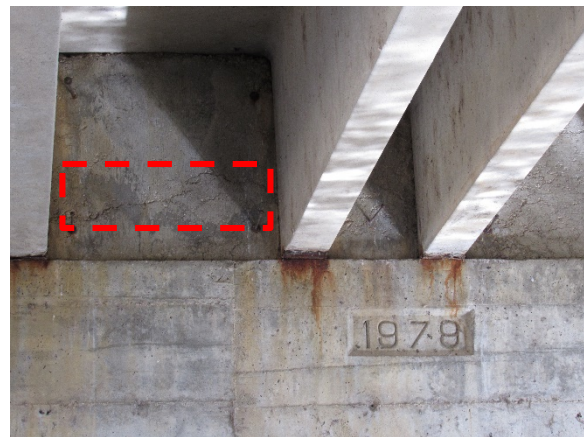
(d) Cracking in diaphragm

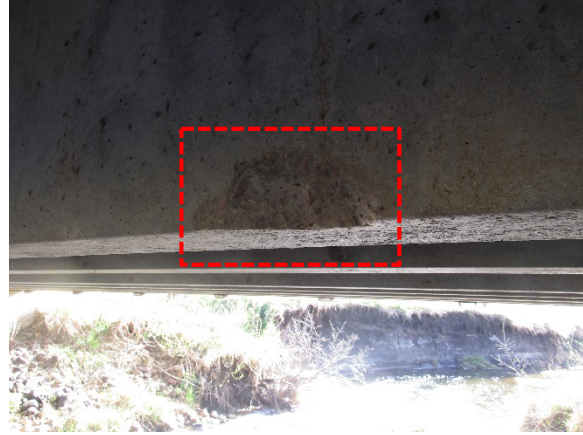
(b) Spalling at stem of bridge

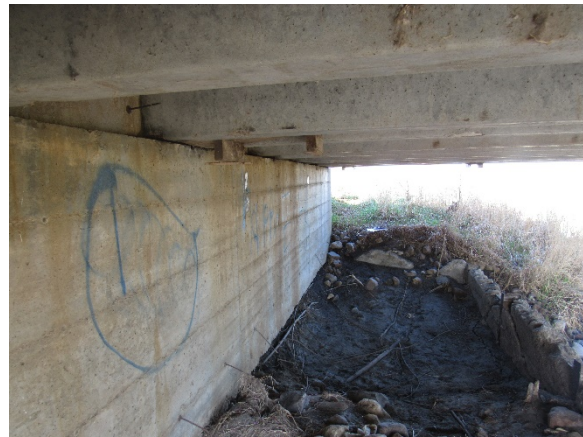
(d) Scouring at abutment of bridge

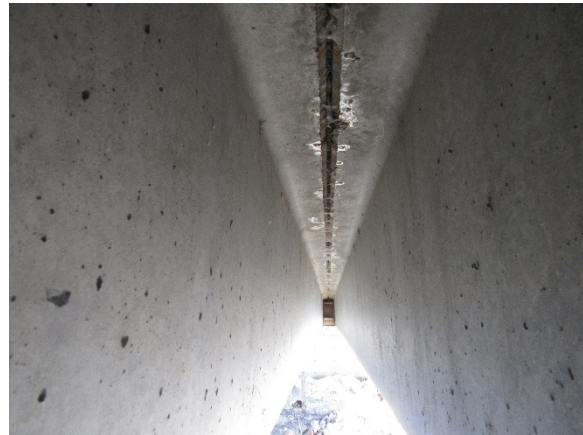
(f) Leakage from joint

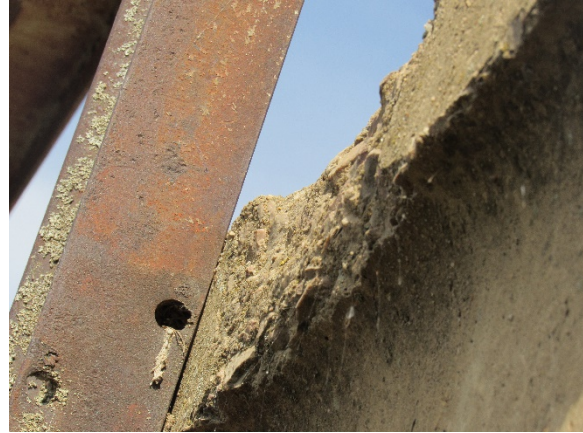
(b) Deterioration at side of bridge

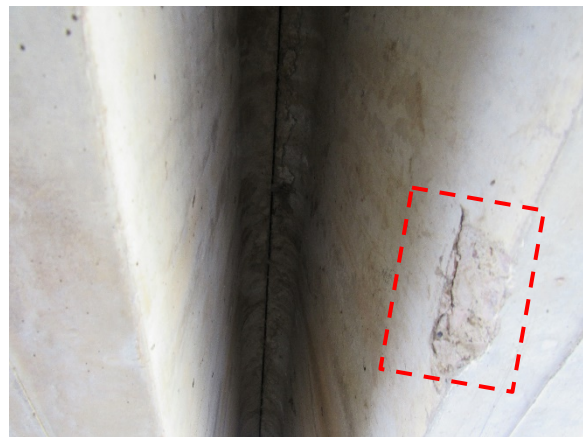
(d) Deterioration at bottom of stem

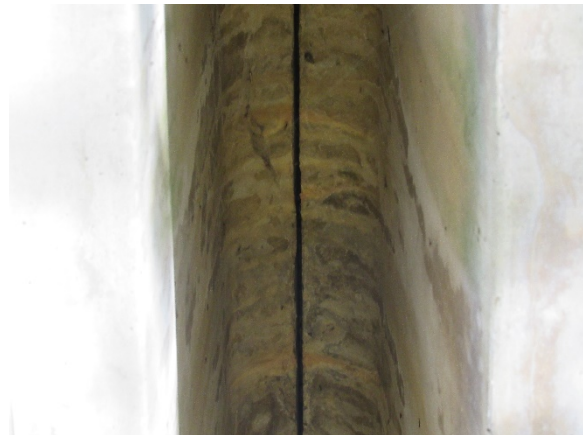
(d) Leakage from joint

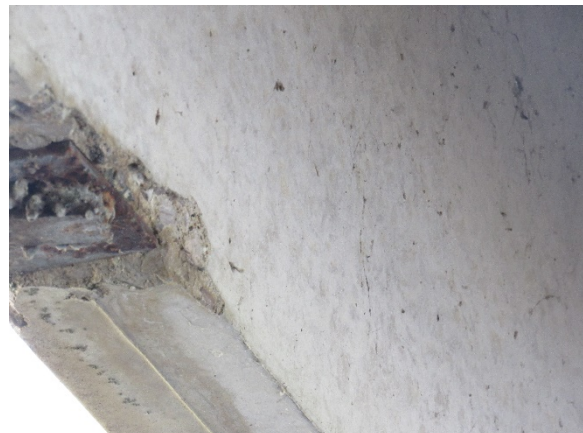
(f) Deterioration at bottom of stem

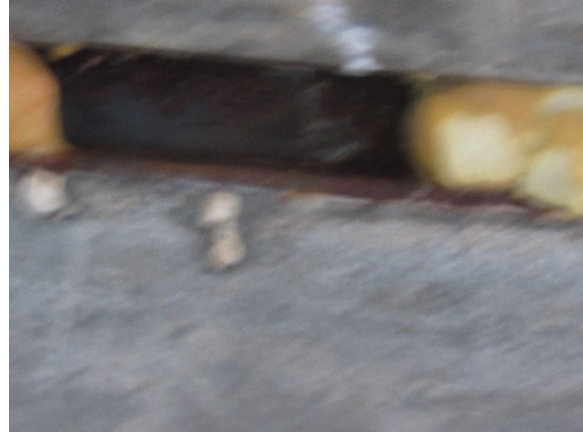
(b) Corrosion of plate of joint

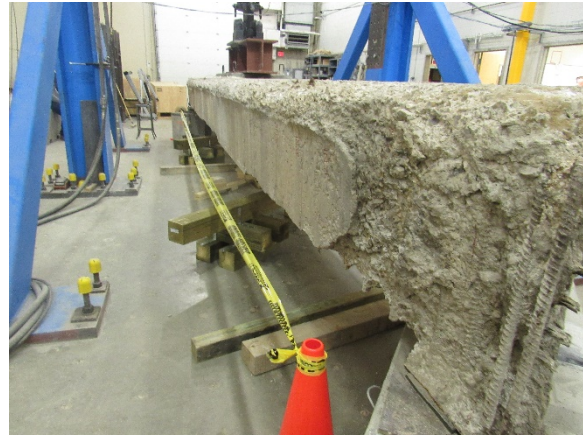
(b) Stem Cover Deterioration

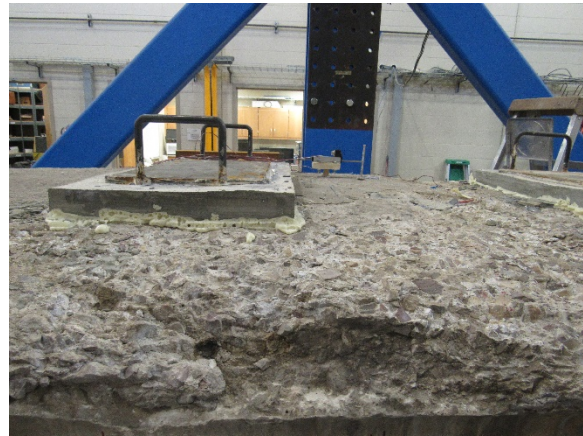
(d) Flange Cover Deterioration

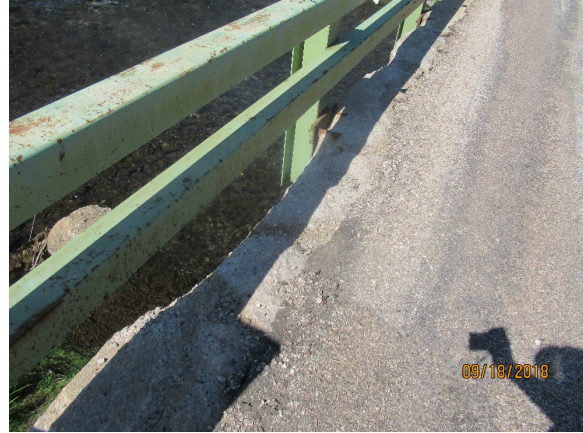
(b) Deterioration of Concrete on Top of West Deck Unit

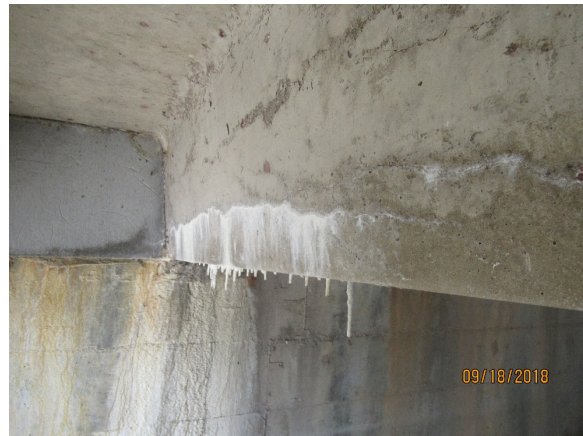
(d) Longitudinal Cracking and Severe Efflorescence-
North End of Deck Unit 1

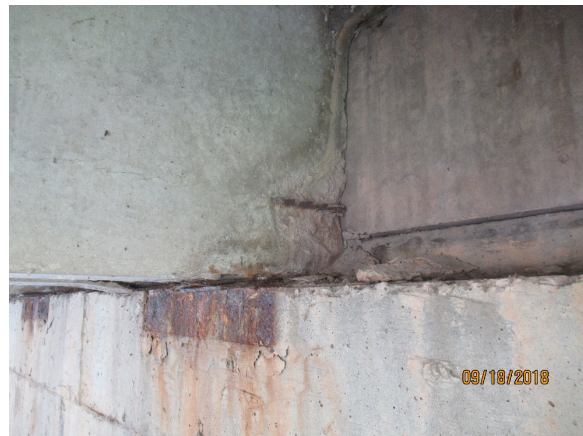
(e) Spall with Prestressing Strand Exposed – South
End of East Stem of Deck Unit 3

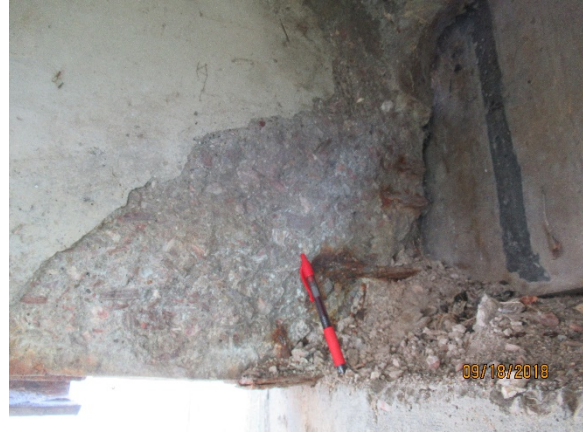
(g) Spall with Prestressing Strand Exposed – South End of East Stem of Deck Unit 7

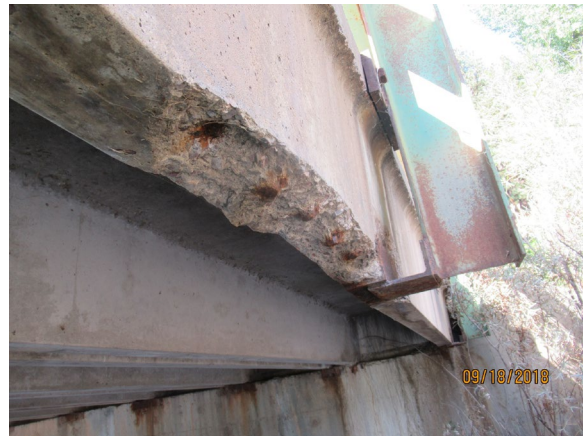
(i) Spall Near Rail Post 5 – Deck Unit 7
