**POST-WINTER EVALUATION REPORT**

**Detectable Warning Devices (Truncated Domes) for use by the Visually Impaired**

Location: Great Falls, 6<sup>th</sup> St. N. W.

Project No.: STPU 5201(11)

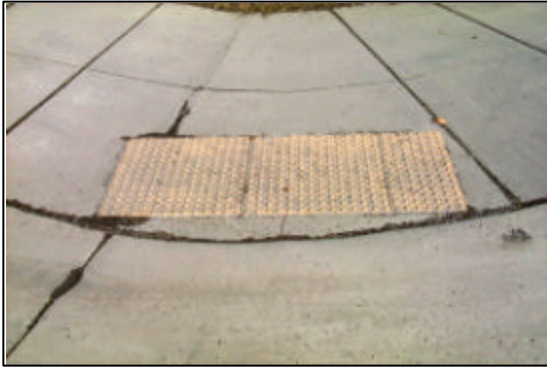
**Installation 1A:** Located on the northeast corner at the intersection of the east entrance to the Expopark adjacent to 5<sup>th</sup> Ave. N. W.

Adhesion tight. No dome loss. No evidence that this product was blade-cleaned during snow events.

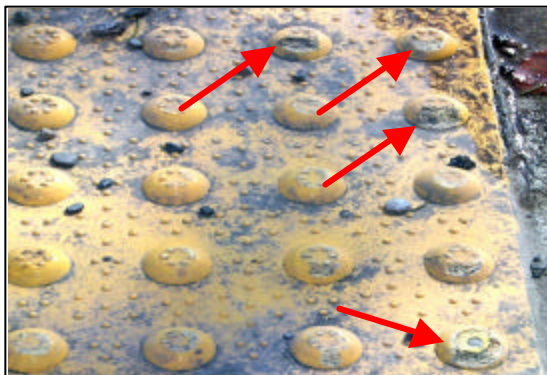
**Installation 1B:** Example close-up of damaged domes.

Evidence of blade being used to remove snow. Some of the setting pins are missing

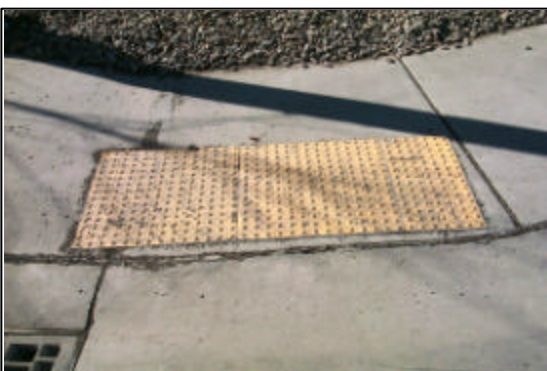
**Installation 1C:** Located on the southwest corner of the intersection 5<sup>th</sup> Ave. N. W. & 6<sup>th</sup> St. N. W. This treatment connects the east-west pedestrian walkway.

Interior seams losing adhesion.

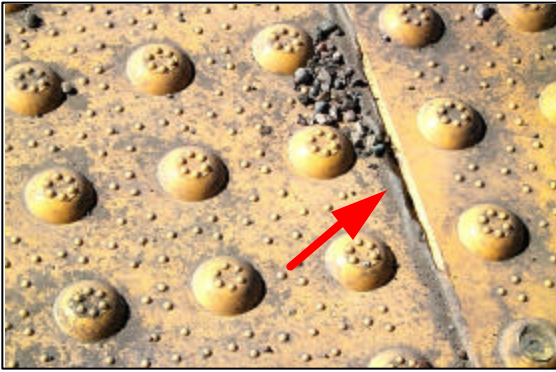
**Installation 1C:** Close-up of interior seam losing adhesion. Debris collecting in the gap.

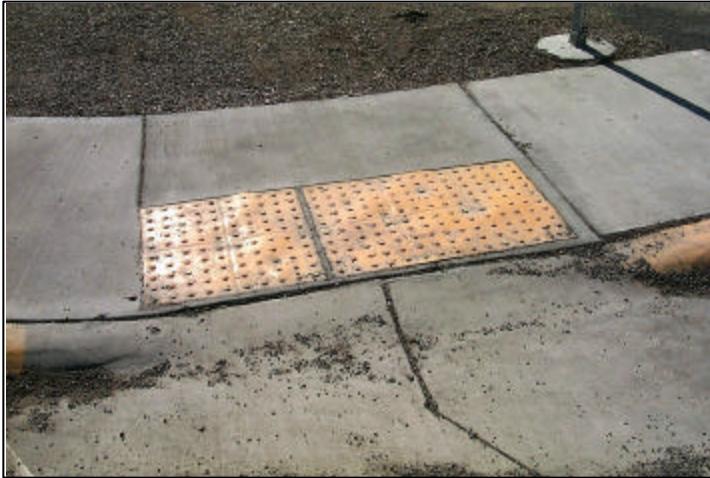
**Installation 2:** Located on the southwest corner at the intersection of 6<sup>th</sup> Ave. N. W. and 6<sup>th</sup> St. N. W.

This treatment performed poorly since construction. Substantial amounts of domes have been sheared off through use of a shovel or blade apparatus when removing snow. The edges within the treatment and perimeter are beginning to loose adhesion. The setting pins are breaking off.

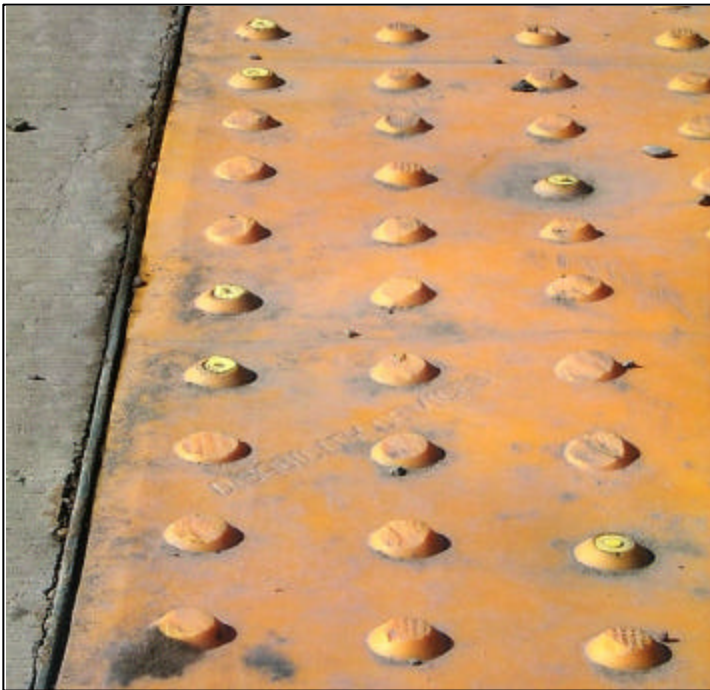
**Installation 2:** Close-ups of sheared domes and example image of edges losing adhesion.

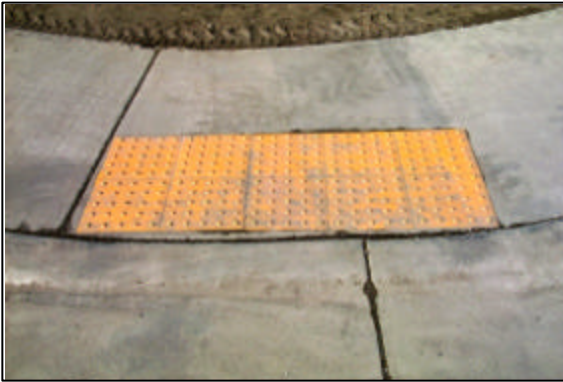
**Installation 3A:** Located on the northwest corner of the intersection of 5<sup>th</sup> Ave. N. W. and 6<sup>th</sup> St. N. W.

This treatment connects the north-south pedestrian walkway.

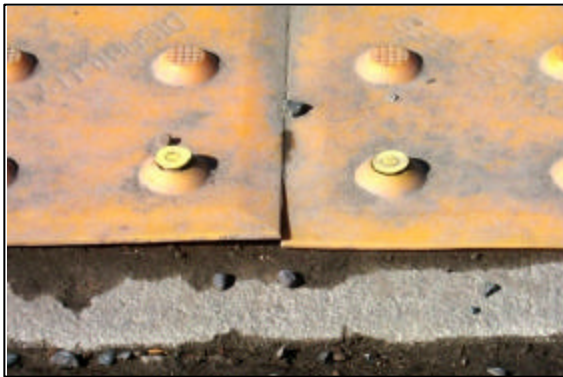
**Installation 3A:** Close-up of edge with loss of adhesion to PCCP.

This scenario is the same with 3B.

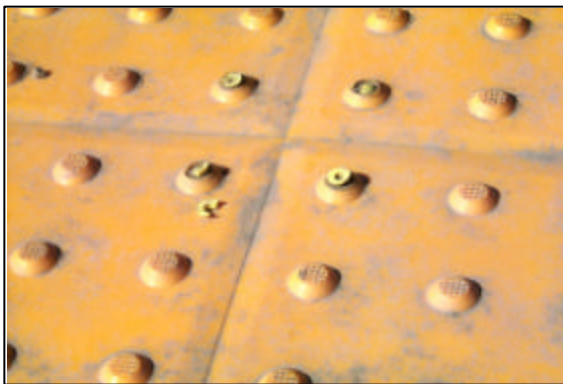
**Installation 3A:** Close-up of broken setting pins.

This scenario is the same with 3B.

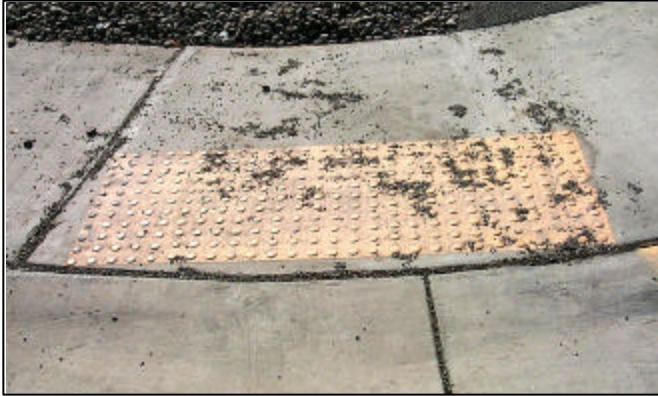
**Installation 4A:** Located on the southwest corner of 5<sup>th</sup> Ave. N. W. and 6<sup>th</sup> St. N. W.

This treatment connects the north-south pedestrian walkway.

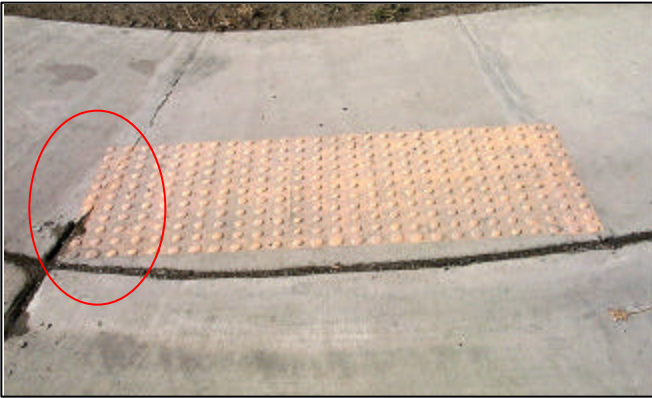
**Installation 4B:** Located on the northwest corner of 5<sup>th</sup> Ave. N. W. and 6<sup>th</sup> St. N. W.

This treatment connects the east-west pedestrian walkway.

South end of treatment deteriorating at mortar joint.

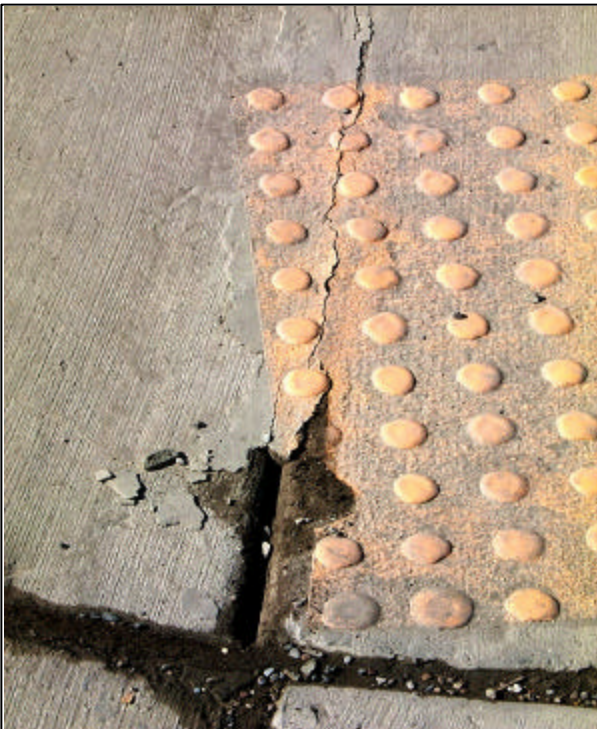
**Installation 4B:** Close-up of deteriorating mortar joint.

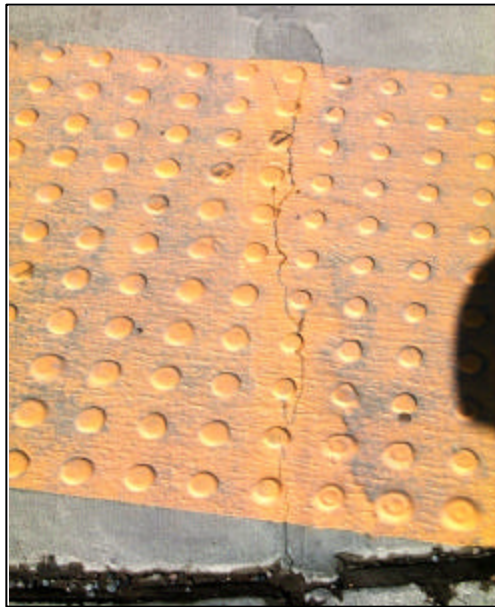
**Installation 4C:** Close-ups of cracked mortar joint and dome loss.

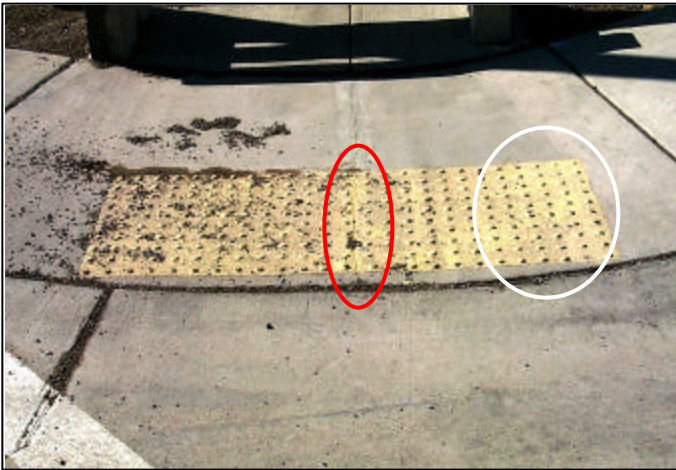
**Installation 5B:** Located at the southwest intersection of 3<sup>rd</sup> Ave. N. W. and 6<sup>th</sup> St. N. W.

This treatment has suffered dome loss and dome shear in the northeast quadrant of the mat (white circle) and has a reflective crack appearing through the base from the underlying mortar joint (red circle)

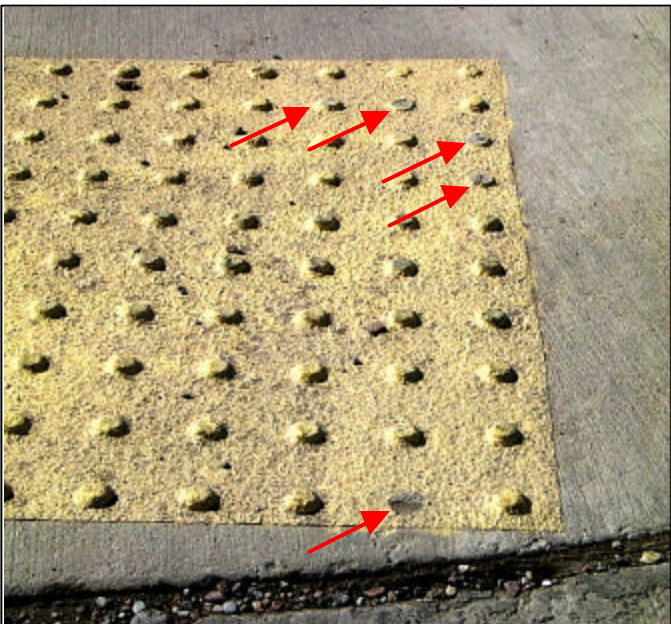
**Installation 5B:** Close-up of missing and sheared domes.

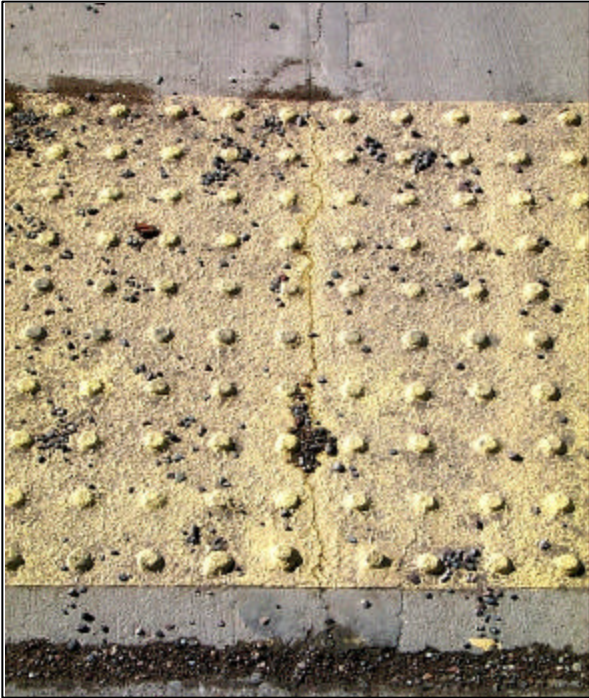
**Installation 5B:** Close-up of mortar crack through mat.

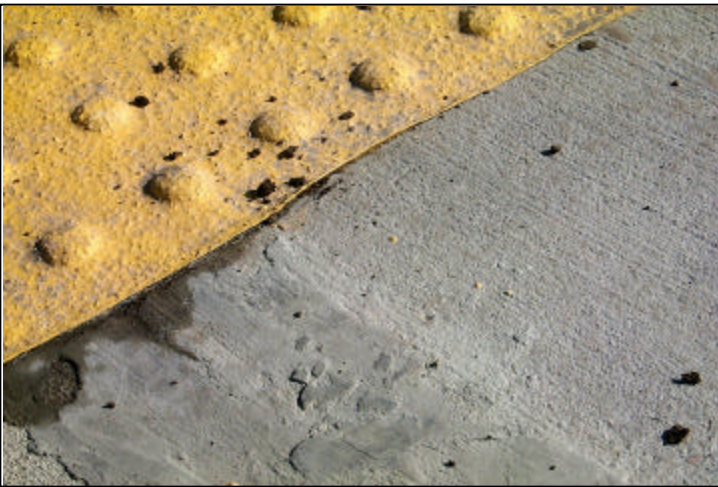
**Installation 6A:** Example close-up of edge losing adhesion from PCCP.

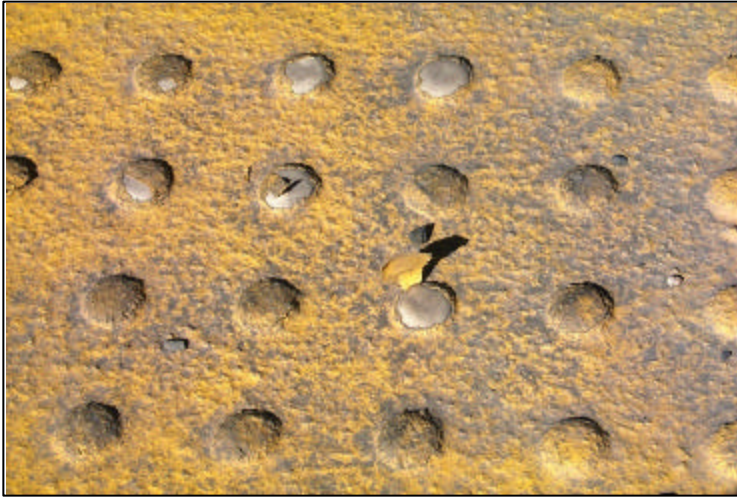
**Installation 6B:** Example close-up of delaminating and cracking surface cover of the rubber domes.

This will facilitate future loss of domes.

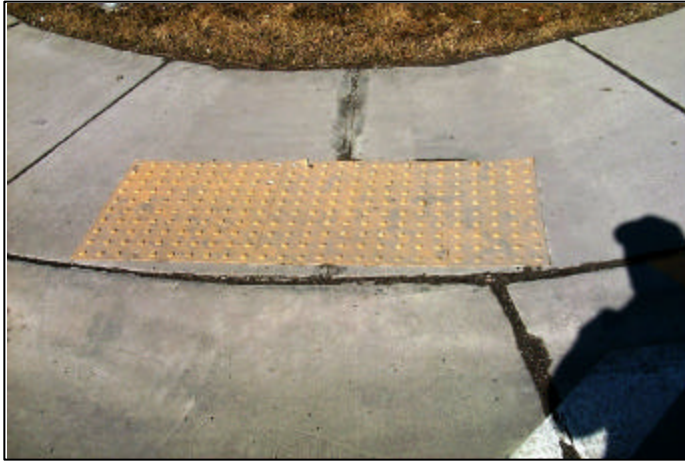
**Installation 7:** Located on the northwest corner of the intersection of 3<sup>rd</sup> Ave. N. W. and 6<sup>th</sup> St. N. W.

This treatment is failing rapidly. The surface of the mat has ripped, sheared and torn domes. Edges are losing adhesion.

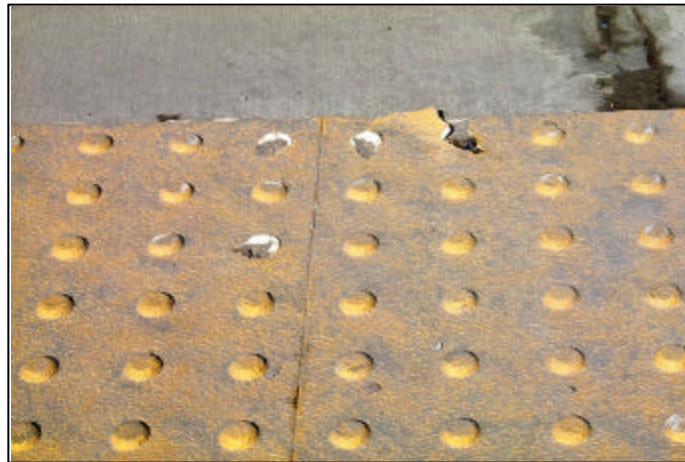
**Installation 7:** Close-up of damaged mat. Loss of domes and ripped mat.

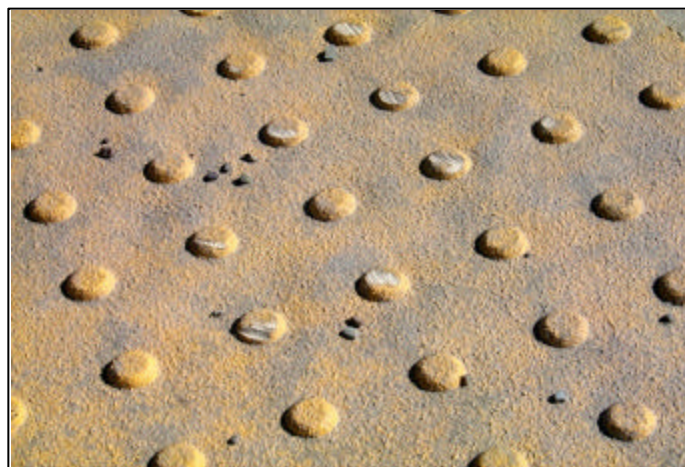
**Installation 7:** Additional close-up of damaged mat. Sheared domes from blade damage.
