## FULL-SCALE SHELL IMPACT TEST OF A DOT-113 TANK CAR

### SUMMARY

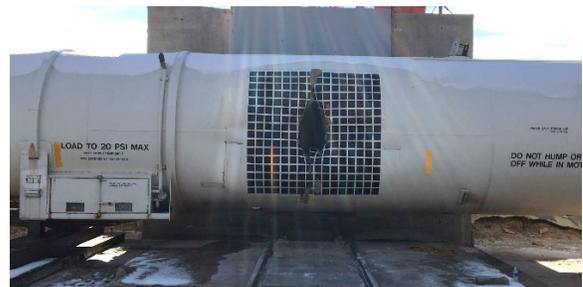
**Figure 2. Post-test Photo of the Punctured Shell**

The tank was punctured after an indentation of ~47 inches, at a force of ~750 thousand pounds. Review of the test measurements showed that the impactor had slowed to ~8.4 mph when puncture occurred, corresponding to a residual kinetic energy of ~0.7 million foot-pounds. The residual kinetic energy corresponded to approximately 25 percent of the initial kinetic energy of the ram car. [Figure 2](#) shows the punctured tank car outer shell.

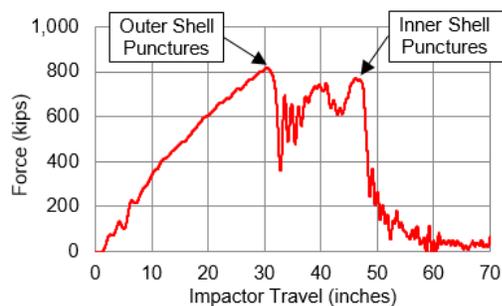
Figure 4. Test Force-displacement Results at 16.7 mph (CFC-60)

The impact occurred at 16.7 mph and resulted in puncture of the inner and outer tanks. The force-displacement results from the test are shown in Figure 4, along with annotations denoting where the outer and inner shells punctured. The force/acceleration results are taken from the average of four of the five longitudinal accelerometers on the ram. A CFC-60 filter was used on these results in accordance with the Society of Automotive Engineers (SAE) J211-1 standard. Examination of the test data revealed that the outer tank punctured after ~31 inches of impactor travel and the inner tank punctured after ~47 inches. The impactor continued to penetrate the inner tank after puncture.

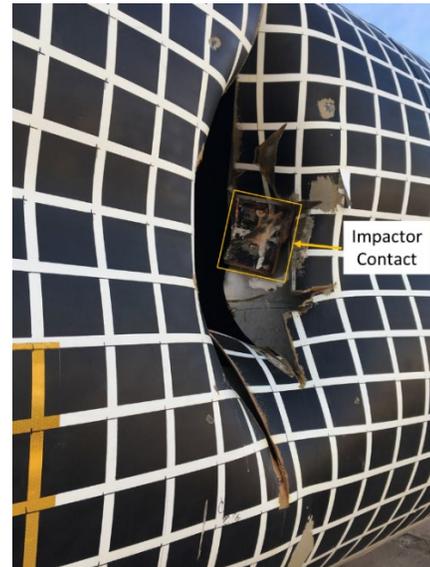
Figure 5. Post-test Tear in Outer Tank

Figure 5 shows the tear in the outer shell after the removal of the ram car. The tear appears to have initiated under a corner of the impactor and propagated vertically, which is consistent with previous tests and pre-test FEA for this test. No welds were involved in tearing of the outer tank. Red paint transfer from the impactor's tip is highlighted in this image as evidence of impactor contact.

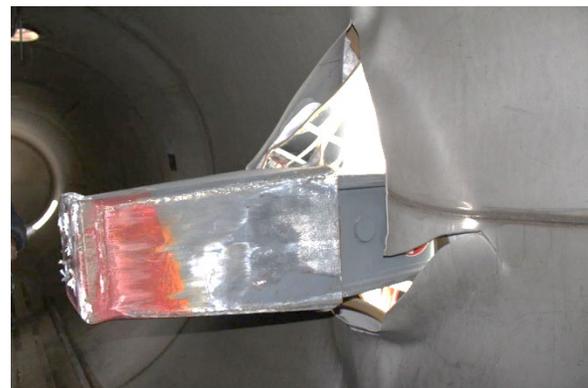
Figure 6. Post-test Tear in Inner Tank

Figure 6 shows the tear on the inner tank from the inside of the tank, prior to the ram's removal. Vertical tears are visible above the head of the impactor and a longitudinal tear is visible on the right of the image. The tear ran close to but did not open a stainless steel longitudinal weld seam in the inner tank.
