## Montana Department of Transportation Research Programs Helena, Montana

## **Annual Experimental Final Evaluation Report**

Project: Fairfield North & South, STPP 3-1(15)18; Teton County

Project Description: 60 mm Cold In-place Recycle, CMS-2 – 60 mm Plant Mix

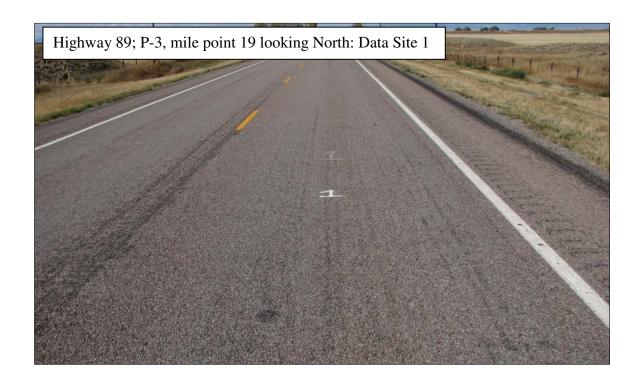
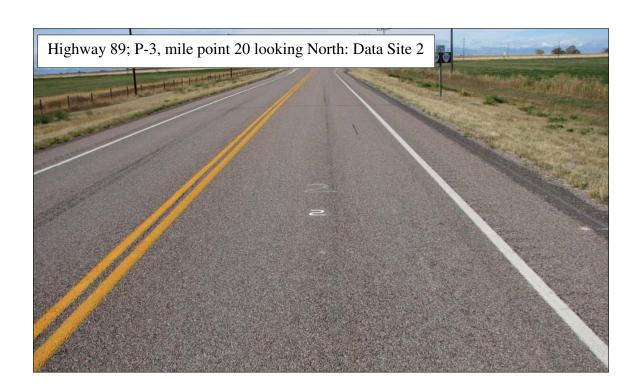
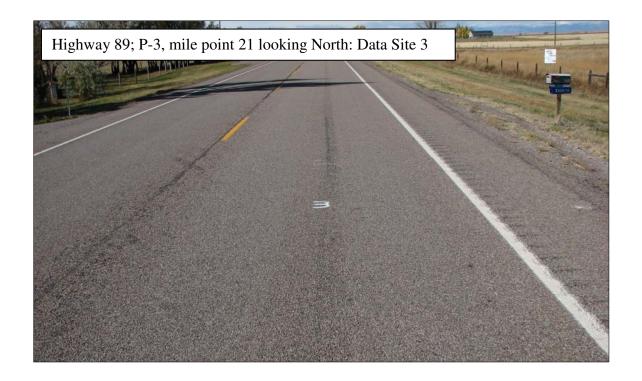
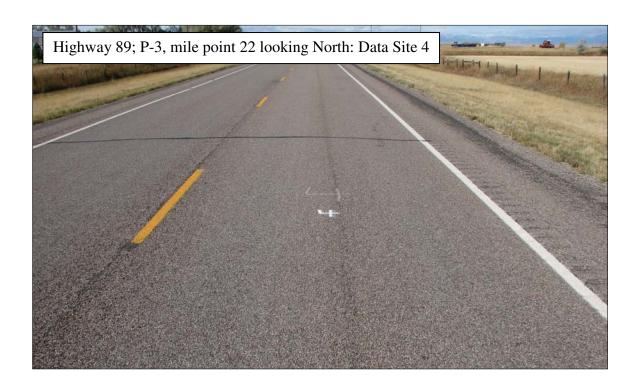
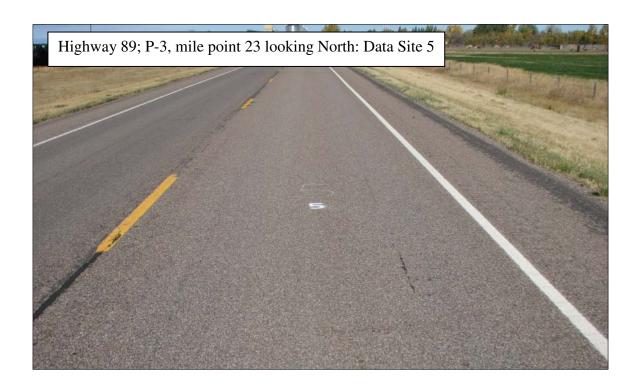
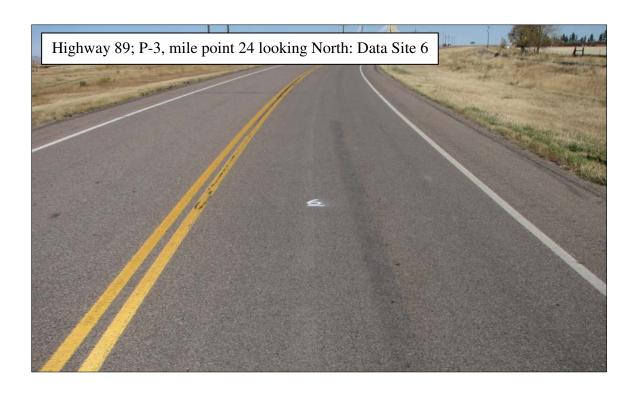
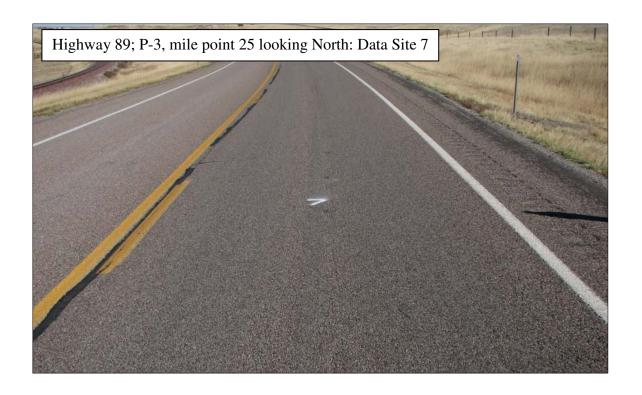
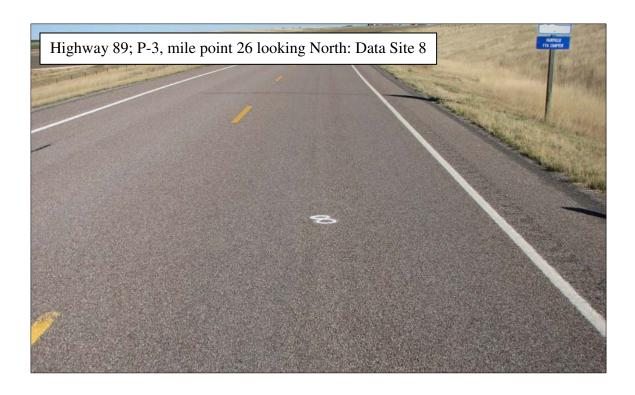
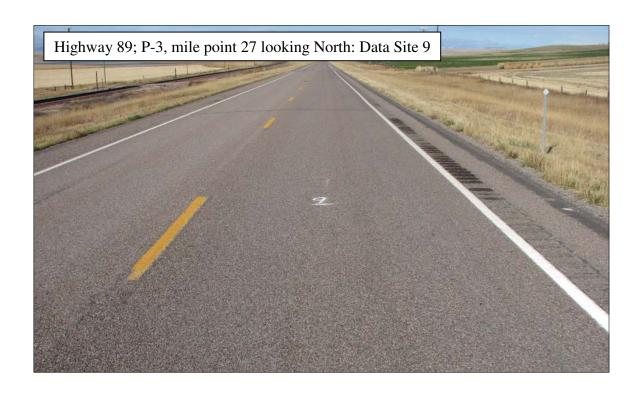
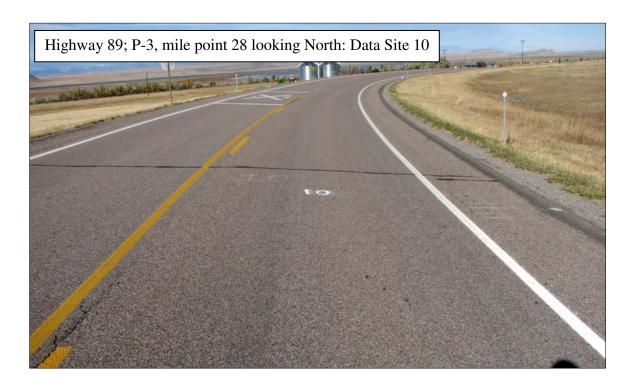
The following images are at each data location point, ten sites total.

Average transverse cracking per mile has increase from 47 cracks-per-mile (CPM) to 56 CPM, with a standard deviation of 1.26. The majority of the cracks were sealed. The additional cracking since the fall of 2006 is low severity in nature. Little additional rutting was observed during this evaluation. Estimated average rut is around 6 millimeter on both lanes. Average IRI for both lanes is rated as fair (60).

Overall, surface appearance of the project is tight and uniform. Based on the crack and rut data, this project has been rated as performing well. Additional information on this project is available at the MDT Research website:
