Montana Department of Transportation
Research Program
Helena, Montana

Annual Experimental Evaluation Report
(Informal)

Project: Fairfield North & South, STPP 3-1(15)18
Location: Highway 89 (P-3), MP 18-28
Evaluation Date: October 2004
Date Constructed: Fall 2001
Project Description: 60 mm Cold In-place Recycle, CMS-2 – 60 mm Plant Mix Bituminous Surface
Report Origin: Craig Abernathy
Experimental Project Manager

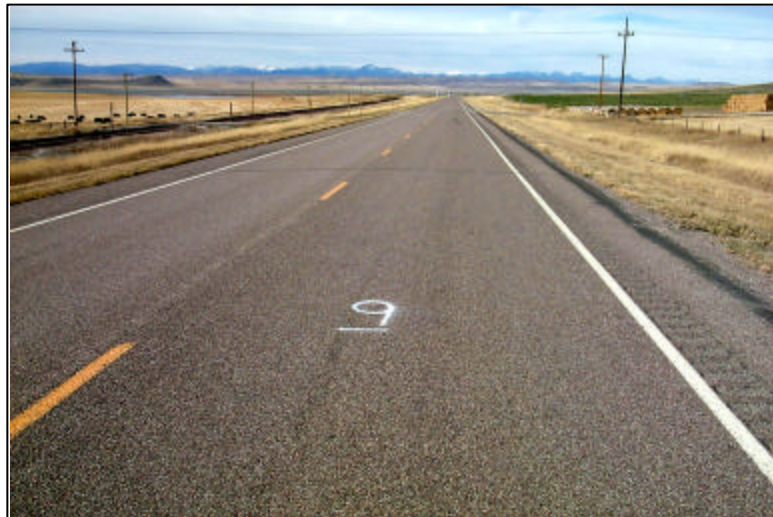
Average transverse cracking per mile (CPM) is low at 37 with a standard deviation of 1. All cracks were sealed. Very little rutting was observed during this evaluation. Estimated average rut is around 2 millimeter on both lanes.

Overall, surface appearance of the project is tight and uniform. The image is a sample representation of the pavement for the entire project (milepost 27). Based on the crack

and rut data, this project has been rated as performing well. Additional information on this project is available at the MDT Research website:
