Edge Drain Performance

Report Number: KTC-19-21/SPR18-557-1F

July 2019

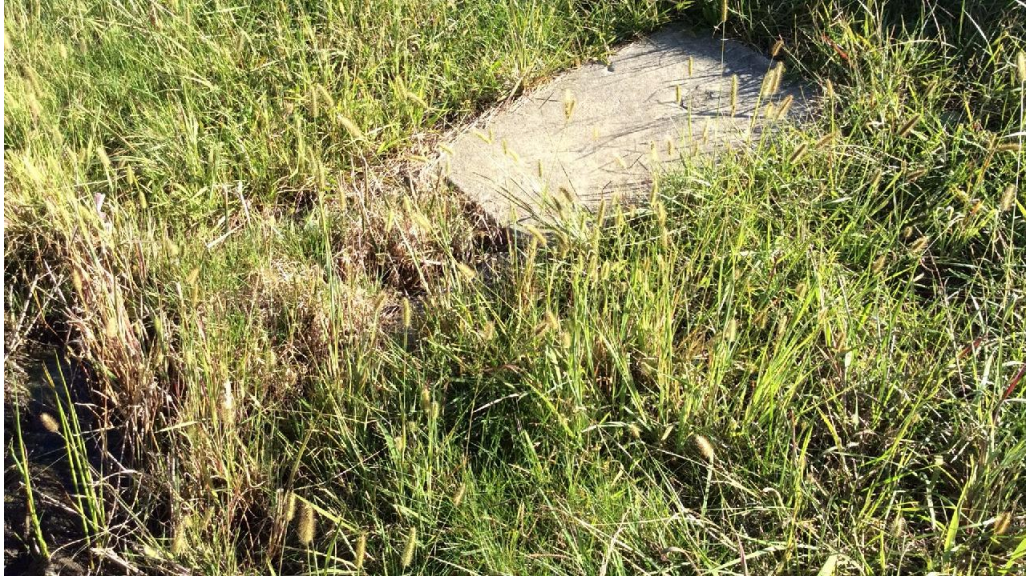
Figure 5 Waterway Completely Inundated

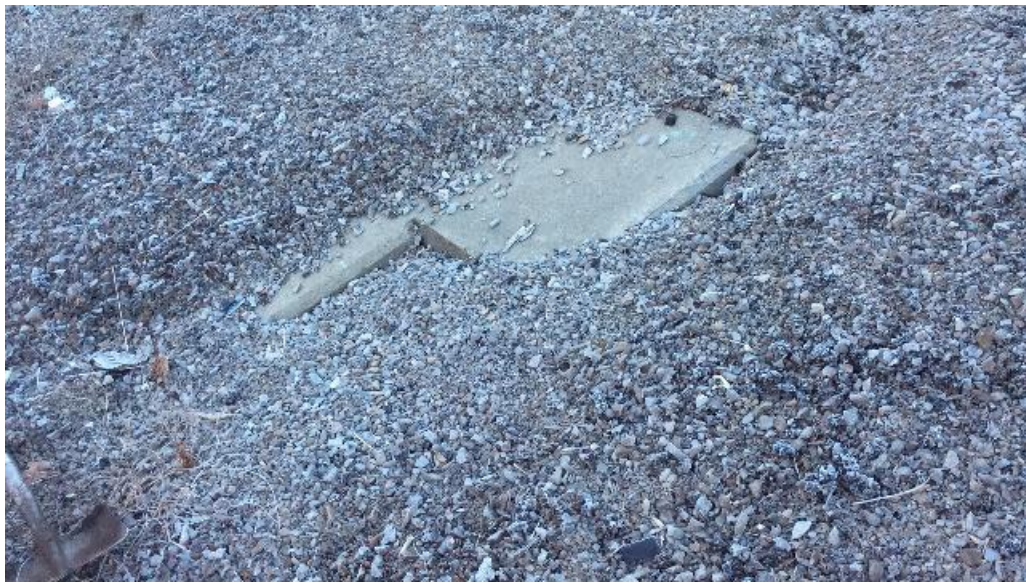
Figure 6 Waterway Completely Inundated

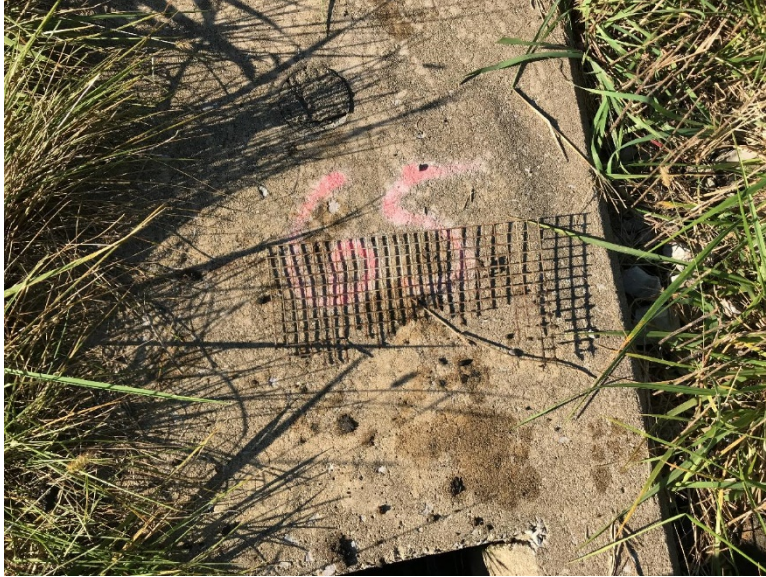
With respect to the presence and condition of rodent screens, 75% of the 126 headwalls had them installed 18% lacked them, while on 6% they were present but not functioning due to the screens being rusted through (Figure 9).

Figure 9 Rodent Screen Rusted Through
