Montana Department of Transportation
Research Program

ANNUAL EXPERIMENTAL FINAL EVALUATION REPORT

Cold In-Place Recycle (CIR) Koch™ Process CIR-EE

Location: Red Lodge, Montana – Carbon County, Highway 212 (P-28) Milepost 90-101.6

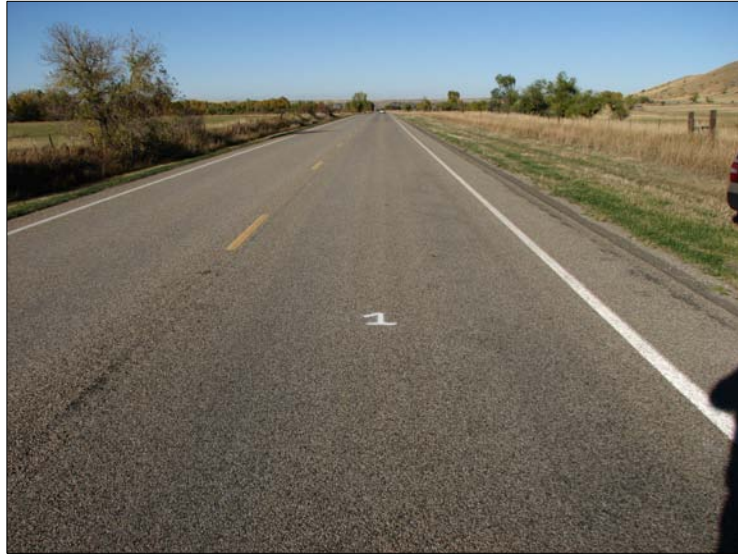
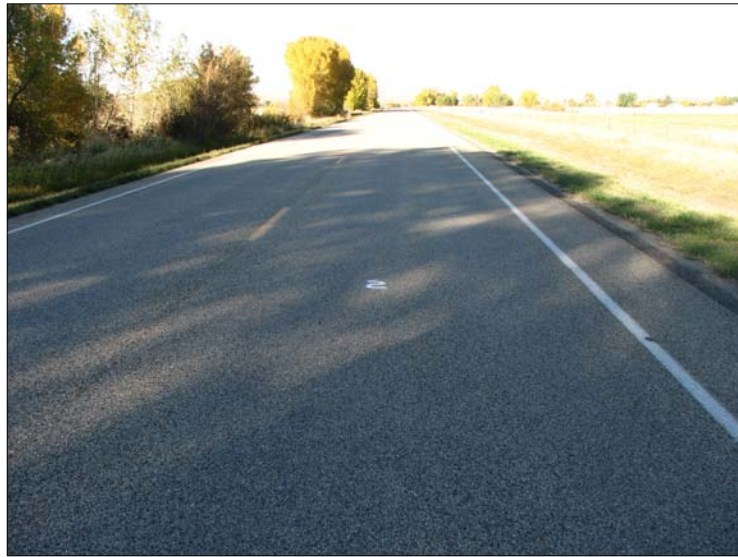
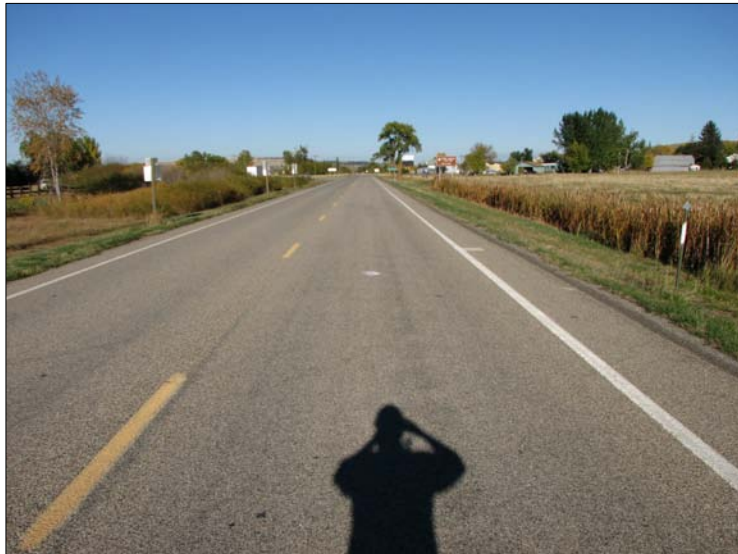
Section 1: MP 89- MP 91, 90mm cold mill, 105mm PMS

To date sections 1 and 6 have no noticeable cracking. Sections 2, 3, & 4 are beginning to show progressive transverse cracking, all low severity in nature. At this time the extent of transverse cracking in all sections is minimum and rated as good to fair.

Data sites 1, 2, & 3

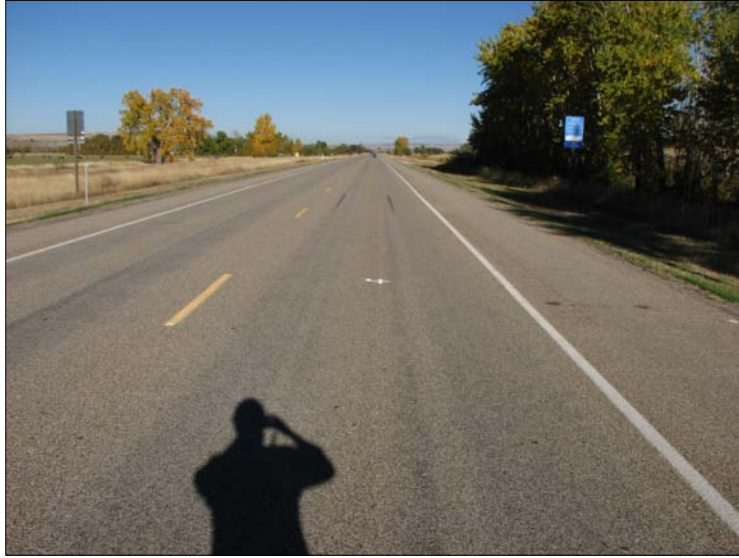
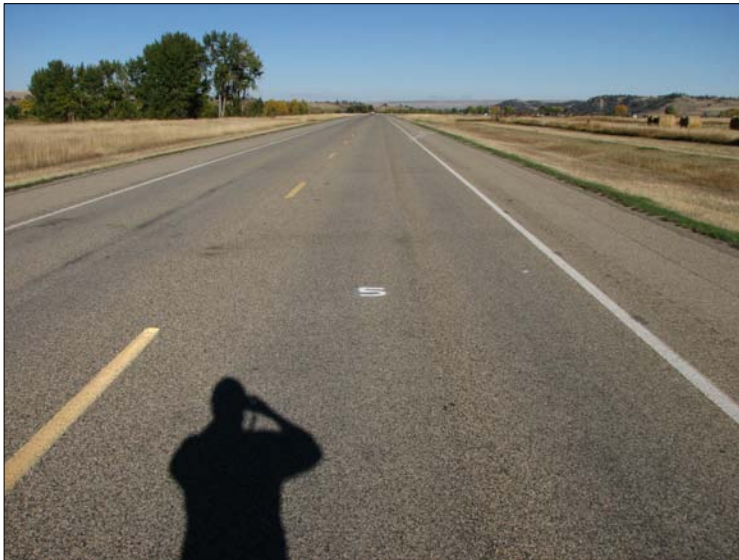
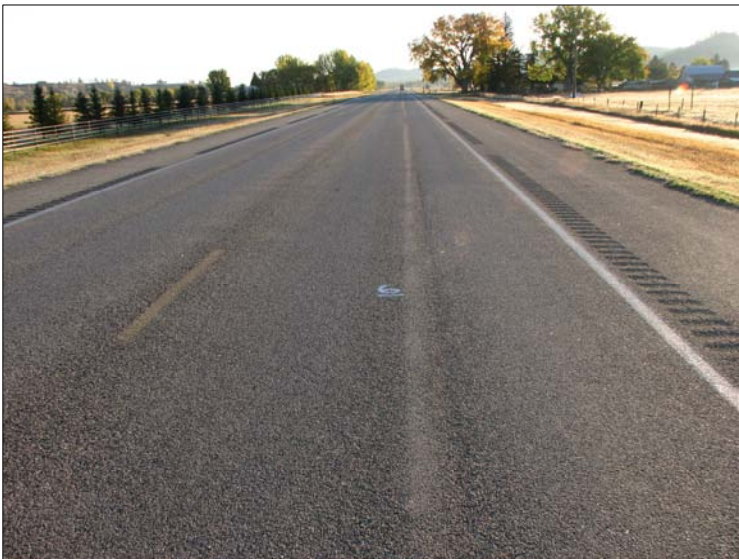
Section 2: MP 91-MP 94.3, 75mm recycle with 45mm PMS overlay

Most data sites exhibited good appearance and even seal with minimum rut. Several sections did have minimum flushing mainly in the wheelpaths. Section 2 (75mm recycle, 45mm PMS) displayed the best performance in rutting. Both 75mm recycle sections (3 & 5) display the most in averaged increased rut and exhibits more flushing. On average rutting is minor on the entire project. Average IRI for the project corridor is 70.

Data sites 4, 5, & 6

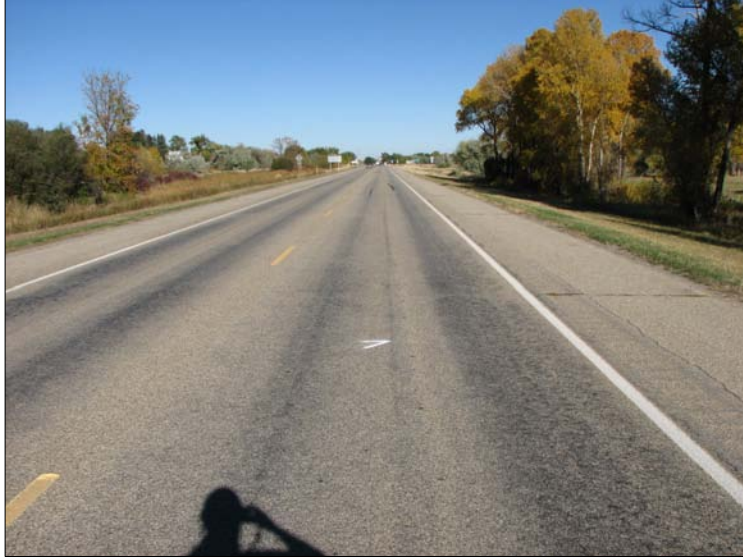
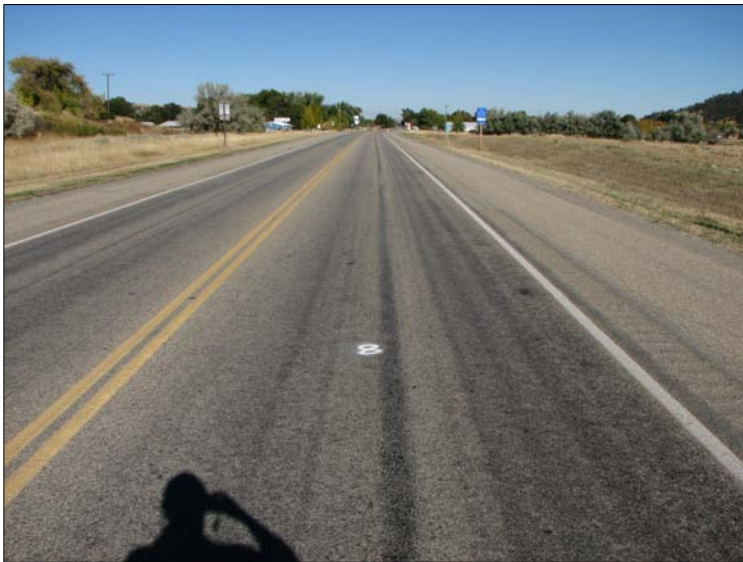
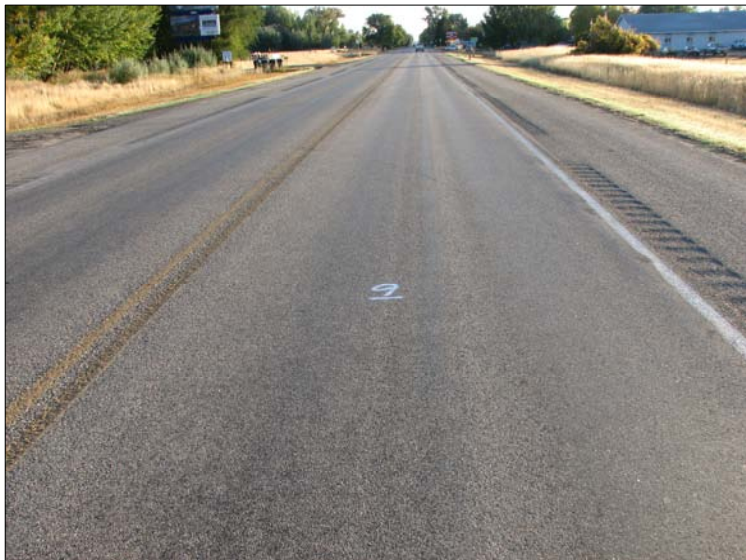
Section 3: MP 94.3-MP 95.4, 75mm recycle with seal and cover

Data sites 7, 8, & 9

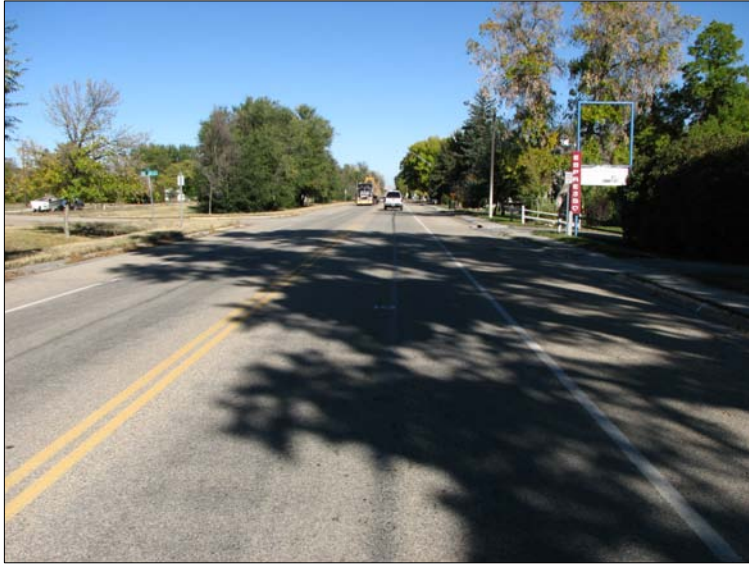
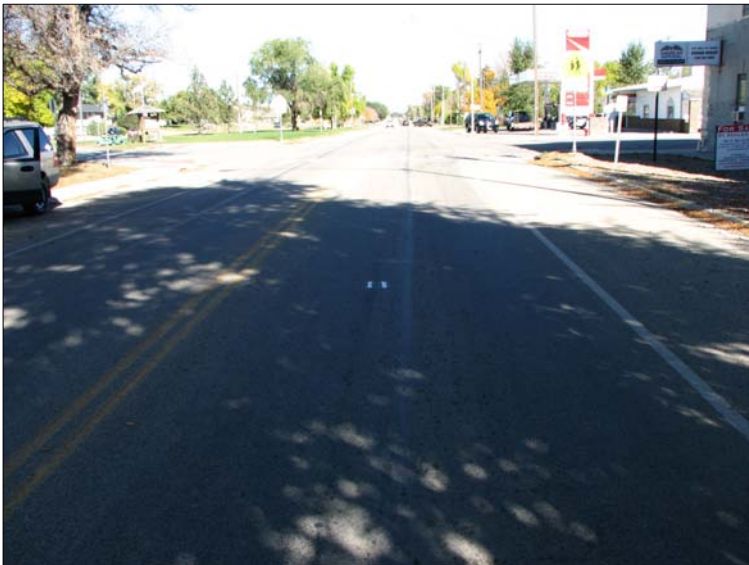
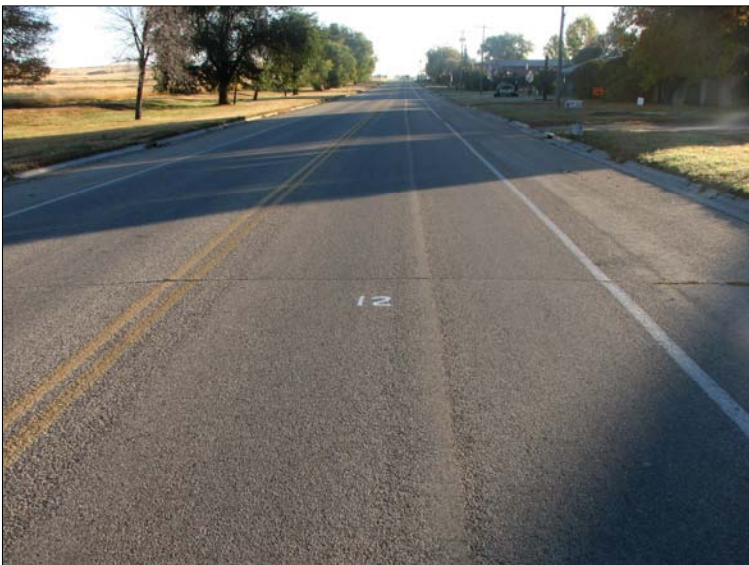
Section 4: MP 95.4-MP 96.3, 75mm mill and fill PMS

Data sites 10, 11, & 12

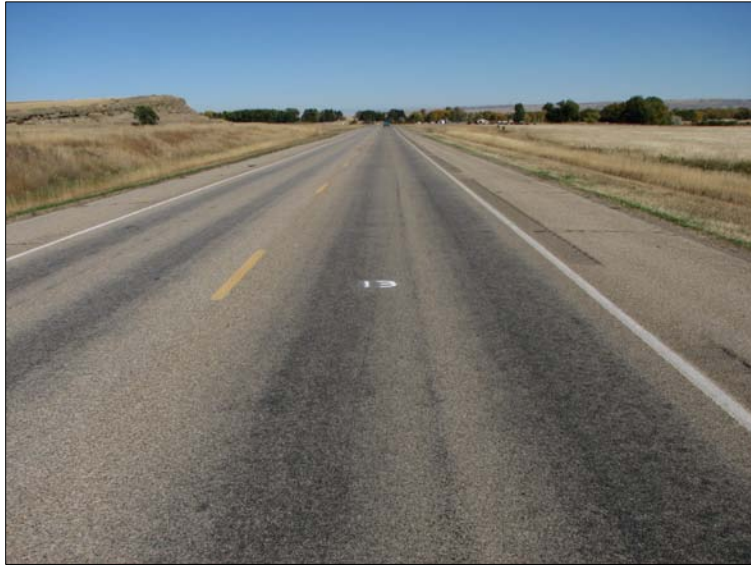
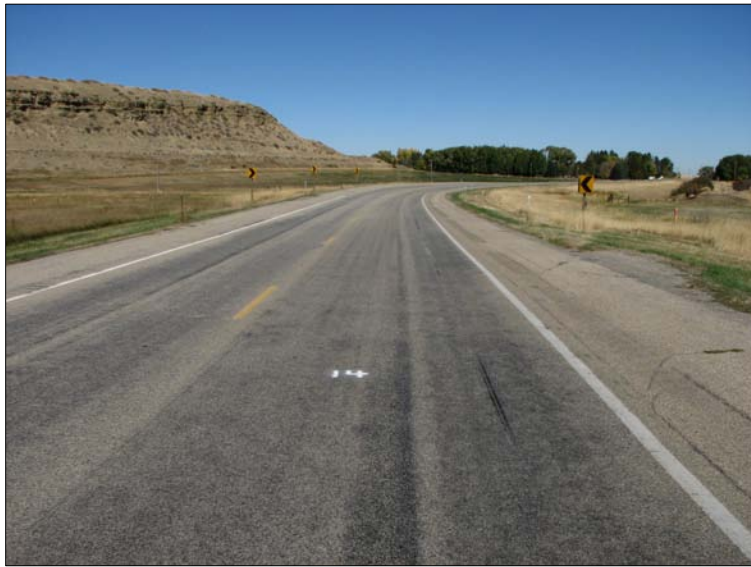
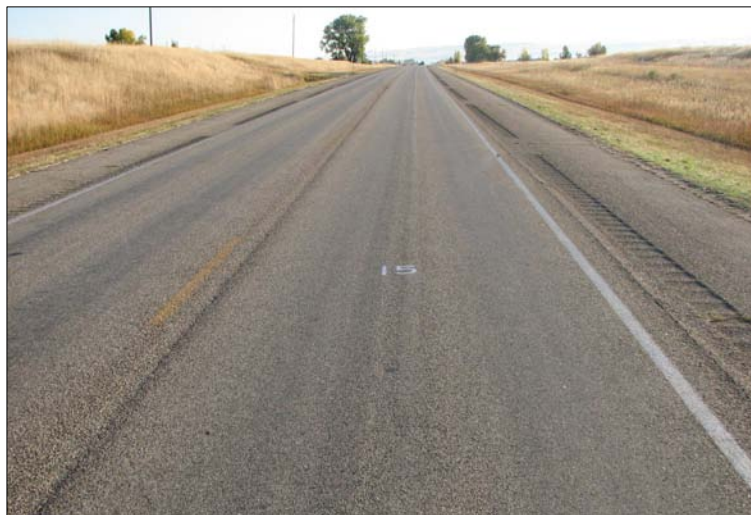
Section 5: MP 96.3-MP 98, 75mm recycle with seal and cover

*This data site was located in section 5, milepost 97.5 at the 75mm recycle site. The extrapolation puts the CPM at 151, with a standard deviation of 2. This report will note that initially with the first annual inspection, there was an abnormally high transverse cracking within the 300' data site. To date, low severity transverse cracks have been documented throughout the entire section. In earlier analysis it was speculated data site 97.5 (field reference number 15) was anomalous with cracking compared to the entire section. However, with the increased cracking within the other two data sites may be an indicator of overall performance.

Data sites 13, 14, & 15

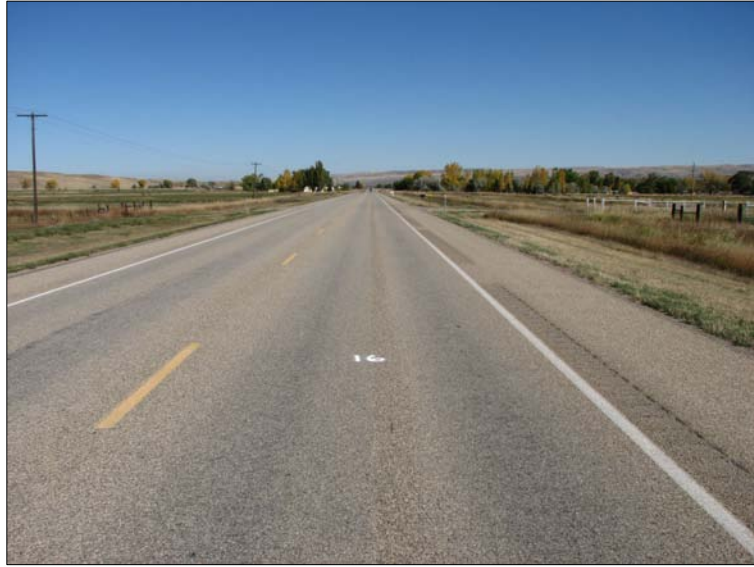
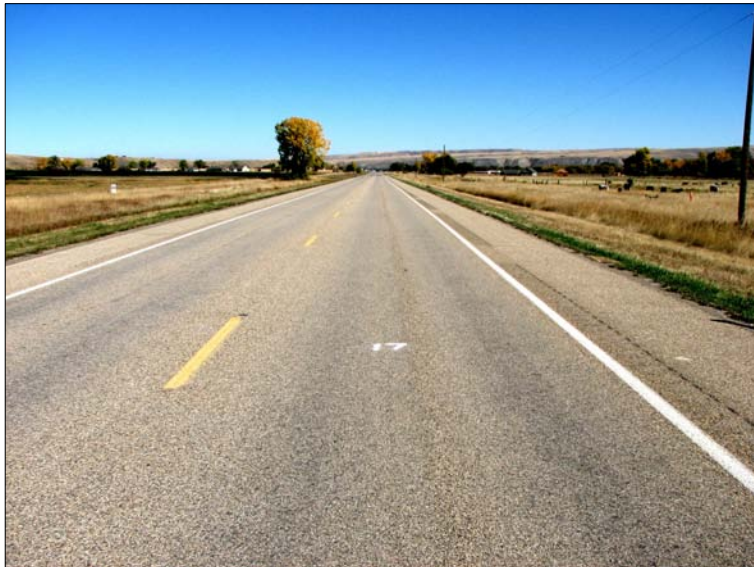
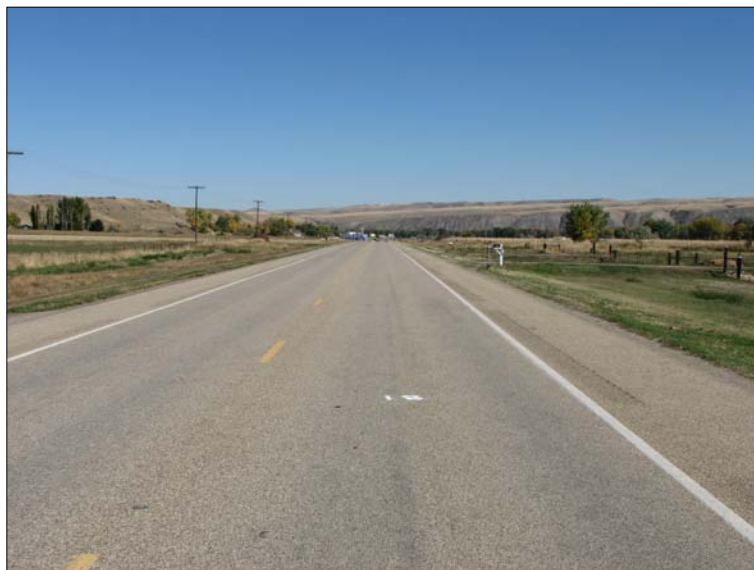
Section 6: MP 98-MP 101.6, 75mm recycle with two lifts of PMS (90mm)

Data sites 16, 17 & 18.
