ANNUAL EXPERIMENTAL EVALUATION REPORT

Cold In-Place Recycle (CIR) KochTM Process CIR-EE

Location: Red Lodge, Montana – Carbon County, Highway 212 (P-28) Milepost 90-101.6

Project No.: Red Lodge North STPP 28-2(22)70

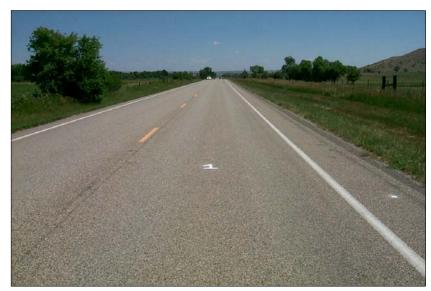
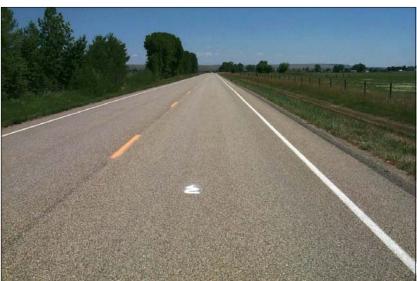
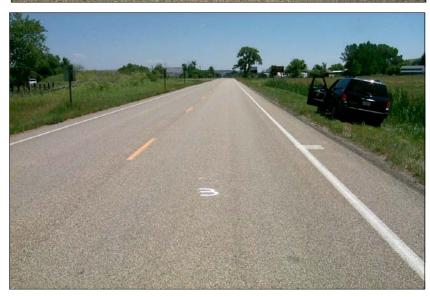
Section 1: MP 89- MP 91, 90mm cold mill, 105mm PMS

To date sections 1 and 6 have no noticeable cracking. Sections 2, 3, & 4 are beginning to show progressive transverse cracking, all low severity in nature. At this time the extent of transverse cracking in all sections is minimum and rated as good to fair.

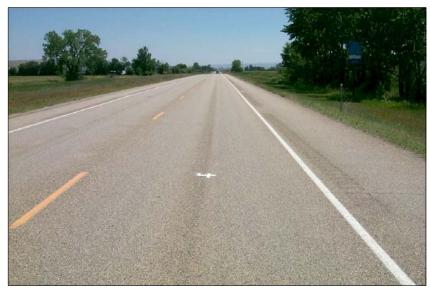
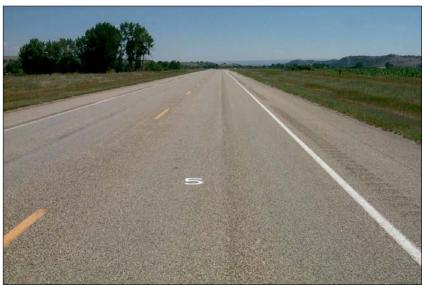
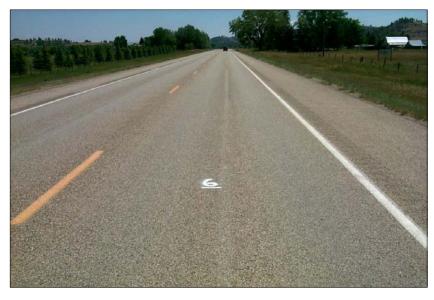
Section 2: MP 91-MP 94.3, 75mm recycle with 45mm PMS overlay

Most data sites exhibited good appearance and even seal with minimum rut. Several sections did have minimum flushing mainly in the wheelpaths. Section 2 (75mm recycle, 45mm PMS) displayed the best performance in rutting. Both 75mm recycle sections (3 & 5) exhibited the most in averaged increased rut. On average rutting is minor on the entire project. Average IRI for the CIPR corridor is 70.

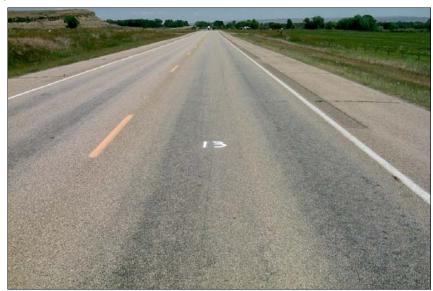
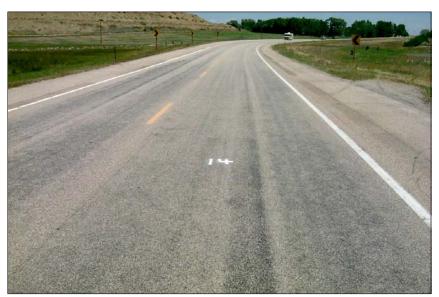
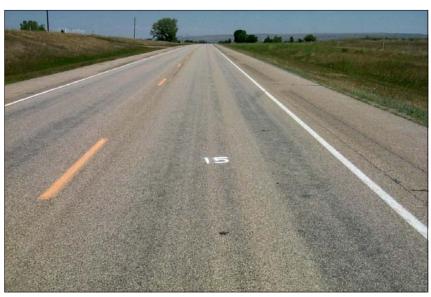
Section 5: MP 96.3-MP 98, 75mm recycle with seal and cover

*This data site was located in section 5, milepost 97.5 at the 75mm recycle site. The extrapolation puts the CPM at 170, with a standard deviation of 2. This report will note that initially with the first annual inspection, there was an abnormally high transverse cracking within the 300' data site. To date, a total of ten, low severity transverse cracks have been documented. The other two data sites within this section are beginning to exhibit across-lane cracking. In earlier analysis it was speculated data site 97.5 was anomalous with cracking compared to the entire section. However, with the increased cracking within the other two data sites may be an indicator of performance.
