## EVALUATION REPORT

### FIBER-REINFORCED POLYMER (FRP) PULTRUDED DECKING MATERIAL AND HELICAL ANCHORING SYSTEM FOR USE IN SNOW FENCE APPLICATIONS

Project No.: IM90-7(63)331

Description: Fourth semi-annual evaluation of remaining test section of snow fence using proprietary EZ-Deck Fiber-Reinforced Polymer (FRP).

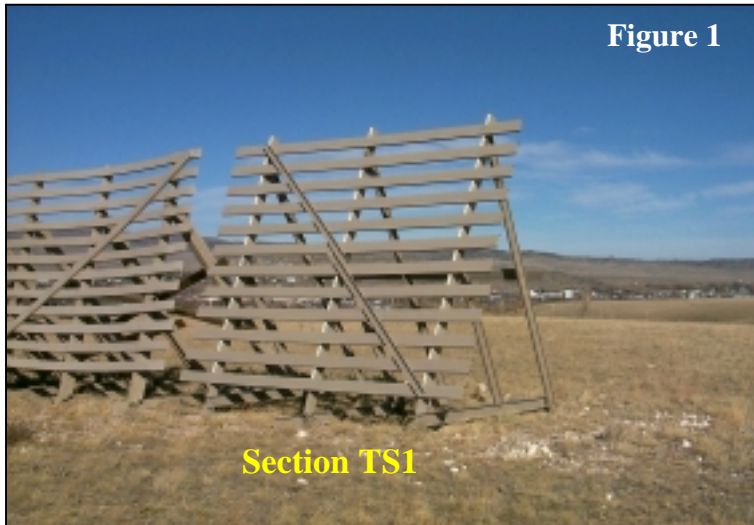
Inspections are held in early spring and late fall to document the environmental effects of seasonal extremes of the FRP material as well as stability of design. Figure 1 shows the remaining section TS1.

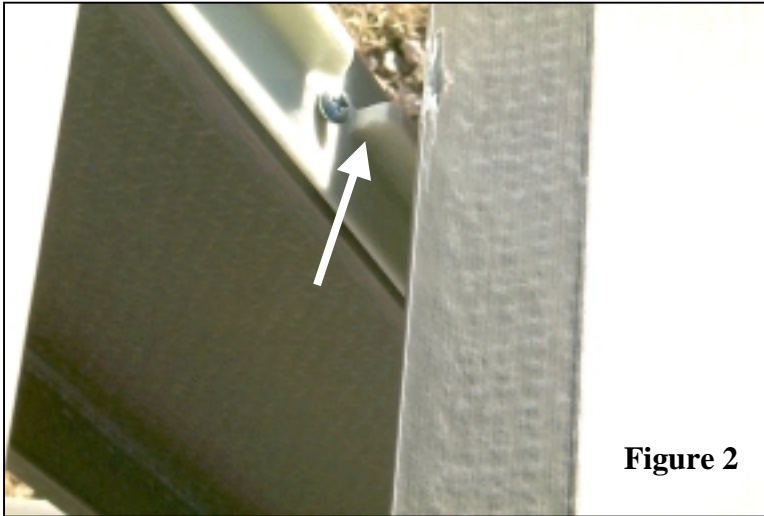
**Figure 2**

The bottom FRP plank, at the top of the center clip attachment, seems to have broken or sheared off. Figure two shows a close-up of the broken clip. The screw used to help secure the plank to clip remains. The plank shows the damage from the screw head as it (apparently) was pulled away. We can assume stress on the front panel from wind turbulence could have caused the separation. This occurrence is just on one clip attachment and was

not noticed on any other areas of the test section during this inspection. At this time, all other connections used to attach the FRP planking to the frames are intact with no evidence of loose screws or chipping of the FRP rail attachments. Visual appearance of all the FRP material shows no signs of sun or wind degradation.

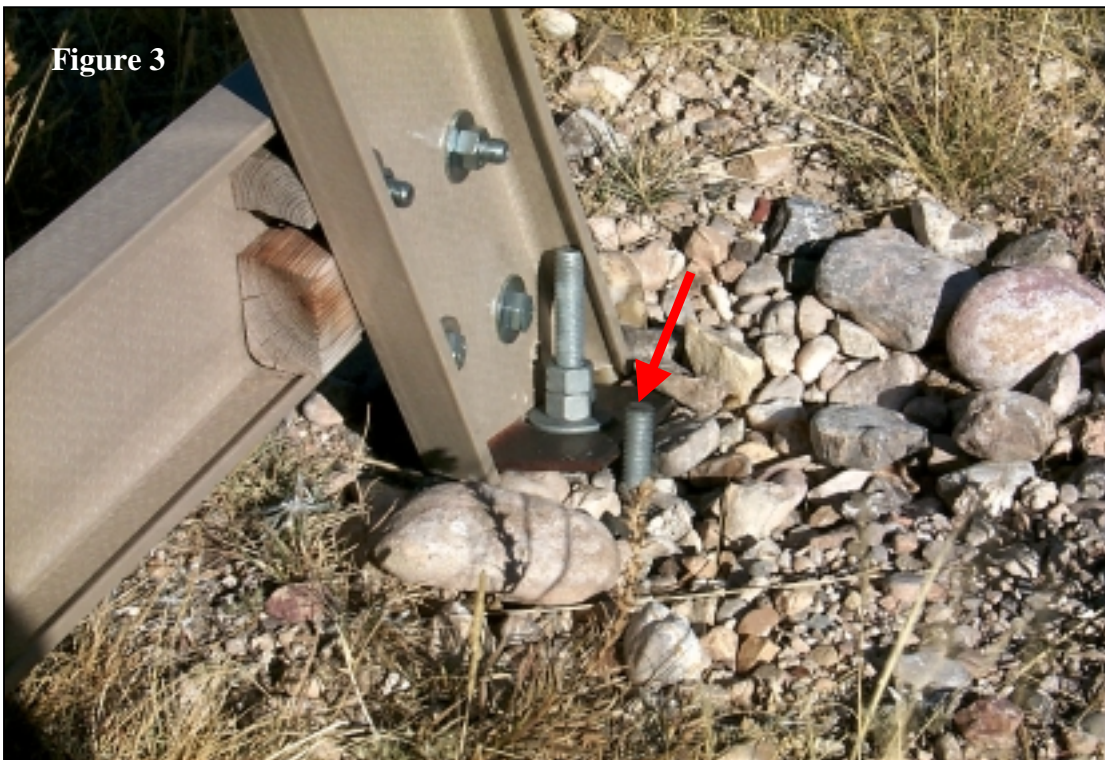
**Figure 3**

As noted in the October 2000 Report. The right, rear bolt attachment to the frame sill has broken (Figure 3). During this investigation, it was observed the sill had jumped to the left side of the

rear ground support. This broken sill support has, up to this time, not caused a catastrophic failure of section TS1. Nor is there any evidence that this loose rear sill attachment may have caused stress that allowed the center clip bracket to shear off. The sill frame will be closely monitored in future evaluations.
