Technical Assistance Report 18-04TA-P

**Submerged Road Characteristics and Distresses  
on LA 493, Natchitoches Parish, State Project Number H.011071**

Kevin Gaspard, P.E.  
Zhongjie Zhang, Ph.D., P.E.

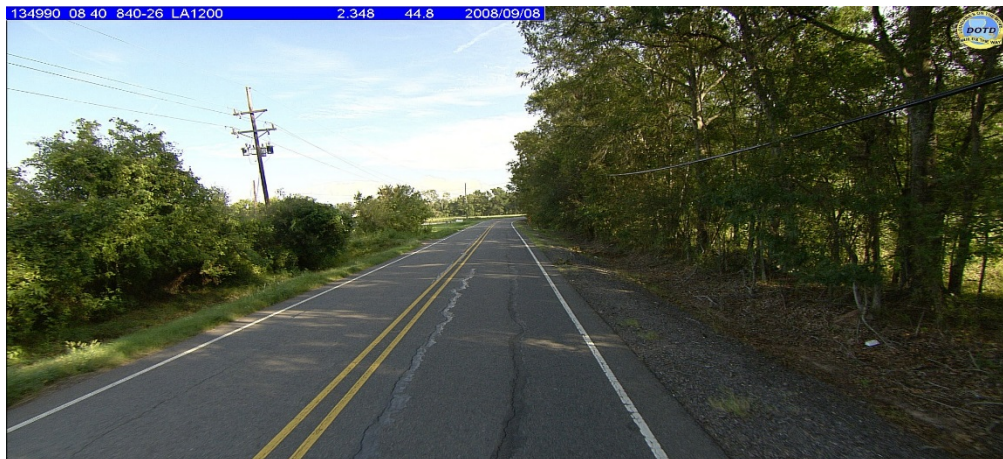
**Figure 1**  
**Longitudinal cracks: LA 1200: CSLM 2.348**

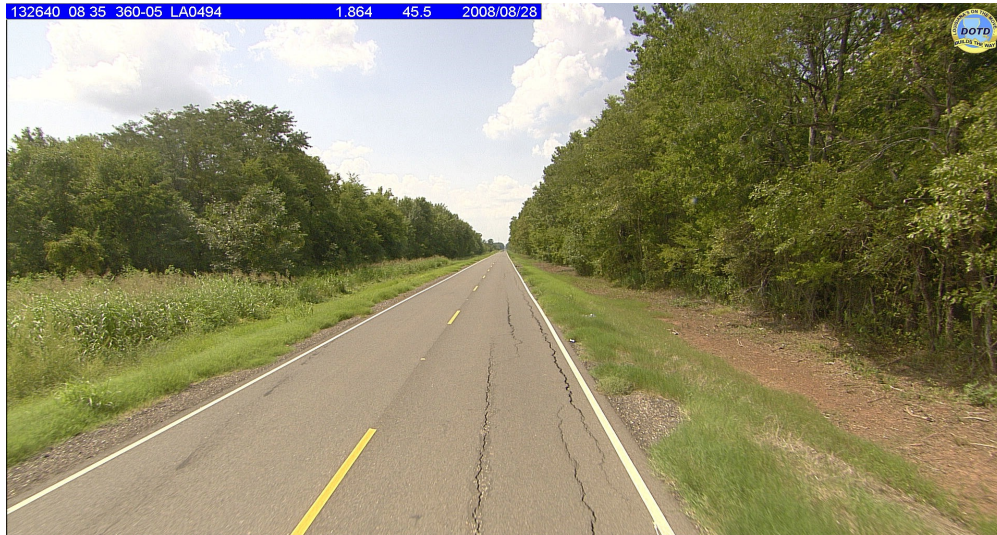
**Figure 2**  
**Multiple Longitudinal cracks: LA 494: CSLM 1.864**

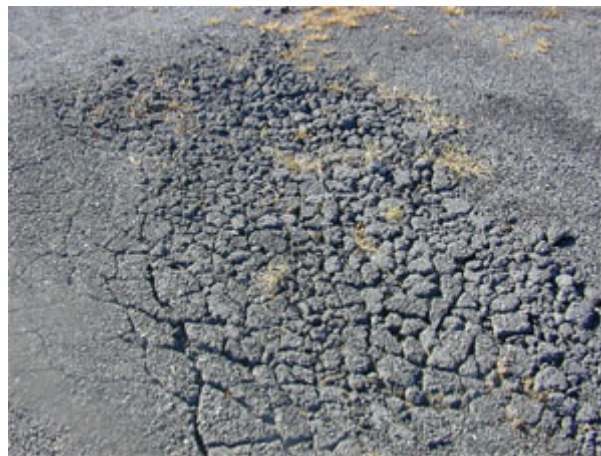
**Figure 4**  
**Alligator cracking in AC surface**

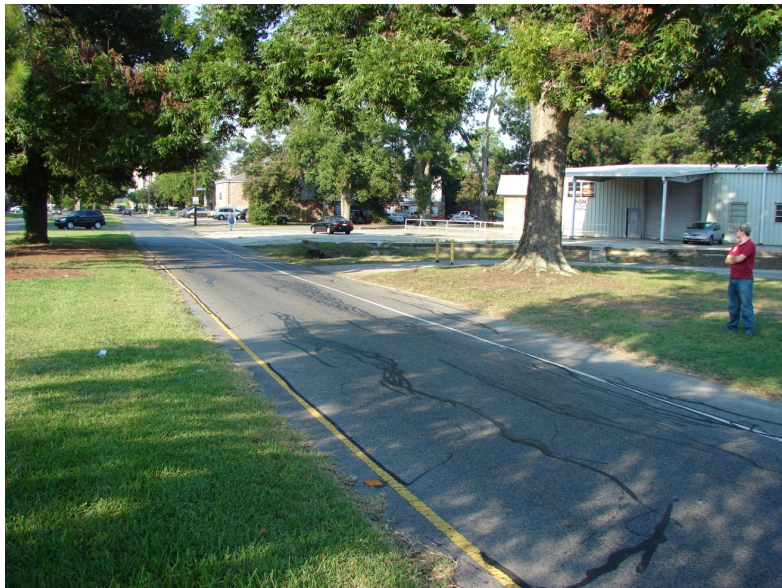
**Figure 7**  
**Multiple longitudinal cracks and subsidence: West Parker near LTRC**

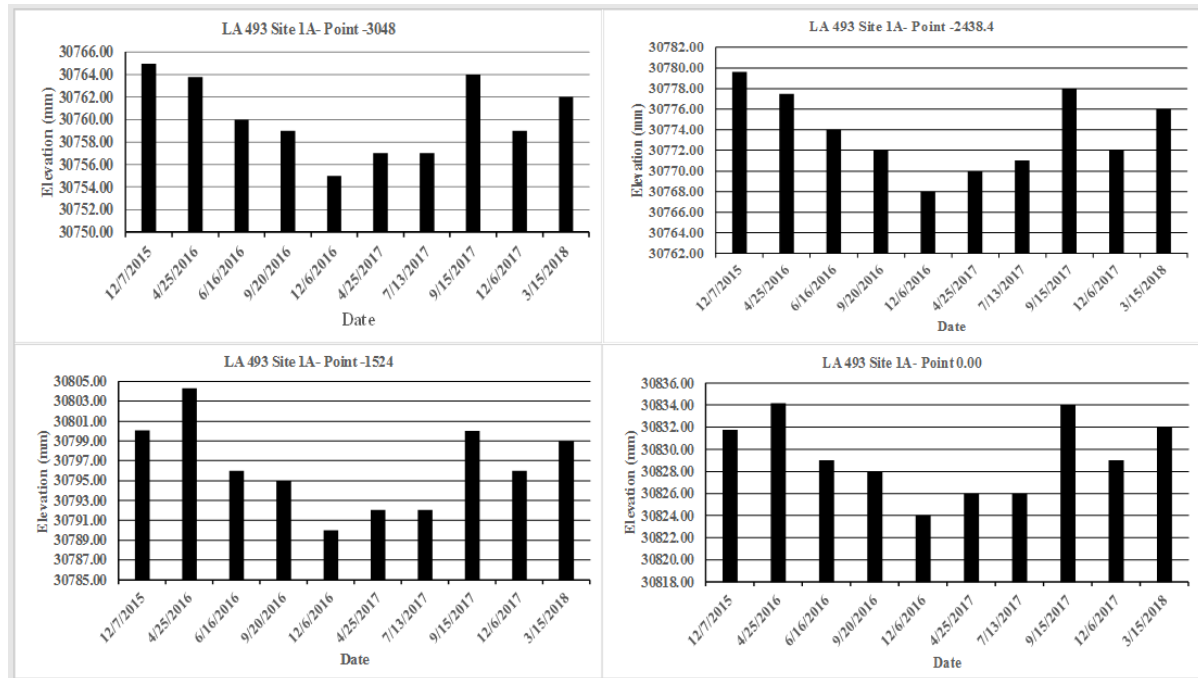
Further interesting observations from the survey measurements from Site 1A were that some points showed elevation increases while others showed elevation decreases across the roadway cross-section. One plausible explanation is that because of differential movement in the subgrade, semi-rigidity of the soil cement base course, and partial rigidity of the AC layer, an upward movement at one location may cause a downward movement at the adjacent location. A detailed finite element analysis, which is beyond the scope of this report, could validate this. This phenomenon though does fortify the notion that differential movements are occurring at roadway surface and those movements will induce stress into the AC layer which will eventually if not immediately lead to damage. In fact, careful examination of the values in Table 6 and Figures 12-13 reveal the obvious movements of each point as well as the differences of movement of each point over the course of the cross-section surveys (12/7/2015 to 3/15/2018) as well as the effect of submergence.

**Figure 12**  
**Charts of cross-section points for Site 1A (point -3048.00 to point 0.00)**

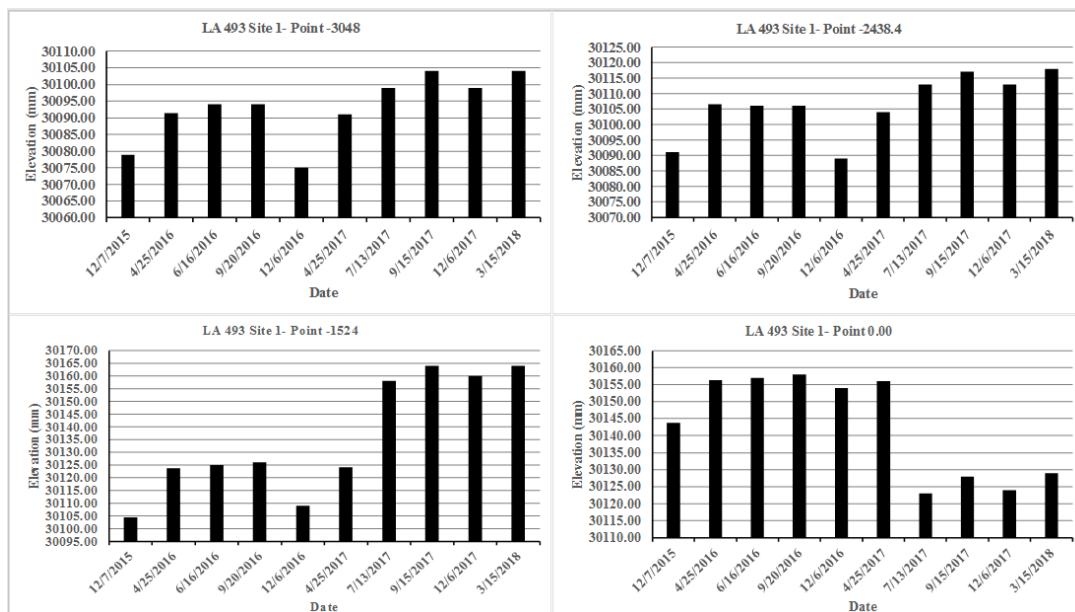
Tables 7-8 and Figures 14-15 present the results for the cross-section surveys. For this cross-section, no data is reported for the point 3230.88 because the edge of the road where this point was originally taken was damaged by heavy machinery. The elevation of the cross-section points (4/25/2016) all increased after the first flooding event with elevation increases ranging from 19.20 mm to 10.97 mm. As with section 1A, no adjacent point increased with a similar magnitude indicating that bending stresses were induced into the AC pavement and underlying layers. The trend toward increasing elevations continued until 12/6/2016 at which time the centerline (0) and left side of the roadway (- distances) reduced in magnitude while there was a general increase in magnitude on the right side (+ distances) of the roadway. The reasons for these differences between the left side and right side of the roadway is unknown. However, the reasons for the decreases in elevation (shrinking) can be explained because no flooding occurred between the 4/25/2016 and 12/6/2016. This trend generally reversed (increasing elevations) in the period between 4/25/2017 and 3/15/2018 which is probably the result of the two flooding events February 2017 to April 2017 and July 2017 to August 2017. It should be noted that on 3/15/2018, the AC surface was 59.51 mm (2.34 in.) higher than the time of the first cross-sectional survey on 12/7/2015 and that no point measured on the cross-section had the same magnitude.

**Figure 14**  
**Charts of cross-section points for Site 1 (point -3048.00 to point 0.00)**

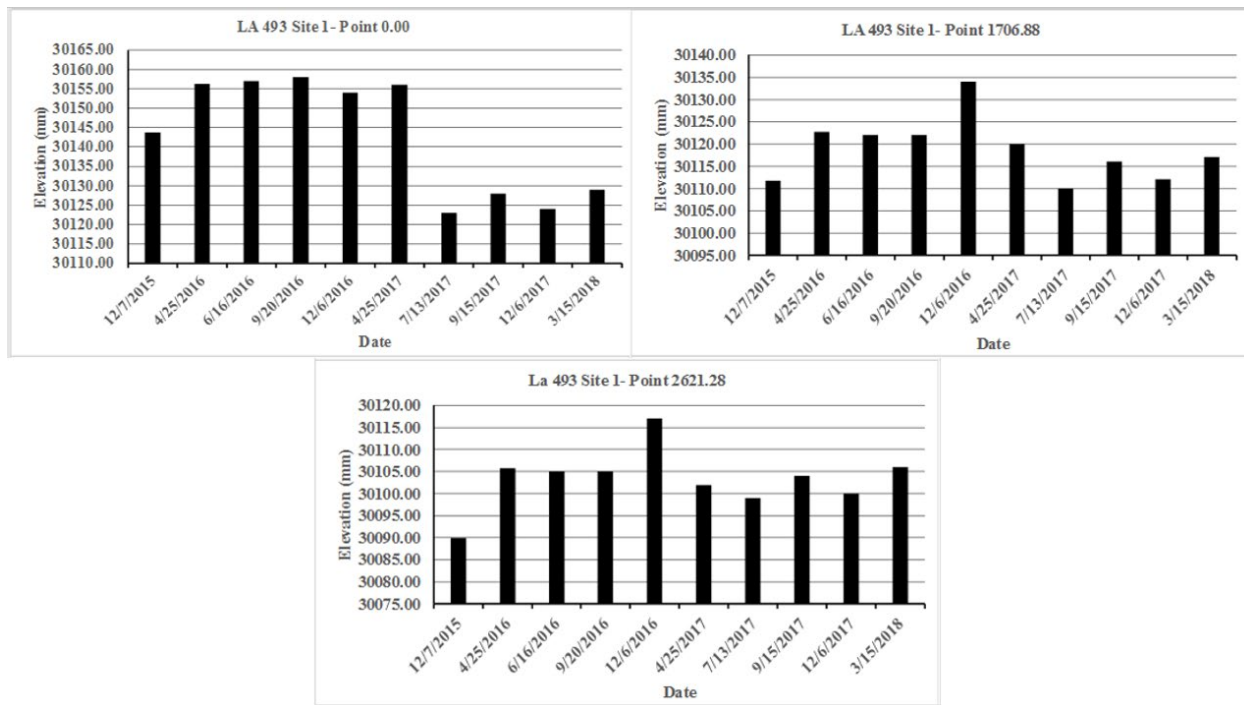
**Figure 15**  
**Charts of cross-section points for Site 1 (point 0.00 to 2621.28)**

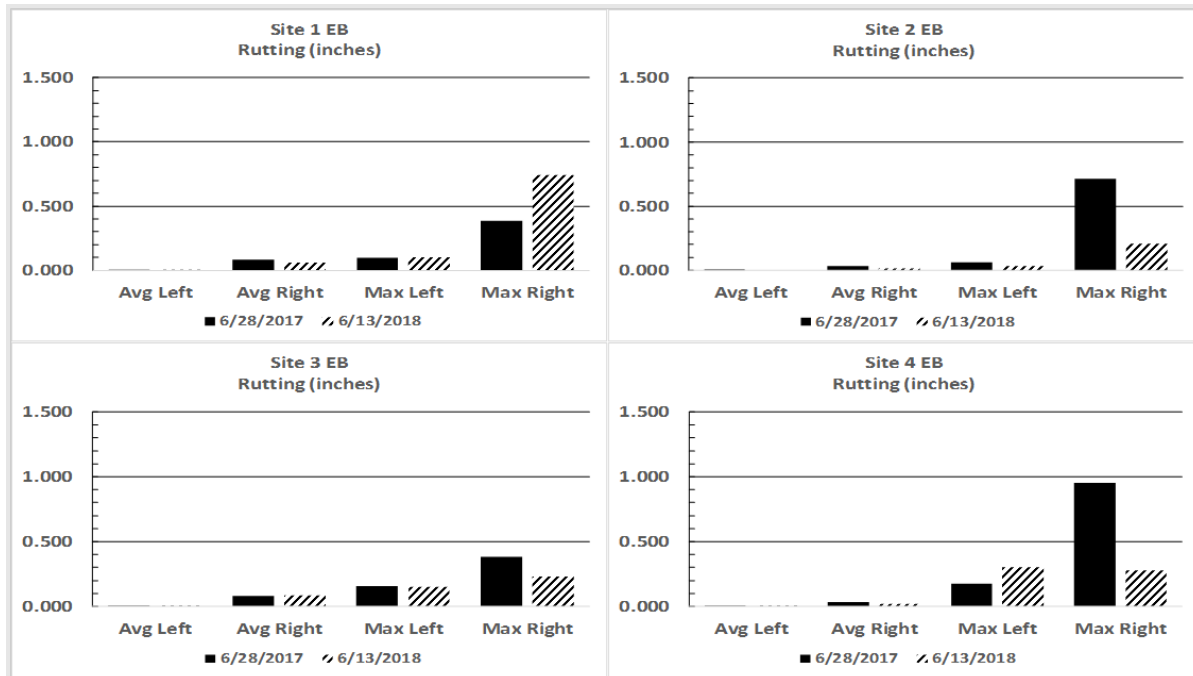
Figures 34 and 35 present the rutting measurements for Sites 1 to 6 on the assessment dates of June 2017 and June 2018. DOTD considers rutting greater than 0.5 in. to be significant and in need of mitigation. The average rutting depths for each site were very minor but there were significant maximum rutting depths at some locations within each Site. It is probable that the significant rutting at some locations were due to weakening of the pavement structure due to volumetric changes in the embankment as well as depressions caused by movements in the embankment. For Site 1, the maximum rutting in the RWP was 0.386 in. in June 2017 and 0.74 in. in June 2018 indicating that rutting in those locations are increasing. Site 2 showed a similar pattern with the maximum rutting in the RWP being 0.713 in. in June 2017 and 0.205 in. on June 2018. The reason for the decrease in the maximum rutting between June 2017 and June 2018 is unknown. The maximum rutting values for Site 3 in the RWP were 0.382 in. on June 2017 and 0.232 in. on June 2018. Site 4 had maximum rutting values in the RWP of 0.953 in. on June 2017 and 0.28 in. on June 2018. As with Site 2, the authors are uncertain of the decrease in maximum rutting between June 2017 and June 2018. The maximum rutting values in the RWP for Site 5 were 0.673 in. and 1.2 in. on June 2017 and June 2018, respectively. This site had the highest maximum rut depth in the EB direction. Site 6 had maximum rutting values in the RWP of 0.953 in. and 1.5 in. on June 2017 and June 2018, respectively.

**Figure 34**  
**EB rutting for Sites 1 to 4**

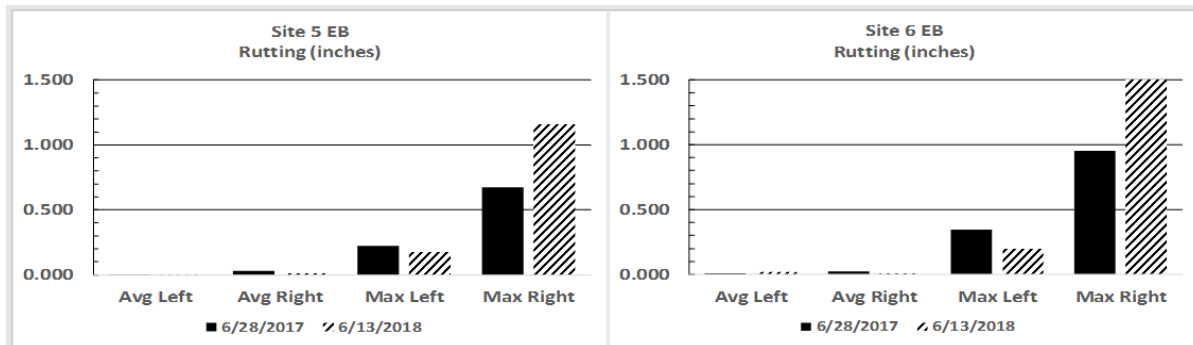
**Figure 35**  
**EB rutting for Sites 5 and 6**

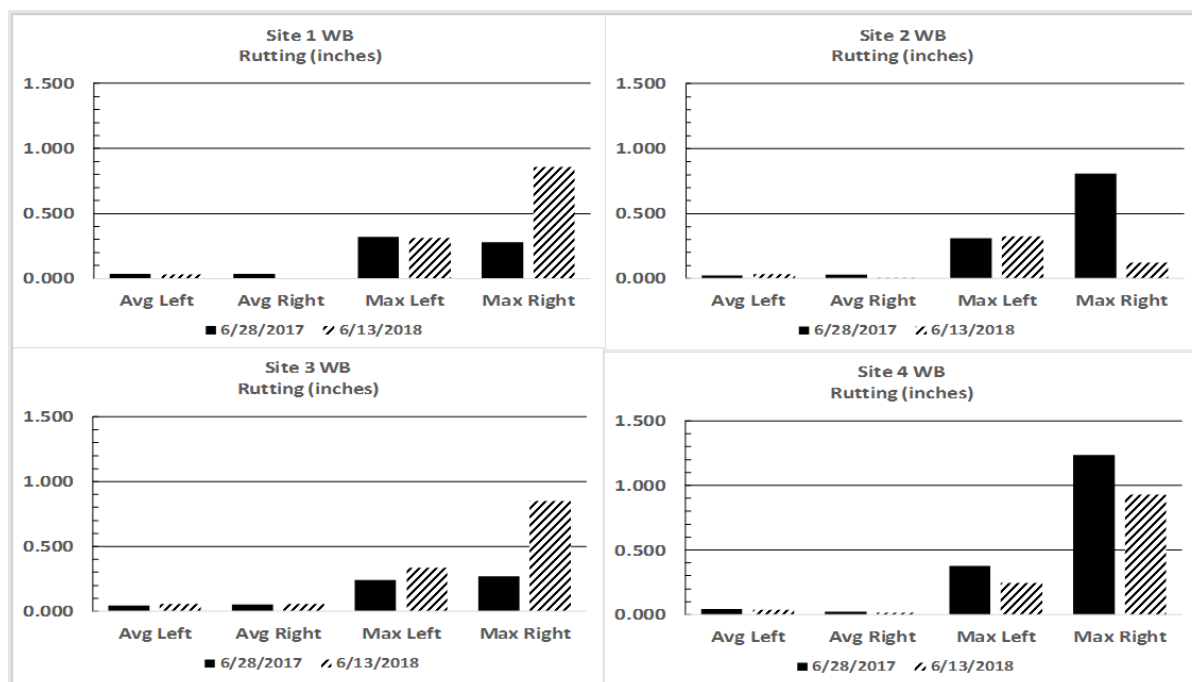
2017 and June 2018, respectively. Regarding Site 5, the maximum rutting depth in the RWP in June 2017 was 0.824 in. and on June 2018 it was 0.965 in. On Site 6, the maximum rutting depth on the RWP was 1.118 in. on June 2017 and 0.118 in. in June 2018.

**Figure 36**  
**WB rutting for Sites 1 to 4**

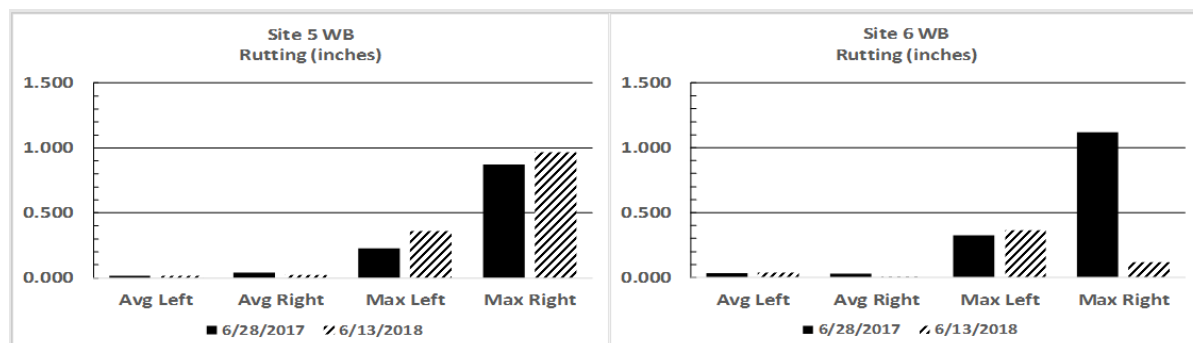
**Figure 37**  
**WB rutting for Sites 5 and 6**
