NATIONAL TRANSPORTATION SAFETY BOARD

RAILROAD ACCIDENT REPORT,

REAR END COLLISION OF AN
ALASKA RAILROAD FREIGHT TRAIN
WITH A PASSENGER TRAIN
NEAR HURRICANE, ALASKA
JULY 5, 1975.

REPORT NUMBER: NTSB-RAR-76-3

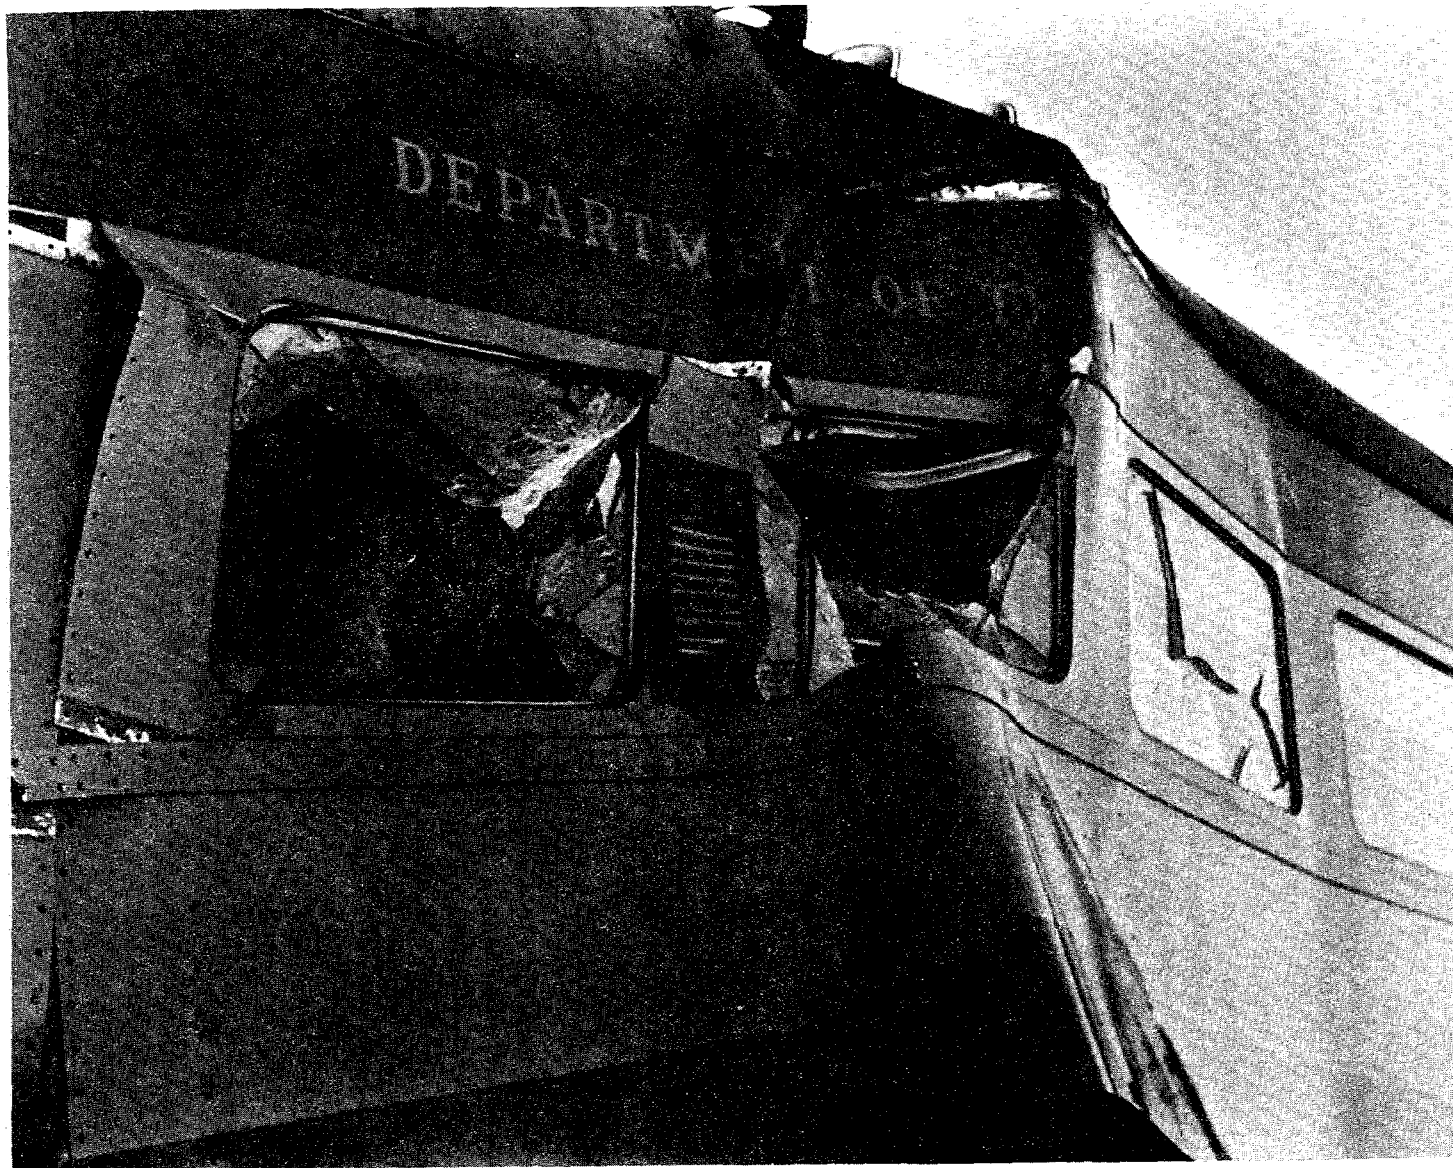
The rear of No. 5 stopped 76 feet south of the point of impact. All cars were derailed. Car 10, a dome car, was heavily damaged when the underframe buckled. (See Figure 1.) The remaining passenger cars were damaged slightly.

Figure 1. Damaged dome car of train No. 5.

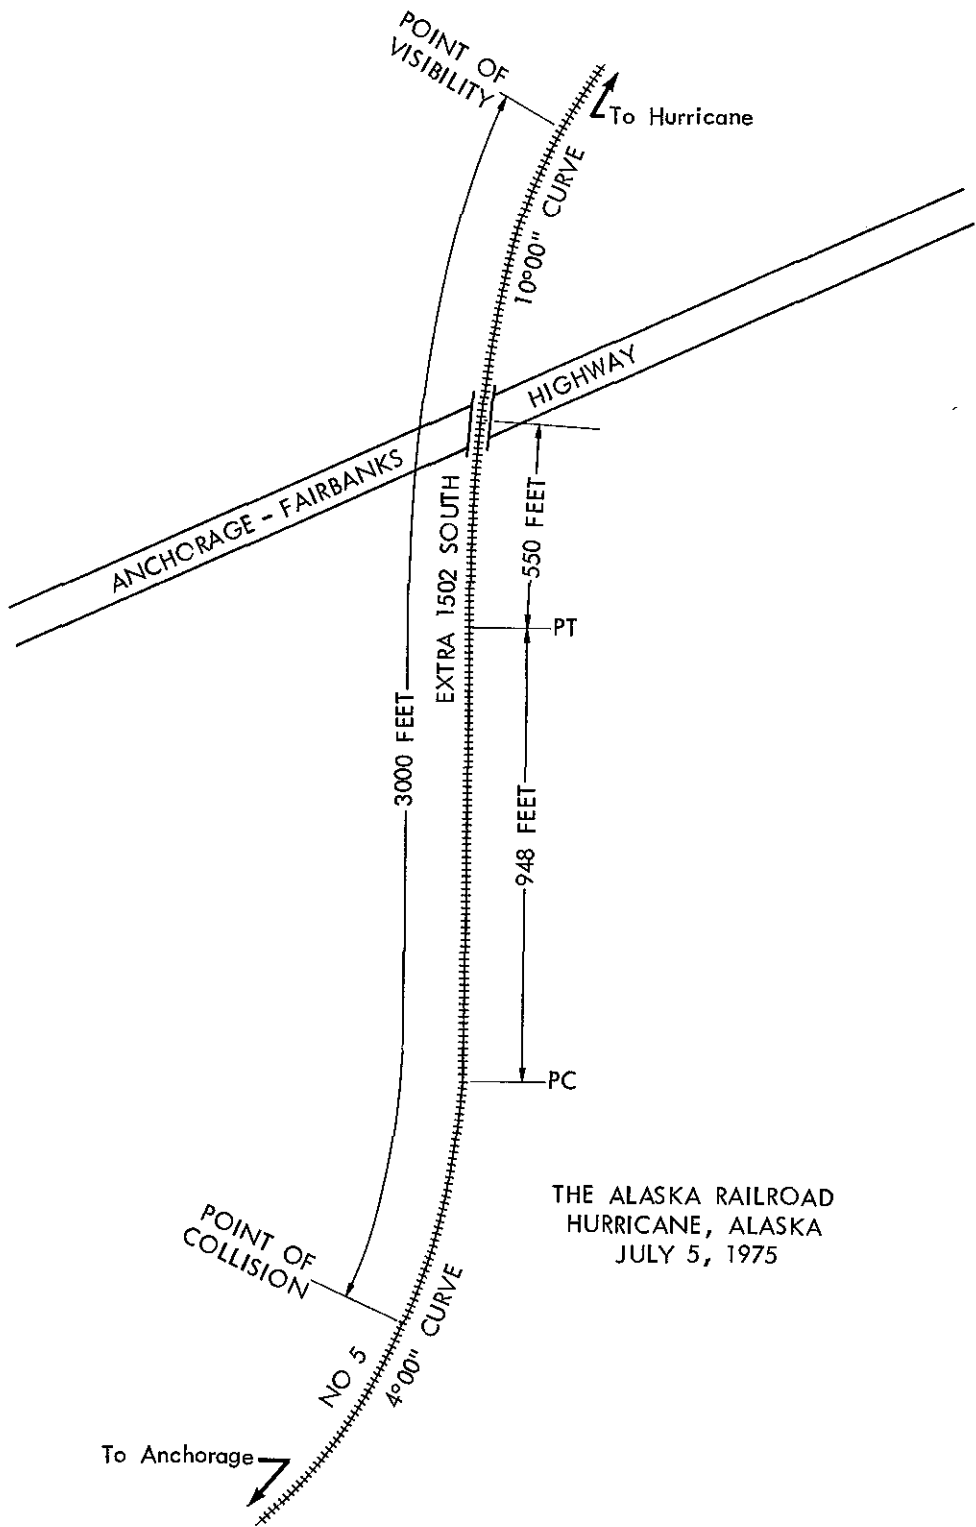
The single main track, south from Hurricane, is straight until a point 3,121 feet north of the collision. There, a 1° curve to the east extends southward 1,597 feet. The track is then straight for 948 feet, where a 4° curve to the west begins; the curve continues beyond the collision point. For southbound trains, the grade is 1.75 percent descending, from about the beginning of the 1° curve to the collision point. The Anchorage-Fairbanks highway crosses the main track 2,079 feet north of the collision point. (See Figure 2.)

Figure 2. Accident site.
