# RAILROAD ACCIDENT REPORT

## HAZARDOUS MATERIALS RAILROAD ACCIDENT

### IN THE ALTON AND SOUTHERN GATEWAY YARD

REPORT NUMBER: NTSB-RAR-73-1

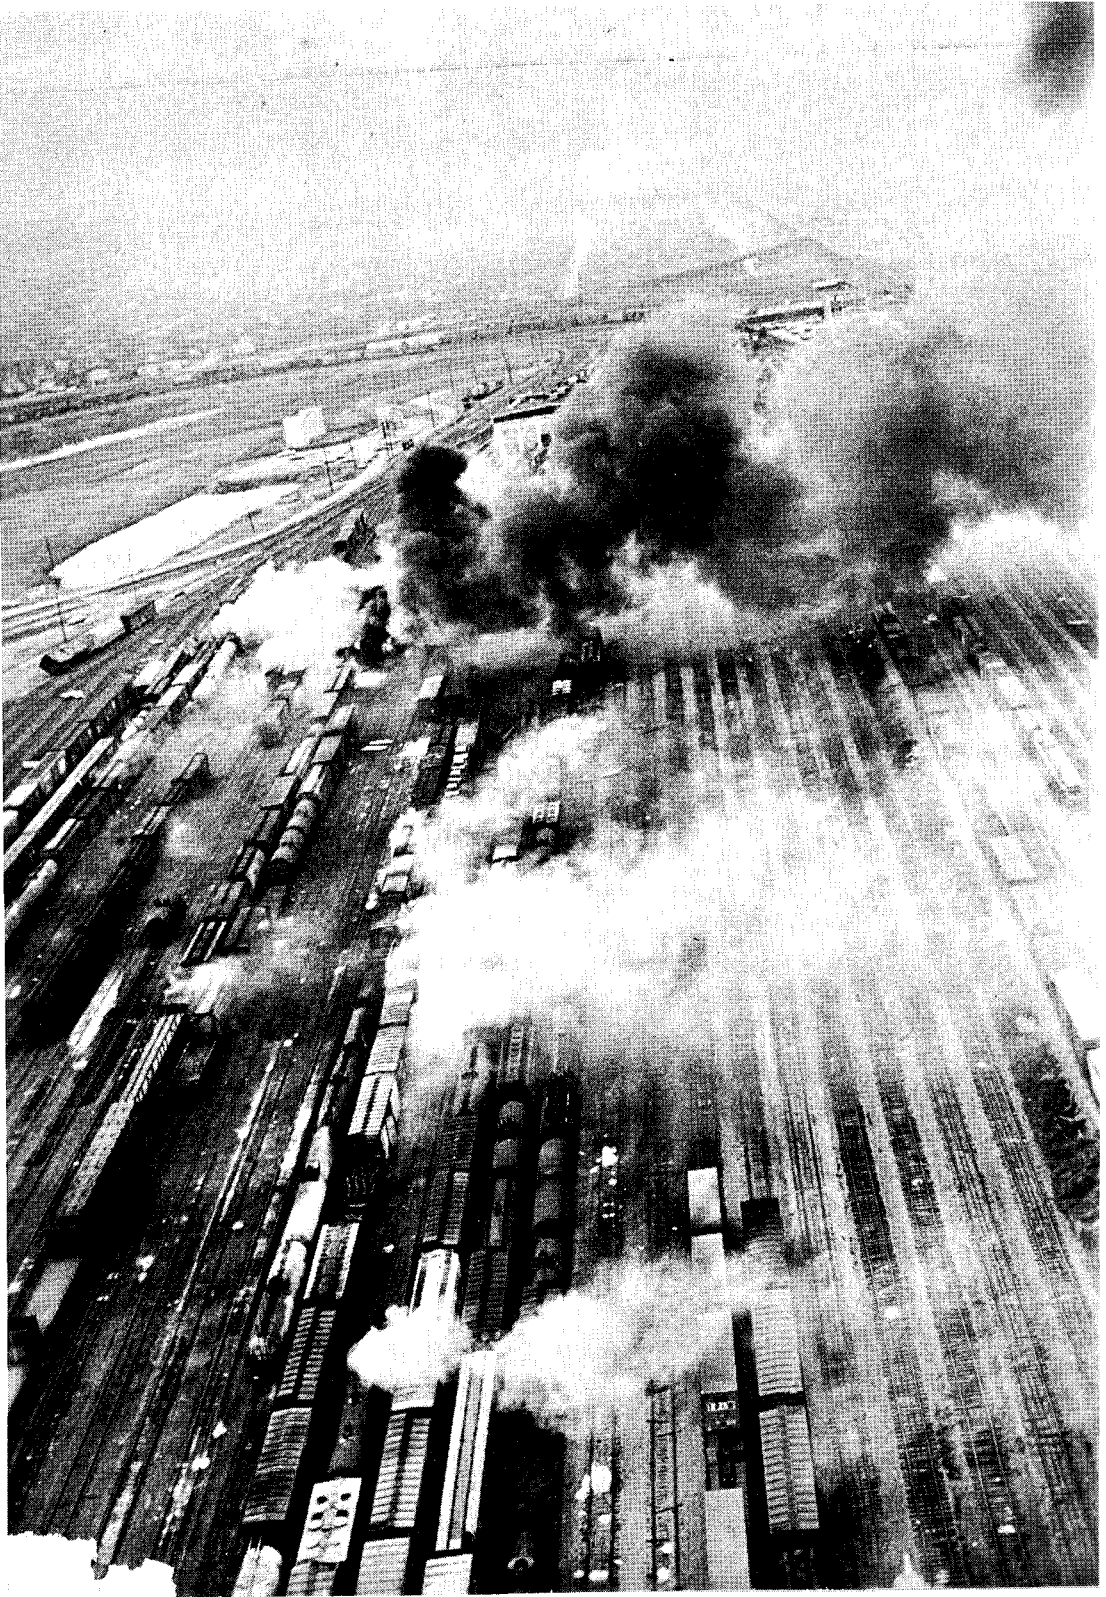
**Figure 1. Alton & Southern Gateway Yard after the explosion.**

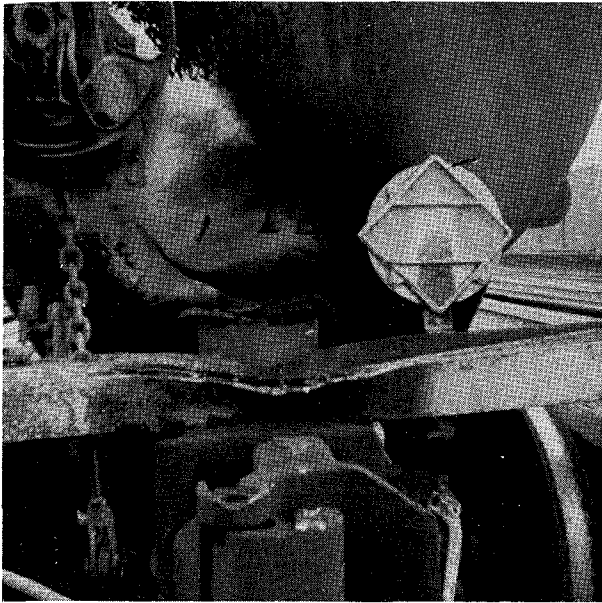
**Figure 4. Punctured head of tank car UTLX 83061.**

Cars 35, 36, and 37, still coupled together, continued onto track No. 15, where they impacted the standing L&N hopper at a speed of about 15 m.p.h. The coupler of the empty hopper overrode the coupler and end sill of the leading tank car (UTLX 83061), bent the end sill and brake wheel, and punctured the head of the tank at the edge of the reinforcing plate. (See Figure 4.) The hopper, which was slightly damaged, was set in motion by the impact. As the four cars rolled down the track together, the 40th car coupled to the last of the three tank cars at about 16 m.p.h. without damage to either car.

When the coupler punctured the head of the tank car, the liquefied contents spilled to the ground, and propylene vapor was observed as a spreading cloud at ground level. The classification-yard employees were warned of this development by the crest operator and ran away from the advancing vapor cloud. A locomotive crew on track No. 12 moved westward to escape it. The yardmaster, on the second floor of the office building at the west end of the yard, also watched this vapor cloud develop.

When the bottom of the tank head on UTLX 83061 was punctured, the internal pressure forced the liquefied portion of the mixture in the car into the atmosphere at a rapid rate. As this liquefied portion passed into the atmosphere, part of it vaporized and the temperature of the rest of the escaping liquid was reduced to the boiling point in air of propylene, which is approximately -55° F. While the leaking car moved toward its resting place just before the explosion, a continuous stream of escaping liquid continued to spew through the puncture at high velocity. This resulted in the vaporization and rapid dispersion of large quantities of flammable gas ahead of the damaged car and in pools of liquid along its path. Since the vapors were heavier than air, they tended to disperse and remain near the ground rather than to rise and dissipate harmlessly into the atmosphere.

Propylene leaked from the tank car because the overriding coupler of the hopper car punctured a tank head too weak to resist the blow. Lack of specifications which define permissible impact and adequate crash resistance was a contributing cause.

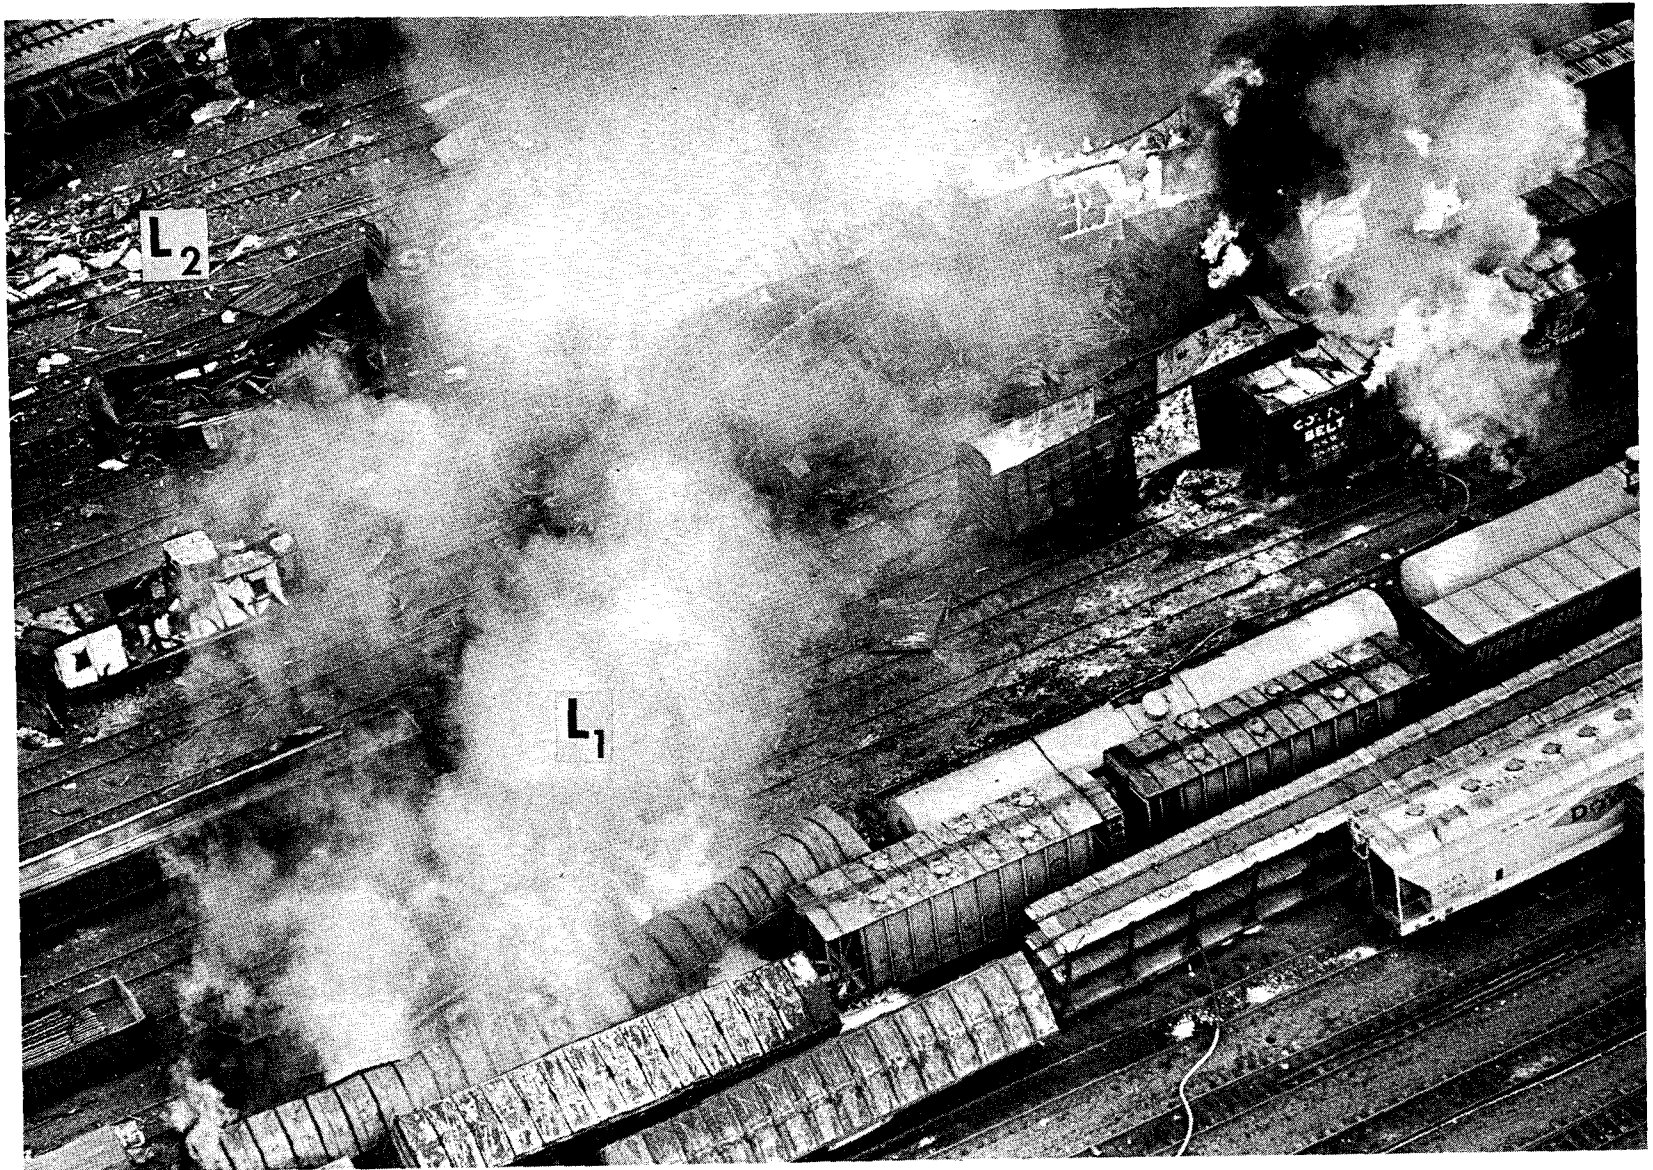
Figure 5. Aerial photo of explosion area.

The force of the explosion damaged buildings and a number of freight cars in the area around the caboose on track No. 19. Some of the damaged freight cars and other, widely scattered cars caught fire. Car damage included both inward and outward bulges. Figure 5 shows the pattern of damage in the classification yard.

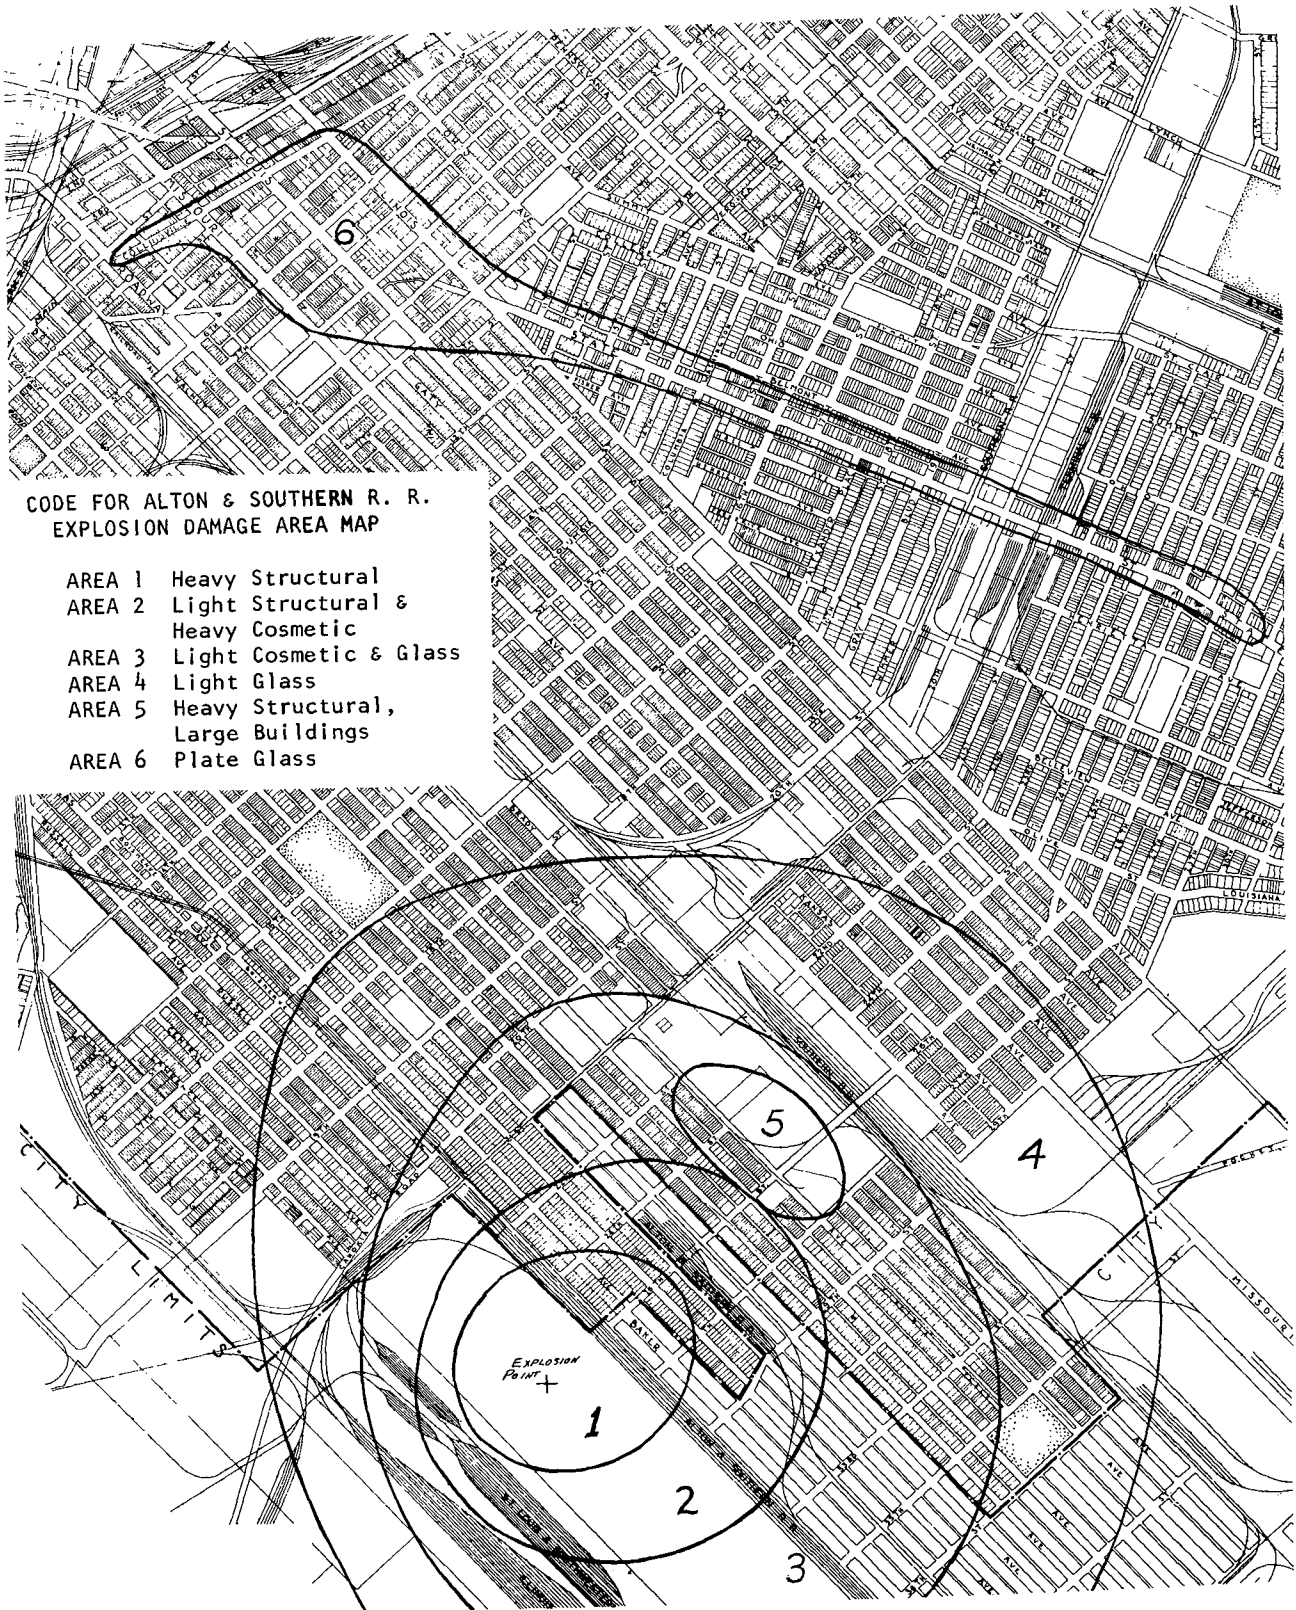
Figure 6. Map of explosion damage.

The most serious damage to noncarrier property occurred in the areas designated as 1 and 5 on the map in Figure 6. The severity of damage ranged from serious structural damage in Areas 1 and 5 to broken glass in Area 6. The Illinois State Police estimated that between 870 and 1,000 homes and buildings, including a church and a school, were damaged. City officials estimated that total damage costs, including railroad property, exceeded \$7½ million. (See Figure 7.)

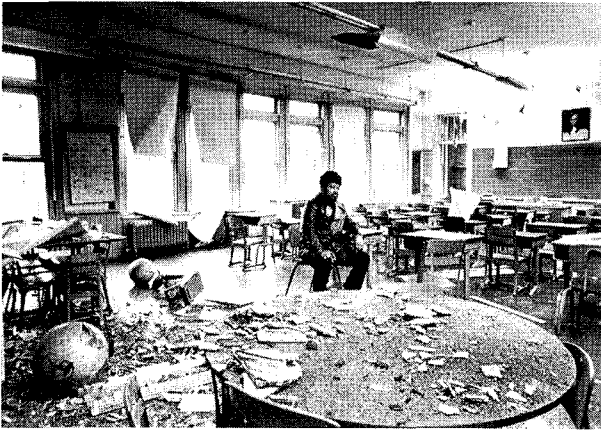
**a. Interior of School.**

**Figure 7. Damage to school in the vicinity of the Gateway Yard.**

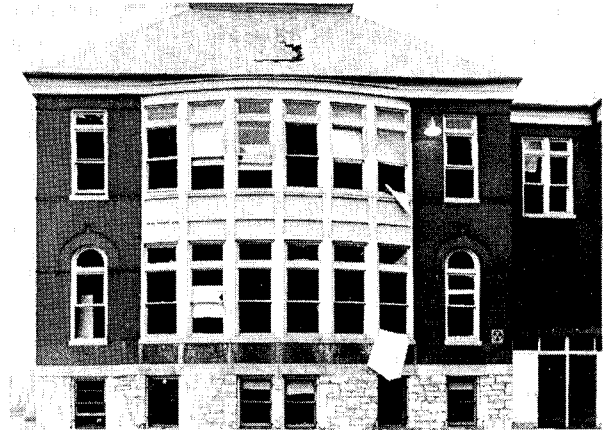
**b. Exterior of School.**

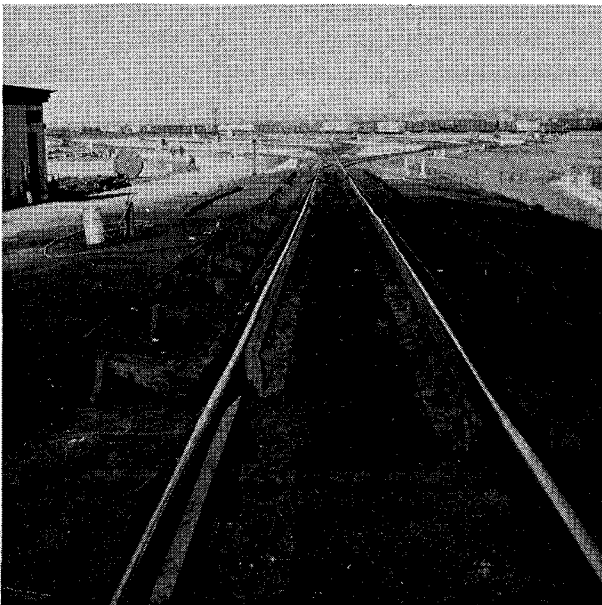
**Figure 8. North master retarder on Alton & Southern hump at Gateway Yard.**

Immediately after the 44th car of the cut was humped, all hump facilities at the Gateway Yard were thoroughly checked. No defects or failures were found that would account for the overspeeds out of the master and "C" group retarders. There was, however, a deposit of grease on the brakeshoes of both retarders

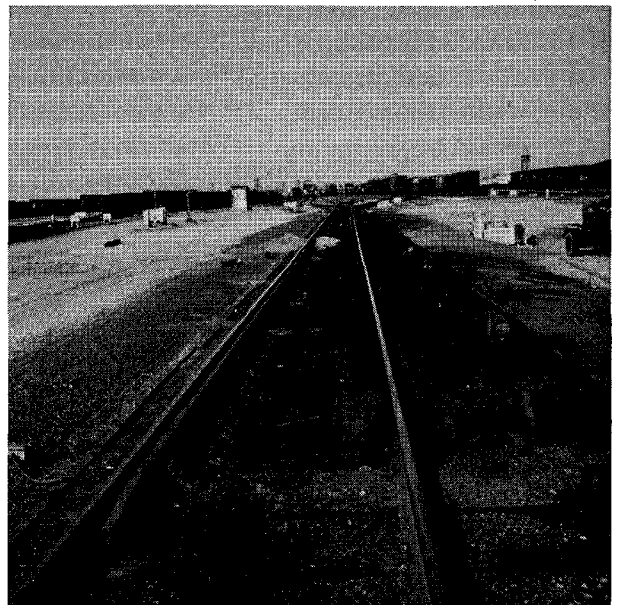
**Figure 9. Typical group retarder on the Alton & Southern hump at Gateway Yard.**

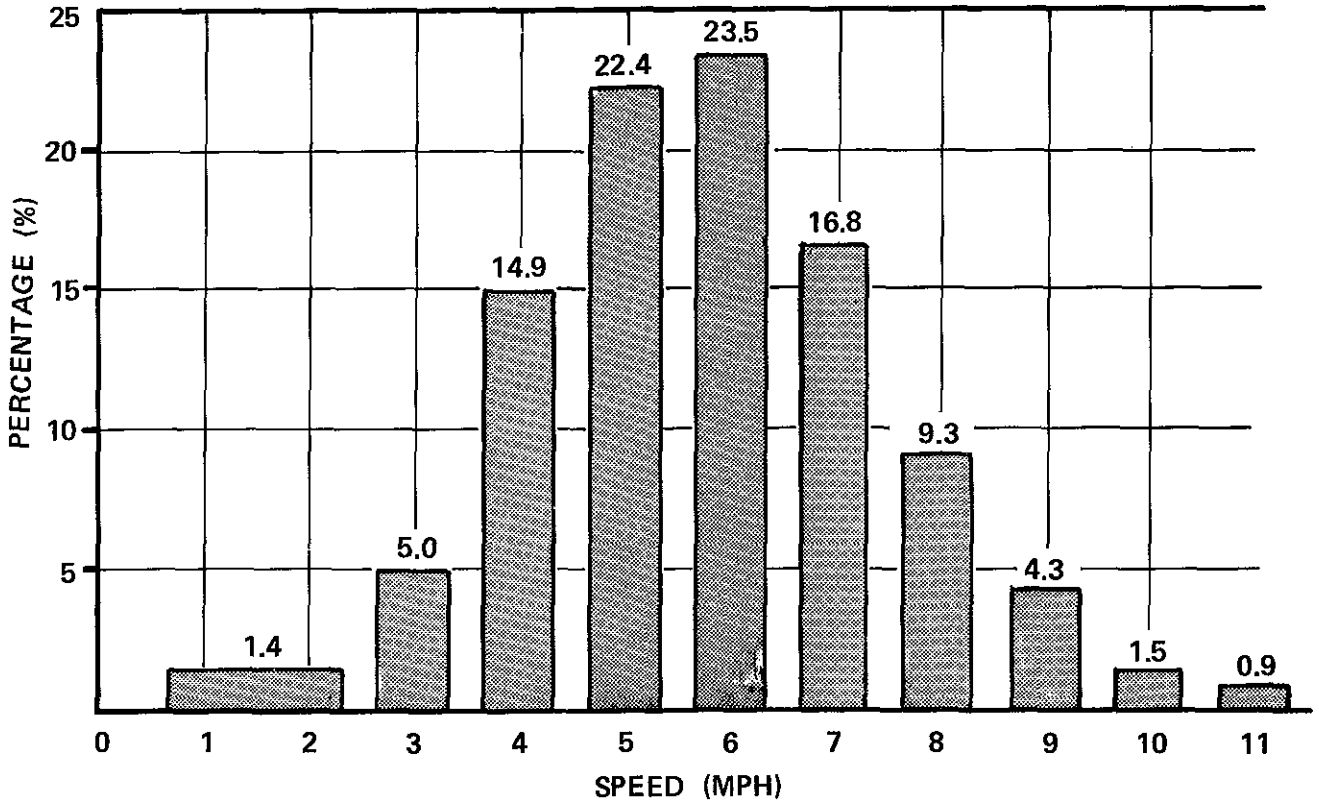
APPENDIX A

Overspeed impacts in railroad yards were the subject of a study made by the Draft-gear Manufacturer's Committee in 1965. A chart in that study, reproduced in Appendix A, illustrates the speed range of switch-yard impacts. Before large quantities of hazardous materials were shipped by rail, overriding couplers rarely resulted in injuries or extensive damages. However, the injuries and damages sustained in this accident suggest that these "minor accidents" are intolerable when hazardous materials are involved.

SPEED RANGE OF SWITCHYARD IMPACTS FOR  
4647 OBSERVATIONS CONDUCTED BY DRAFT GEAR  
MANUFACTURERS' COMMITTEE (1965)
