RAILROAD/HIGHWAY ACCIDENT REPORT

COLLISION OF A
CROWN-TRYGG CONSTRUCTION
COMPANY TRUCK WITH
AN AMTRAK PASSENGER TRAIN

ELWOOD, ILLINOIS

REPORT NUMBER: NTSB-RHR-76-2

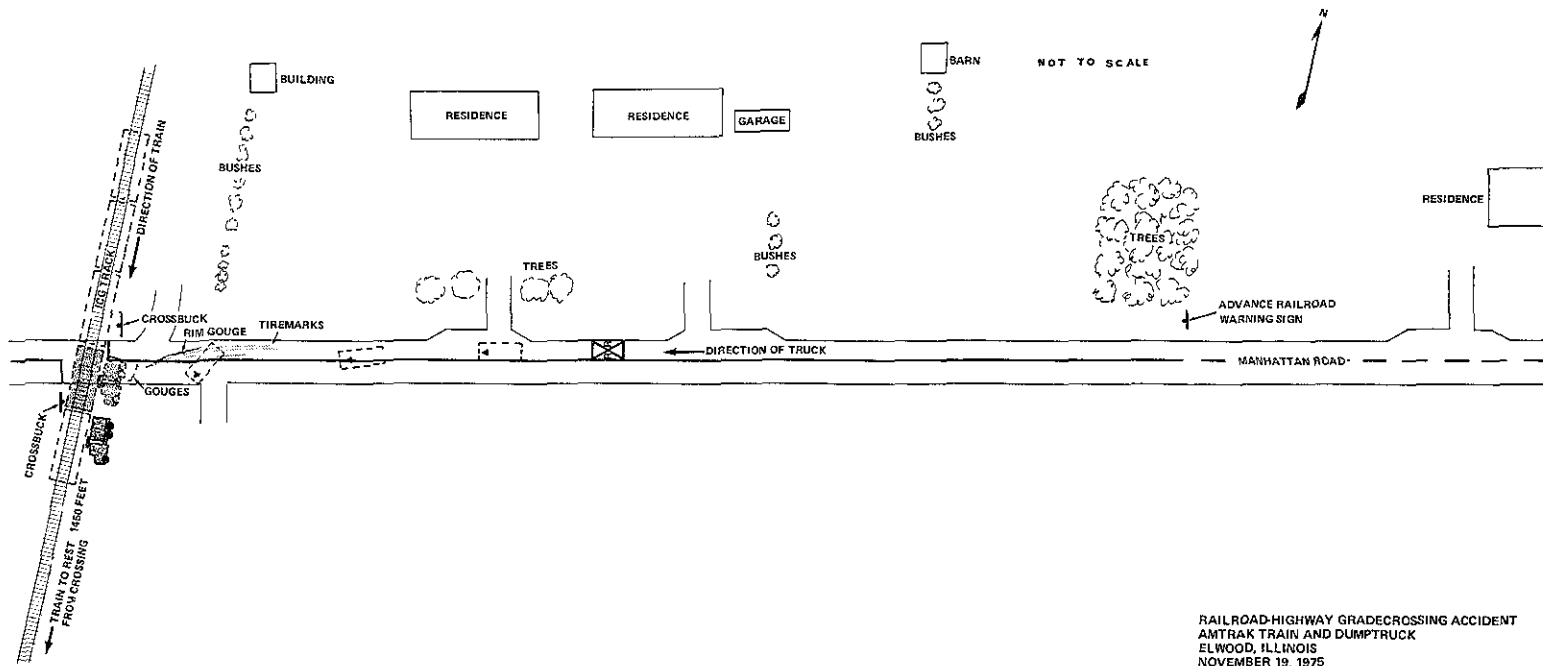
Figure 1. Accident site and crash sequence diagram.

Three arc-shaped tiremarks were found along the path followed by the truck after it began to swerve. The marks were identified as side scuff marks caused by the tires on the right side of the truck as it moved toward the southwest in a counterclockwise rotation. The longest mark, which was caused by the right rear outside tires, measured 108 feet 8 inches.

A gouge, caused by the rim of the outside rear right wheel, was found parallel to the tiremark made by that wheel as it moved across the centerline of the roadway. The gouge had a radius of 121.875 feet.

Several other gouges, caused by the overturned truck as it slid toward the track, also were found on the road. (See Figure 1.)

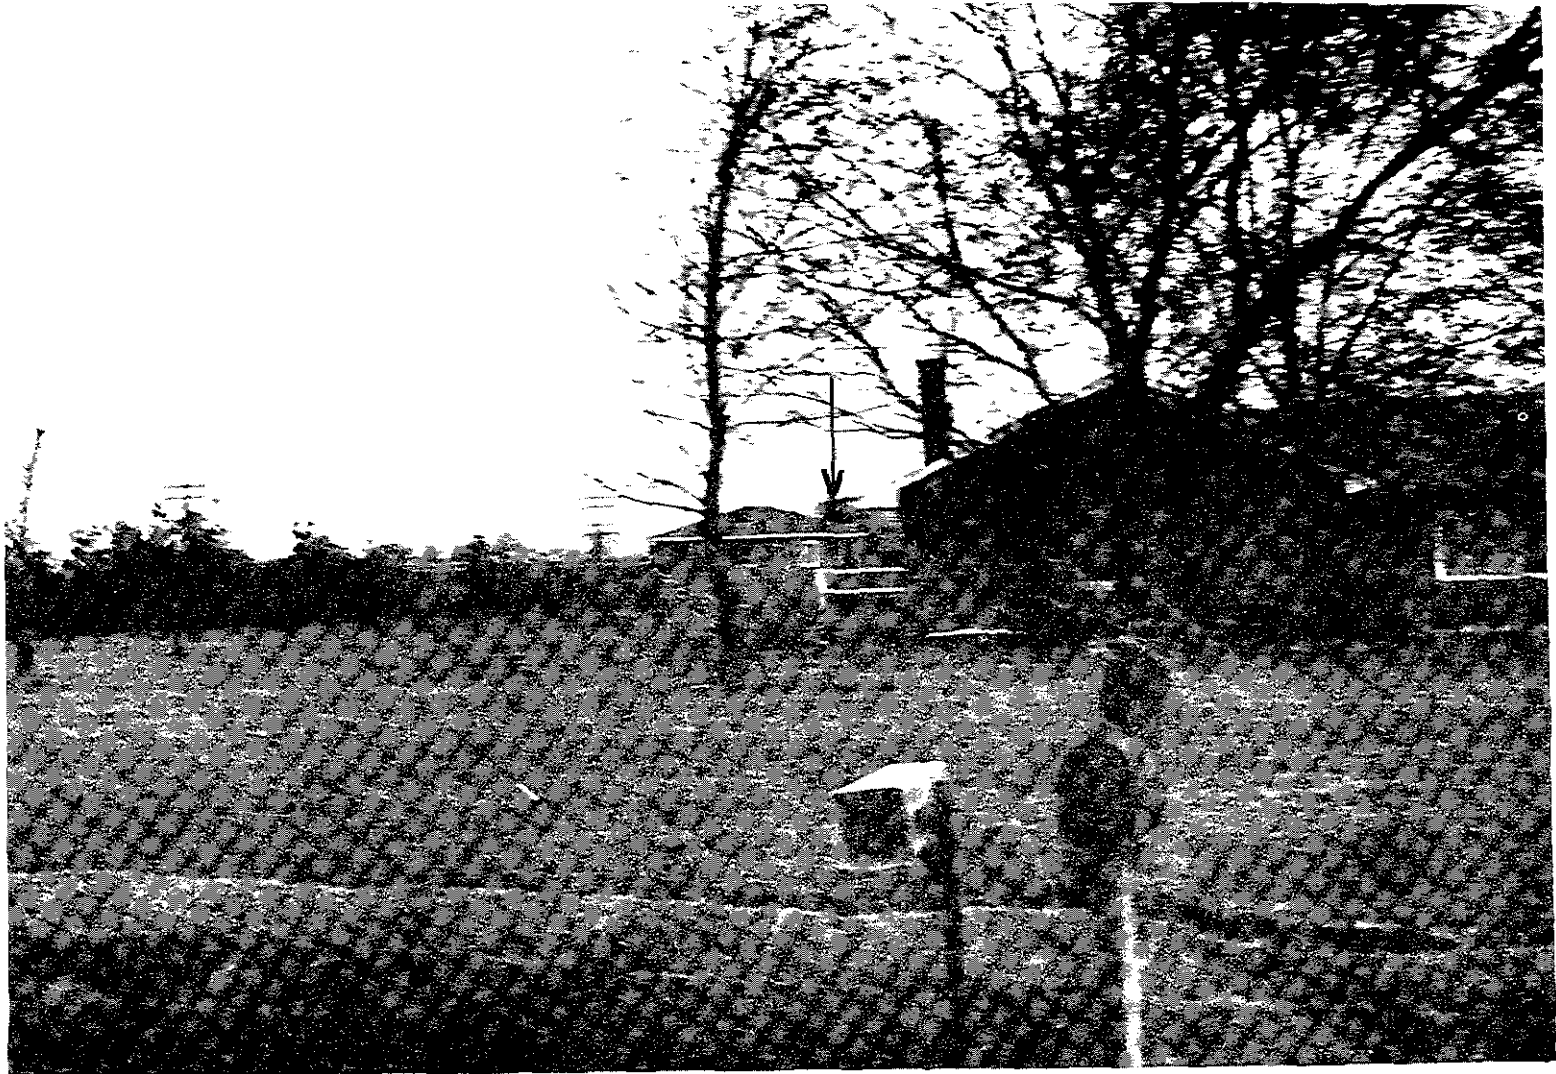
Figure 2. Looking north along the track from Manhattan Road, 200 feet from the east rail. Note (arrow) lead power car of southbound passenger train.

Two private residences, which are located on the north side of the westbound approach to the track, limit the visibility between the road and track until 200 feet before the grade crossing. From that point to the grade crossing, visibility is obstructed slightly by a fence, trees, and a freestanding building which are located on private property adjacent to the railroad right-of-way.

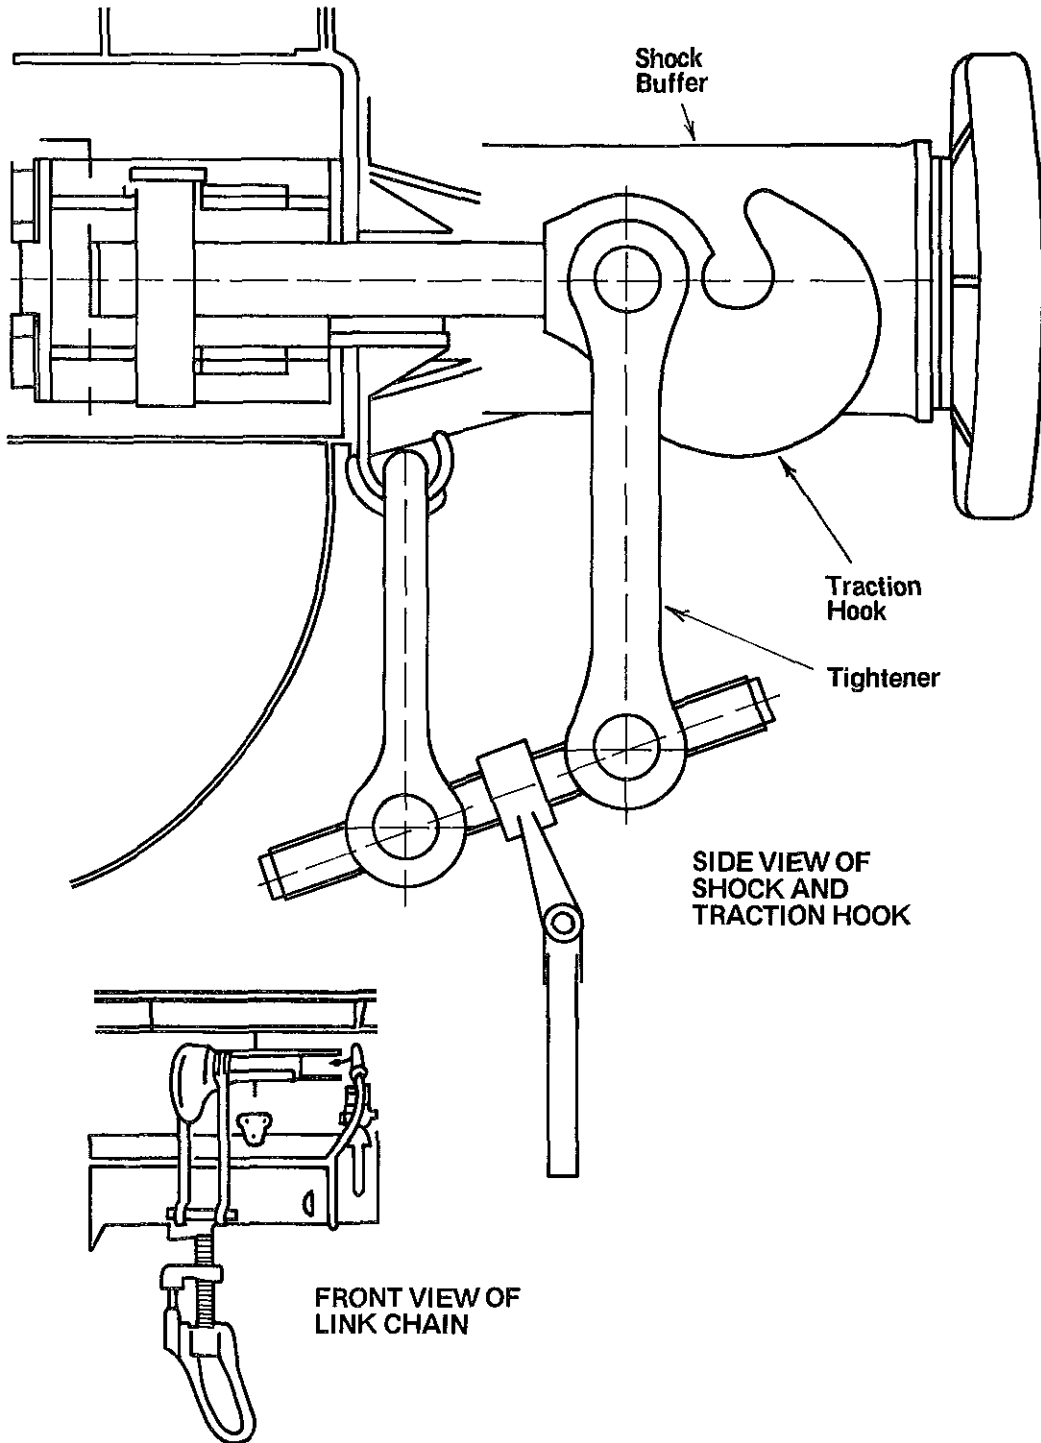
The coupler on the turbotrain was the standard type used on European and British railroad cars. (See Figure 3.) In the United States, this type of coupler is found only on the French turbotrains. The Federal Railroad Administration (FRA) had issued an exemption to Amtrak to allow the use of these couplers. Turbotrains currently under manufacture for use in the United States will be equipped with conventional H-type couplers.

Figure 3. European-type coupler assembly.

The forces generated during the crash dynamics caused the buffers which connected the end of the second car to the front of the third car to misalign and to bypass. Once the buffers were separated, the tension on the link coupler relaxed and the link was able to bounce off the hook. This permitted the cars to separate and contributed to the derailment of the third, fourth, and fifth cars.

The ease with which the European-type coupler can uncouple increases the potential for each car to react independently in an accident situation. When cars are not attached to other equipment, they are more likely to derail and to roll over; this increases the risks of loss and injury. Practical methods exist to improve this type of coupler assembly in order to insure its integrity under crash conditions.

"Require improvements to the coupler assembly on the French-manufactured turbotrains currently in service to minimize the possibility of uncoupling under crash conditions." (R-76-23)

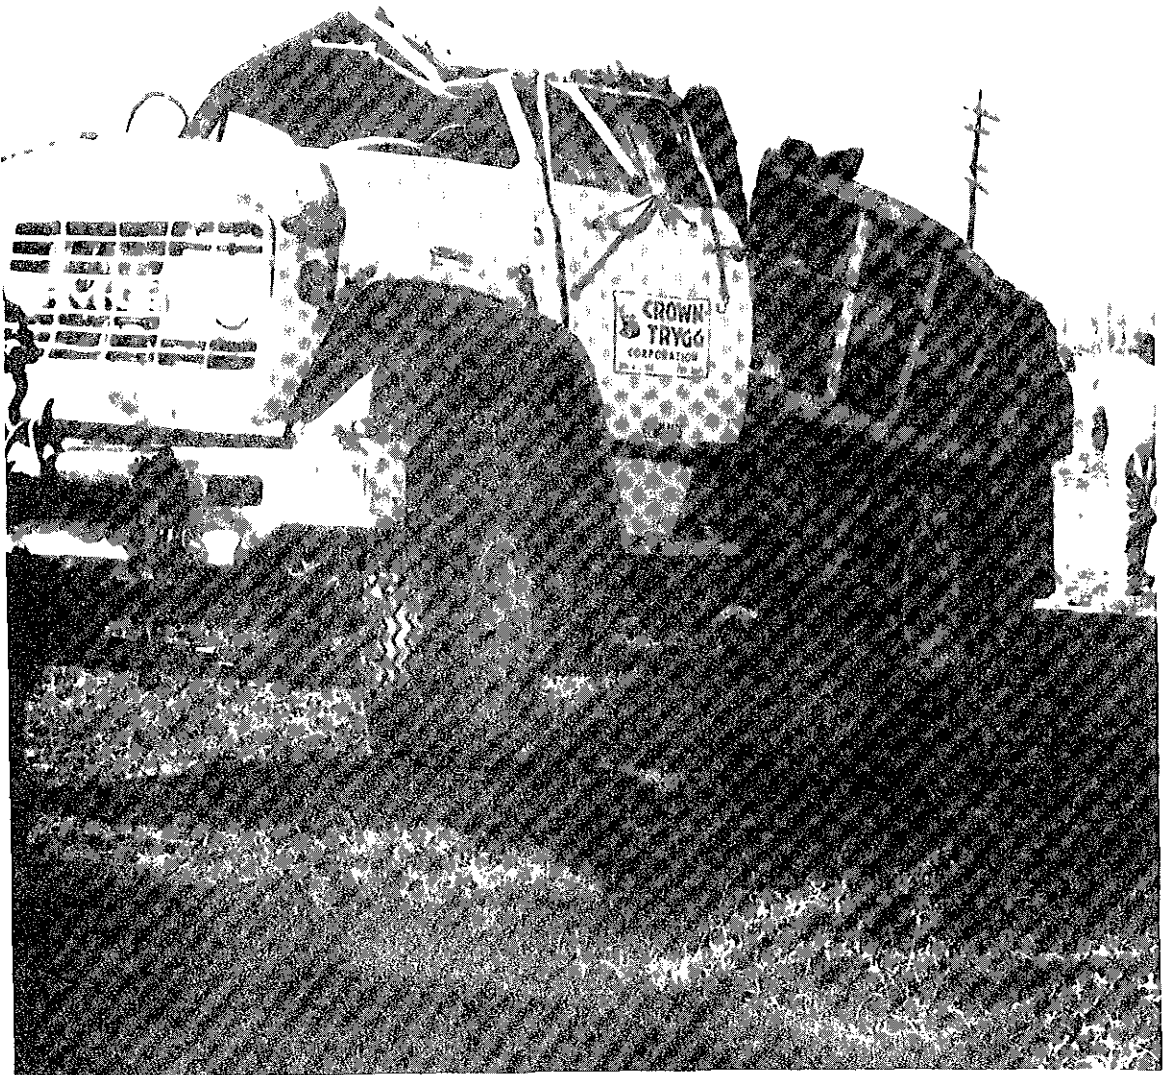
The primary damage incurred by the truck included deformation of the left side of the cab roof, deformation of the left side of the dump body, deformation of the right front fender and bumper, and displacement of the windshield. (See Figure 4.)

Figure 4. Accident truck being removed from the track area.

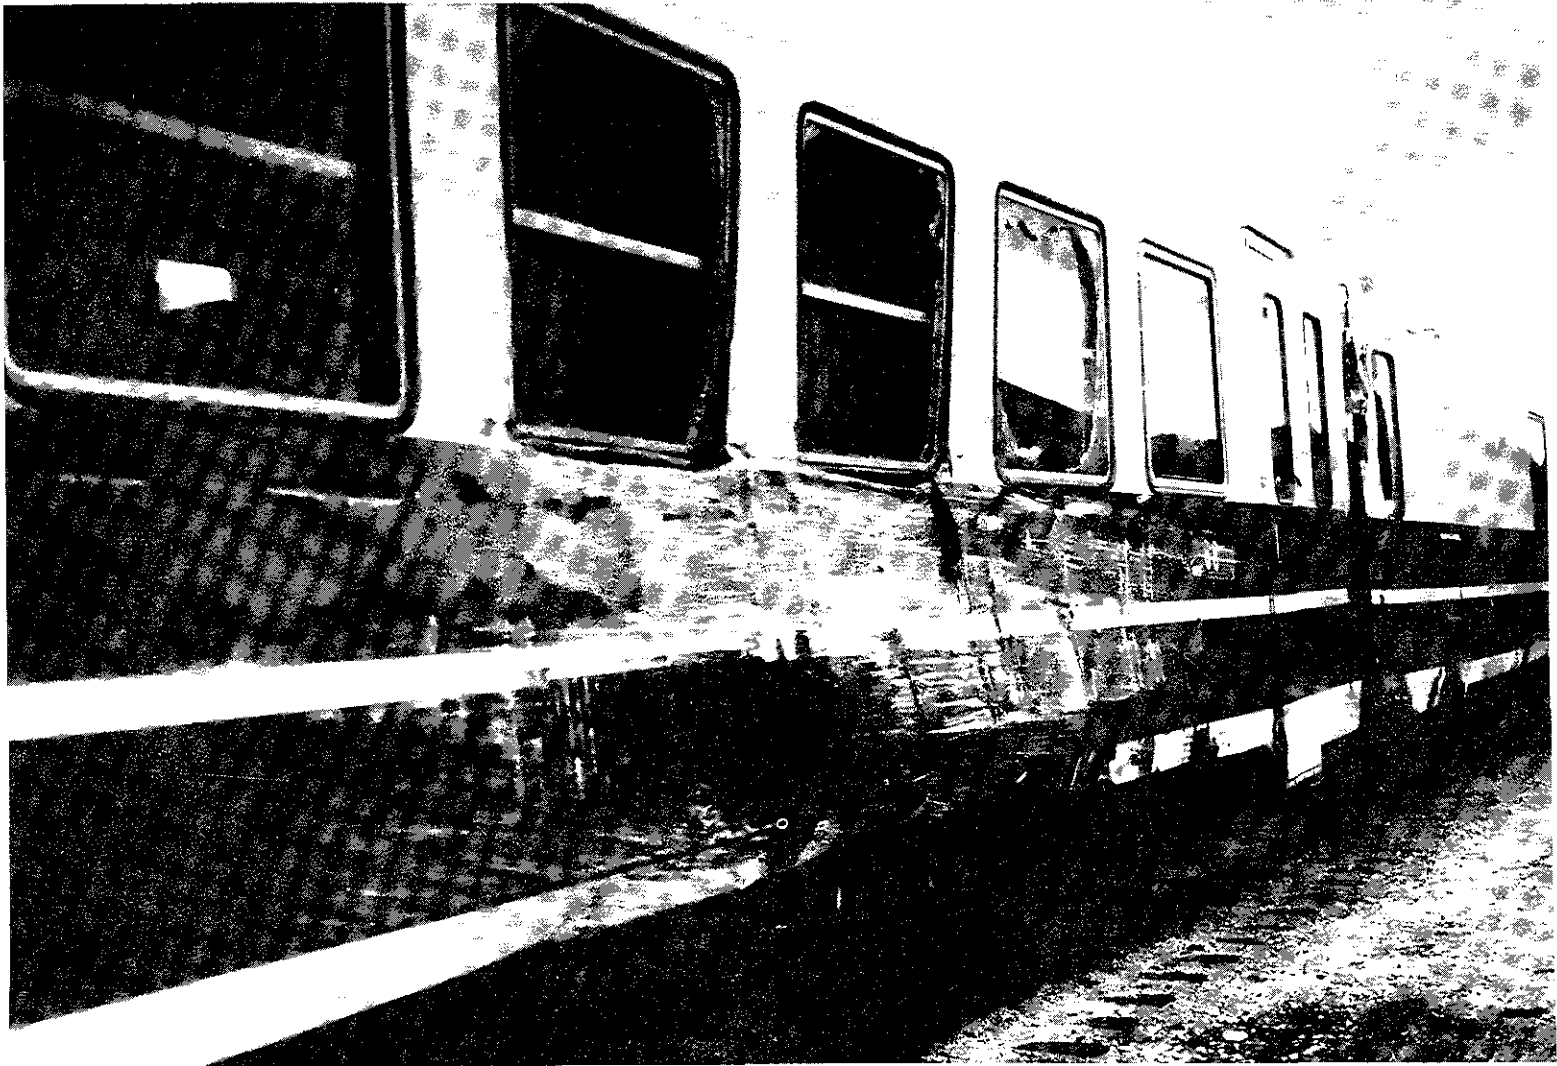
Turbotrains -- The leading power car was not damaged. Impact damage to the second car was restricted to the left rear side of the car. (See Figure 5.) The damaged area was 24 feet 6 inches long, about 6 feet high, and about 8 inches deep at its deepest point. Two double-pane windows were shattered completely and a third had only its outer pane shattered. In the area of impact, the floor was deformed slightly, a pair of seats had rotated partially, and a folding tray was deformed to the right. The floor and seats were littered with broken window glass. There were no signs of side or roof panel buckling or deformation of the overhead baggage racks.

The third car was damaged at its left front corner. At that point, the lower-outside paneling had been crinkled and had been marked with horizontal striations, and the window was broken. The left front corner of the car was crushed beginning about 8 feet above the top of rail and extending upward for 21 feet. Some additional deformation occurred just above that crushed area.

Both the second car and third were covered with asphalt in the areas which were struck by the truck. Air and electric lines which connected the second and third cars were broken.

Figure 5. Crash damage to the second and third cars of the turboliner.
