PB92-916301  
NTSB/RAR-92/01

# NATIONAL TRANSPORTATION SAFETY BOARD

## RAILROAD ACCIDENT REPORT

DERAILMENT AND COLLISION OF  
AMTRAK PASSENGER TRAIN 66 WITH  
MBTA COMMUTER TRAIN 906  
AT BACK BAY STATION  
BOSTON, MASSACHUSETTS  
DECEMBER 12, 1990

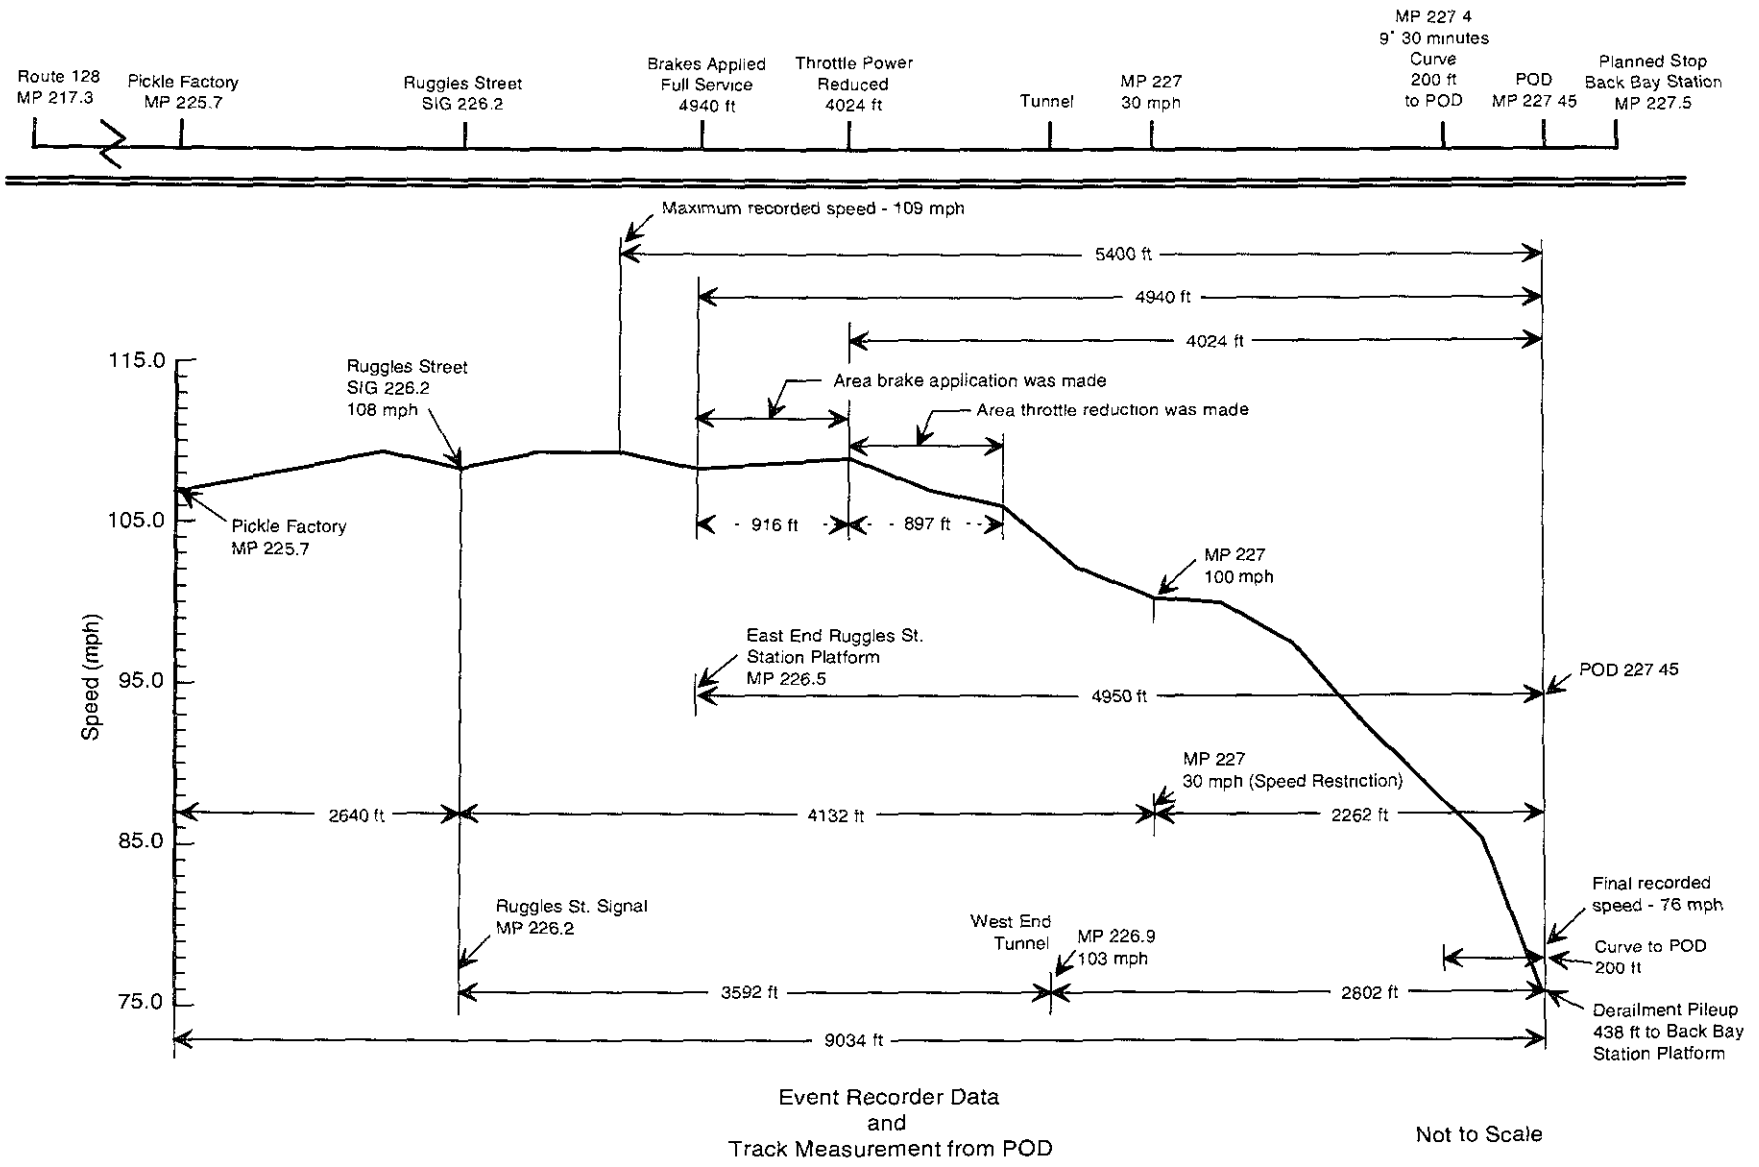
Figure 2 --Diagram of Amtrak train 66 speed and distance travelled.

- 3 Recovered event recorder data indicate that the speed of Amtrak train 66 was about 76 mph as it entered the 30-mph curve into Back Bay station.
- 4 Had Amtrak recognized the potential problems for the slowing condition entering the curve to Back Bay station earlier and taken action to correct them at that time, the accident may have been prevented.

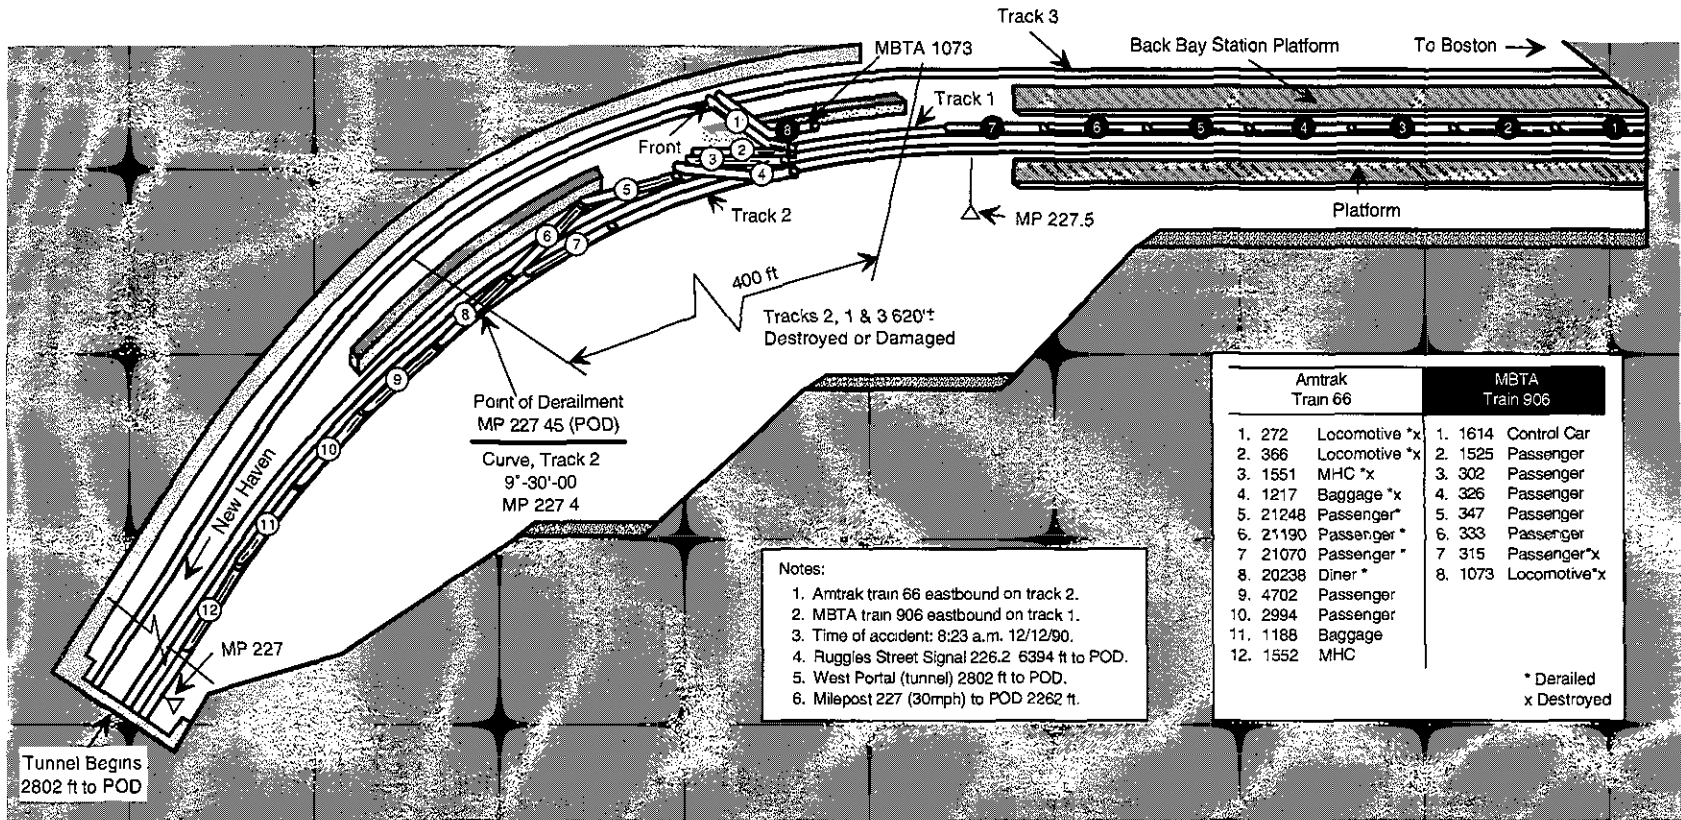
Figure 3 --Diagram of derailment site.

At the initial derailment marks on track 2, both rails remained undisturbed on the ties. Beginning 250 feet before the POD, the track was forced approximately 1 inch out of alignment for 62 feet to the south. The track immediately east of the POD was heavily damaged for approximately 30 feet; beyond this area, the track was undisturbed for approximately 120 feet leading into the area where the cars came to rest on track 2.

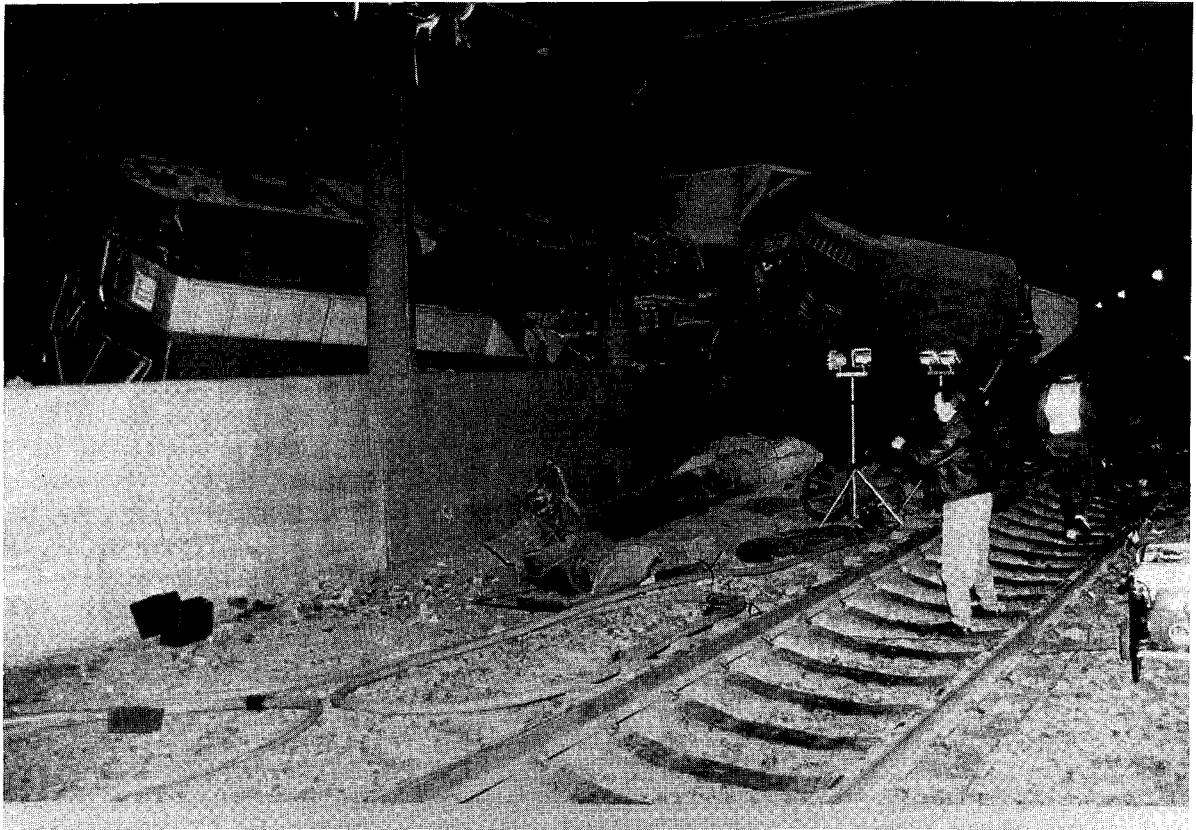
Figure 4.--MBTA train 906 wreckage.

On Amtrak train 66, the two-unit locomotive and five cars were destroyed, and one car was significantly damaged. On MBTA train 906, the locomotive and one car were destroyed.

MBTA Train 906 Exits --Control car 1614 (lead car) and passenger cars 1525, 302, 326, 347, and 333 did not derail following the collision. The passengers exited from the doors at both ends of the cars. All wheels on passenger car 315 had derailed, and the car sustained massive damage. It remained upright against the stairwell housing between tracks 1 and 3. All emergency windows were removed. The west end of the car was crushed and the exit door blocked; at the east end of the car, the exit door to the platform was opened. The unoccupied locomotive 1073 was destroyed. (See figure 4.)

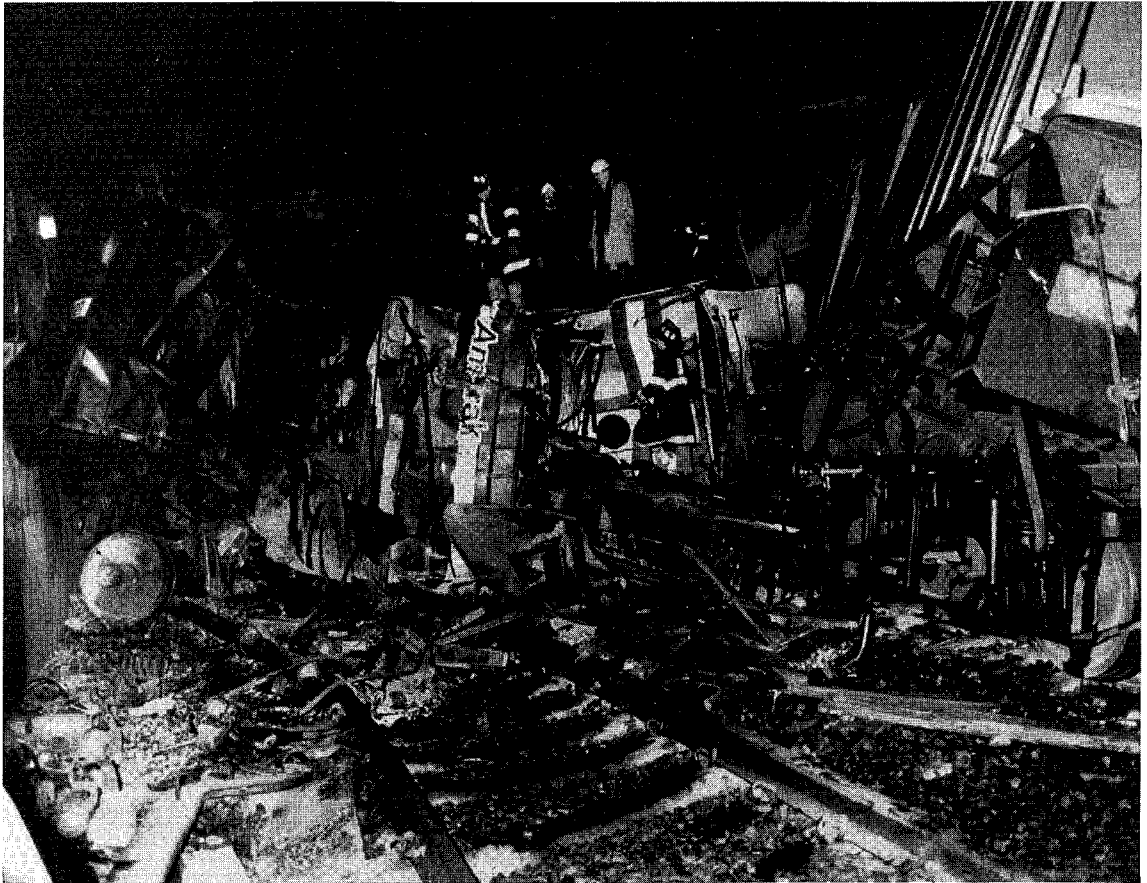
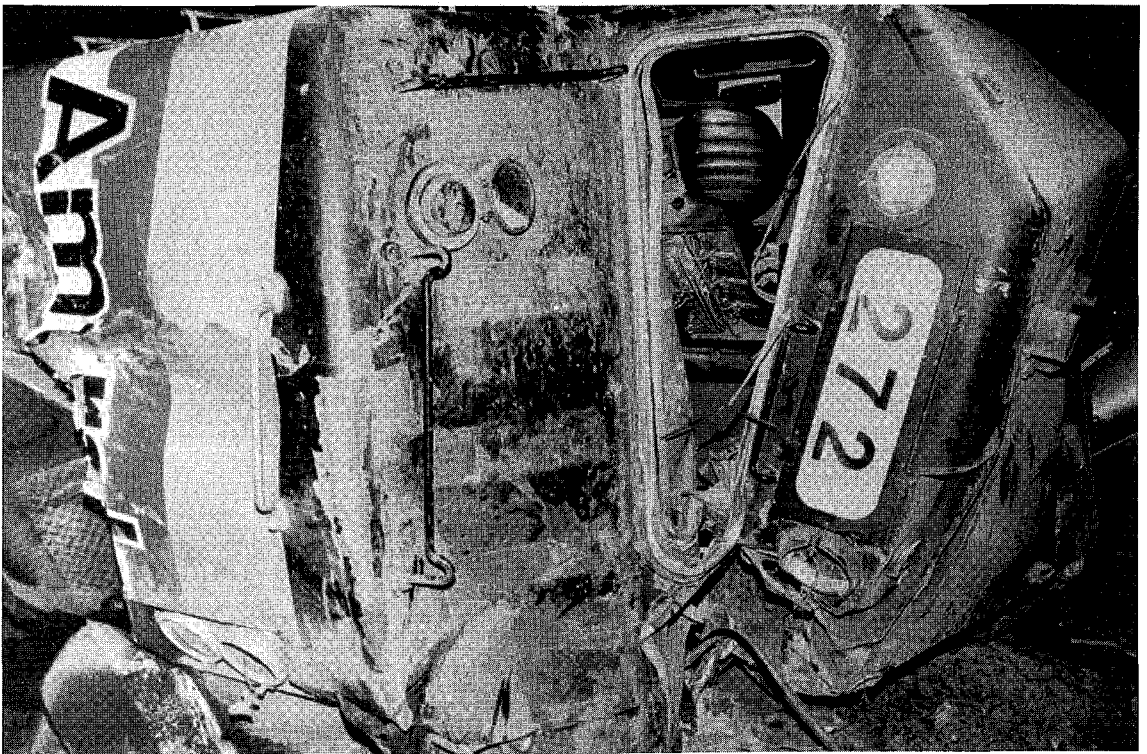
Figure 5.--Amtrak train 66 wreckage.

Both trains sustained massive equipment damage. The fuel tank on Amtrak locomotive 366 broke loose, and a diesel fuel fire ensued. The fire department quickly extinguished the fire, but moderately heavy smoke and minor fire damage resulted. Exhaust fans in the tunnel reduced the smoke and removed it completely after the fire was extinguished.

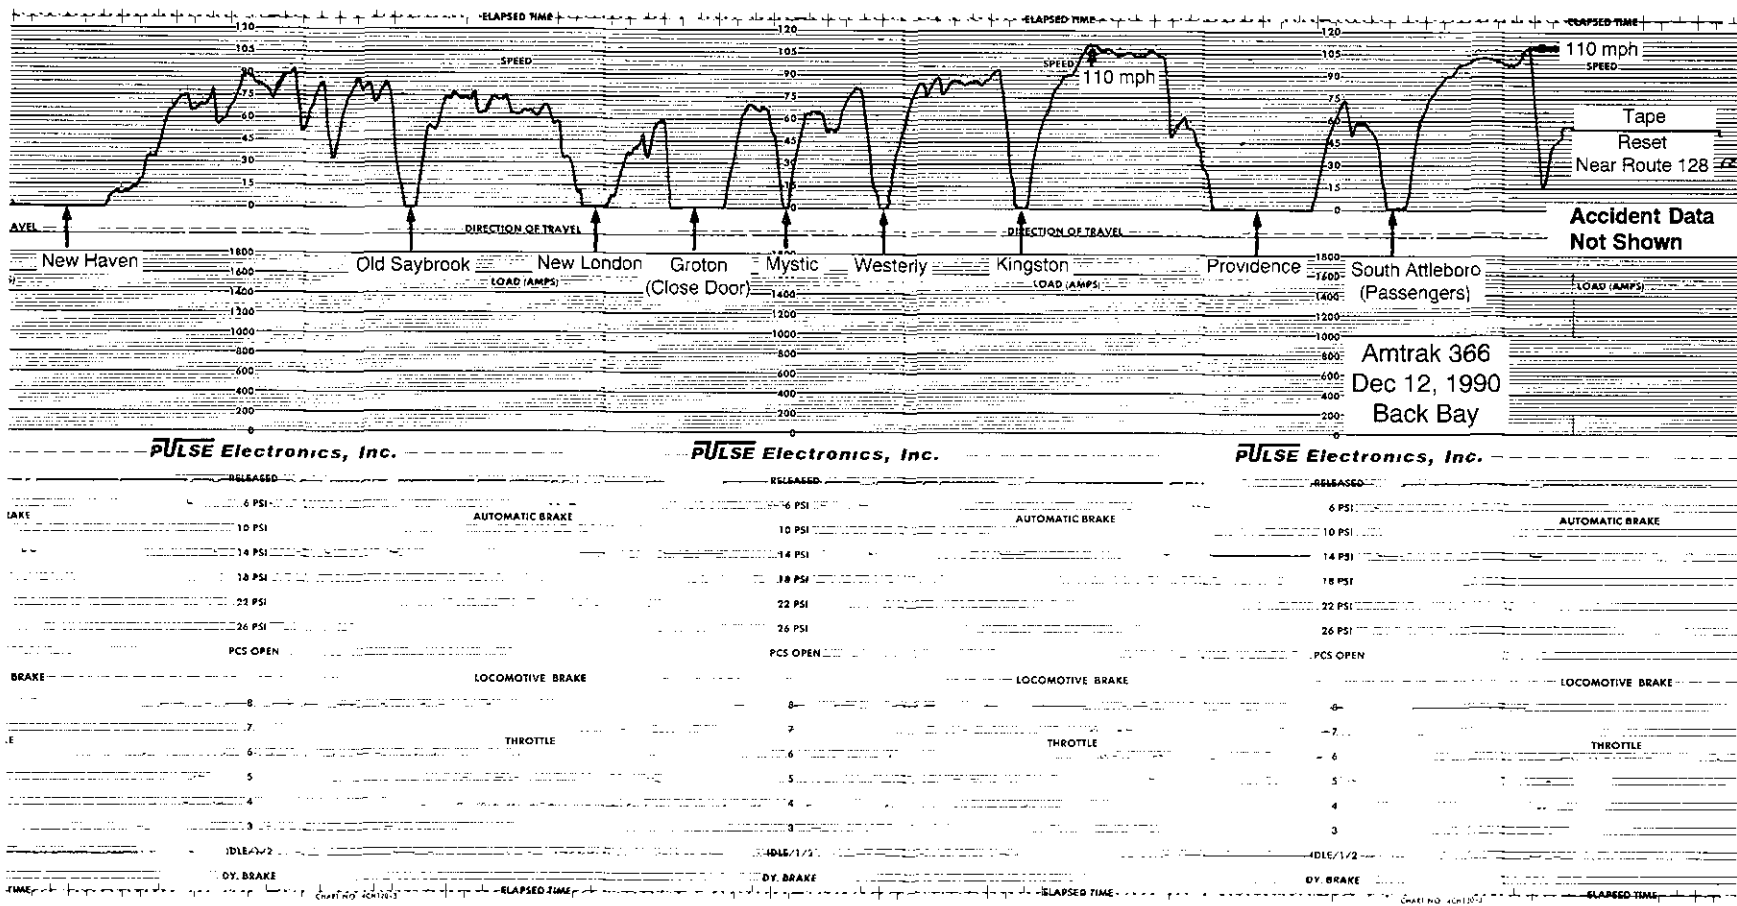
Figure 7.--Amtrak train 66 Pulse magnetic tape event recorder strip chart.

Event Recorder Tests --The Safety Board laboratory received the Pulse data pack from Amtrak locomotive 366 for readout and evaluation on December 13. The laboratory's Pulse readout machine generated a strip chart of the data recovered. Data from the event recorder, which recorded information about every 5 3/4 seconds, showed no signs of accident damage. Safety Board engineers found an electronic end-of-tape mark<sup>5</sup> on the magnetic tape that prevented strip chart output of data from Route 128 to just beyond the accident. Data before the end-of-tape mark indicated that the train had operated at speeds up to 110 mph between Kingston and Providence and between South Attleboro and Route 128. (See figure 7 for the Pulse magnetic tape event recorder strip chart.)

Safety Board laboratory engineers found that the end-of-tape mark on the magnetic tape was 13.6 minutes long, 2.2 minutes longer than the minimum 11.4-minute end-of-tape mark that usually exists after a readout. Also, this end-of-tape mark began at Route 128 (MP 217.3) and ended just beyond the accident (MP 227.45) data. Given the safeguards designed into the Pulse event recorder system components, the end-of-tape mark over the most recently recorded data should not have occurred.

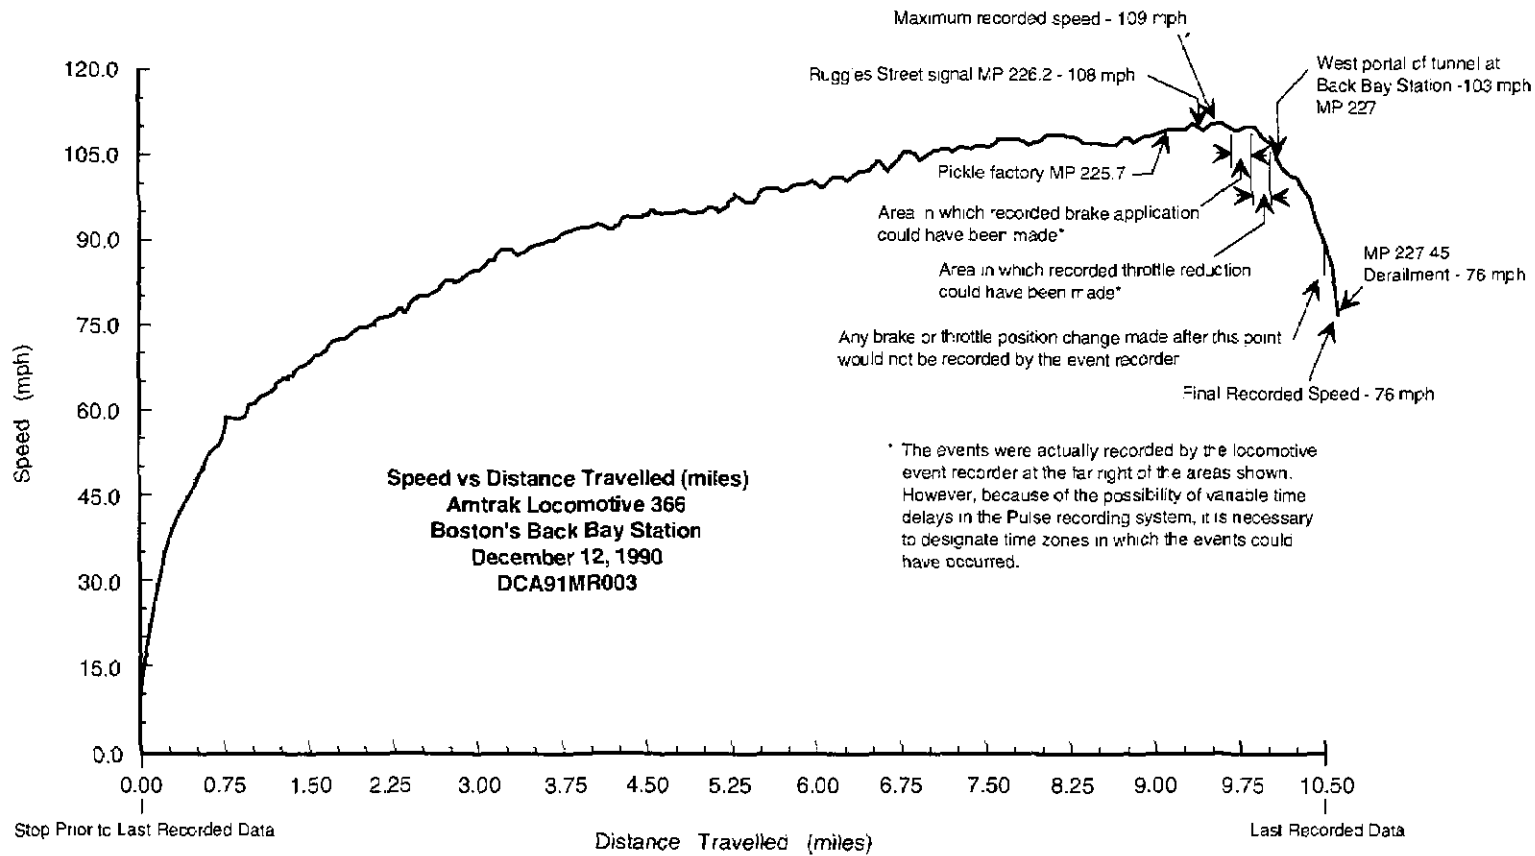
Figure 8.--Event recorder data recovered from Amtrak train 66.

Additional conditions for each test were determined from the Pulse event recorder data and the reported operating procedures of the train's locomotive crew. According to the locomotive engineer and the recovered event recorder data, the apprentice engineer began braking Amtrak train 66 at the west end of the Ruggles Street platform (about 4,950 feet before the POD). Event recorder data show a maximum recorded speed of 109 mph approaching Ruggles Street.

According to the locomotive engineer, he instructed the apprentice engineer to initiate the braking sequence for Back Bay station near the west end of the Ruggles Street station platform (MP 226.2). However, the event recorder data indicate that braking was not initiated at that location. Even if the instructions had been issued there, they would have been issued too late to slow the train to comply with the 30-mph speed restriction at MP 227. The locomotive engineer stated that a 10- to 12-psi first-service reduction was made, but the train failed to slow as much as usual. The event recorder data do not show that a 10- to 12-psi reduction was made.
