NATIONAL TRANSPORTATION SAFETY BOARD

RAILROAD ACCIDENT REPORT

HEAD-ON COLLISION OF AMTRAK TRAINS
EXTRA 769 EAST AND NO.195
BRISTOL, PENNSYLVANIA
MARCH 29, 1982

NTSB-RAR-82-5

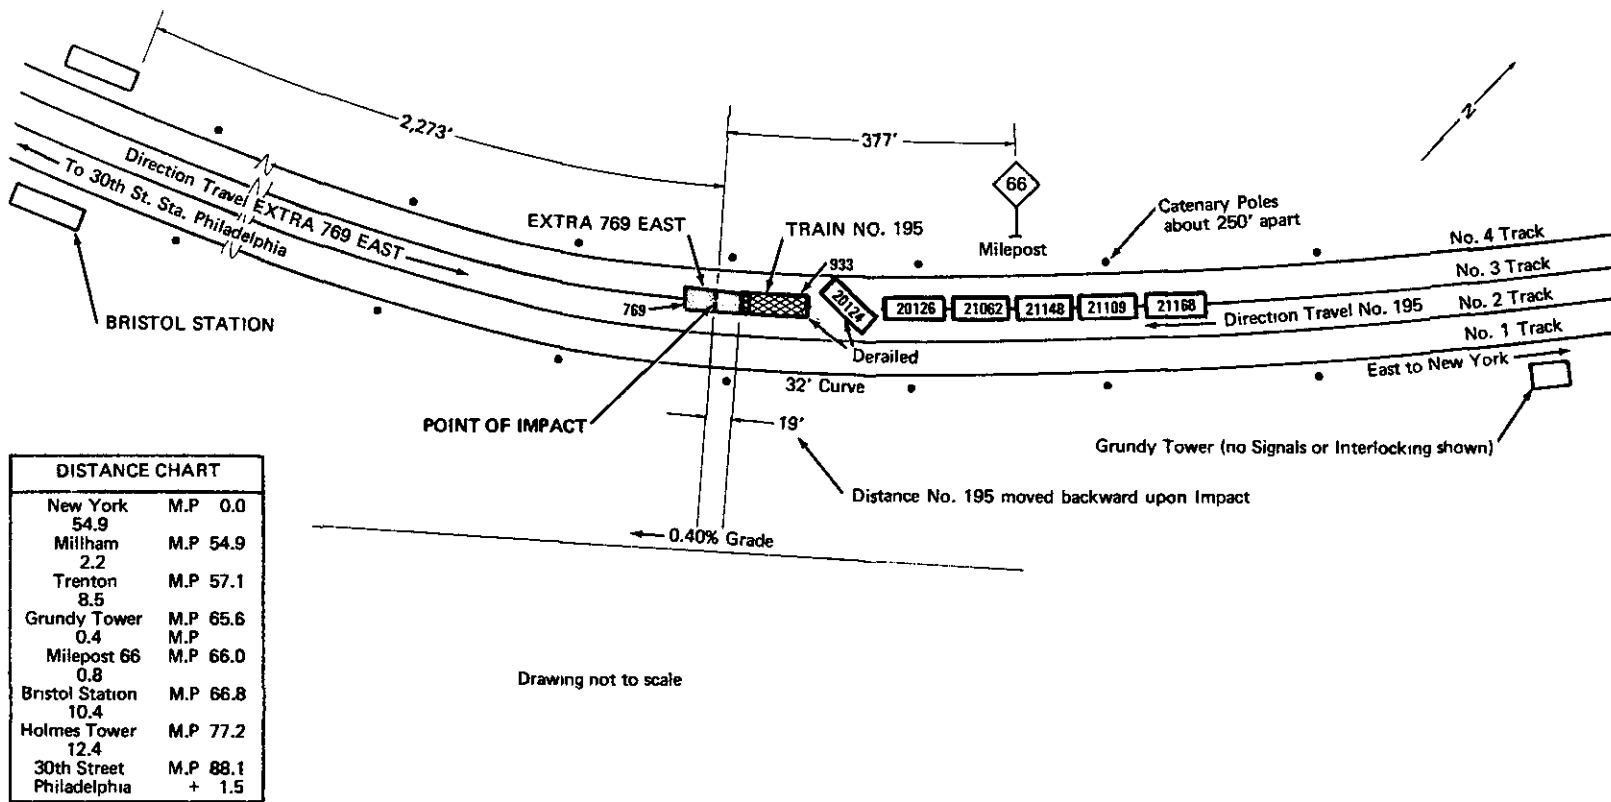
Figure 1.--Location of equipment following the impact and distances involved.

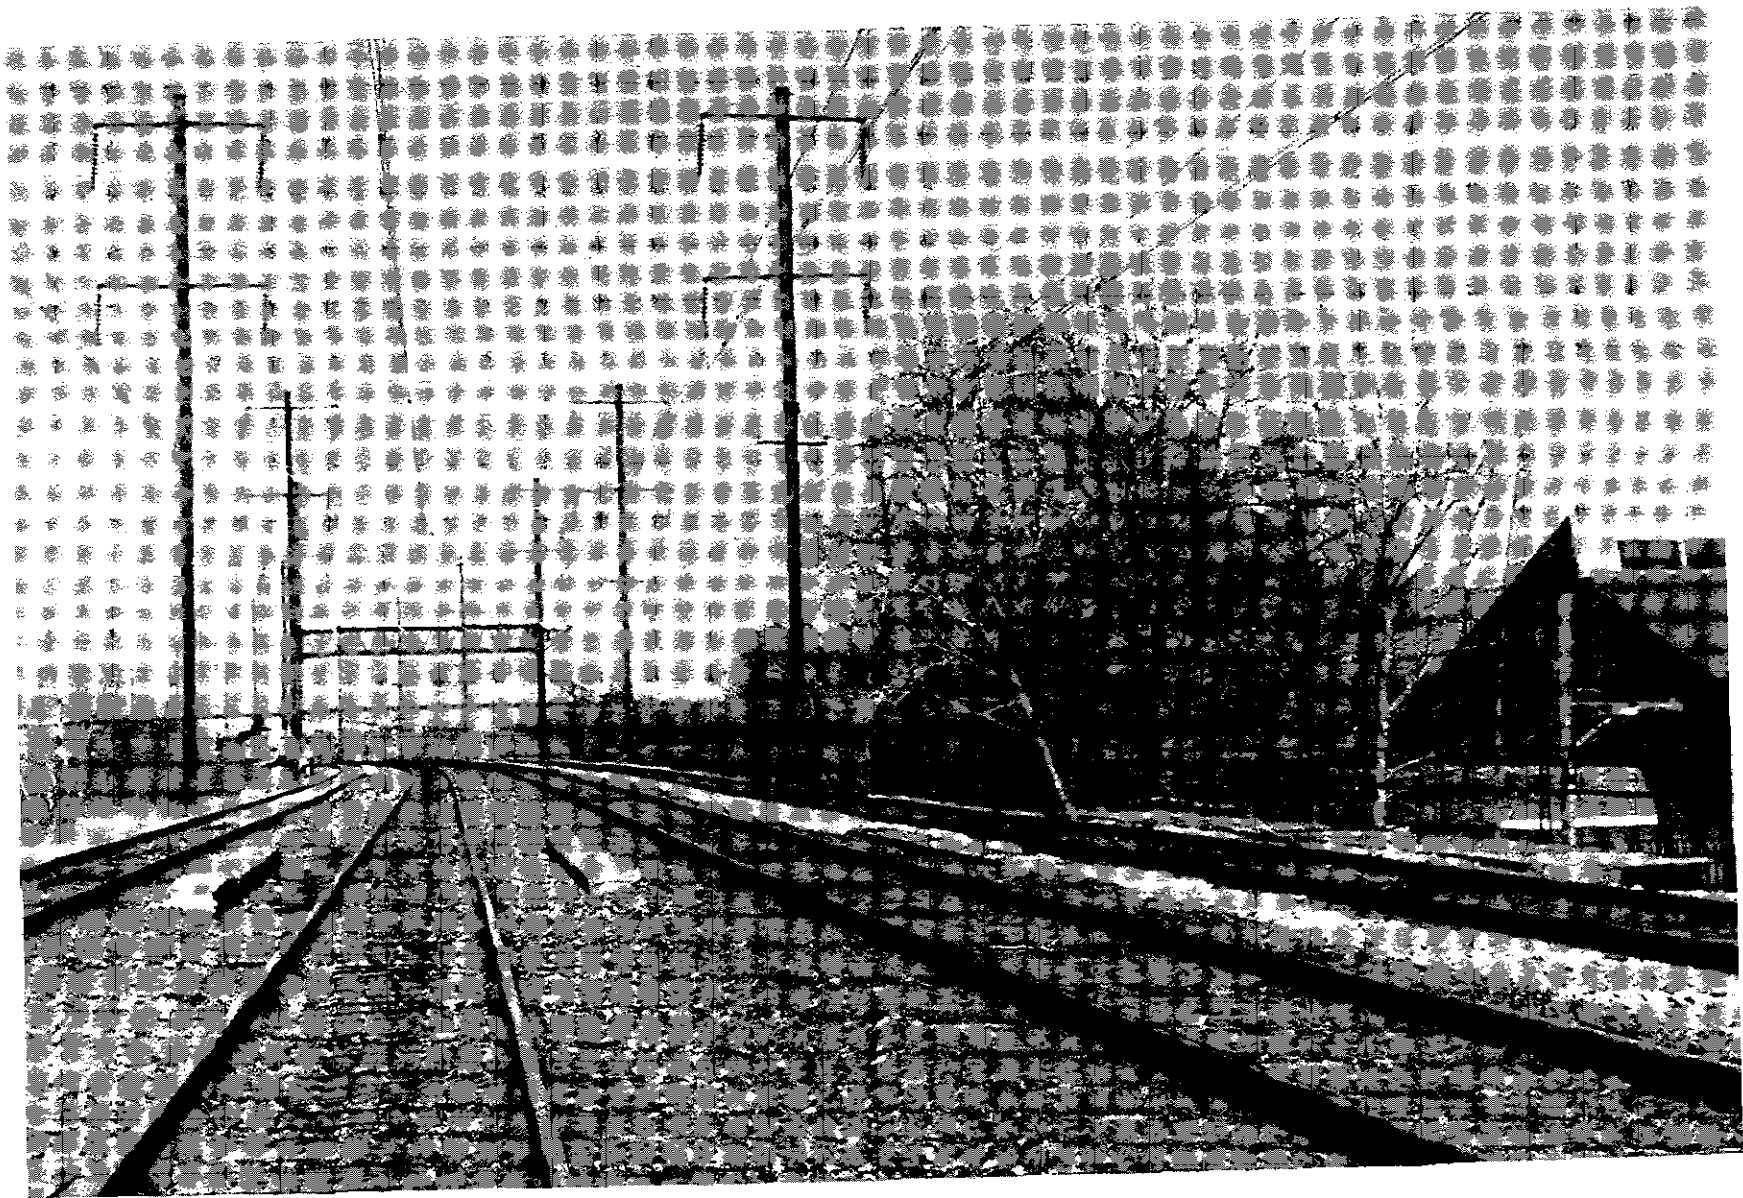
Figure 2.--Approach view to standing train No. 195.

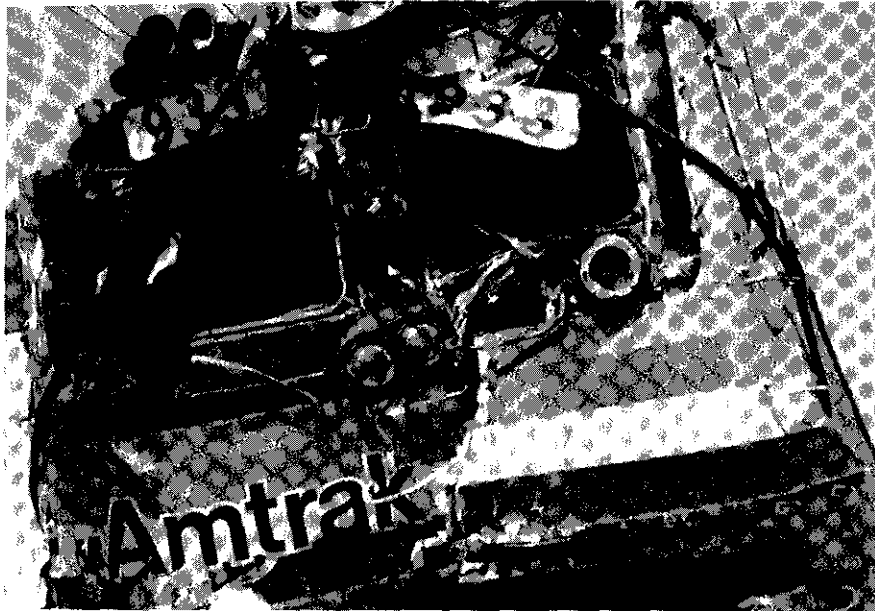
The front end of locomotive unit No. 933 was crushed 7 feet 3 1/2 inches to the rear. The locomotive operating compartment, the engineer's control console, and the engineer's and fireman's respective seats were badly damaged. The automatic brake valve and its associated piping were bent and twisted. The throttle and related wiring were twisted and broken. The windshield was broken and the side doors of the operating compartment were bent. There was no evidence of damage to the equipment room located behind the bulkhead of the operating compartment. (See figures 3 and 4.) The derailed passenger car had only slight damage to the body.

Figure 3.--Locomotive unit No. 933 of train No. 195.

Locomotive unit No. 933, being the lighter of the two units, slightly overrode the heavier freight locomotive unit 769. The operating compartment of locomotive No. 933 was crushed by locomotive unit 769 and it is doubtful if an occupant in the operating compartment of unit No. 933 could have survived. The equipment room to the rear of the operating compartment of unit No. 933 was not damaged and the equipment remained intact.

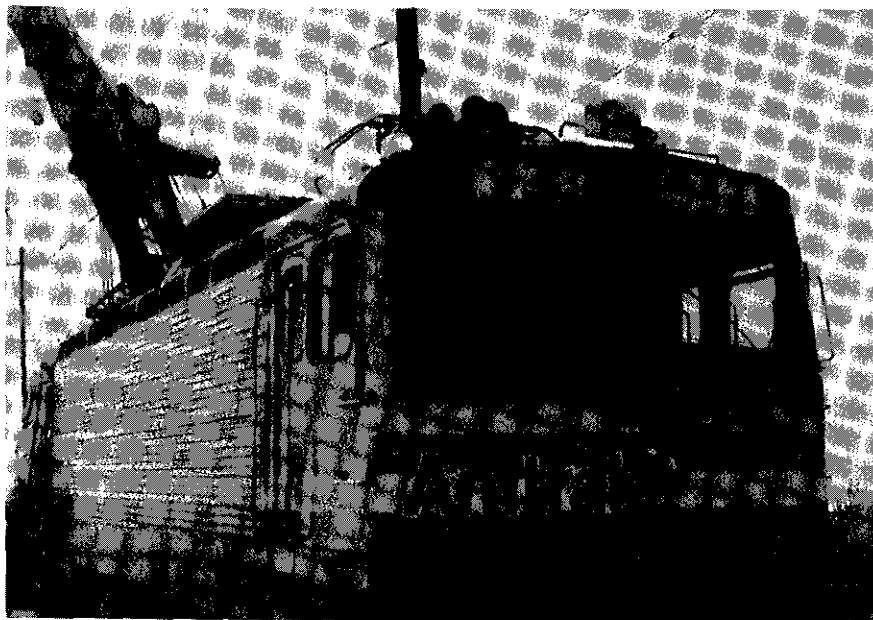
Figure 4.--Undamaged end of locomotive unit No. 933.

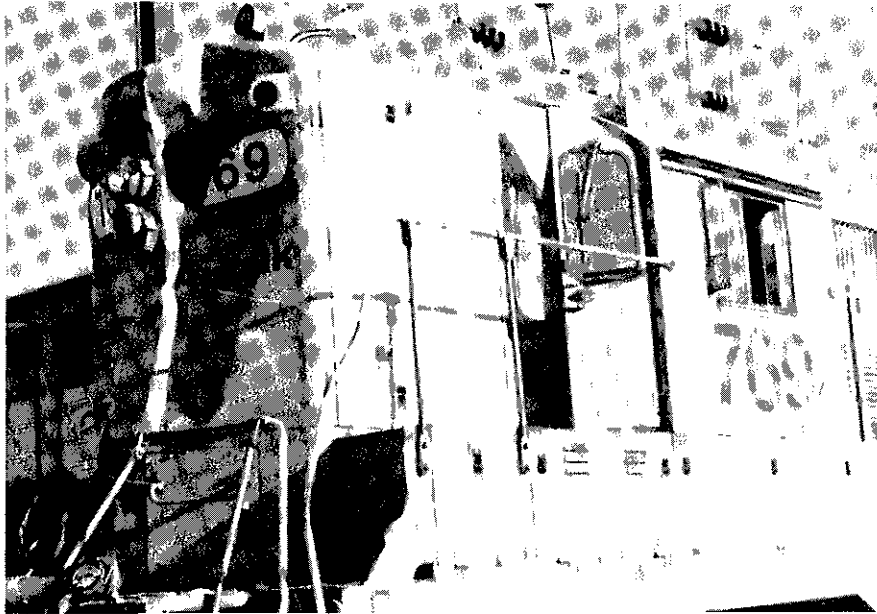
Extra 769 East was not derailed and had light damage to the short hood end and to the steps and hand railings which made contact with the standing train. The impact caused the diesel engine power unit to shift on its base, but there was no apparent mechanical damage. The fuel tanks on Extra 769 East began to leak after the collision and the engineer of train No. 195 said he extinguished the fusees near the front of train No. 195 because he was afraid the fuel oil might ignite. The commutator riser and slip ring of the main generator were damaged. (See figure 5.) The damage to the track was insignificant and the catenary and signal systems were not damaged. The estimated total damage was:

Figure 5.--Locomotive unit Extra 769 East.

Locomotive unit 769 received very little damage to the impacted end and no damage to the operating compartment. Since the most severe damage occurred where the hand brake control of the locomotive is located at the front of the long hood, the conductor of Extra 769 East was fortunate that he did not reach the hand brake control or he may have been killed.

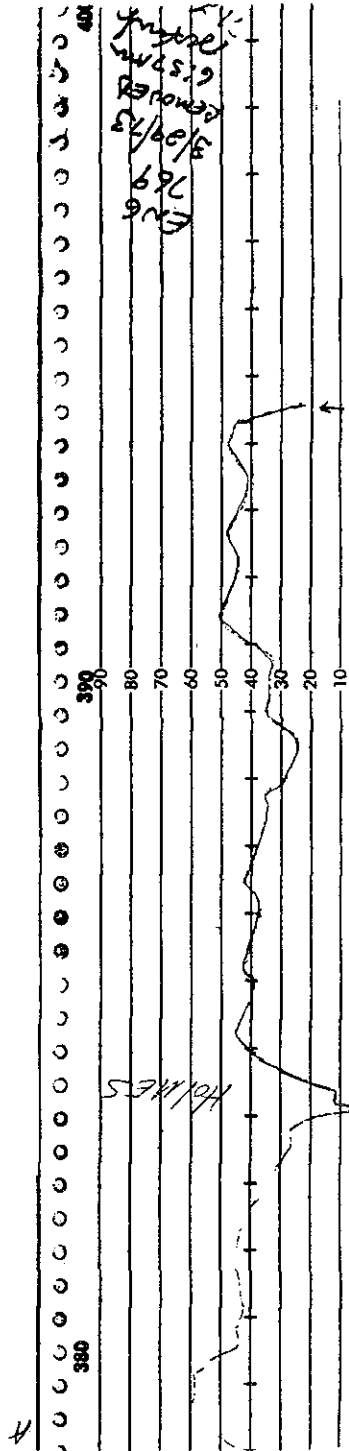
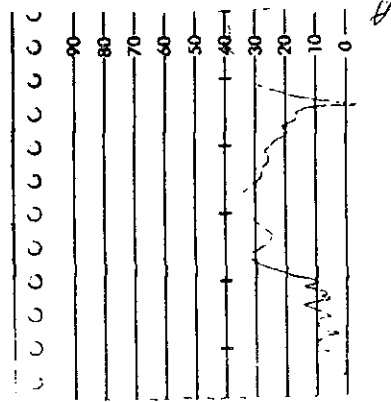
APPENDIX E
SPEED TAPE
EXTRA 769 EAST

Excessive speed was also a factor in the failure of the engineer to stop Extra 769 East before it struck No. 195. The engineer had testified that the speed indicator was inoperative, but the trainmaster stated that he had observed it at one point and that the train was moving about 40 mph. The speed tape indicated that a maximum speed of about 50 mph had been attained on the outward trip and that the train was traveling between 45-48 mph when it passed Bristol Station. The test results from the 24-month inspection made on March 5, 1982, and the results of the postaccident tests made on March 31, 1982, revealed that the speed indicator and tape essentially indicated the same speeds and that they were accurate.
