# NATIONAL TRANSPORTATION SAFETY BOARD

## RAILROAD ACCIDENT REPORT

COLLISION OF AMTRAK TRAIN 66, THE NIGHT OWL  
WITH ON-TRACK MAINTENANCE-OF-WAY EQUIPMENT  
CHESTER, PENNSYLVANIA  
JANUARY 29, 1988

NTSB/RAR-89/01

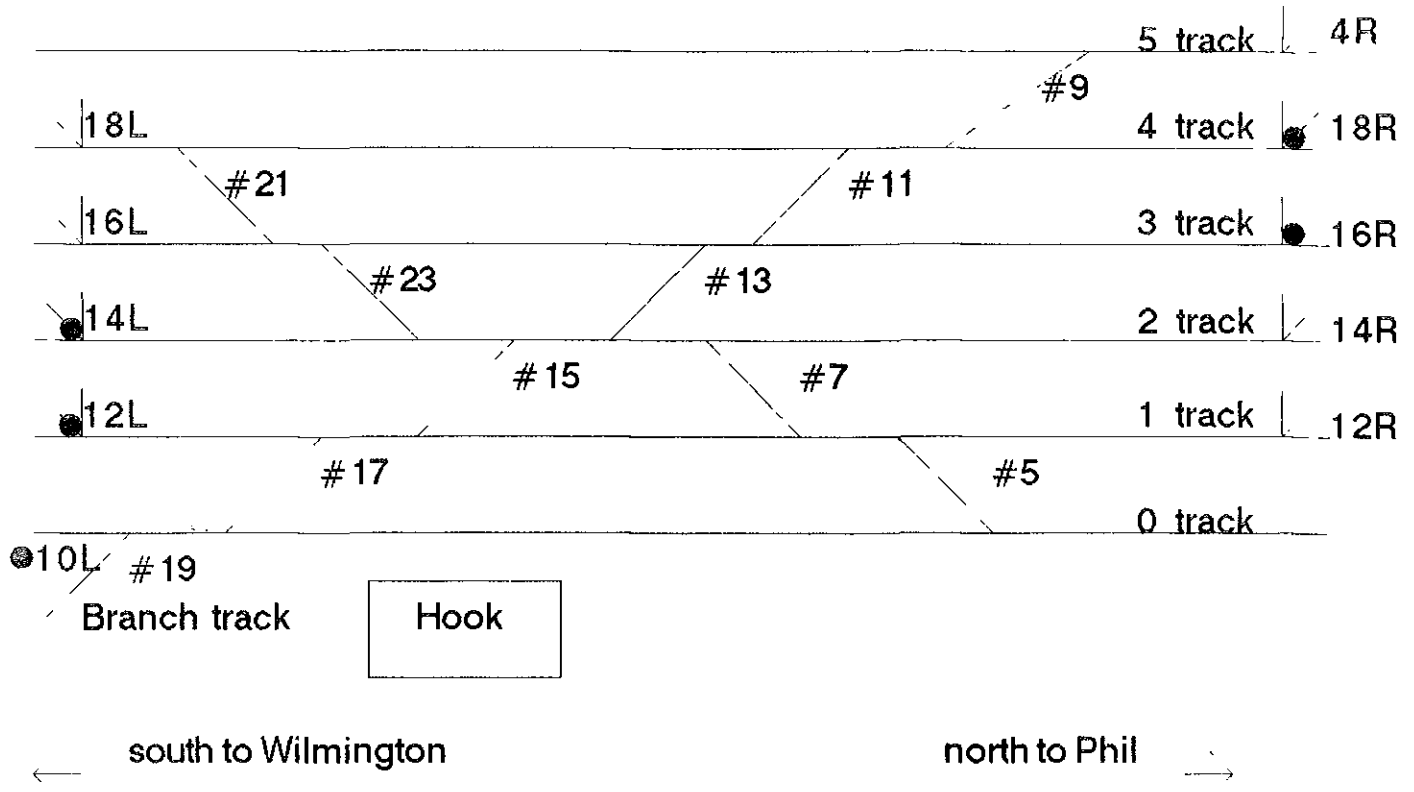
Figure 2 --Interlocking, signals, and crossovers

Train 66 intruded onto the out-of-service track and collided with the ballast regulator as a direct consequence of the Hook tower operator's failure to operate the 7 switch lever and properly align the track for the crossover before removing the stop aspect from signal 14L. The Safety Board determines that this failure by the third-shift tower operator at Hook tower was the primary cause of the accident, raising questions about the performance of the tower operator.

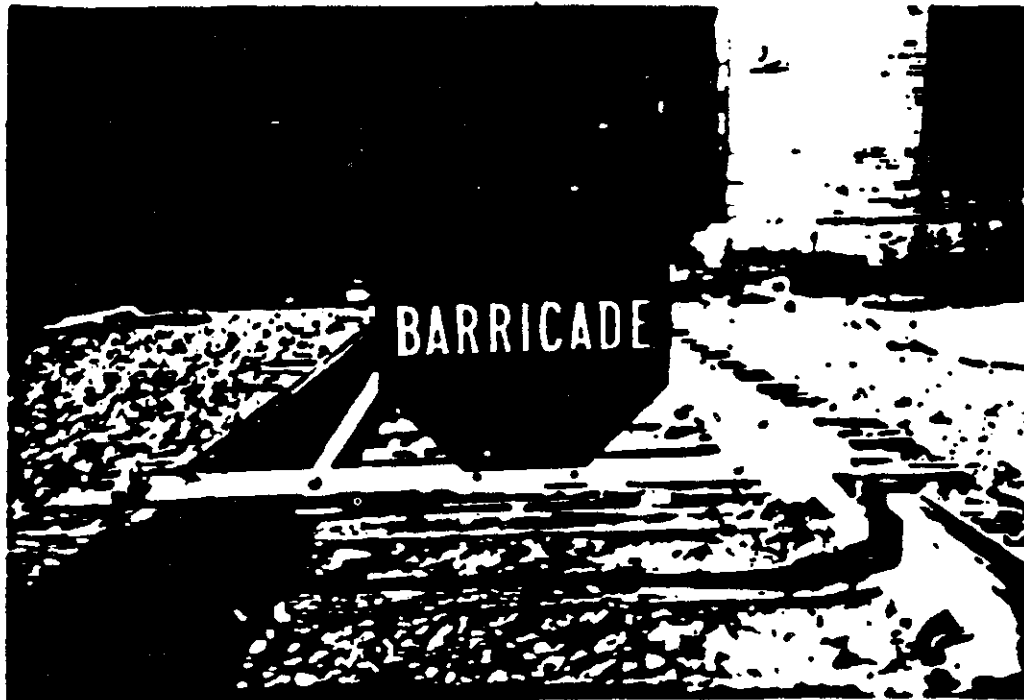
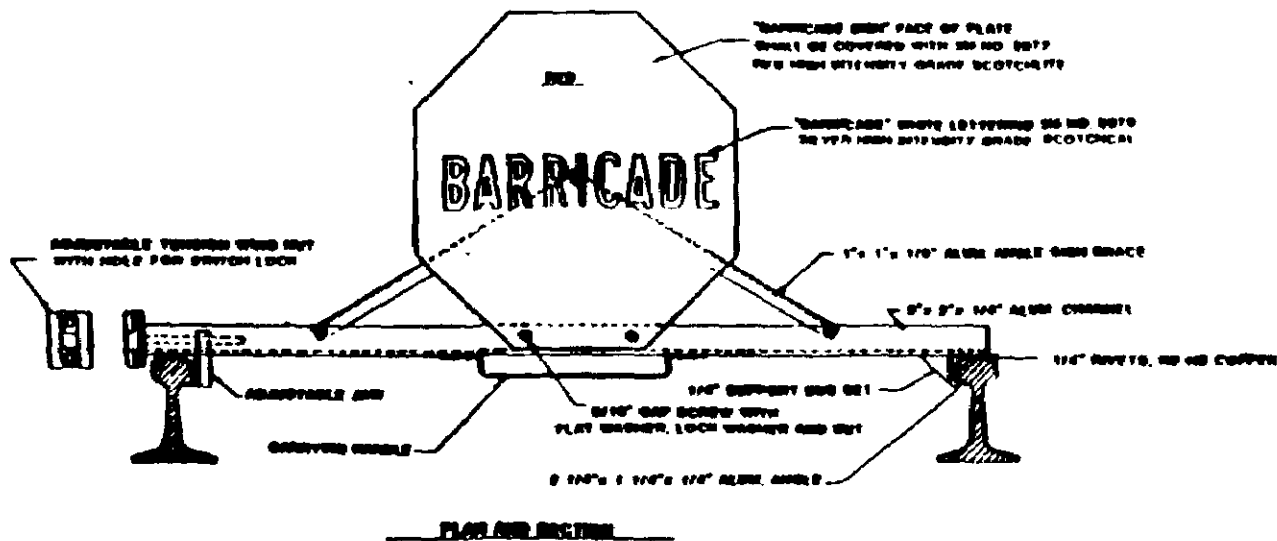
TYPICAL INSTALLATION

Use of Track Barricades.--The protection to prevent trains from intruding onto out-of-service track can, under some circumstances, be provided by shunting the track using barricades so that the automatic block signal system will function. However, testing of the track barricades used by Amtrak to provide shunt protection, demonstrated that even if these barricades were properly applied, they would not provide a reliable shunt. The failure of the track barricade to effectively shunt the signal circuitry during the testing was an indication that the track barricade should not, in its present design, be used to provide shunt protection for employees working on out-of-service track. Amtrak did not dispute the failure of its track barricade to shunt reliably.

The Safety Board believes, this accident demonstrates a deficiency in the review and oversight by Amtrak management of the design of its equipment and adequacy of and adherence to its procedures. The design and manufacture of track barricades that do not provide a reliable shunt is an example of this deficiency. If the barricade does not shunt the signal
