NATIONAL TRANSPORTATION SAFETY BOARD

RAILROAD ACCIDENT REPORT

HEAD-END COLLISION OF
AMTRAK PASSENGER TRAIN NO. 74
AND CONRAIL TRAIN OPSE-7
DOBBS FERRY, NEW YORK
NOVEMBER 7, 1980

NTSB-RAR-81-4

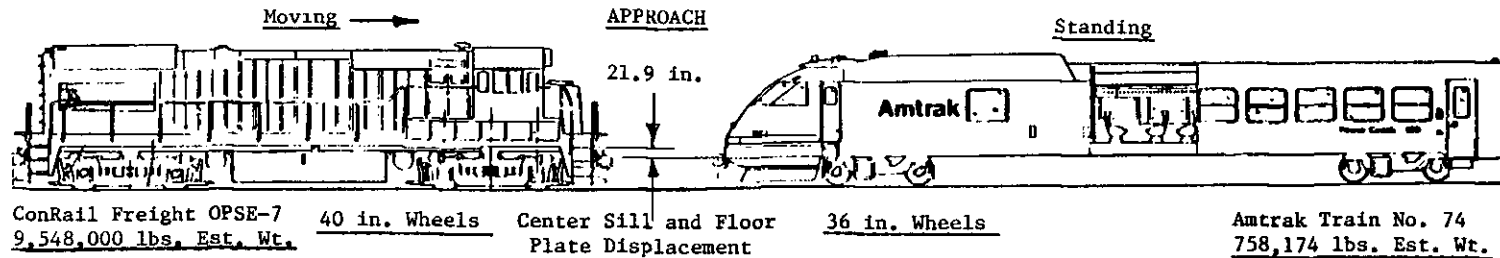
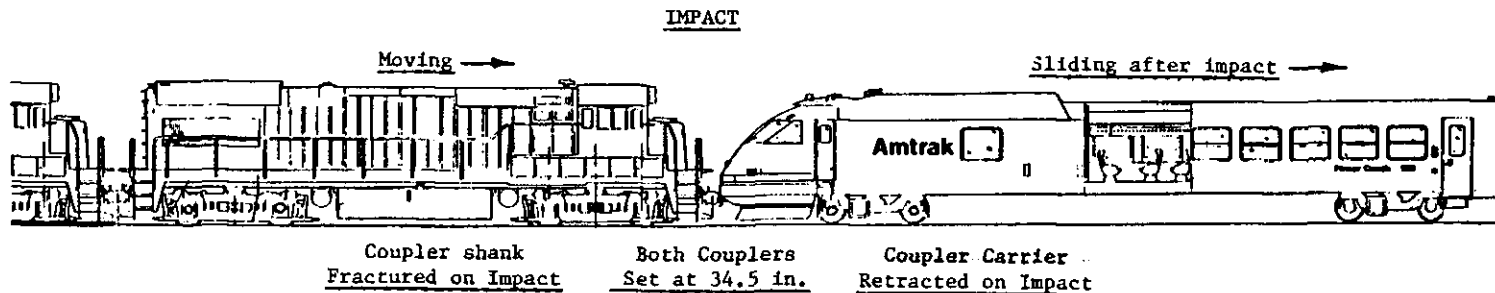
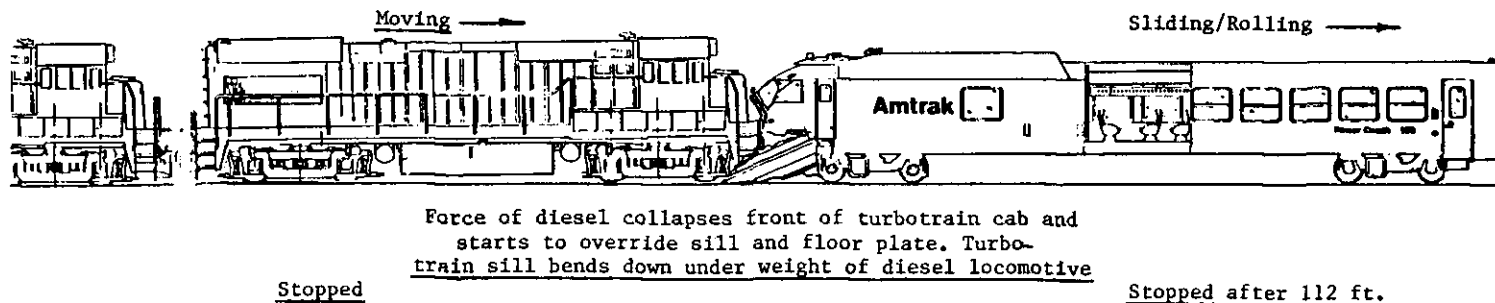
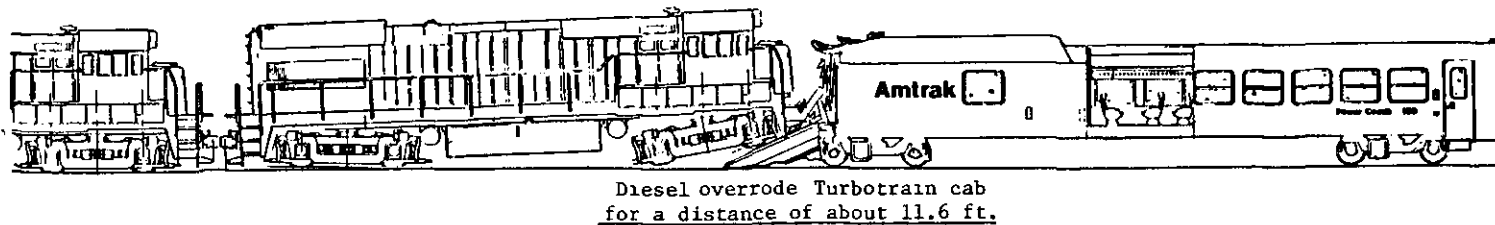
Figure 2.—Diagram of impact of OPSE-7 and No. 74.

Moments later, OPSE-7 collided with standing train No. 74 at about 10 mph. The impact derailed the lead unit of OPSE-7 and pushed train No. 74 rearward about 112 feet, derailling the lead power car (see figure 2) and the following three passenger cars. (See figure 3.) Electrical power to the four tracks was shut off after a crewmember boarded the cab of the rear power car and used the radio to request that the power be shut off because of the collision and because passengers were getting onto the tracks. An employee of a restaurant adjacent to the accident site immediately called the Dobbs Ferry Police Department. Within 3 minutes after the accident, emergency forces began to arrive at the accident site.

Damage to OPSE-7 was limited to the derailed lead locomotive unit. The front end coupler was broken and the front deck, handrails, and side steps were bent, torn, and twisted. The short hood was forward and it was crushed inward.

The operating cab of the power club car of train No. 74 was destroyed because of the 10-mph impact. All floor or deck mounted equipment was torn or sheared off. The other cars in the train sustained minor structural damage.

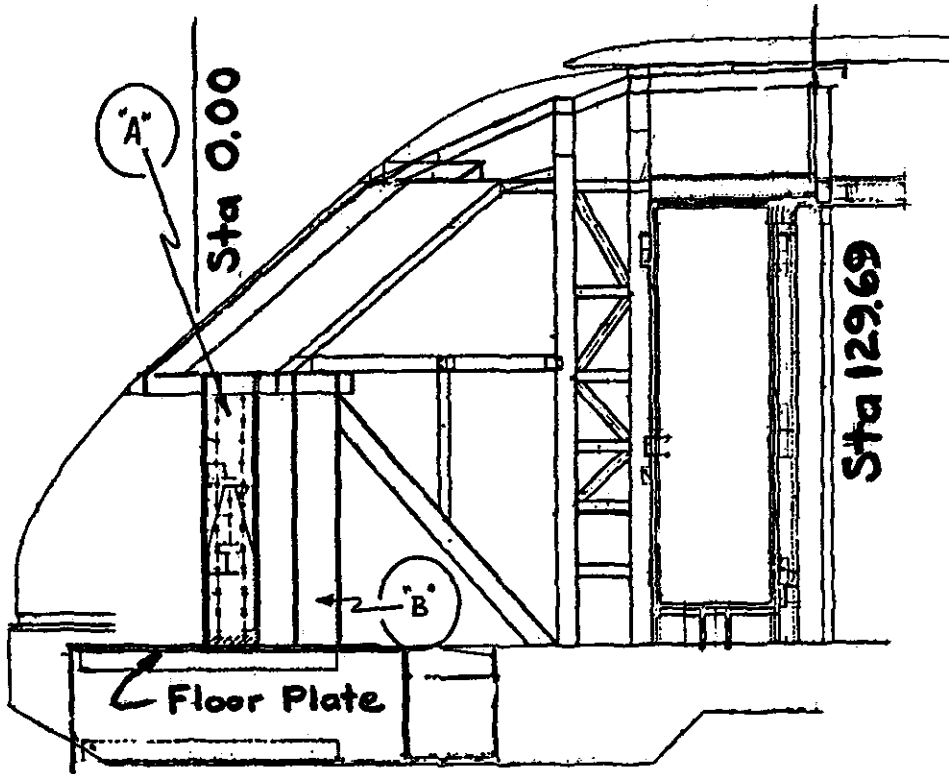
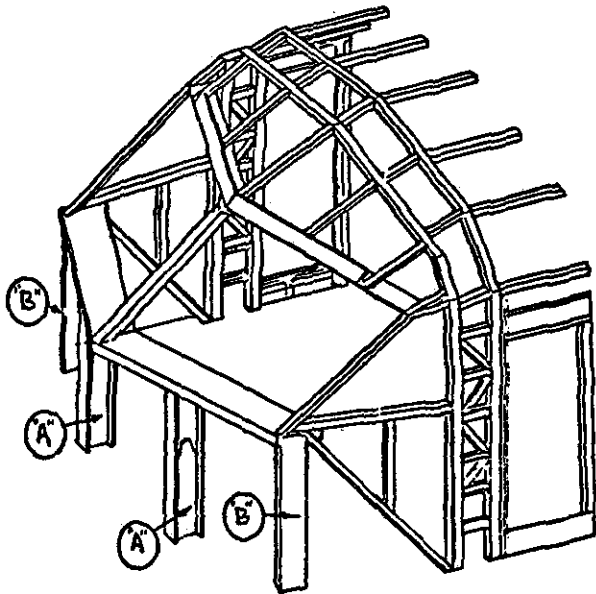
"A" = Collision Posts (Center)

The operating cab of the power car had two 10-inch I-beam forward posts, identified by Amtrak as collision posts, (see figure 4 item "A"), welded to the floor. One end of the angled supports (item "B") was welded to the I-beams and the other end was welded to the floor. The forward posts (item "A") were tested in a mock-up configuration to meet the AAR specifications Nos. C-75 through -84, revised 1967. (See appendix H.) The height of the sill and floor plate on the power club car was 45.67 inches above the top of the rail.

Train No. 74 had traveled approximately 4 miles east of OW when it stopped. Two vertical I-beams were located at the forward end of the power car at Body STA. 0:00. (See figure 4.) These I-beams, identified as collision posts, had failed at the base welds and were pushed rearward about 7 feet. Outboard angled supports which were tied laterally to the vertical I-beams by welded steel structural members had failed at the floor attachment and had torn the floor material. The attaching welds had not failed. These posts were also pushed rearward about 75 inches. The car frame was bent downward until the forward section of the frame contacted the rail. The front AAR type E-coupler, mounted in a retractable coupler box, was found in the retracted position. The two pin-type locks which secured the coupler carrier in the extended position were found undamaged but pushed rearward to an angle of about 60° on both sides. The structural metal of the coupler carrier and the lock pin guides were bent and deformed. The lock pin retracting mechanism was severely bent and damaged. All exterior metal and fiberglass skin panels were destroyed to about 112 inches from the front. All four of the third-rail contact shoes were severely damaged.

Although the I-beam forward posts of the power car were intended to be collision posts, they failed to provide any protection since they were torn loose and pushed rearward even in a relatively low speed collision. In the test mockup that was performed on the collision posts before they were installed in the power car, the collision posts were welded to an I-beam before the test loading was applied. (See appendix H.) The actual installation of these collision posts differed from the testing because they were welded only to the much thinner floor plate. In this accident, the collision posts tore loose from the floor plate, or tore the floor plate metal. It is evident that modern passenger equipment, such as that used on train No. 74, will always sustain extensive damage in a collision with conventional locomotives because of the incompatibility of the rigid frames; its frame being approximately 21 inches lower than standard railroad equipment. Apparently, this matchup was not considered when the turboliner equipment was adopted for use on American railroads.

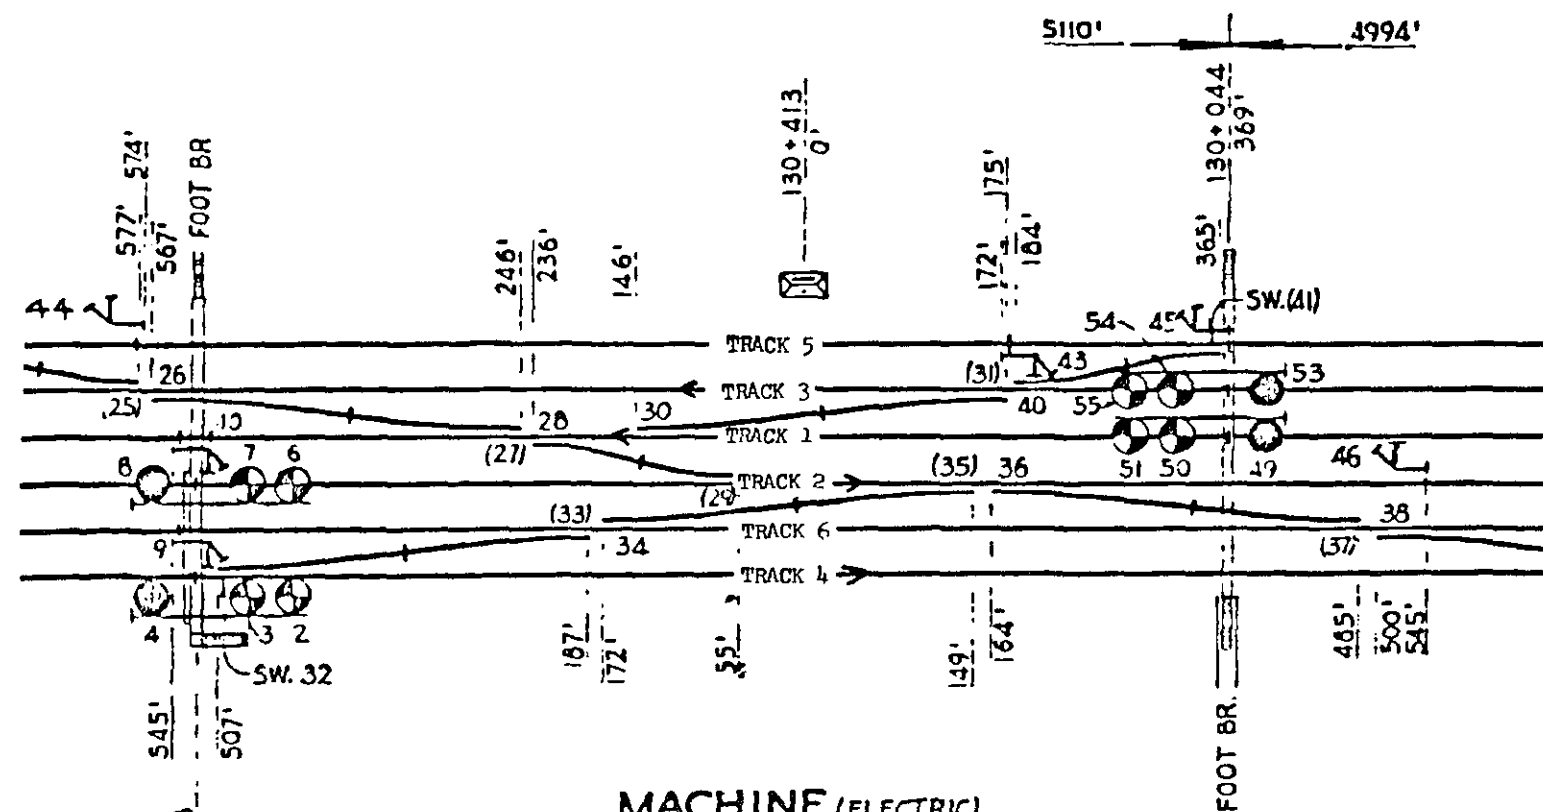
Figure 5.-- OW interlocking.

On the eastward signal mast for track No. 2 at OW interlocking, there was a fixture for a flashing letter "O", a train order signal; however, the signal had been electrically disconnected. A bracket for attaching a yellow flag or light, also a train order signal, to the tower building at OW was not accessible to the operator because the storm windows were nailed shut.

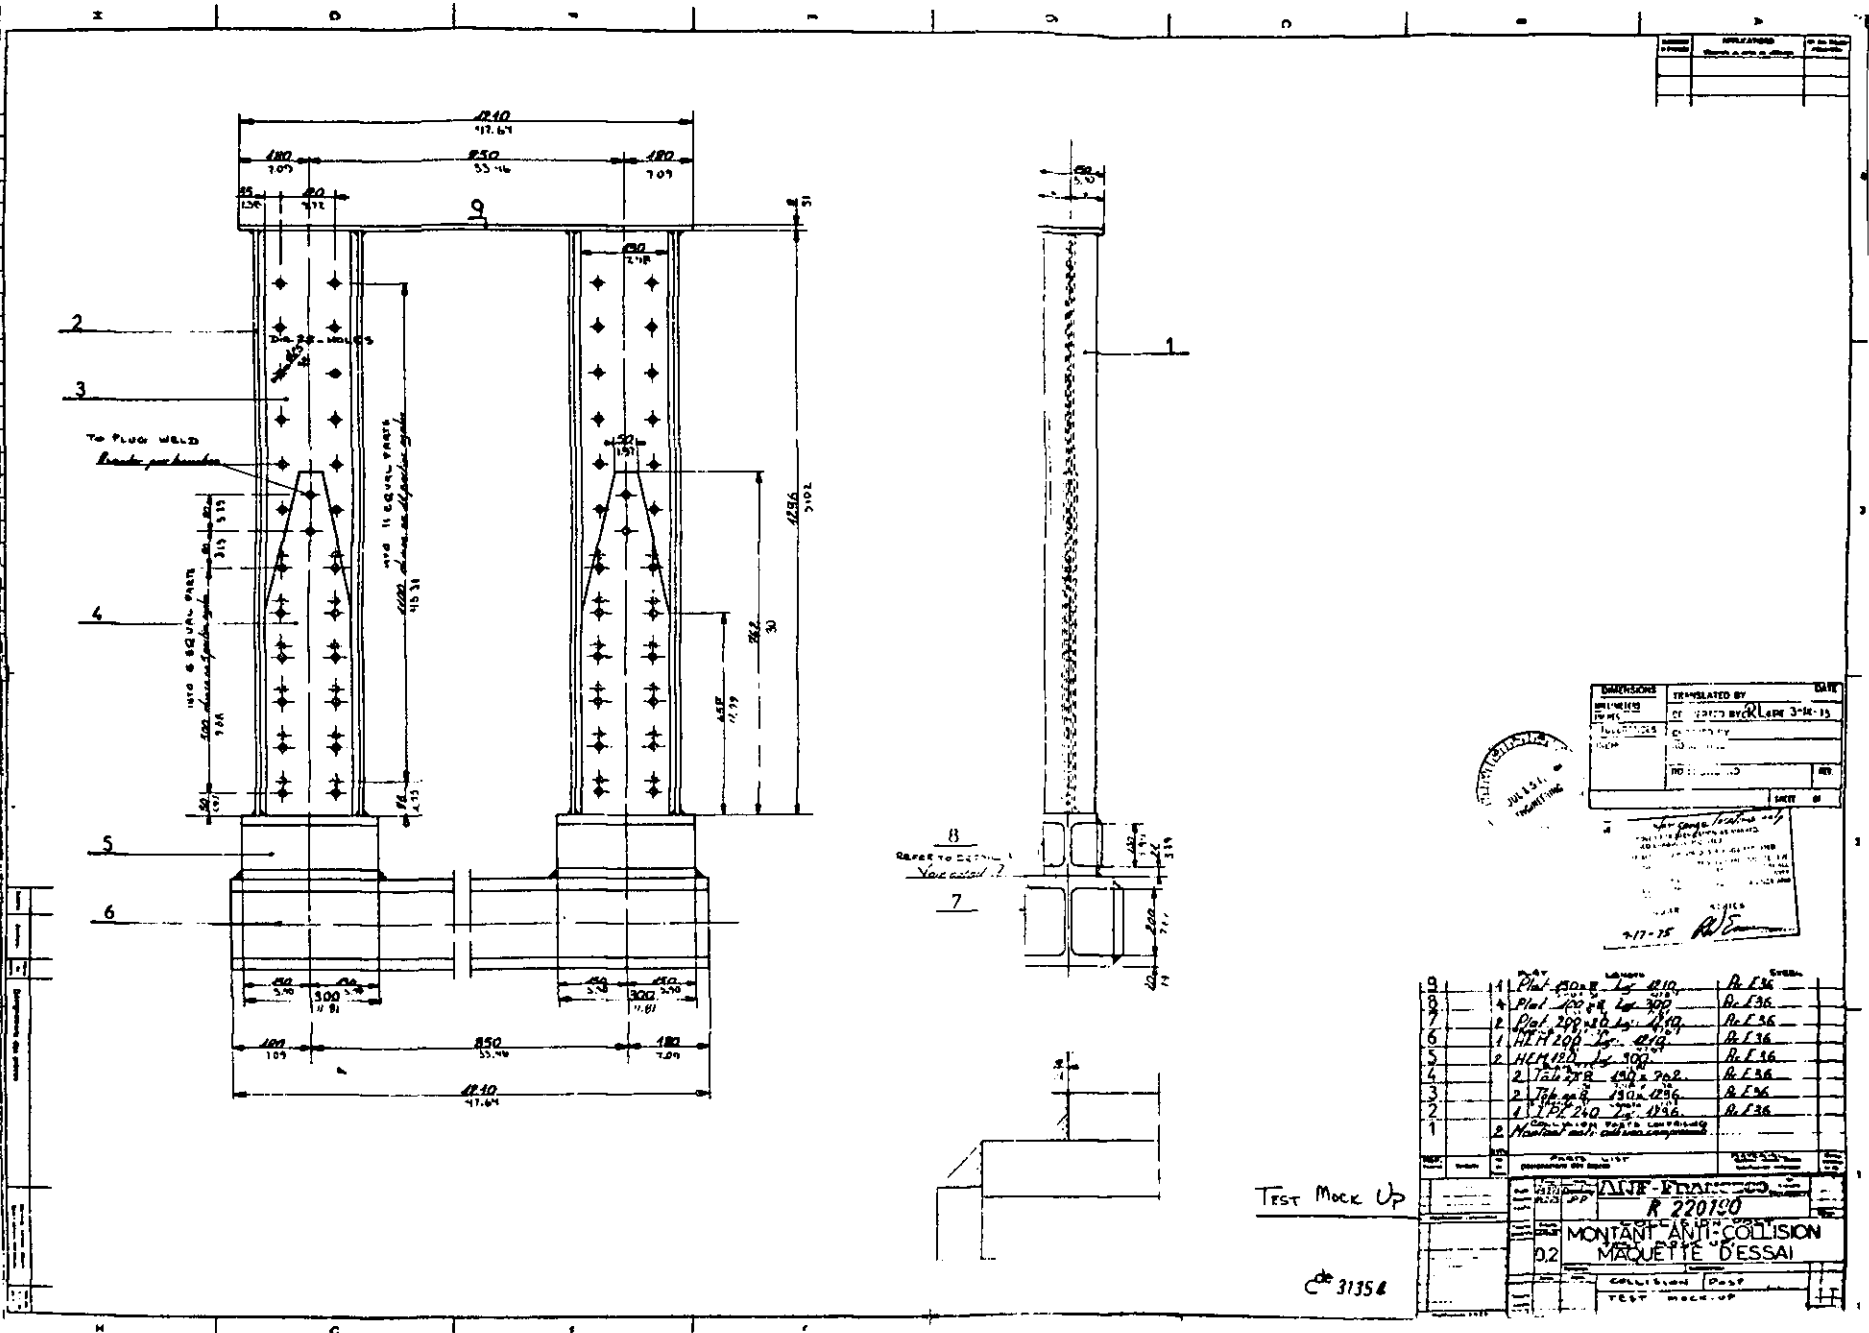
A 150K load was applied 18" above lower attachment with no failure.

A 300K load was applied at the base with no failure.
