NATIONAL TRANSPORTATION SAFETY BOARD

RAILROAD ACCIDENT REPORT

FIRE ONBOARD AMTRAK PASSENGER TRAIN
TRAIN NO. 11, COAST STARLIGHT
GIBSON, CALIFORNIA
JUNE 23, 1982

NTSB / RAR-83 / 03

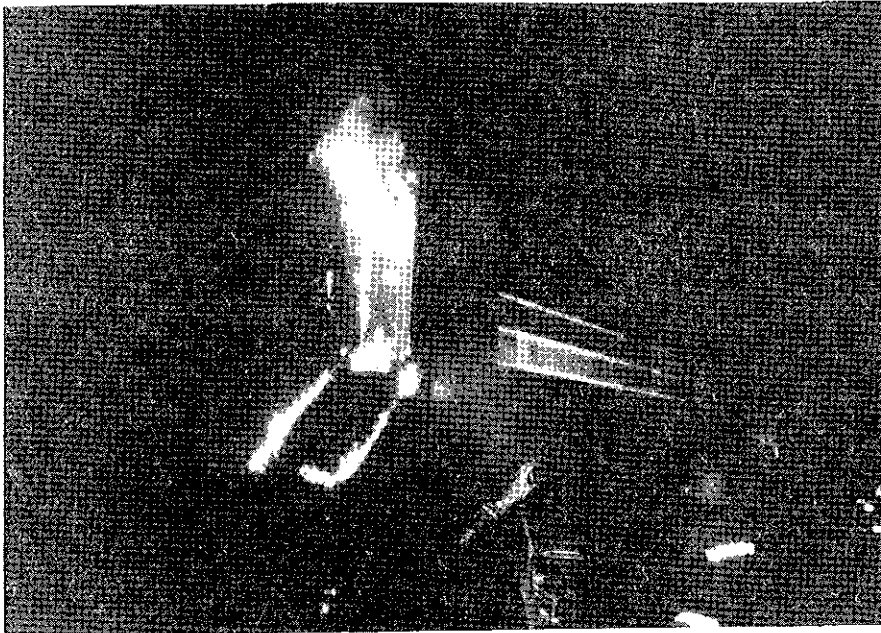
Figure 5.--View of front end of the 1130 car during fire.

engineer said the flames broke through the car "long" before the firefighting equipment arrived. (See figure 5.)

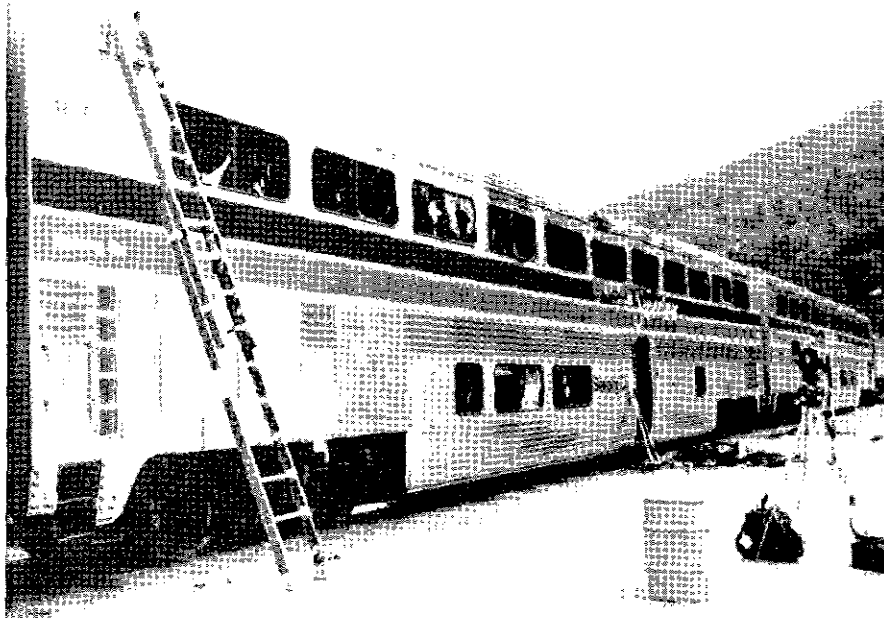
The upper level of sleeper car No. 32010 (1130) was destroyed; the lower level was damaged by the intense heat and smoke. (See figures 6, 7, and 8.)

Figure 6.--Exterior view of the 1130 car.

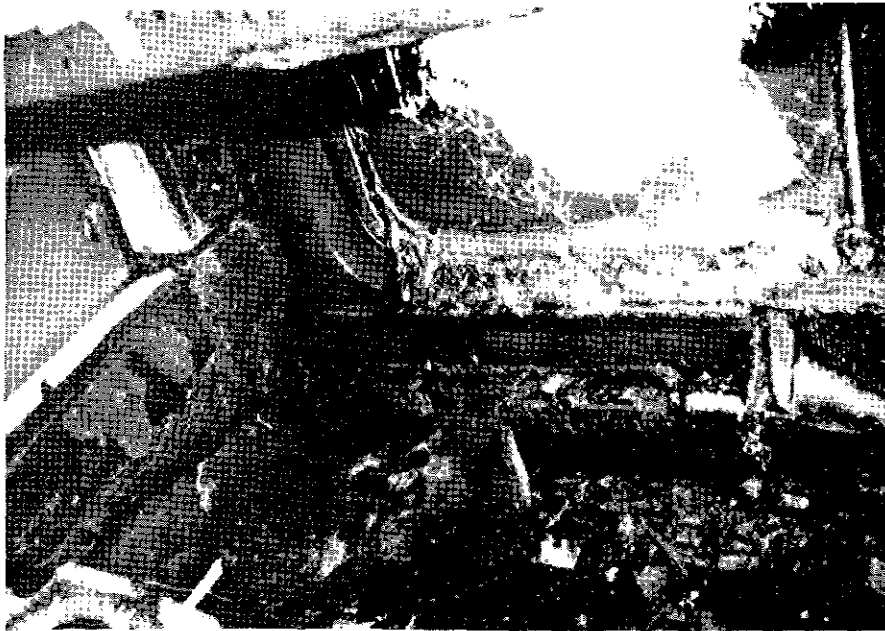
Figure 7.--Interior view of burned economy-type bedroom in the 1130 car.

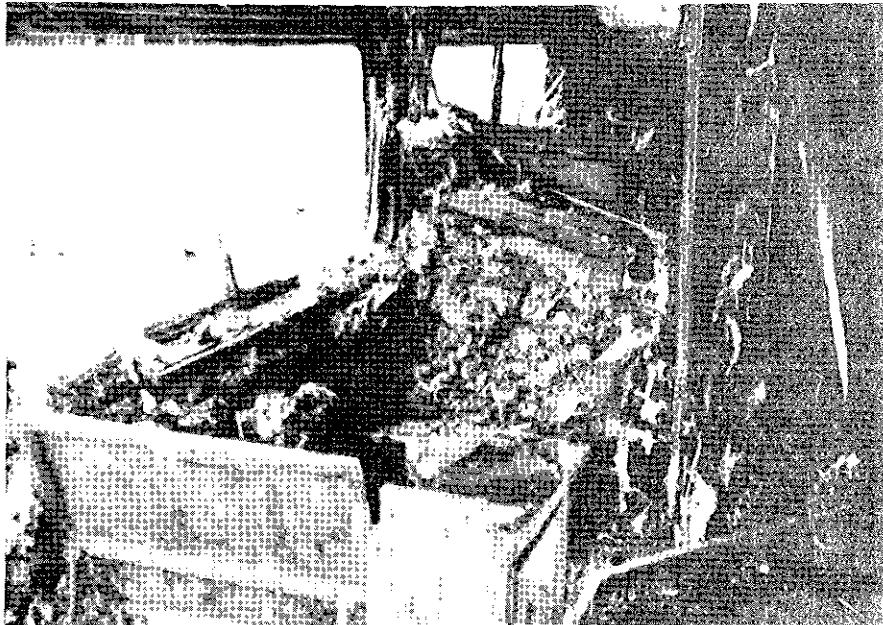
Figure 8.--Interior view of burned economy-type bedroom in car 1130.
