NATIONAL TRANSPORTATION SAFETY BOARD

RAILROAD ACCIDENT REPORT

DERAILMENT OF
AMTRAK TRAIN NO. 7,
THE EMPIRE BUILDER,
ON BURLINGTON NORTHERN TRACK,
GLACIER PARK, MONTANA
MARCH 14, 1980

NTSB-RAR-80-6

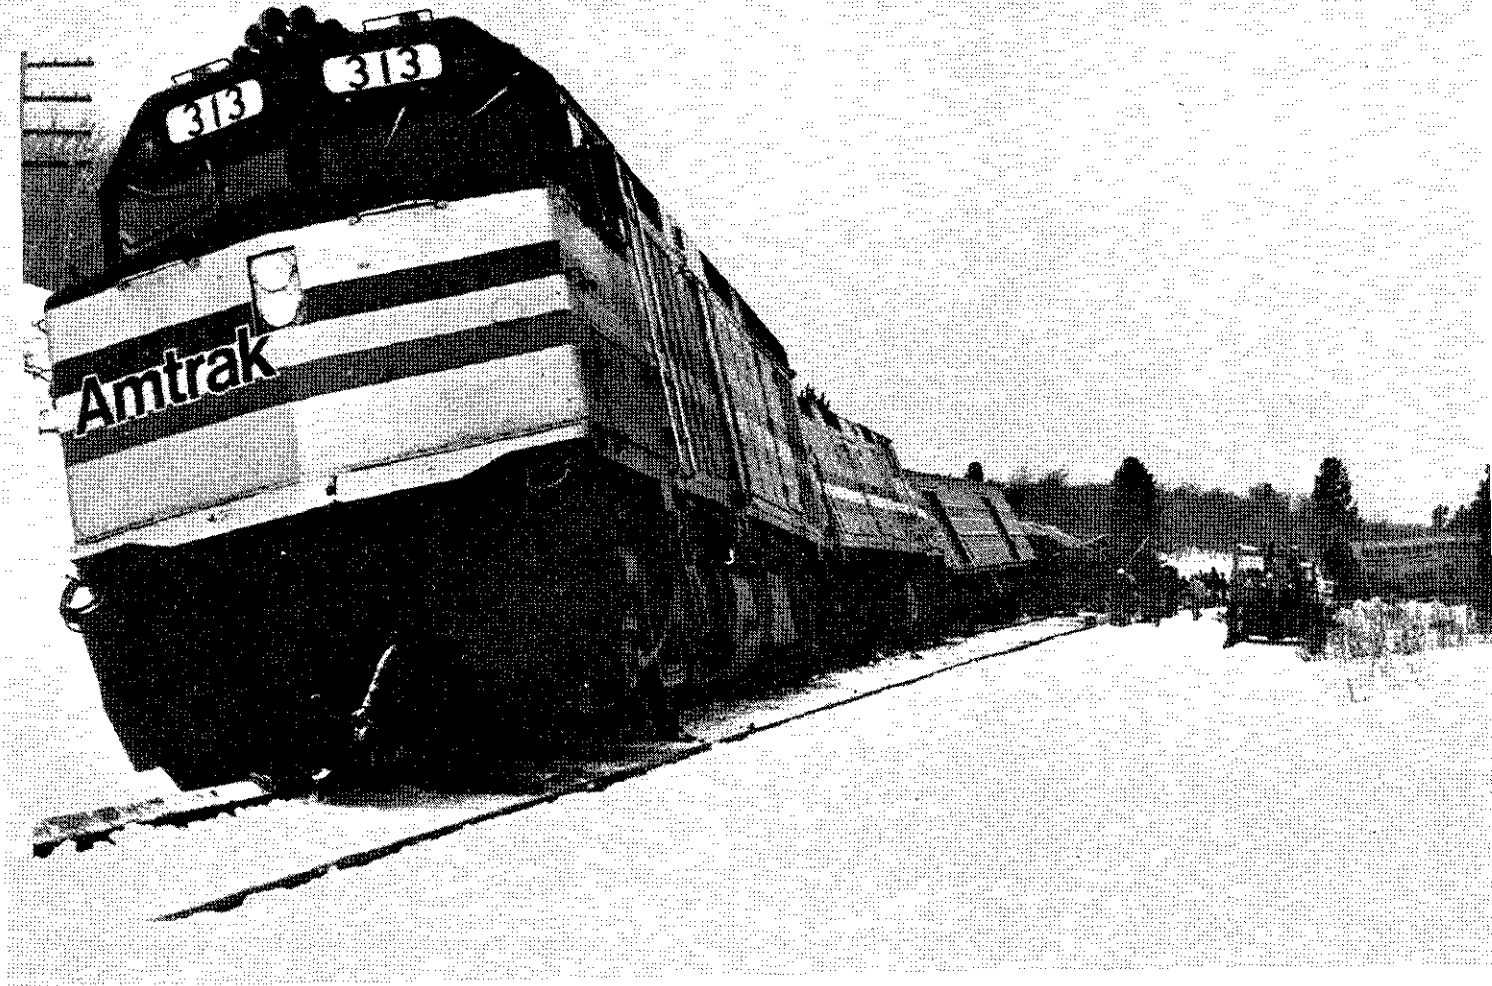
After derailling, the locomotive continued over 800 ft around the remainder of the curve, stopping about 60 ft beyond the curve on tangent track. (See figure 1.) Both locomotive units, the baggage car, and the first two coaches remained coupled. The two coaches had tipped toward their right sides and were leaning at a 45° angle against the bank of a side hill cut. (See figure 2.) The fourth and fifth cars continued down a 15-ft-high embankment and tipped onto their sides near the bottom. The sixth car was leaning about 30° near the top of the bank. The seventh and eighth cars remained upright and derailed within the track structure. (See figure 3.)

Figure 1.--Derailed locomotive.

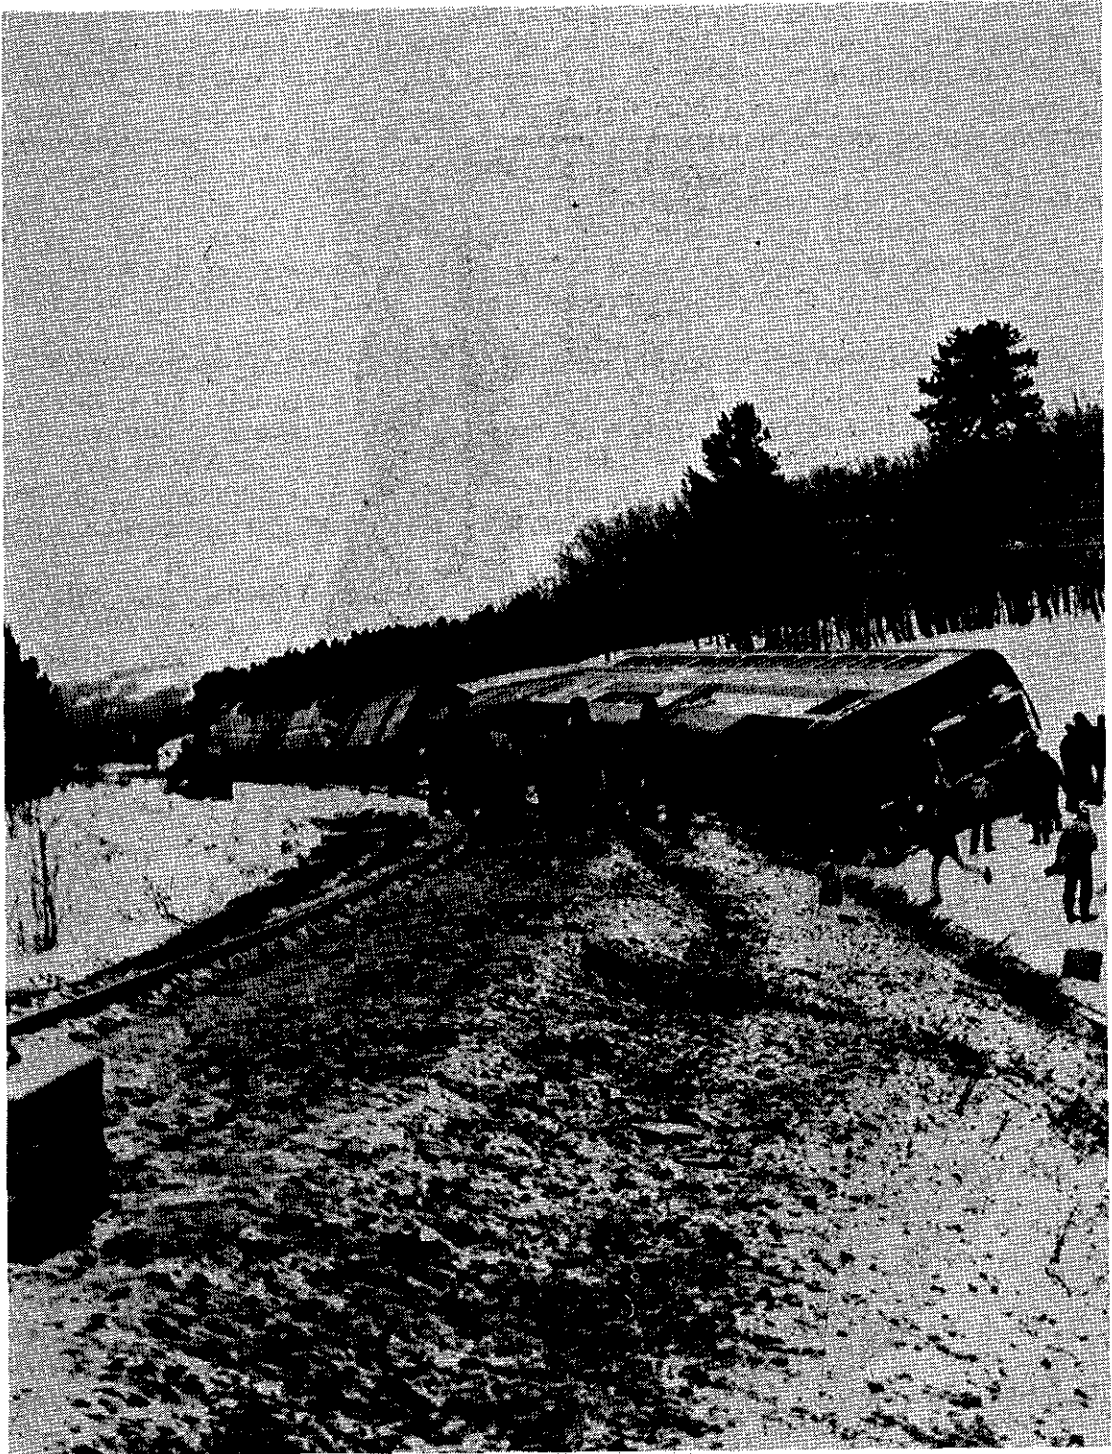
Figure 2.--Track and first three derailed cars.

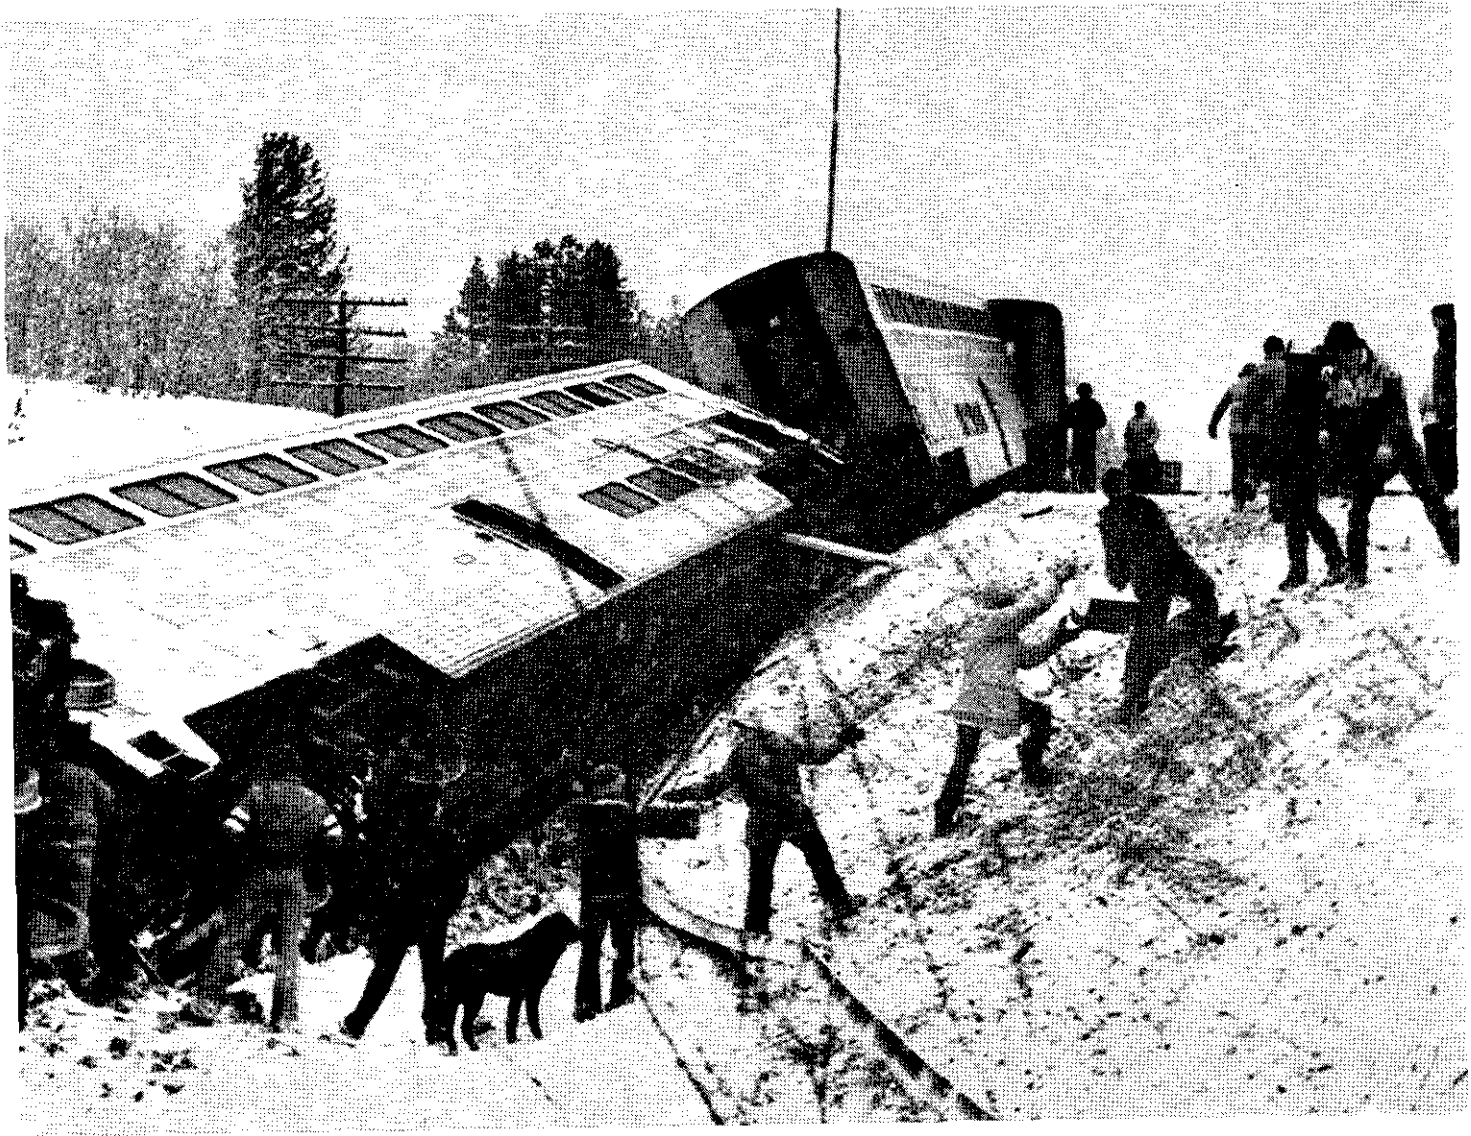
Figure 3.--Last three derailed cars.

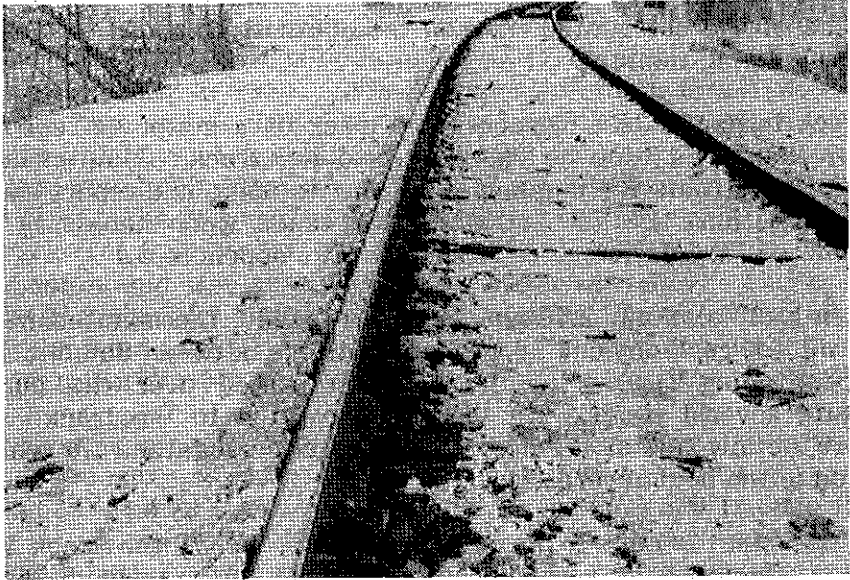
Figure 5.--High track spikes in north rail.

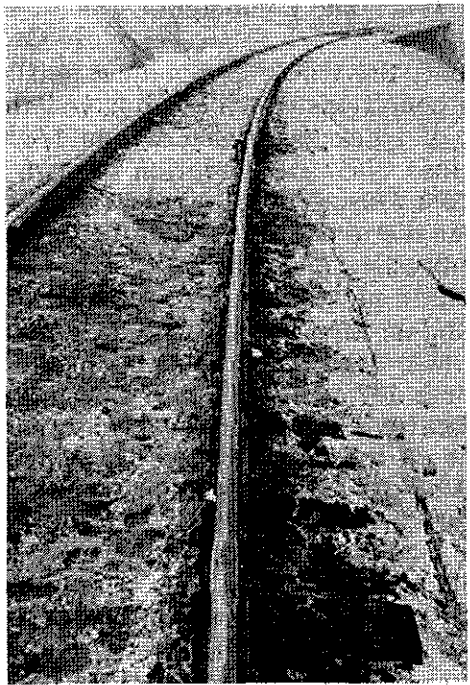
Figure 6.--Corrugations in south rail.

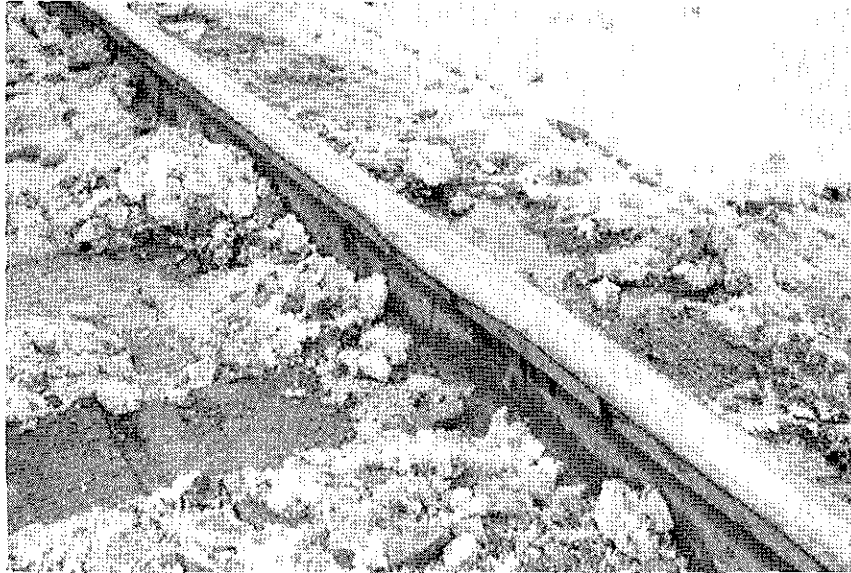
Figure 7.--Head crushing in south rail.

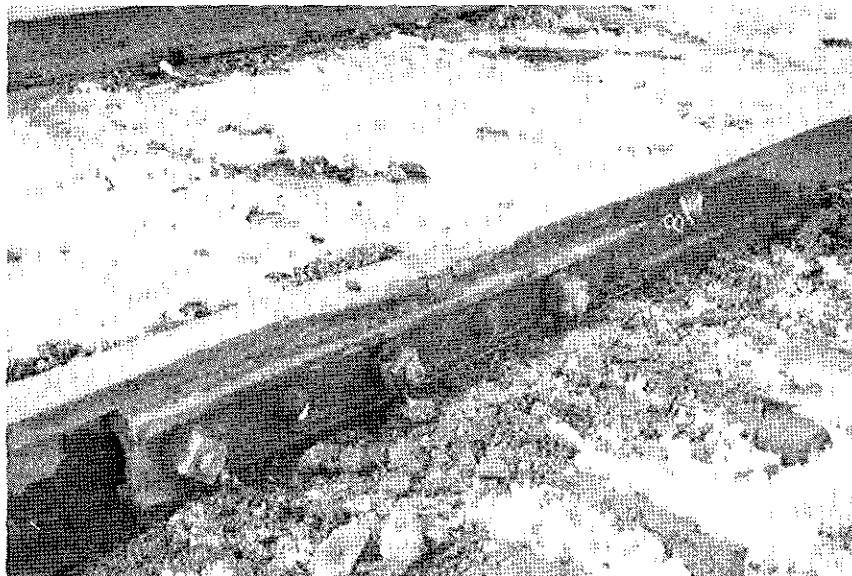
Following the accident, the track approaching and leaving the accident site was checked for defective conditions which could have caused or contributed to the accident. Measurements of track gage varied from 1/4 in. to 7/8 in. more than the standard of 4 ft 8 1/2 ins. The superelevation through the curve varied in a few locations from 2 1/4 ins. to 3 3/8 ins. (See figure 4.) The crossties were frozen in the ballast and had not been disturbed by the derailing cars. Snow was covering the crossties, and it had to be brushed from the base of the rail and tie plates in order to inspect the spiking pattern and the tie plate condition. The crossties exhibited 1/4-in. average plate cutting on the field sides of the high rails. The base of rail at the field side of the high rail was higher than the shoulder of a number of the tie plates creating more than a 1/2-in. gap when the rail was not under load. At several suspended joint locations between the bridge and derailment area, there were no rail holding spikes on the field side of the joint bars. A number of gage side rail spikes for several of the high rails just beyond the bridge and approaching the derailment location were protruding from 1 in. to 3 ins. above the base of the rail. (See figure 5.) The high rail was curve worn from 1/4 in. to 1/2 in. The bottom surfaces of the rails indicated wear from contact with the tie plates on the gage side of the rail base. A number of low rails were corrugated and had crushed heads and were mushroomed and shelled to the extent that required the rails be replaced. (See figures 6 and 7.) At suspended joints, several low rails exhibited 1/2-in. end batter, crushed heads, and horizontal separation of the rail head surface metal. (See figure 8.)

Figure 8.--Rail end batter in south rail.
