# NATIONAL TRANSPORTATION SAFETY BOARD

## RAILROAD ACCIDENT REPORT

DERAILMENT OF  
AMTRAK TRAIN ON  
ILLINOIS CENTRAL GULF RAILROAD

REPORT NUMBER: NTSB-RAR-77-3

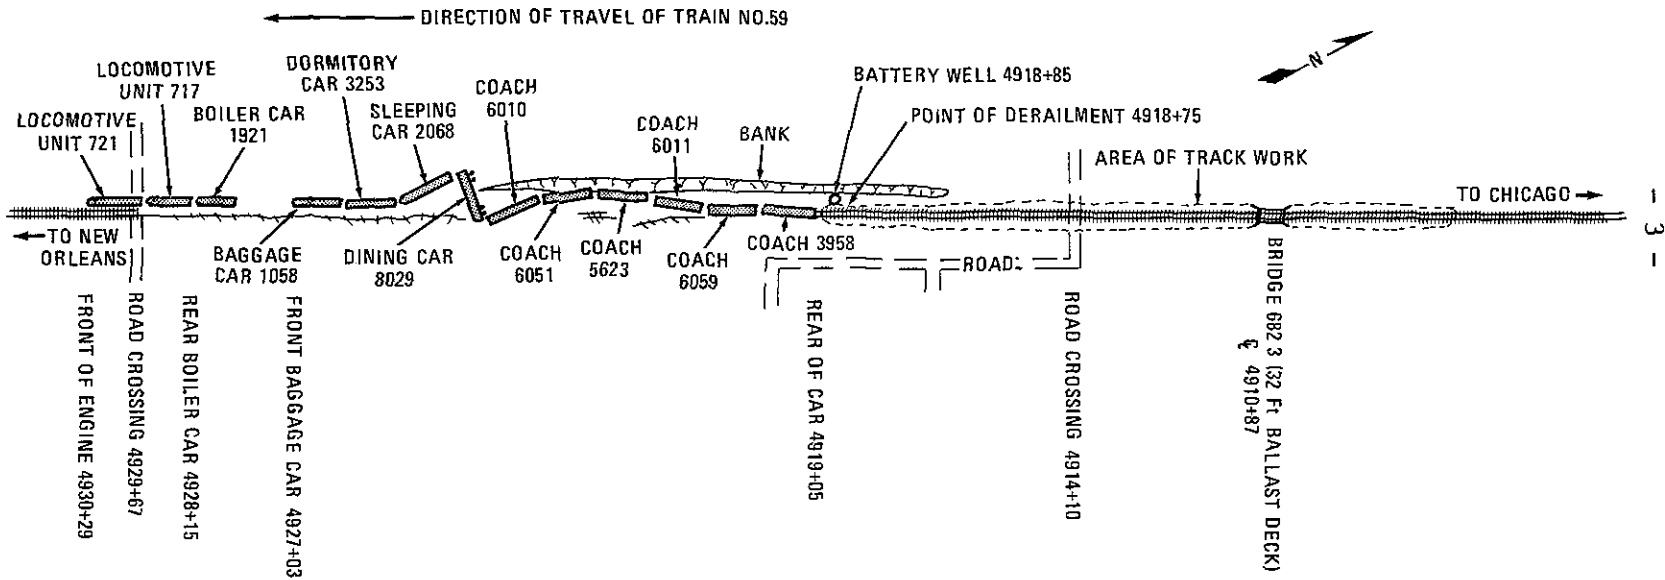
Figure 1. Plan of accident site.

The track is straight for more than a mile on each side of the derailment site. (See figure 1.) The grade descends southward and varies from 0.2 to 0.4 percent. The track was constructed on a fill section up to the point of derailment and in a cut section at the point of derailment. Drainage ditches on each side of the track were filled with water and weeds at the time of the derailment. The roadbed and track were wet and muddy from recent rains.

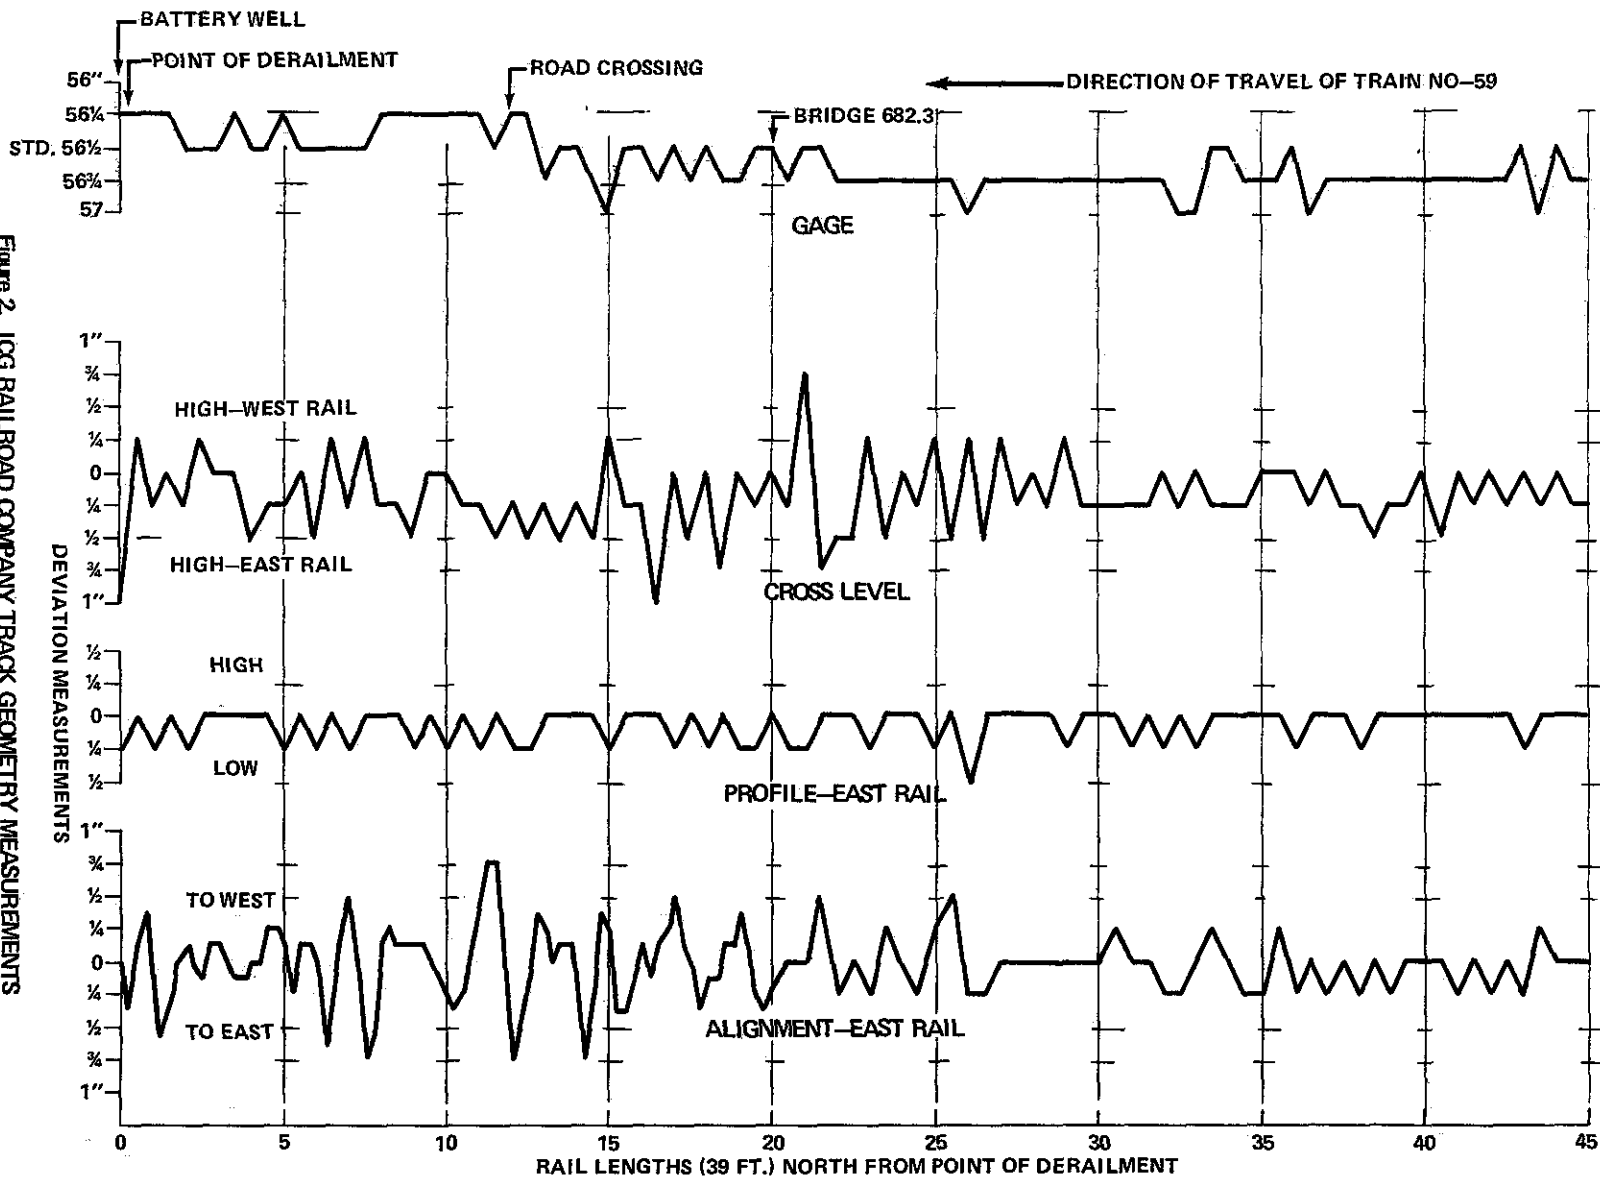
Figure 2. ICG RAILROAD COMPANY TRACK GEOMETRY MEASUREMENTS

Inspection of the track in the recently worked area north of the derailment site disclosed variations in gage, irregularities in line and cross level, and tie plate movement. Gage varied from 1/4-inch less than standard to 1/2-inch more than standard. Alignment of the east rail in one 19 1/2-foot section varied from three-fourths of an inch to the east of three-fourths of an inch to the west when measurements were taken from the center of a 62-foot stringline. Cross level varied from 3/4-inch high to 3/4-inch low in a 19 1/2-foot section. Tie plate movement on the older crossties, in addition to wide gage, was one-half inch. None of these gage, alignment, cross level, and tie plate movement measurements were taken under the static loading of a train. (See figure 2.)

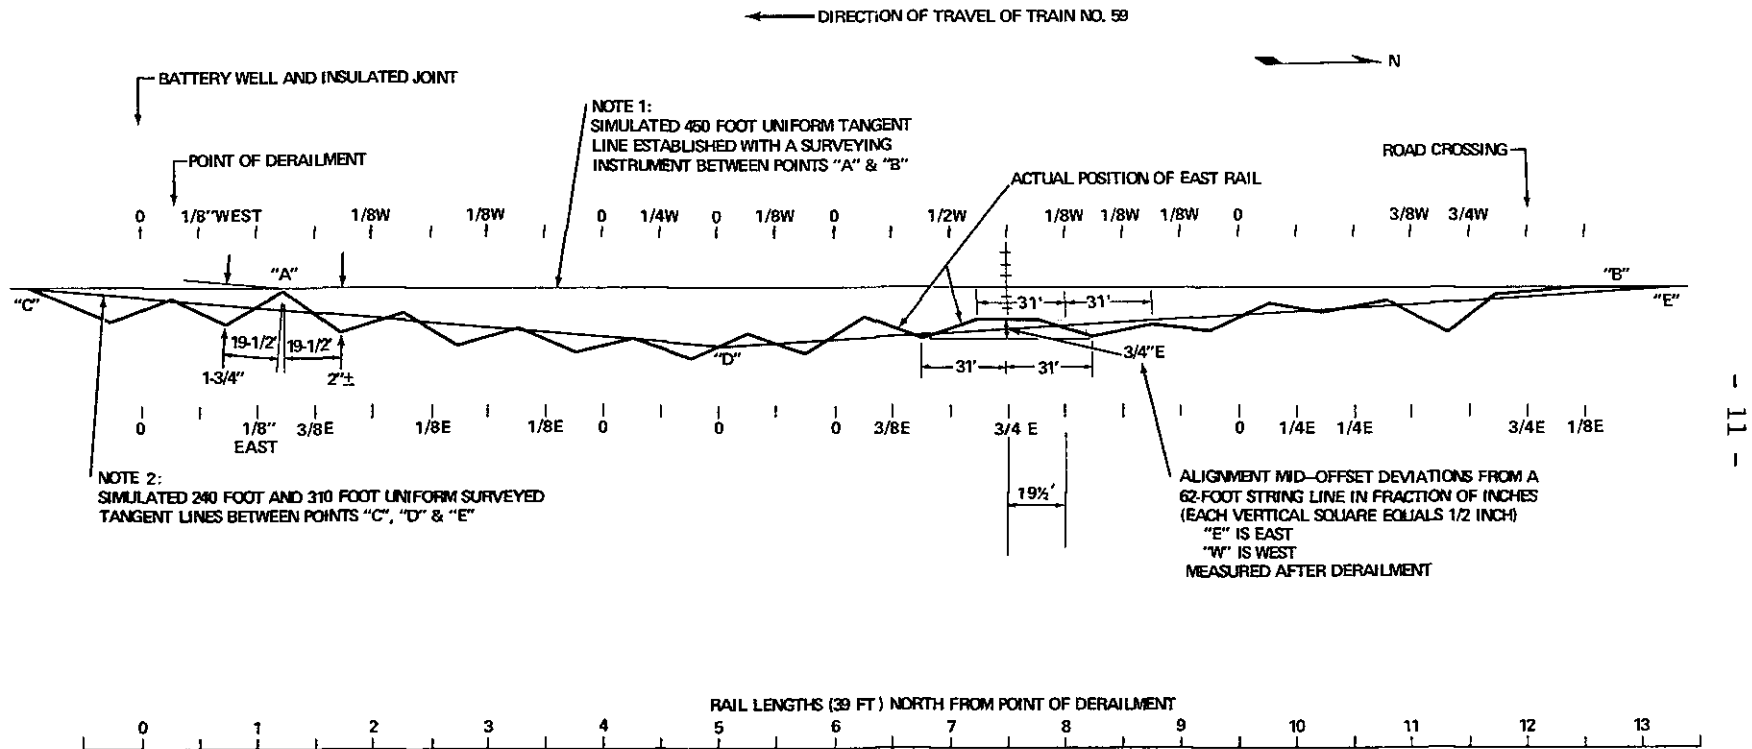
Figure 3. Plot of alignment measurements.

For example, the Class 4 Track Safety Standards allow an alignment deviation "from uniformity" of 1 1/2 inches from the mid-offset of a 62-foot stringline without any loading on the track. The track at the derailment site met the FRA alignment standards because the greatest mid-offset in any 62-foot section measured was only three-fourths of an inch. However, to obtain the mid-offset measurement this way, and then to relate this measurement to uniformity is misleading because any chord measurement made in this manner does not indicate the actual position of the rail or its actual amount of misalignment from track uniformity. The Track Safety Standards neither define uniformity nor stipulate a method by which uniformity shall be established. Without a geometrically correct uniform line to use as a reference line when plotting the deviation measurements, the true amount of deviation cannot be determined. The standards also do not state how often a measurement shall be taken or an allowable rate of change in uniformity. Mid-offset measurements made with a 62-foot stringline after the accident show that the track directly north of the derailment site geometrically deviated about 2 inches in 19 1/2 feet from a uniform tangent line such as that established with a transit surveying instrument. (See figure 3.) This 2-inch deviation exceeds the 1 1/2-inch deviation allowed by the Class 4 Track Safety Standard.

The cross level, in combination with rail profile, is at or near the maximum allowable 1 1/4-inch deviation at several locations north of the road crossing. Just north of bridge 682.3 the difference in cross level changes from three-fourths of an inch to the east, to 1 1/4 inches to the west, to 1 inch to the east in 39 feet of track. However, the maximum single-field measurement taken was three-fourths of an inch which is within FRA standards. (See figure 4B.) This extreme rate of change in cross-level, along with the irregular alignment would have precipitated the oscillation of the locomotive that the trackman saw. The poor cross level would also have caused the track to move farther out of line under train movement.

"Amend track geometry standard 49 CFR 213.55, Alignment, so that it defines "uniformity," establishes a maximum rate-of-change in alignment deviation, and establishes the maximum number of feet between which each alignment mid-offset measurement shall be taken. (Class II, Priority Followup) (R-77-6)

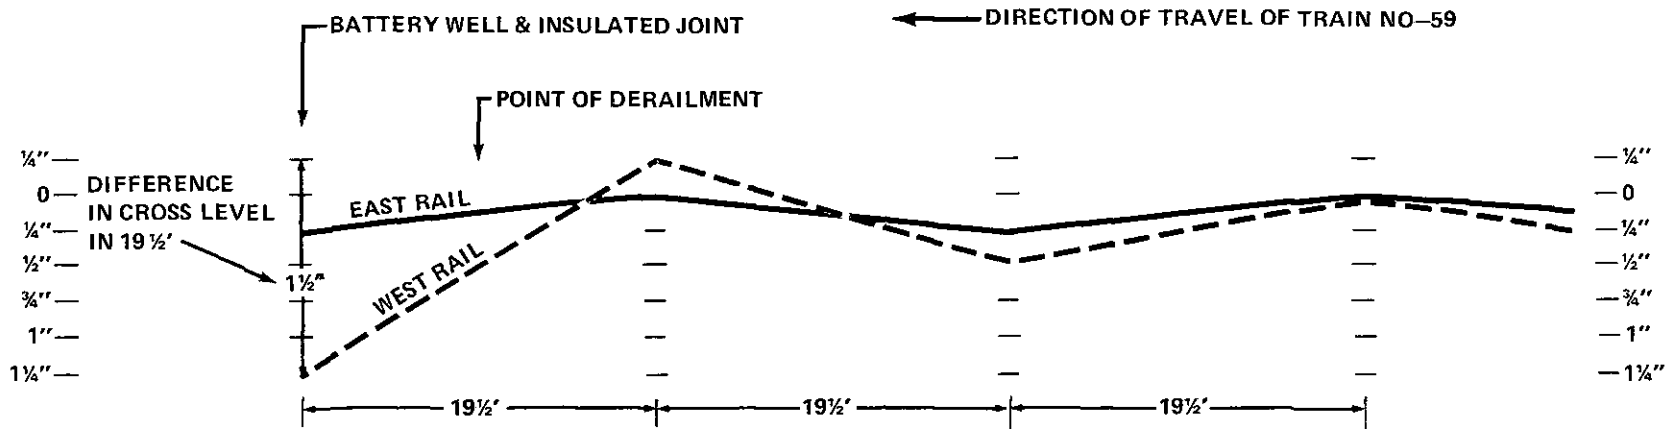
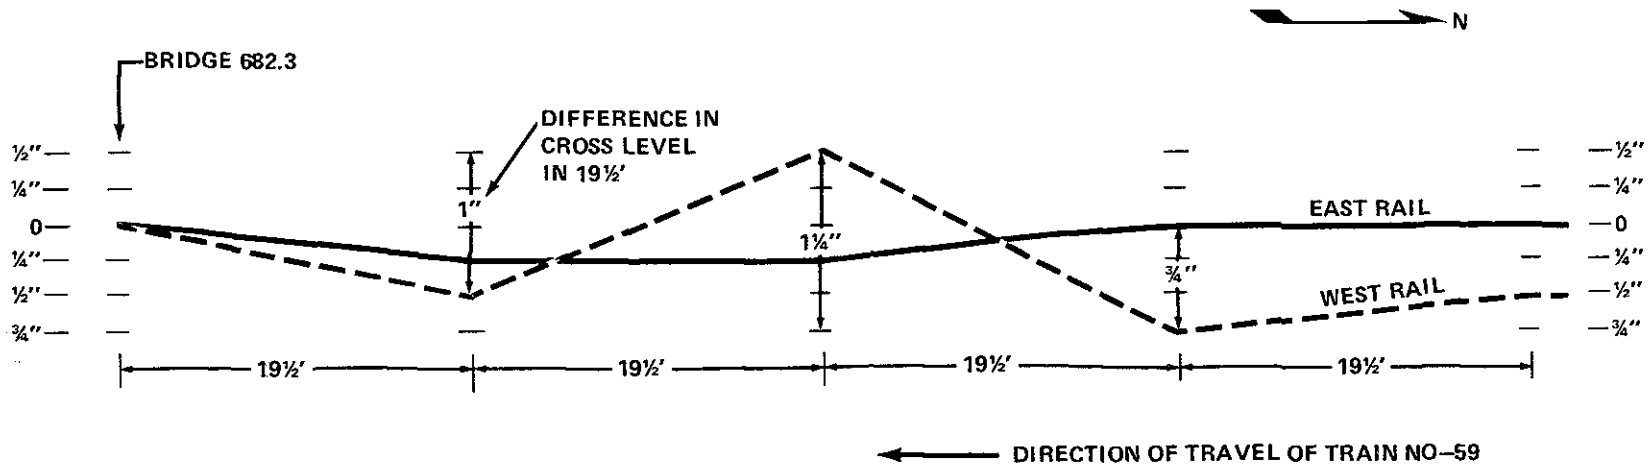
Figure 4B  
PLOT OF PROFILE AND CROSS LEVEL MEASUREMENTS

The same problem exists when using the stringline method to determine the deviation from uniform profile and cross level. The FRA standards allow a 2-inch deviation in profile and a 1 1/4-inch deviation in cross level. The profile measurements at most rail joints where new crossties were installed north of the derailment site were found to be only 1/4-inch to 1/2-inch low but cross level at these locations was as much as 3/4-inch to 1-inch out of level at opposite points on the rails within 19 1/2-feet.

Since the difference in cross level between any two points is related to the profile of each rail, and opposite irregularities within a short distance create an unsafe track condition known as "warp," it is essential to take both measurements at any one point under investigation. Therefore, differences in profile and cross level, which are both plus or minus at the same location, should be added to obtain the total difference in cross level between any two points less than 62 feet apart. This method of evaluation revealed a noncomplying 1 1/2-inch deviation in cross level in 19 1/2 feet of track near the derailment point. (See figure 4A.) Cross level measurements taken in the track revealed that 10 feet south of the point of derailment the east rail was 1 inch higher than the west rail. This section of track may have been disturbed in the derailment. However, the east rail at this point was one-fourth inch lower than the east rail at a point 19 1/2 feet farther north. At the point 19 1/2 feet farther north, the west rail was one-fourth inch higher than the east rail. The measurements were not taken under train static or dynamic loading.

"Amend track geometry standard 49 CFR 213.63, Track Surface, so that it defines "uniform profile," establishes maximum rates-of-change in profile and cross level deviations, and establishes the maximum number of feet between which each profile midordinate measurement and each cross level measurement shall be taken. (Class II, Priority Followup) (R-77-7)
