# NATIONAL TRANSPORTATION SAFETY BOARD

## RAILROAD ACCIDENT REPORT

HEAD-ON COLLISION BETWEEN  
AMTRAK TRAIN NO. 82 AND  
SEABOARD COAST LINE EXTRA 2771 SOUTH  
LAKEVIEW, NORTH CAROLINA  
APRIL 2, 1980

NTSB-RAR-80-8

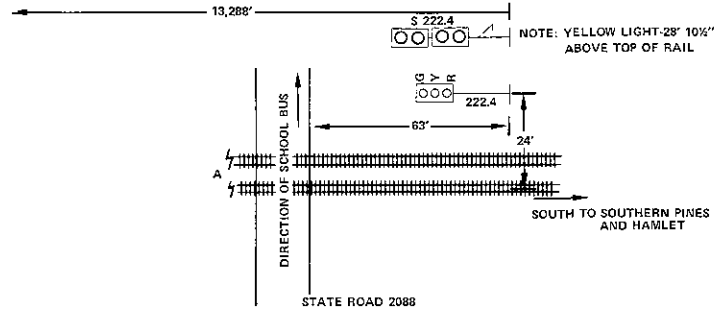
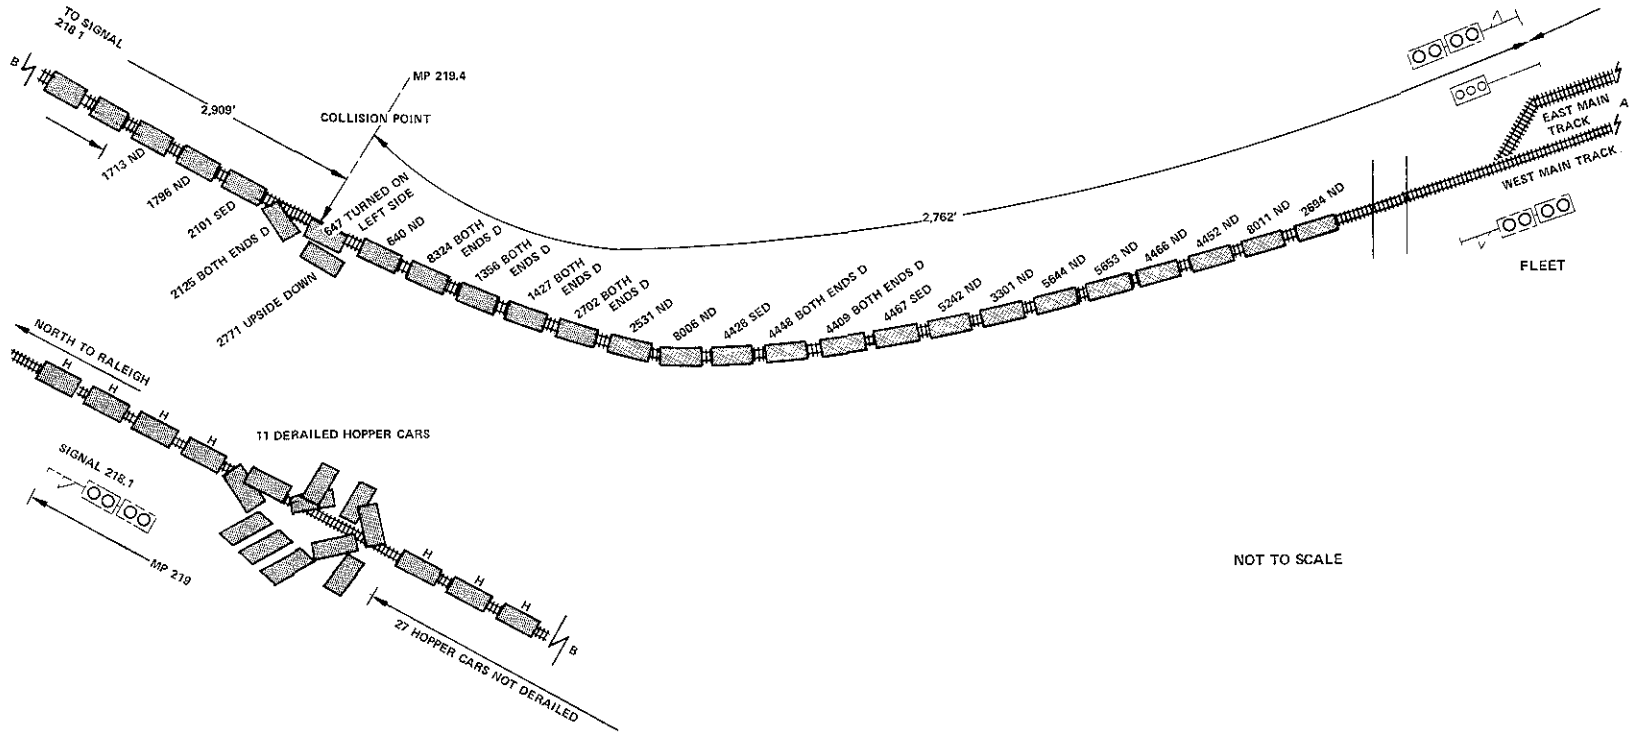
Figure 2.--Derailment site of Train No. 82 and Extra 2771 South.

Just before the engineer sighted the home signal at Fleet Interlocking, he made a brake application to reduce the train's speed for another 50-mph restricted speed curve just north of Fleet. When the train was about 250 feet from the interlocking home signal at Fleet, the engineer saw the "red" aspect through the fog. About the same time, the fireman returned to the operating compartment, and he also saw the "red" aspect, which he called to the engineer as "stop." The engineer repeated the aspect "stop," but he did not immediately put the train's brakes into emergency. The engineer was trying to decide whether to stop the train with a full service brake application and pass the stop signal or to put the train's brakes into emergency and attempt to stop sooner. When he recognized that the track switch was aligned for a southbound train to enter the east track, he put the train's brakes into emergency without hesitating. The train began to decelerate as it passed the "stop" signal, ran through the switch, and moved into the 3° 15' curve to the right, north of Fleet Interlocking. As the train continued northward, the engineer looked across the curve and saw the headlight of an approaching locomotive. He grabbed the radio handset and yelled, "Stop that freight train, I got past the switch at Fleet." The fireman immediately left the operating cab and stepped off the west side of the locomotive without falling, about 250 feet from the impact site. The engineer left the cab and jumped from the east side of the locomotive, about 100 feet from the impact site. The engineer testified that, when he recovered from his fall, he was adjacent to the second unit of train No. 82. (See figure 2.)

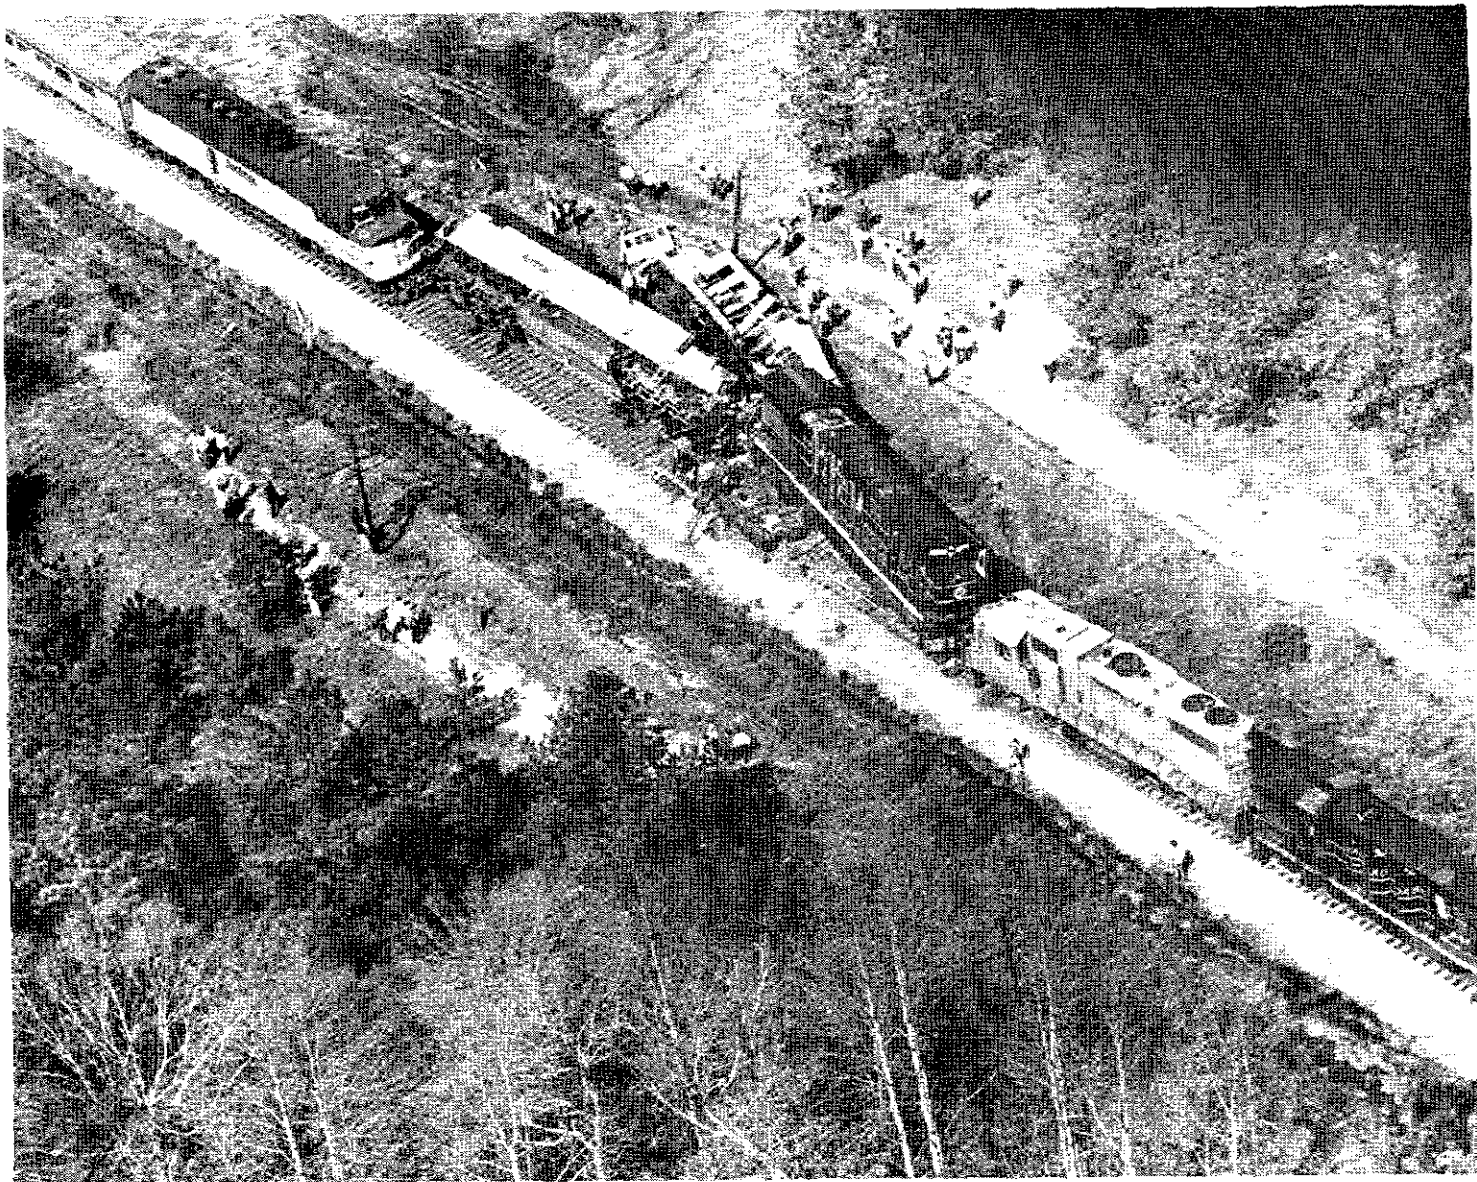
Figure 3.--Aerial view of derailment.

About 7:33 a.m., immediately after the crews jumped from each train, train No. 82, which was either stopped or barely moving, collided with Extra 2771 South, which was moving about 35 mph, 0.5 mile north of Fleet Interlocking. (See figure 3.)

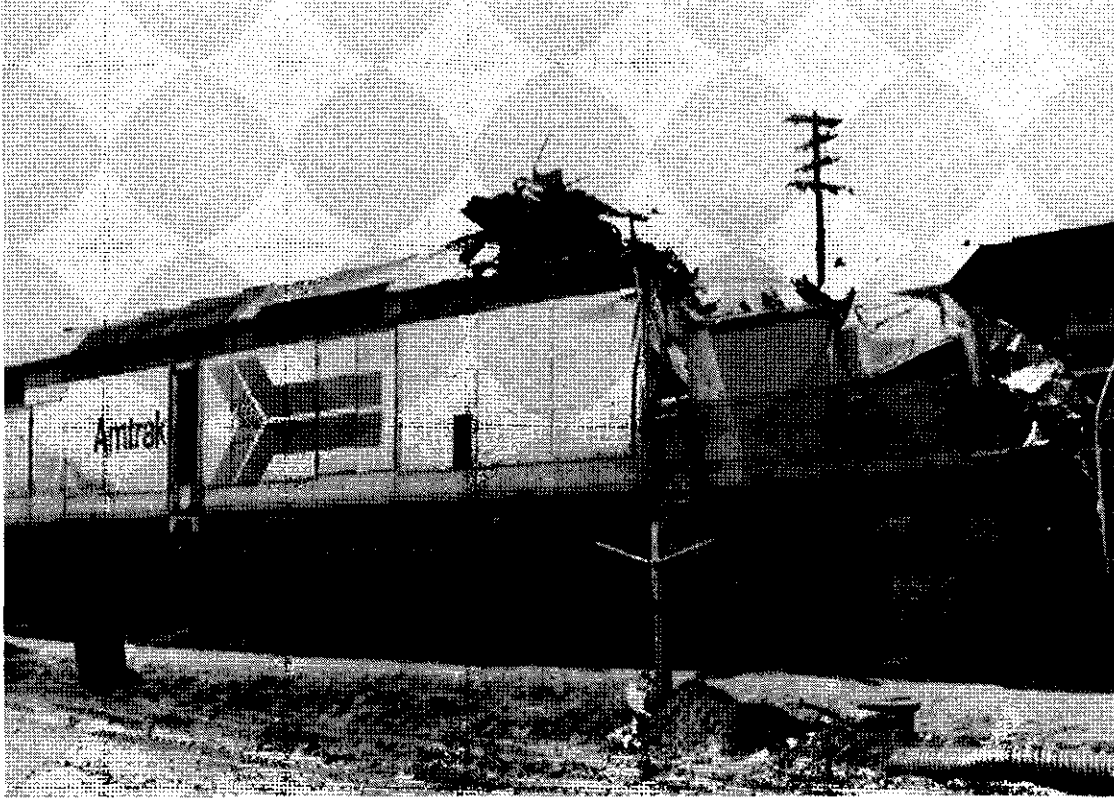
Figure 4.--Locomotive unit No. 647,  
train No. 82

The operating cab of train No. 82, locomotive unit No. 647, was destroyed when the locomotive unit of Extra 2771 South overrode it. (See figure 4.) The second locomotive unit remained upright and it did not derail. The first 10 cars of train No. 82 were derailed, but did not overturn, and all stopped in line with the track structure. The eight rear cars did not derail.

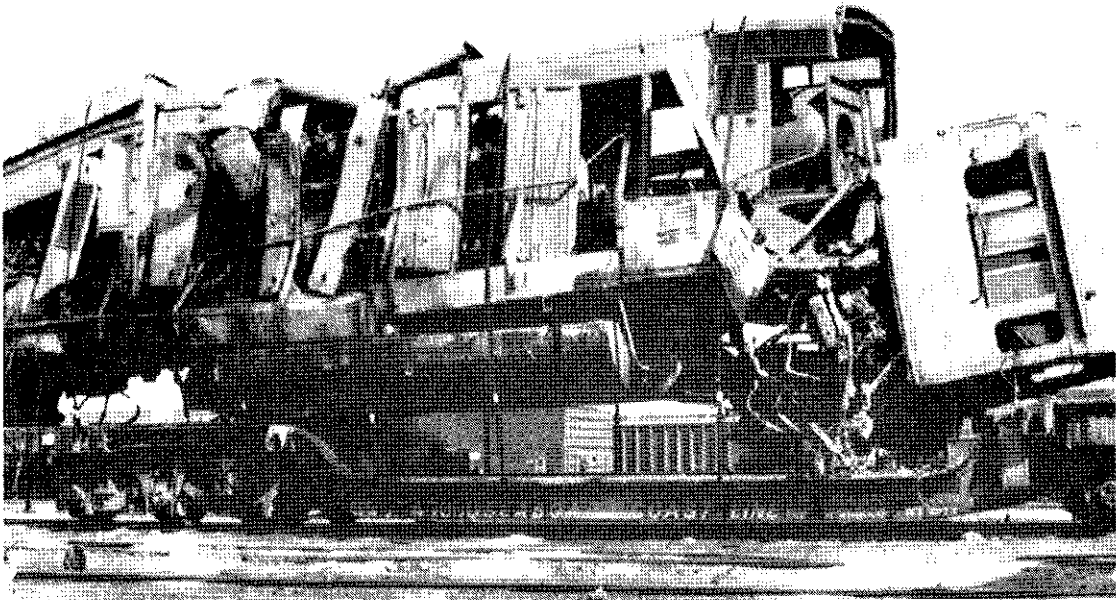
Figure 5.--Locomotive unit No. 2771,  
Extra 2771 South.

The lead locomotive unit of the Extra 2771 South overturned on its top after overriding the Amtrak locomotive unit. The operating cab was badly crushed and the locomotive was a total loss. (See figure 5.) The second unit of Extra 2771 South derailed and the head end moved to the west. The south truck of the third unit of Extra 2771 was derailed, and one wheel of the north truck was inside the overturned east rail. The other 3 locomotive units did not derail and the cars remained on the track, except for cars 28 through 38 which derailed 0.8 mile north of Fleet Interlocking.
