# NATIONAL TRANSPORTATION SAFETY BOARD

## RAILROAD ACCIDENT REPORT

DERAILMENT OF AMTRAK TRAIN NO. 4  
THE SOUTHWEST LIMITED  
ON THE ATCHISON, TOPEKA  
AND SANTA FE RAILWAY COMPANY  
LAWRENCE, KANSAS  
OCTOBER 2, 1979

NTSB-RAR-80-4

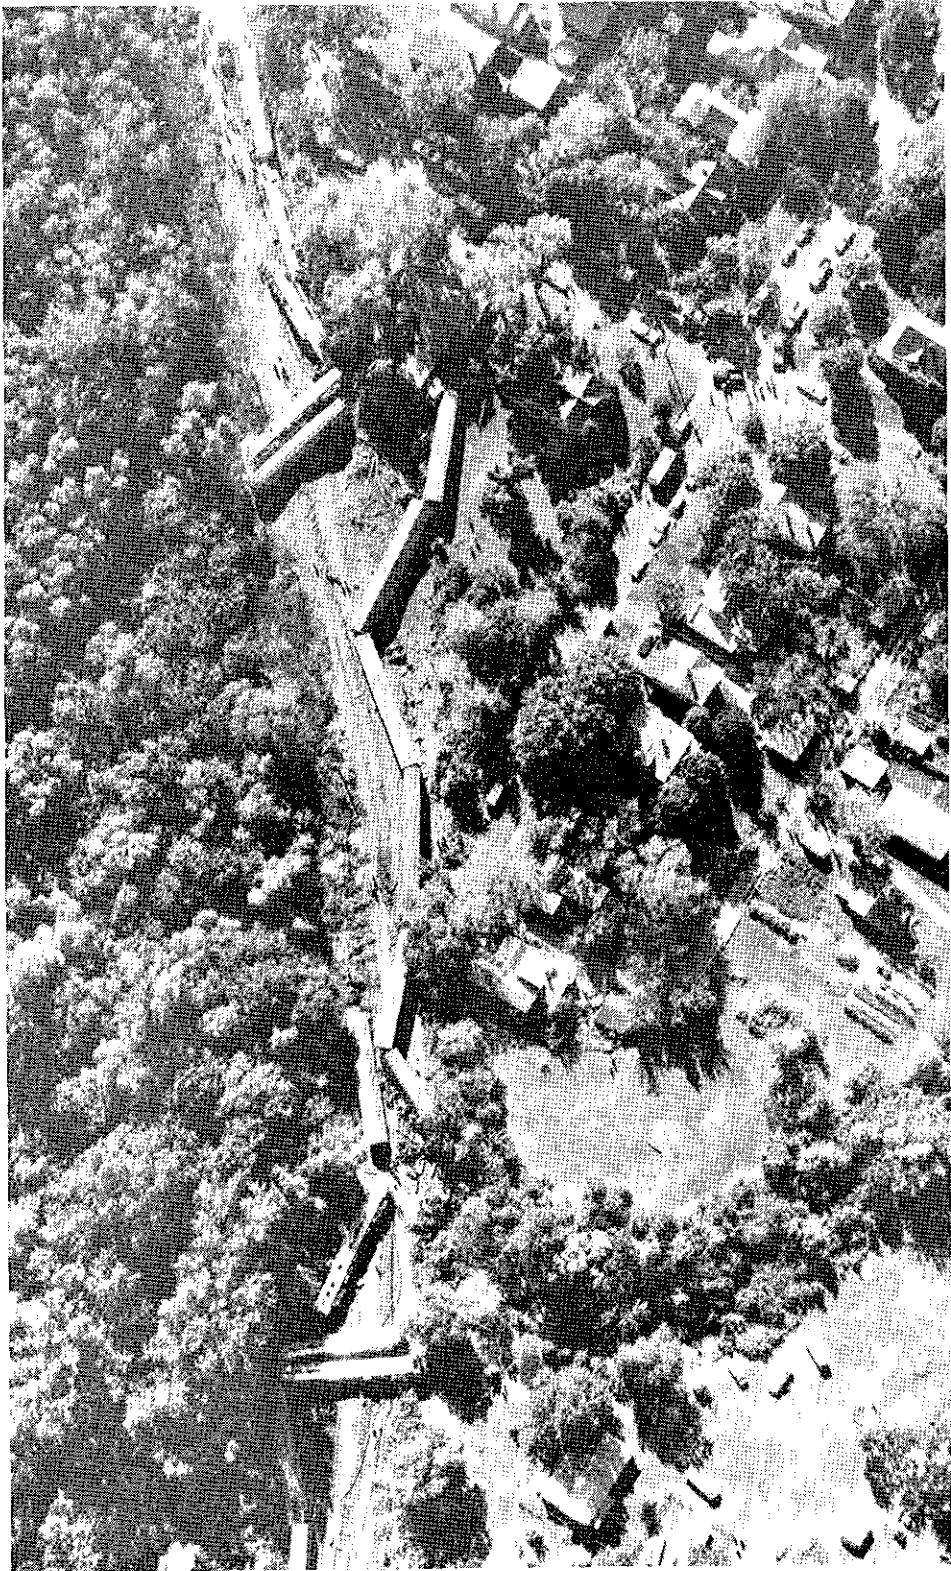
Figure 3.—Aerial view of accident site.

As a result of the derailment 1,400 ft of track and roadbed were destroyed, along with 600 ft of signal and communications lines. Costs of damage were estimated as follows:

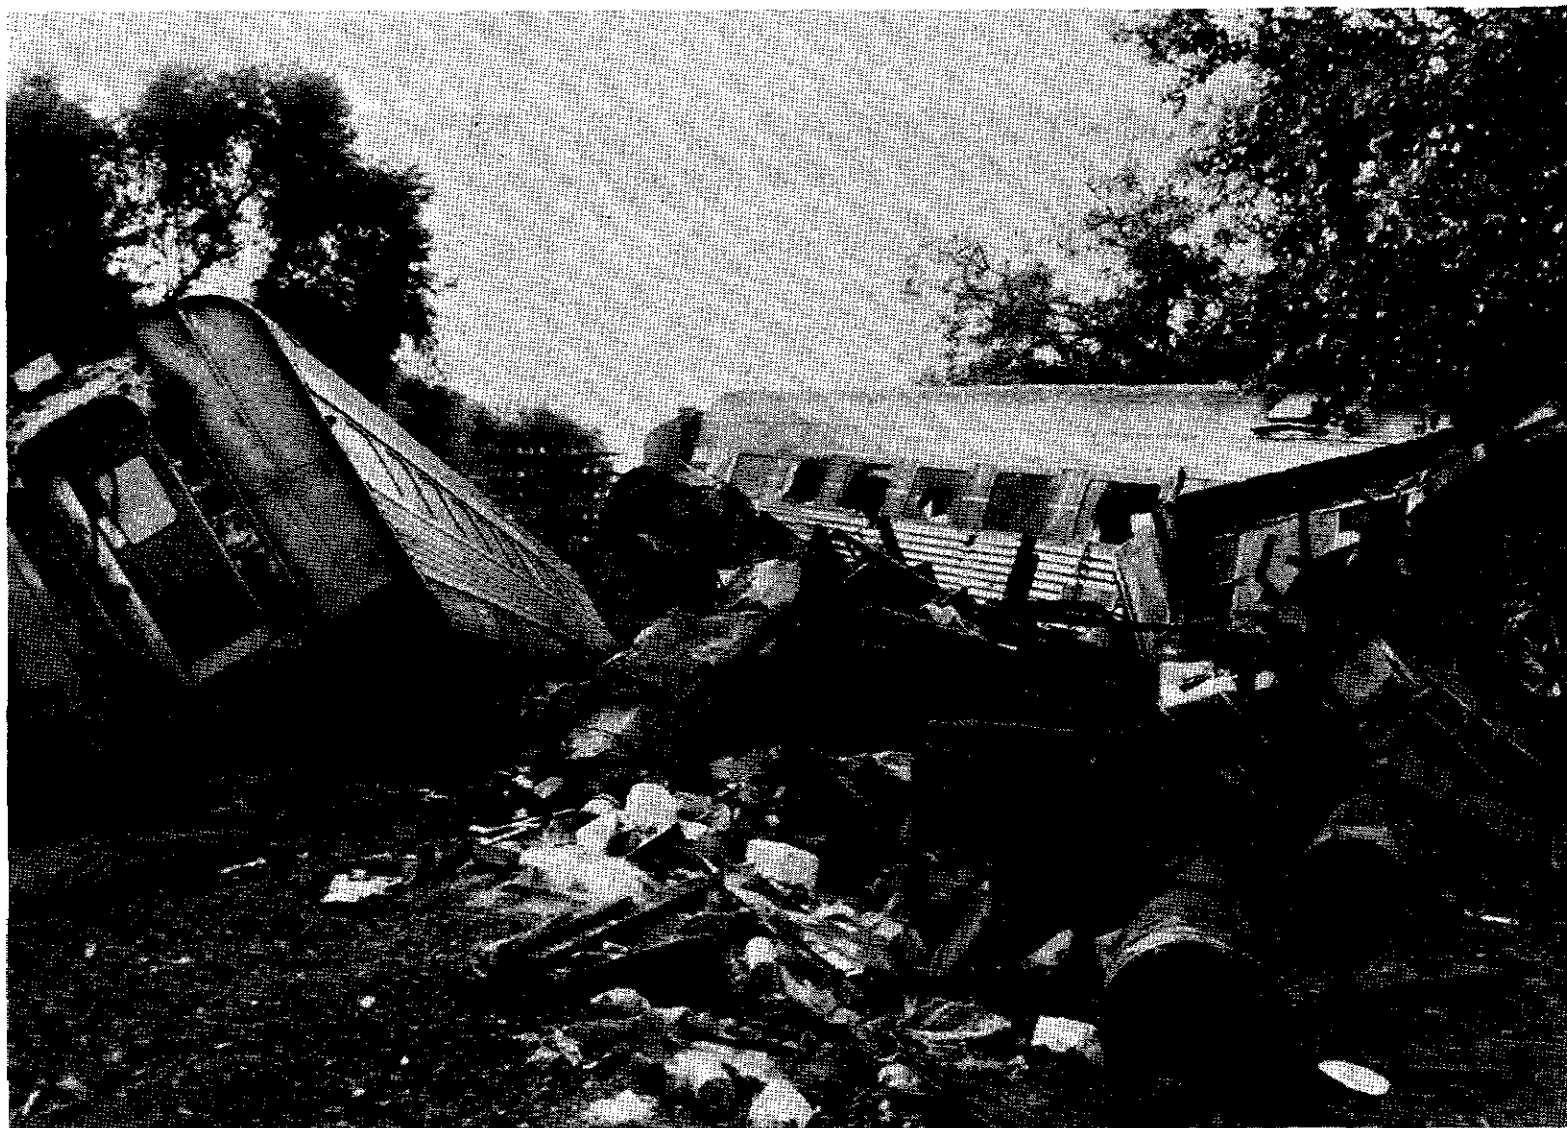
The lead locomotive unit was damaged extensively on the right side. A section of rail passed through the right front of the locomotive near the engineer's seat and out through the roof. The second unit was damaged extensively on the right side; the third unit was damaged extensively on its left side since it was operating with its front rearward when it overturned to the right of the track and slid along the ground. The first three cars were destroyed. The following four coaches sustained considerable interior damage to seats, compartment bulkheads, and doors; the exterior frames and trucks were also damaged. The eighth car, the first diner, was destroyed. Sleeping compartment berths and doors on the ninth car were damaged. The interiors of the next three sleeping cars were destroyed. The last five derailed cars sustained moderate interior damage to the seats and exterior damage to the trucks.

Figure 4.--West end of destroyed diner.

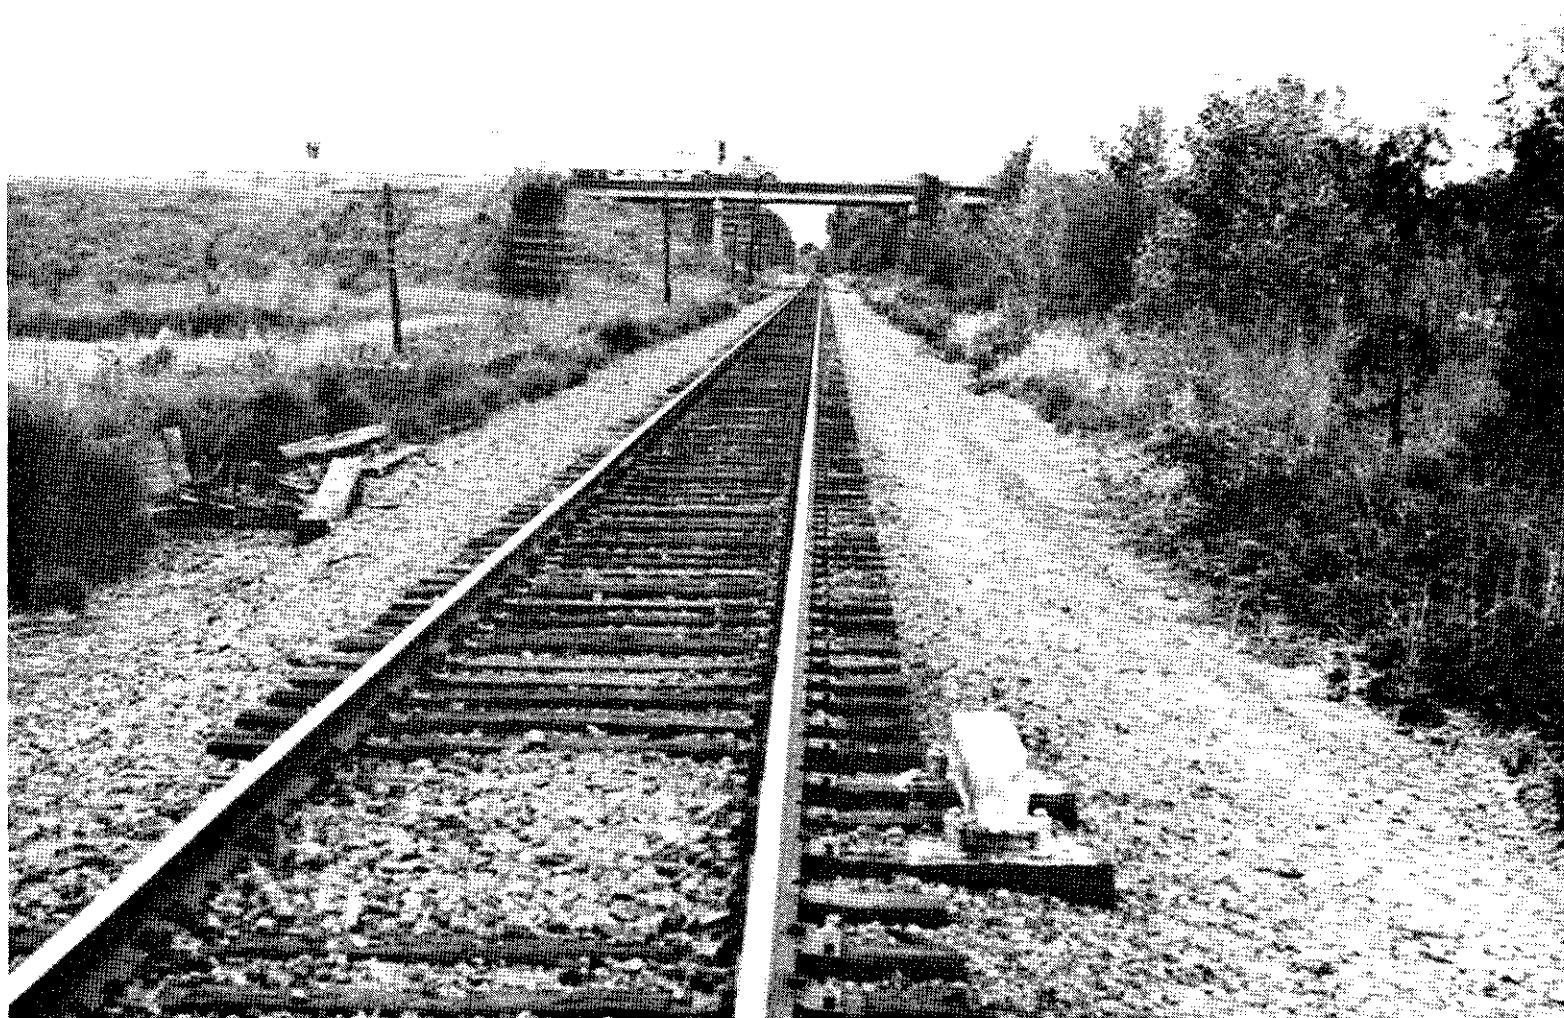
Figure 5.--Inert inductor to outside of right rail on south side of track.

Postaccident inspection of the ATS inert inductor for the six curves at Lawrence indicated that it was in good condition and was properly located. Its height above top-of-rail was 2 7/8 in, which is the proper height according to AT&SF standards.

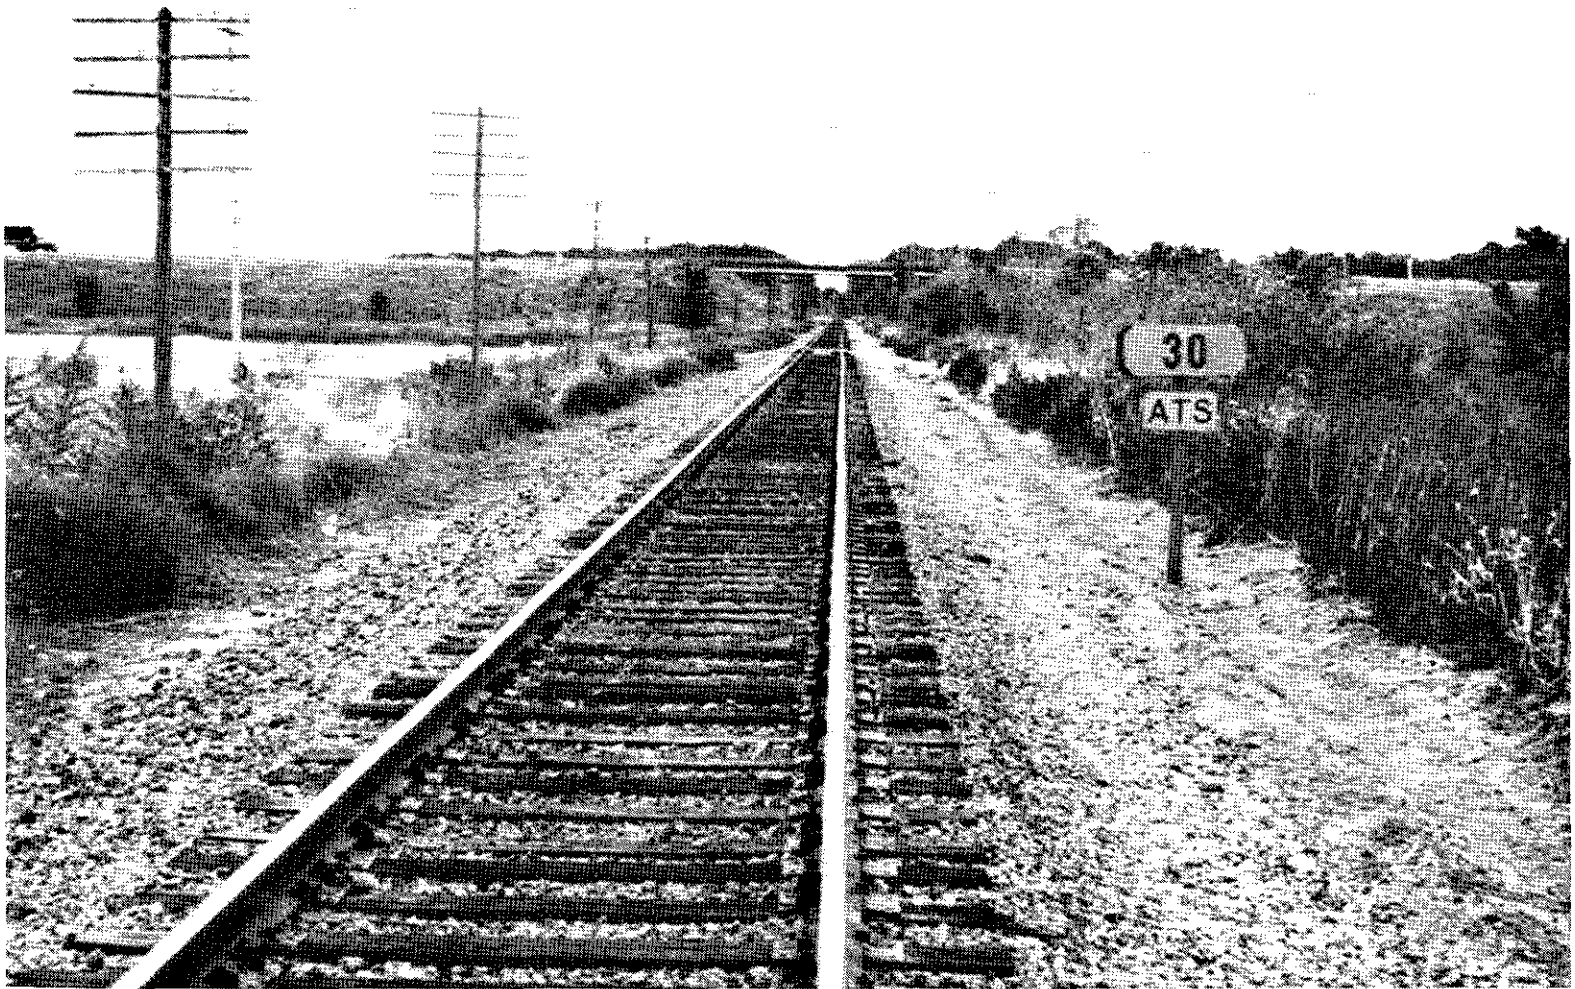
Figure 6.--New 30-mph speed-restriction and ATS signs installed in location of missing 30/25-mph speed-restriction sign on south side of track.

Postaccident inspection of trackside signs approaching Lawrence disclosed that the post with the 30/25-mph speed-restriction and ATS signs that should have been in place 5,838 ft before the first of the curves was not in place. The post with these signs was broken at the ground line and was found lying in the tall grass next to a posthole 14 ft from the south side of the track, 4 ft beyond its proper erected location, about 11 a.m., October 2, 1979, by AT&SF engineering department survey personnel. Investigators could not determine who moved the sign. All other trackside signs in the area were found to be in place except the yard limit sign at milepost 30 which was located about 14 ft rather than the required 10 ft from the track. Track signs 14 ft or more from the track are difficult to see if they are placed in the tall grass of the seldom-maintained edges of the track right-of-way. (See figure 6.)

Since the 30/25-mph and ATS signs and post were found lying in the tall grass near a shallow posthole 14 ft from the track after the accident, and since the engineer of the eastbound train entering Lawrence 20 minutes before train No. 4 did not see the signs, the Safety Board concludes that the 30/25-mph and ATS signs were not standing at the time of the accident and could not be seen by the engineer of train No. 4 who was relying on such signs in the safe operation of his train. Other locomotive engineers and an AT&SF supervisor said the sign had been missing for several weeks before the accident. The sign would have interfered with the crosstie installation and removal in the area, and it is likely that the sign would have been moved to a temporary location or removed to allow passage of equipment when the track gangs and contractor worked in the area. When the track inspector told investigators that the 30/25-mph and ATS signs were in place when he passed the location about 3:30 p.m., on October 1, 1979, it is apparent that he was mistaken or just took no exception to the missing sign.

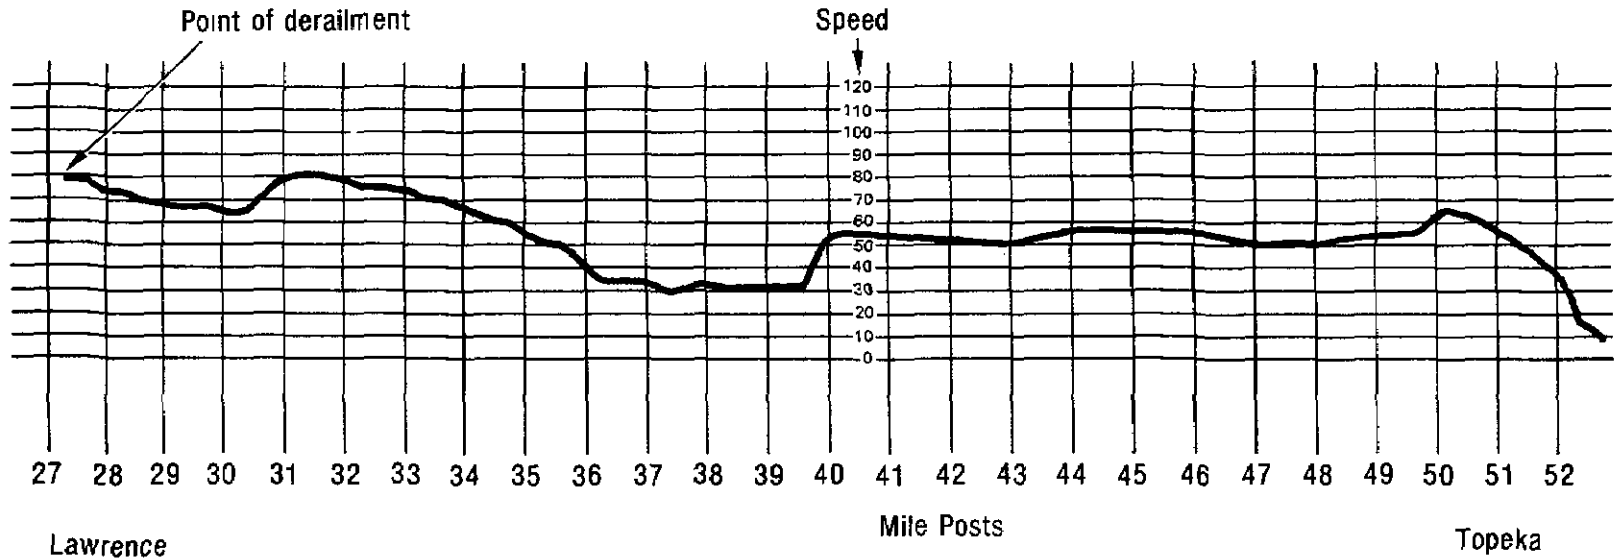
SPEED RECORDER TAPES FROM TRAIN NO. 4

Postaccident inspection of the damaged cars, locomotive units, and pertinent equipment were conducted at both railroad and manufacturer facilities. The inspection of brake equipment on the passenger cars and locomotive units did not disclose any conditions which would have contributed to or caused the brakes to malfunction. Inspection of the trucks and undercarriage of locomotive units did not reveal any defects in the wheels, axles, or suspension systems. The speed recorders on the locomotive units were checked for accuracy; on the lead unit a speed of 78 mph was recorded as 80 mph, and on the second unit a speed of 80 mph was recorded as 75 mph. Examination of the speed recorder tapes indicated the engineer had properly controlled the speed of the train prior to approaching the curve where the accident occurred. (See appendix K.)
