# NATIONAL TRANSPORTATION SAFETY BOARD

## RAILROAD ACCIDENT REPORT

**TRAIN ACCIDENT INVOLVING  
AMTRAK PASSENGER TRAIN NO. 225  
AND AMTRAK WORK EXTRA NO. 4934  
LINDEN, NEW JERSEY  
JULY 9, 1980**

**NTSB-RAR-80-12**

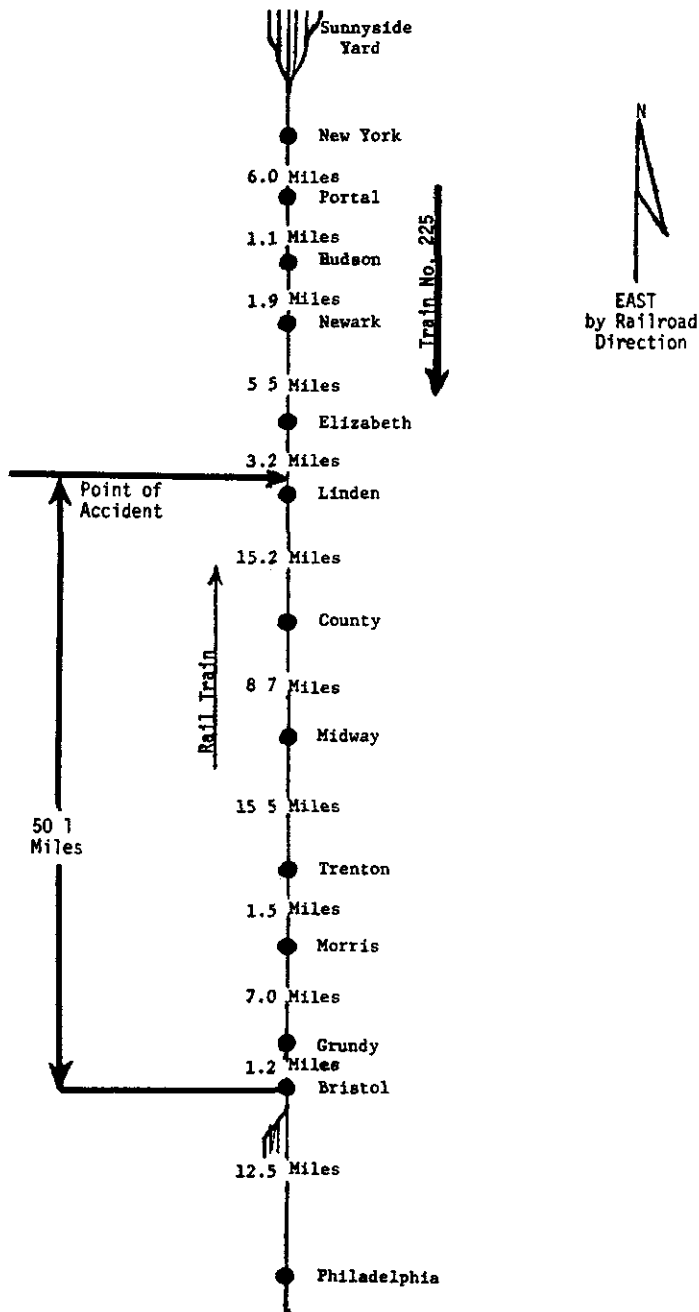
the side of the next to the last railcar, struck and penetrated the first car of passenger train No. 225. (See figure 3.)

Figure 3.-- Plan of locations and distances.

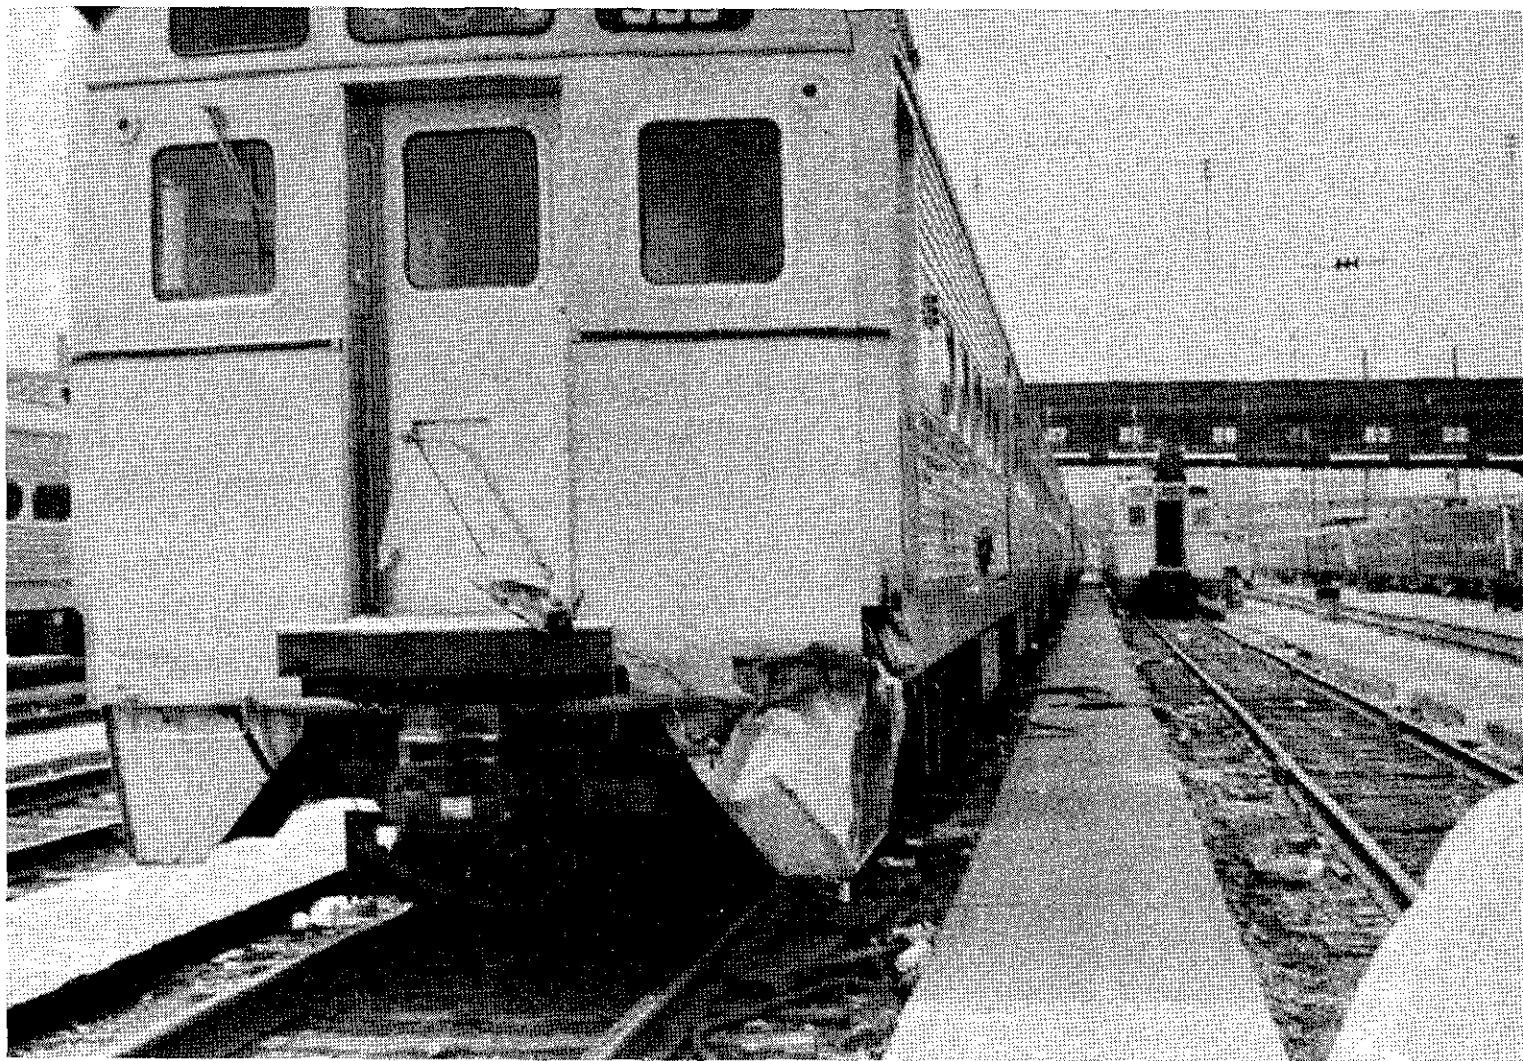
The protruding buffer rail struck the left side (opposite the engineer's station) of the first car of passenger train No. 225 at the steps immediately below the floor. The steps were destroyed. (See figure 4.) The rail then penetrated the side of the car, 26 feet behind the front end of the car, immediately above the floor level and under the fourth window. (See figures 5a and b.) Seat Nos. 7, 8, 9, 10, 11, and 12, and a partition, which was located behind the seats and contained electrical equipment, were extensively damaged.

Figure 4.—Front end of the first passenger car of train No. 225.

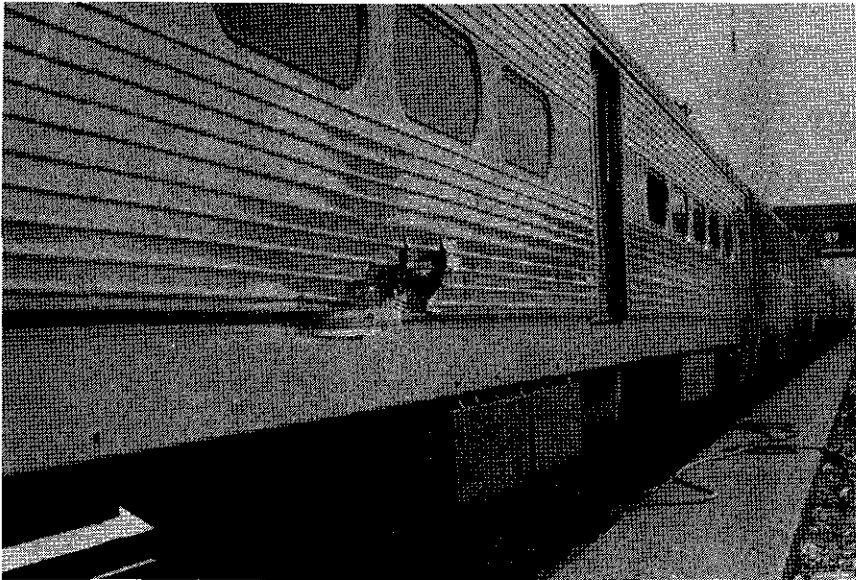
Figure 5a.--Exterior entry of rail of first passenger car of train No. 225.

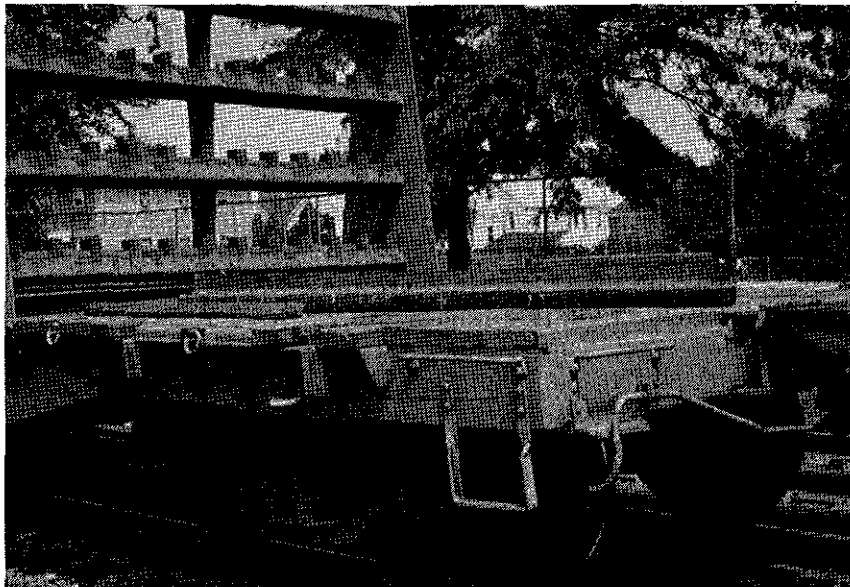
An inspection of the track disclosed that five sections of buffer rail and seven joint bars, which had fallen from Work Extra No. 4934, were found lying along track No. 3 between Bristol Yard and the accident site. An inspection of the railcars of Work Extra No. 4934 after the accident revealed 5 sections of buffer rail and 13 joint bars lying loosely on two of the last three railcars, and two tie plates, one pin, and 100 rail anchors lying loosely on the anchor car. (See figures 6 and 7.)

Figure 6.--Loose rails lying on the 31st car of Work Extra No. 4934.

As a train moves over the rails, vibration of the car floors would cause the dangerous condition of loose material, buffer rails, and rail joint bars moving to the edge of the car floors and falling from the car to the ground. As the buffer rails fell from the railcar, one rolled under the last railcar and damaged a brake beam of that car and a brake beam on the following gondola car. It was probably these damaged brake beams that struck and activated the dragging equipment detector at County.

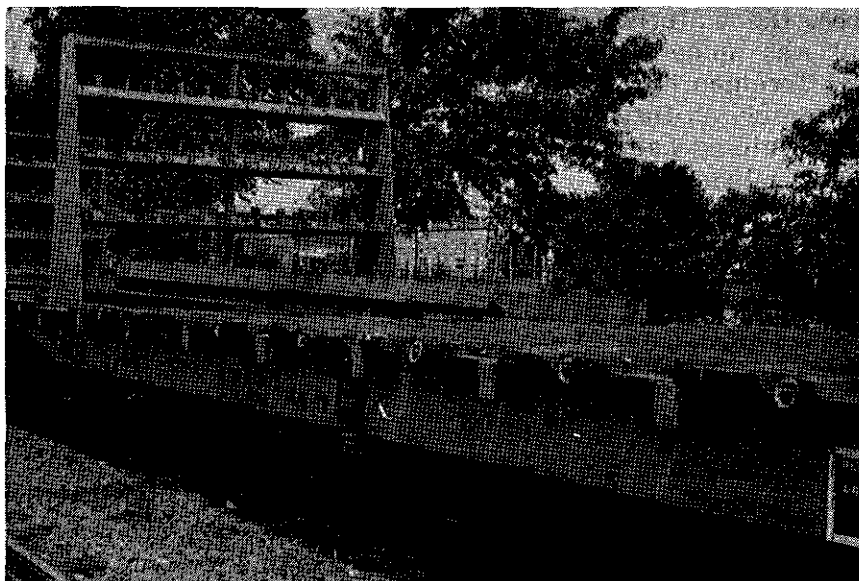
Figure 7.--Loose rail lying on the 32d car of Work Extra No. 4934.
