NATIONAL TRANSPORTATION SAFETY BOARD

NATIONAL TRANSPORTATION SAFETY BOARD
Washington, D.C. 20591
REPORT NUMBER: NTSB-RAR-75-1

**DERAILMENT OF AN AMTRAK TRAIN
ON THE TRACKS OF THE ATCHISON,
TOPEKA AND SANTA FE RAILWAY COMPANY AT
MELVERN, KANSAS
JULY 5, 1974**

ADOPTED: FEBRUARY 5, 1975

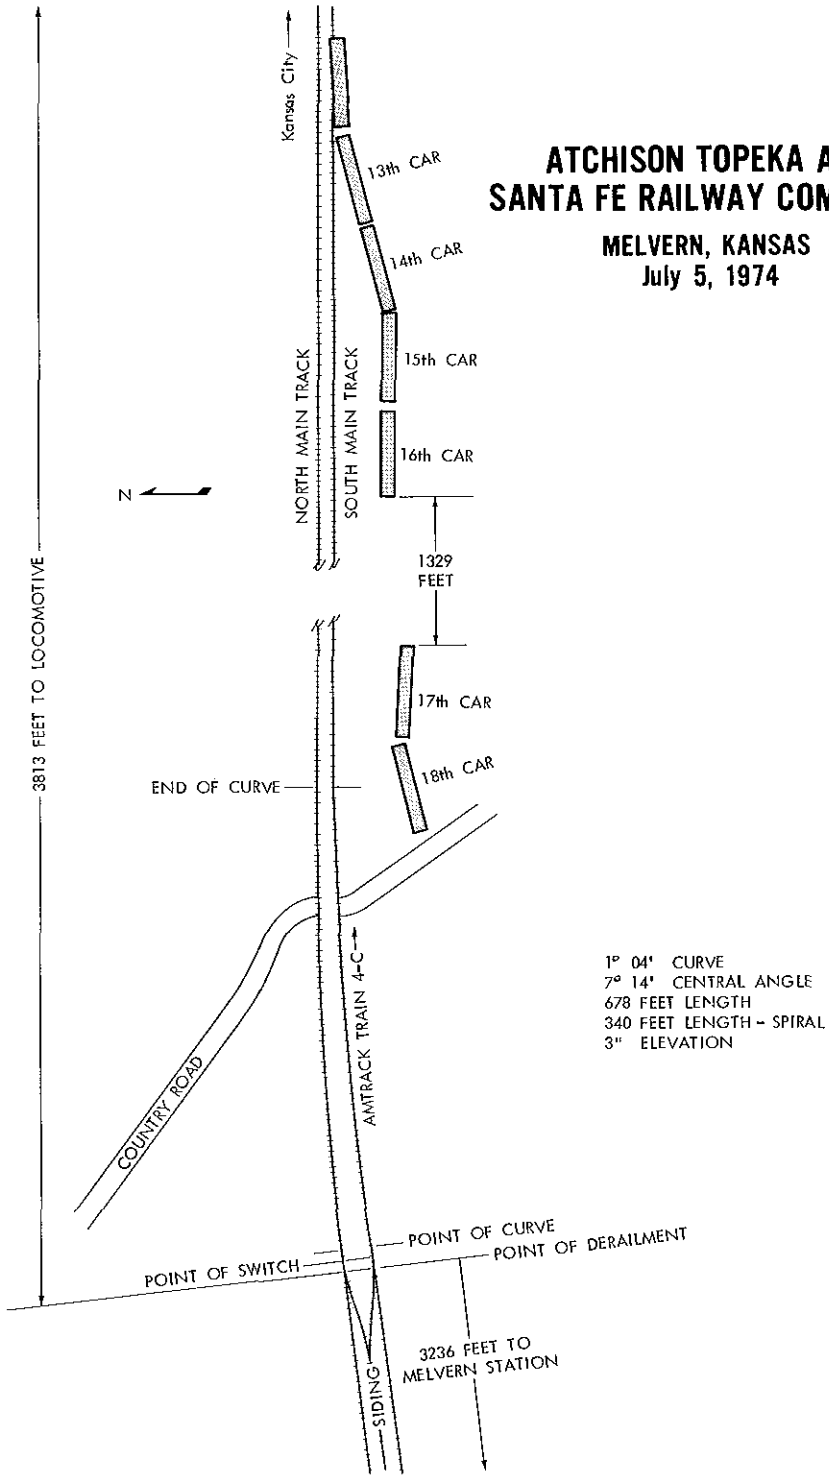
Figure 1. Area of the derailment.

Marks of the Derailment and Damage to the Track. -- The rail ends adjacent to the straight closure rail and the switch point of the east siding turnout were broken. The first wheel marks of the derailment appeared on the track structure beyond the gap in the north rail which had been created by the broken rail ends. Wheel marks appeared on the ties and base of the rail between the switch point and the running rail. The switch point was displaced southward. Eastward from the switch, the south rail of the main track was displaced southward for a distance of 2,400 feet. Ties were destroyed or heavily damaged where the rail was displaced.

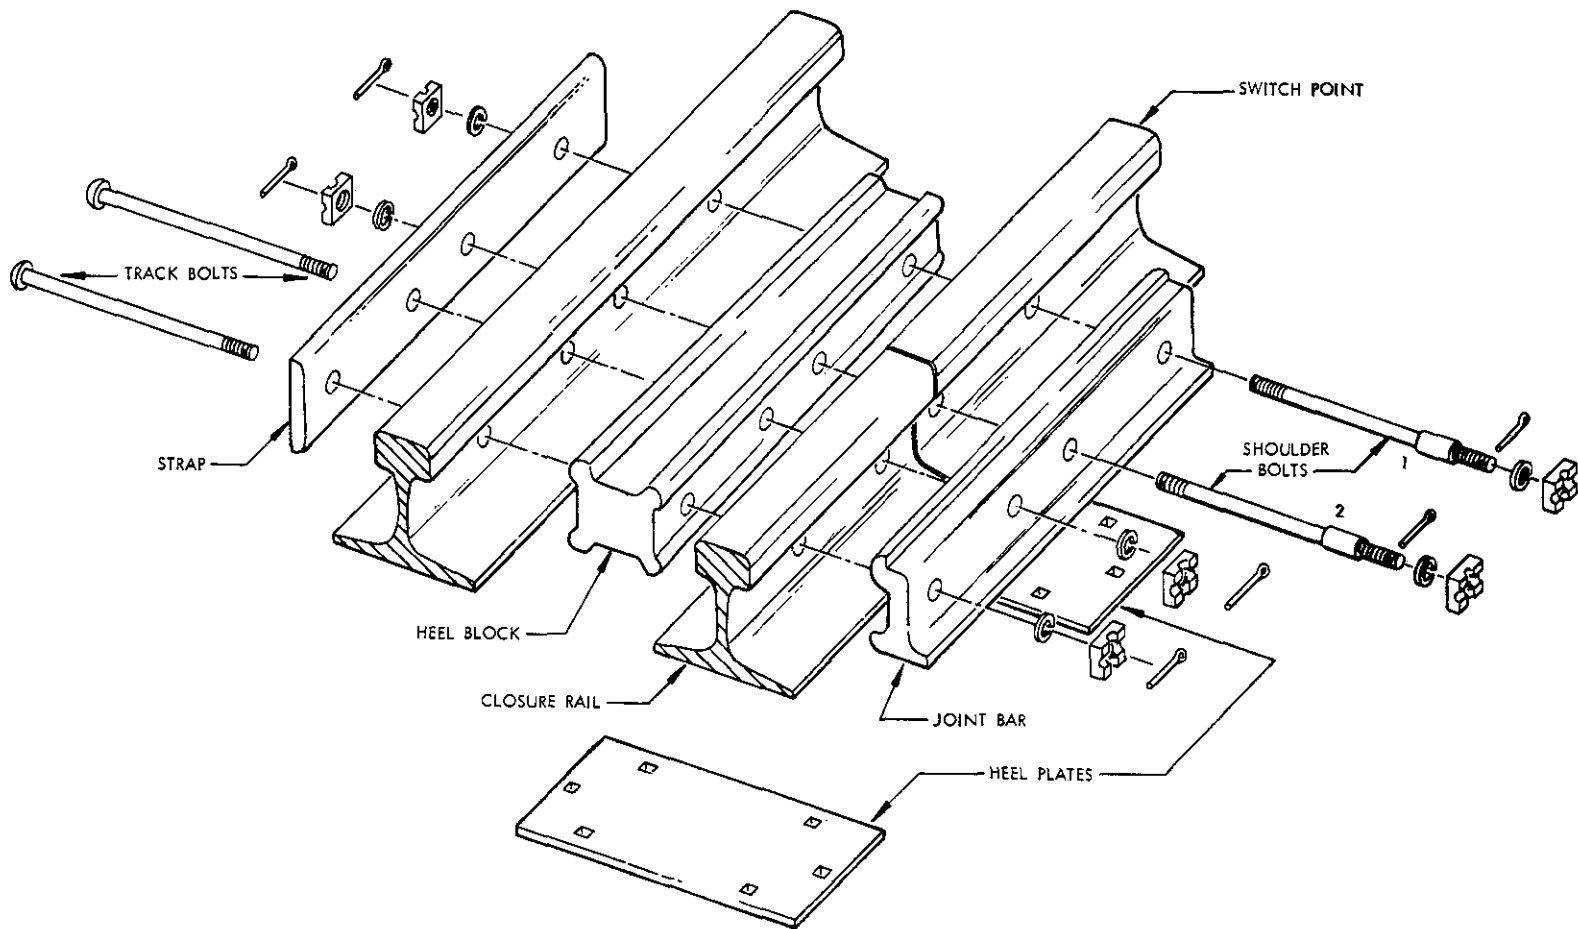
Figure 2. Assembly diagram of the heel portion of a 16-ft. switch.

A right-hand turnout, with 136-lb. rail, 16-foot 6-inch switch points, and a No. 10 spring-rail frog, connects the east end of the siding with the south main track. The straight closure rail is 30 feet long and was also installed in October 1965. The closure rail is connected to the switch point by a four-bolt heelblock assembly. The signal bond wires span the heelblock and are connected to the rails on each side of the heelblock. (See Figure 2.)

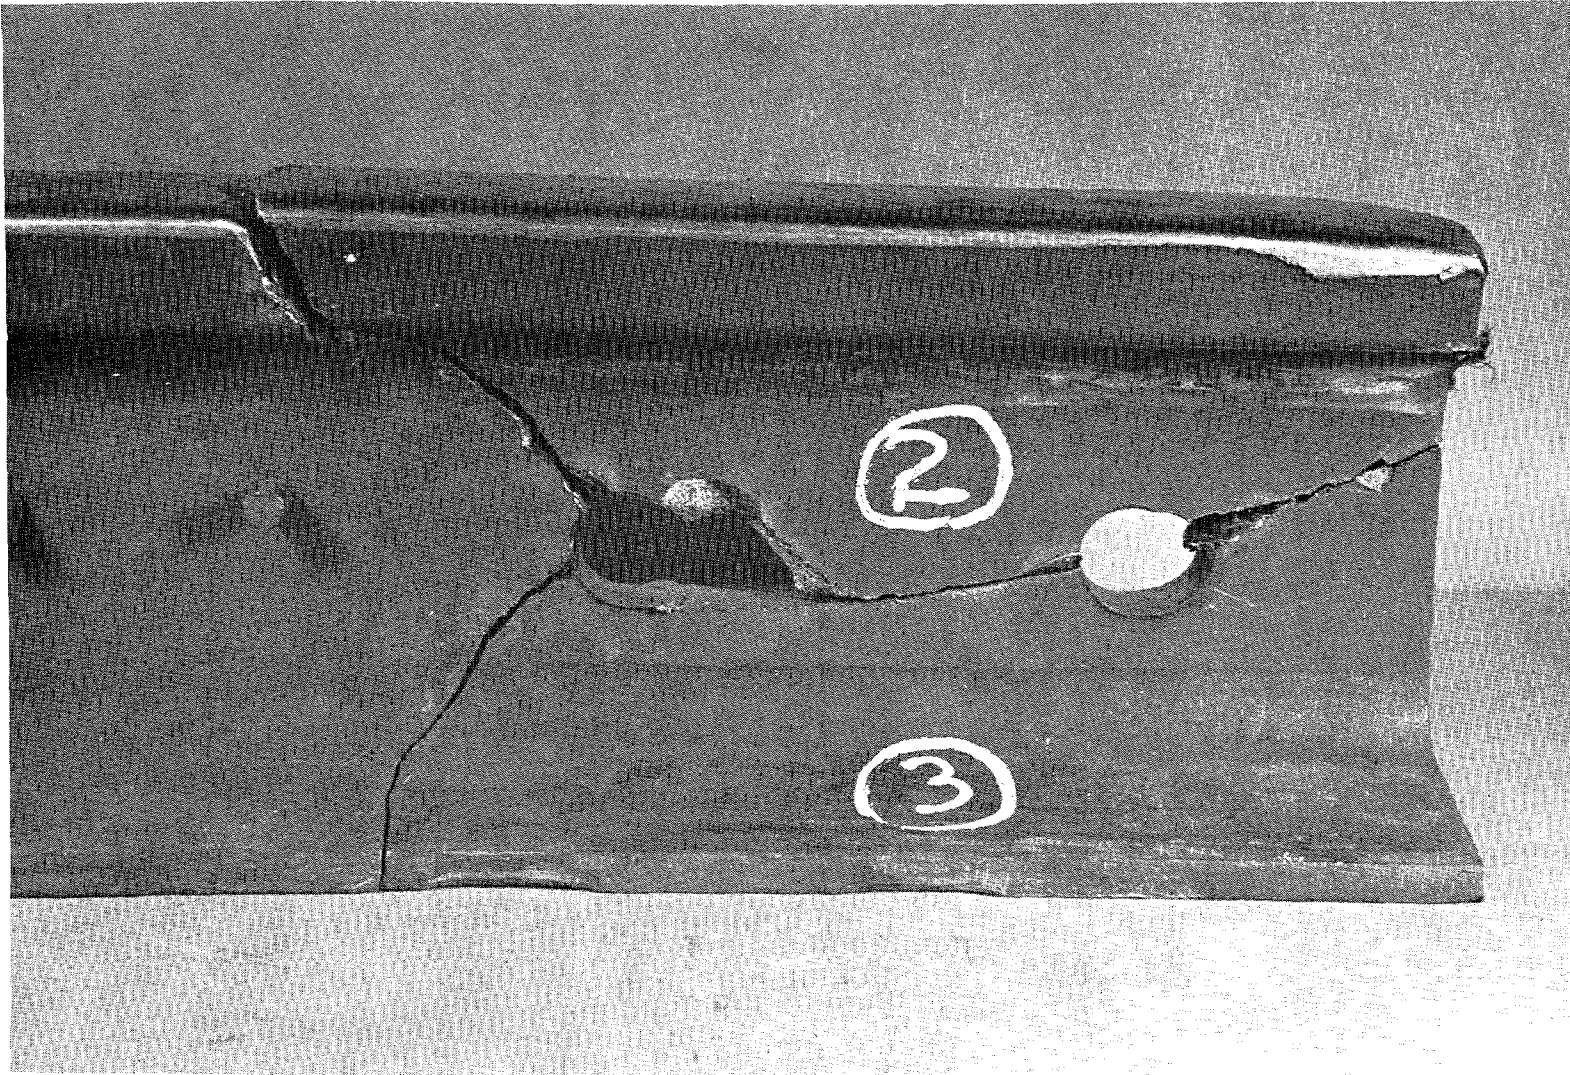
The original crack of the straight closure rail began at the first bolt hole and progressed 4 3/4 inches to the second hole and 3 inches to the rail's end. The crack then progressed rapidly up through the head and down through the base. (See Figure 3.) Rubbing between the bolt holes and the end of the rail had deformed the surfaces of the crack. The other broken surfaces of the closure rail and the switch point were bright and contained a granular structure with a minimum of plastic flow which indicated a rapid brittle cleavage fracture. The broken head of the switch point was not found.

The ends of the rail heads adjacent to the broken portions of each rail had been battered. On the closure rail, the battered surface was 3/4-inch long by 5/16-inch deep.

Figure 3. Closeup of bolt hole break in straight closure rail of switch.

The examination of the broken closure rail disclosed that the original fracture between the bolt holes and the end of the rail had occurred before the accident. The fractured surfaces had been distorted from rubbing against each other. The other fractures of the closure rail and all of the fractures of the switch point were bright and well defined, which indicated that they were recent.

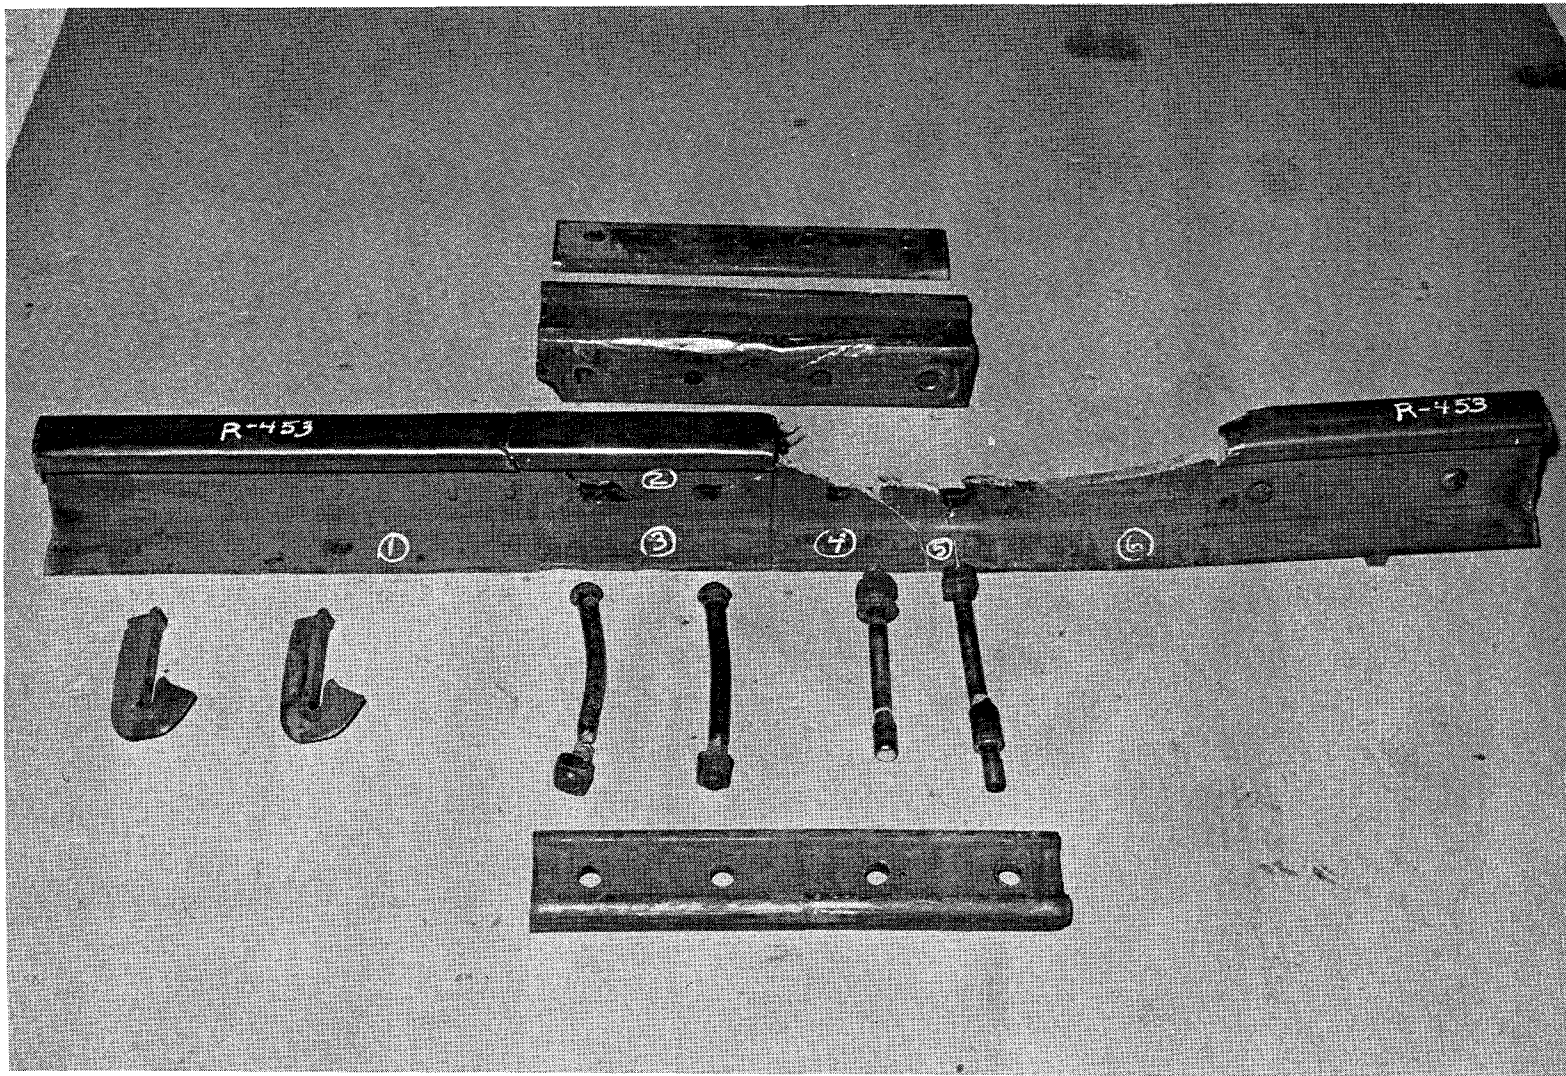
An examination of the broken rails disclosed that 13 5/8 inches of the head of the east end of the straight closure rail, 24 1/4 inches of the head of the west end of the switch point, and the corresponding sections of the web and base were broken and dislodged. The heelblock bolts were broken and the joint bars were found on the ties near their original positions. The heelblock was found about 75 feet north of the track.

Figure 3A. Broken switch involved in derailment at Melvern, Kans., July 5, 1974.

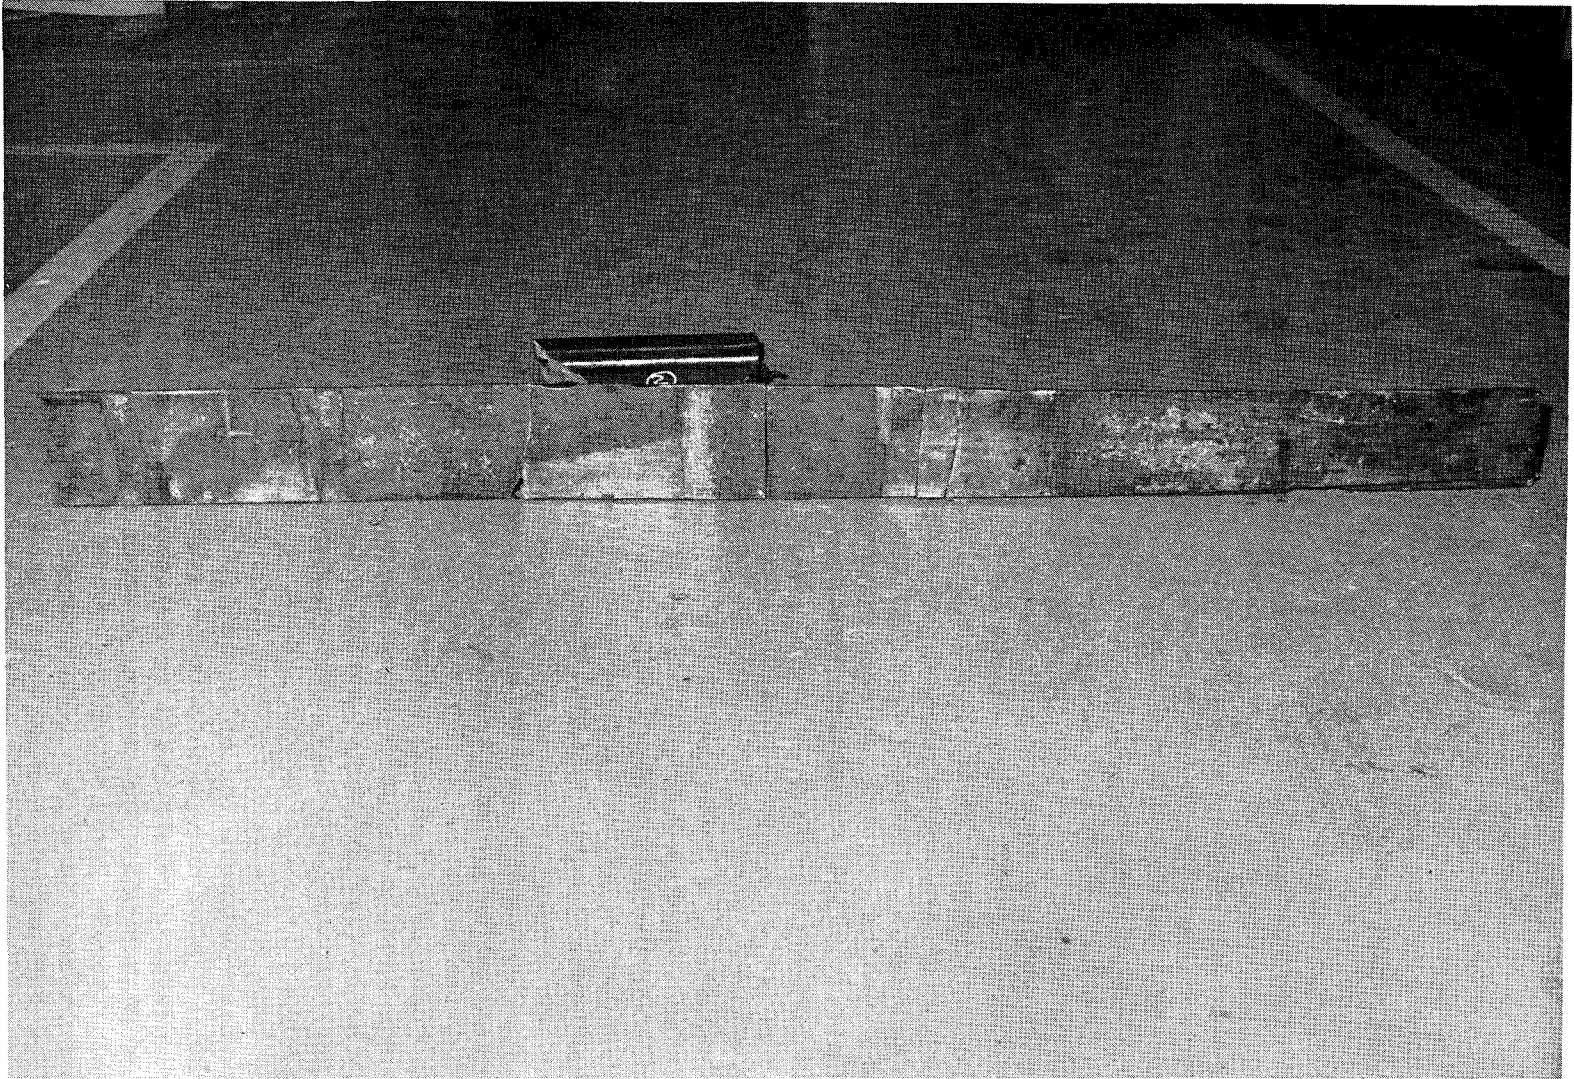
Wear marks on the underside of the base near the end of the closure rail indicated that the heelplate had provided uneven support. (See Figure 4.) Other support areas along the base of the switch point and the closure rail indicated that the plates had provided support evenly throughout the width of the base. However, in the area where the rail fracture initiated, support had been provided only along one side of the base.

Figure 4. Base of broken switch showing rail support.

Based on the examination of the track bolts after the accident, which disclosed that one of the bolts was softer and had a lower tensile strength than the other bolts, this bolt probably broke first and caused more stress to be placed on the other bolts. Of the two bolts that initially failed, the one with the lower strength showed evidence of a rapid fatigue fracture. The fractured surfaces of both bolts had corroded sufficiently to indicate that they had been exposed to water. These bolts would have had to break before the track inspection on July 3 since there had been no rain in the area between the dates of inspection and the accident. (At this location, the only plausible exposure to water would have been from rain.) The uneven support beneath the area may have resulted from a bent plate, a twisted rail or switch tie, or for several other reasons. No matter what the reason, however, the results would have been the same--additional stress would have been placed on the closure rail when a train passed over it. In turn, more stress would have been placed on the web of the rail at the bolt-hole area. The stressed condition

could have been responsible for the original fracture. The wear pattern indicated that the condition had existed for some time.
