PB94-916301
NTSB/RAR-94/01

RAILROAD-MARINE ACCIDENT REPORT

DERAILMENT OF AMTRAK TRAIN NO. 2
ON THE CSXT BIG BAYOU CANOT BRIDGE
NEAR MOBILE, ALABAMA
SEPTEMBER 22, 1993

Adopted: September 19, 1994
Notation 6167B

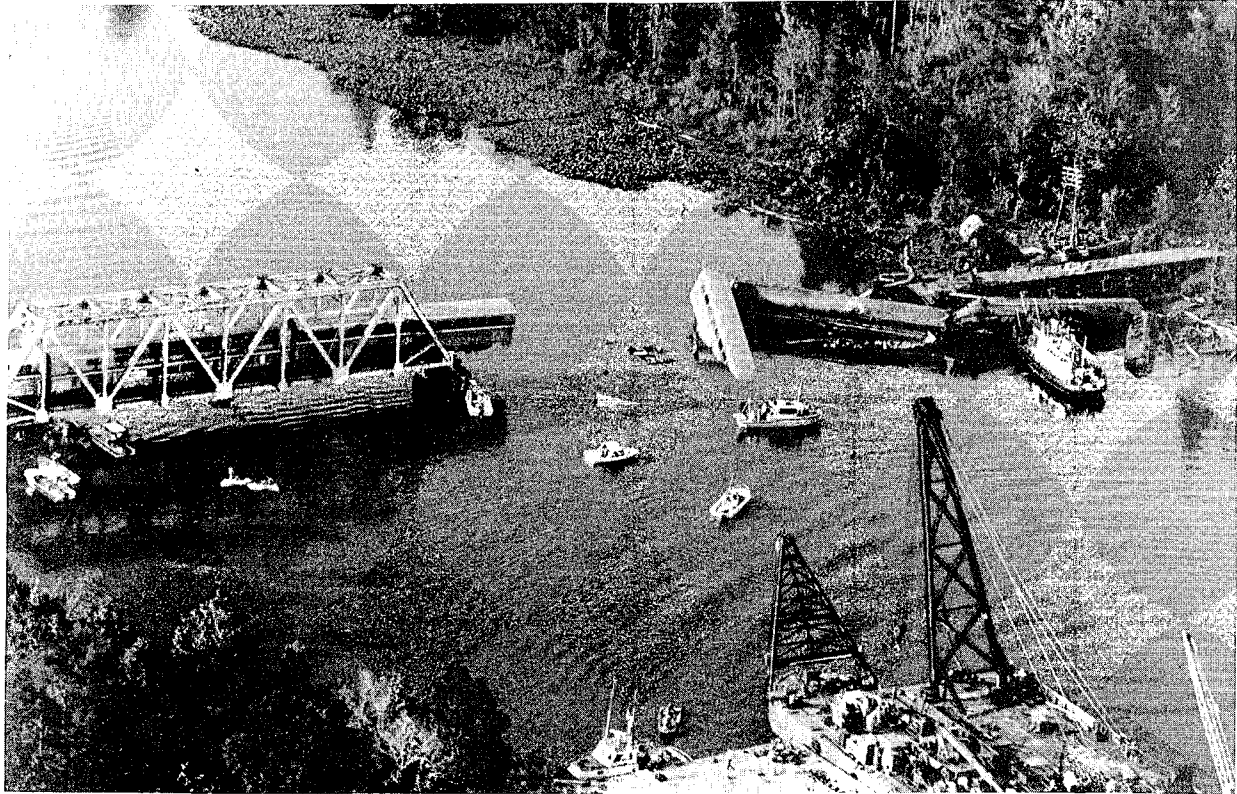
The conductor described the trip from Mobile to the accident site as uneventful. He said the locomotive crew called all signal indications over the radio, and he repeated them over his portable radio.⁸ According to the assistant conductor, he last talked with the locomotive crew before the accident when the engineer called to thank him for bringing coffee at Mobile. The assistant conductor last remembered the locomotive crew calling the signal at Bayou Sara, mile post (MP) 658.4; the call was "clear" and the conductor repeated it to them shortly before the derailment. The train accelerated toward the Big Bayou Canot bridge and, traveling about 72 mph (authorized speed was 70 mph), struck the displaced bridge girder and derailed at MP 656.7 about 2:53 a.m. (see figure 5).

Figure 5.--Photograph of accident site.

Following the derailment, the three locomotive units came to rest on the east side of the bayou. Part of the lead unit, 819, was buried in about 46 feet of mud, and the part protruding above the embankment burned. The second unit, 262, also burned. The fuel tank of the third unit, 312, separated from it, and all equipment along the bottom of the unit below the frame was sheared off.

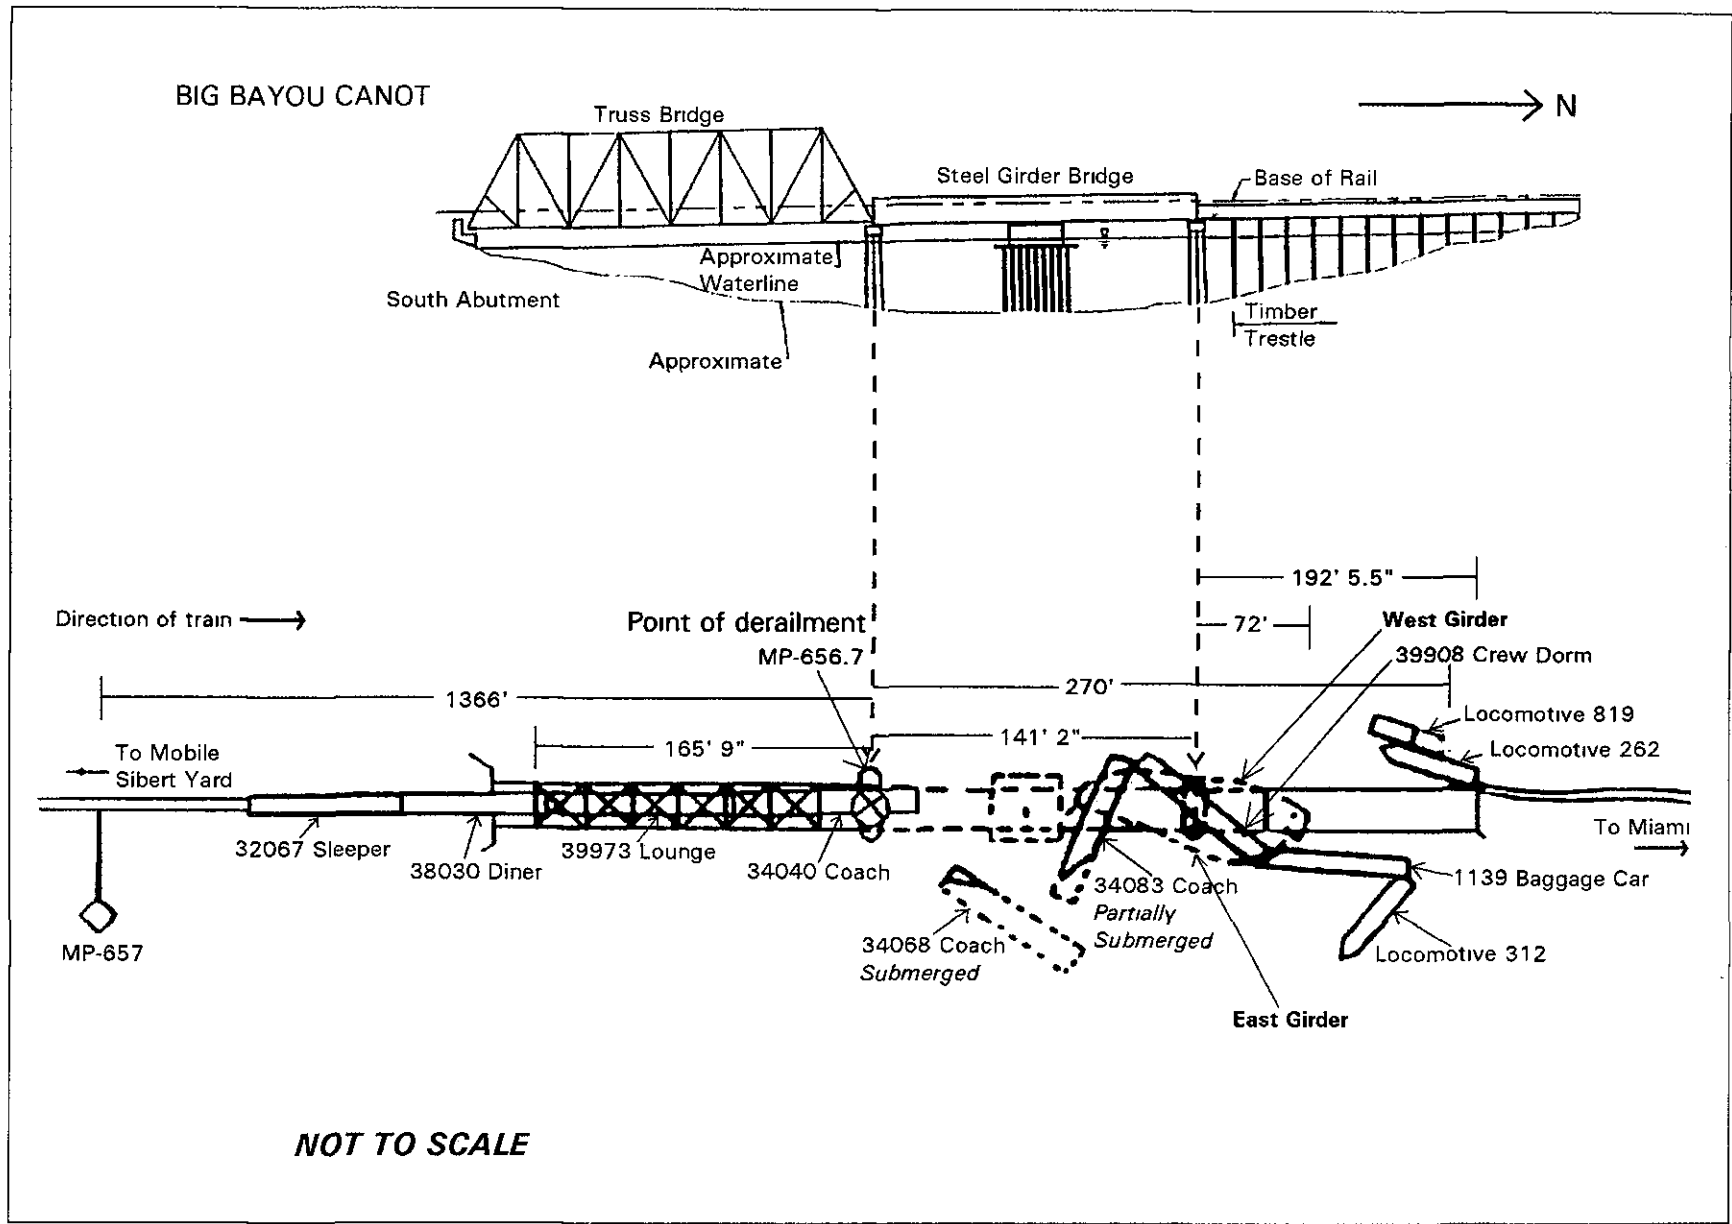
Baggage car 1139 and dorm-coach 39908, also on the east side of the bayou, were gutted by fire, and parts of both cars sustained major structural damage. About half of coach 34083, which rested against the bridge after the accident, was submerged, and coach 34068 was almost totally submerged. The next four cars, coach 34040, lounge 39973, diner 38030, and sleeper 32067, remained on the bridge. All passenger cars were double-decker cars. (See figure 6.)

Figure 6.--Diagram of accident scene.

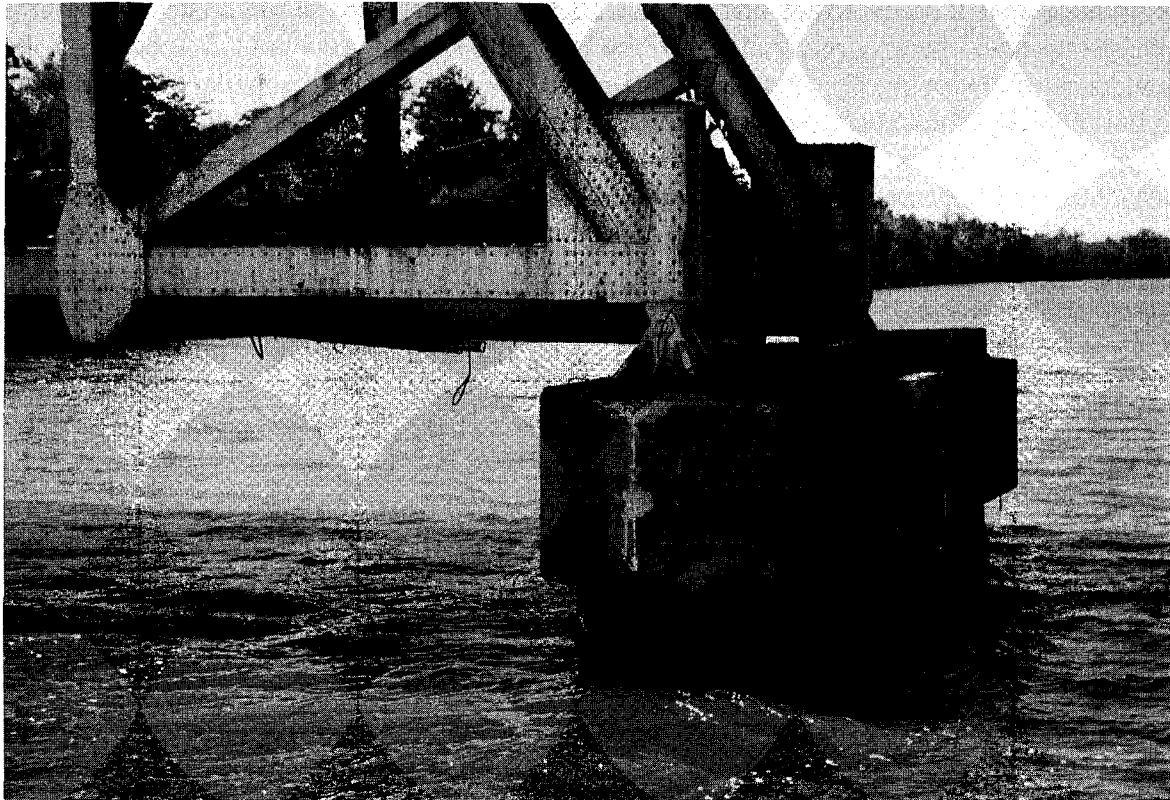
The nose of the south pier sustained some concrete spalling (chipping or scaling) from the MAUVILLA's lead port barge (see figure 7). The east edge of the sole and filler plates for the east girder's south bearing came to rest on the west edge of the east pedestal and the west edge of the pier cap plates. The west girder plates were found on the pier cap adjacent to the west edge of the west pedestal. The bottom of the east girder sole plate had large radius lateral striations (grooves or channels), and the west sole plate had straight lateral striations.

About 15 feet of the top flange of the east girder, beginning at the south girder face, was separated from the web. Part of the top of the plate over this 15-foot section was "accordianed", the rest of the top flange was comparatively undamaged. The web sustained two tears, one extending from the top to the bottom flange and a large horizontal tear between the fourteenth and seventeenth stiffeners. The bottom flange had two indentations, 21 inches and 22 inches wide, respectively, on the bottom east side.

The girders, which were about 40 feet apart laterally at the widest point, were displaced some 70 feet to the north. The northernmost and two southernmost floorbeams remained connected to both girders. The other eight floorbeams were severed from the east girder but remained connected to the west girder. The stringers remained connected to the floorbeams. Concrete had broken off the east angular nose of the pier that supported the south end of the girders and off part of the north edge of the pier cap. Surface evidence indicated the fractures were recent.

Figure 7.--Collision marks on Big Bayou Canot bridge.
